PROPERTY INSPECTION REPORT

Concerning: 508 Tishomingo Road

Waxahachie, Texas 75165 (City, State, Zip)

September 22, 2004

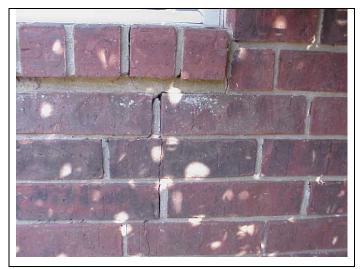
- 1. The foundation has shifted in one or two areas evident mainly by a hairline crack in the brickwork on the bedroom side of the house and slight separation between one window frame and brickwork. Also, there is a larger crack in the brickwork on the garage side wall. Also, there are cracks in garage drywall. Also, there are repaired cracks in the brickwork mortar under the utility room window and cracks and repaired cracks in the drywall over the utility room door. Also, the utility room door does not latch properly. Recommend a structural engineer and/or drainage specialist be consulted for further evaluation.

Hairline crack, bedroom side

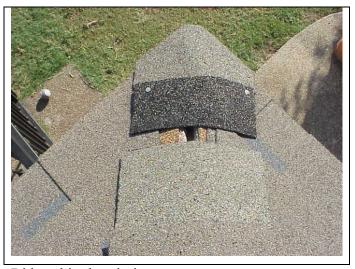
- 2. There is at least one missing ridge shingle from the roof over the garage area with exposed underlying materials. Recommend a roofer be consulted for further evaluation/repairs and check for other repairs that may be needed at that time.

Ridge shingle missing, garage area

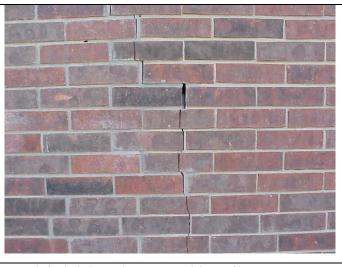
Crack in brickwork, garage side wall

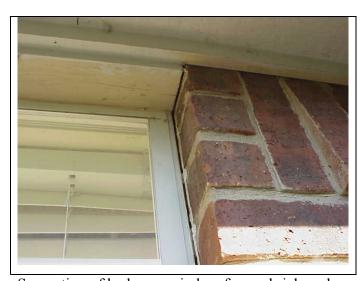
Separation of bedroom window frame, brickwork

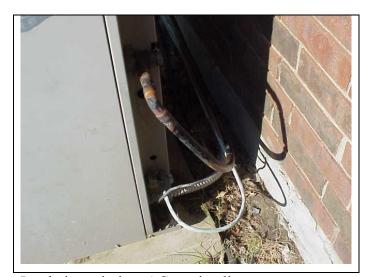
Insulation missing, AC suction line

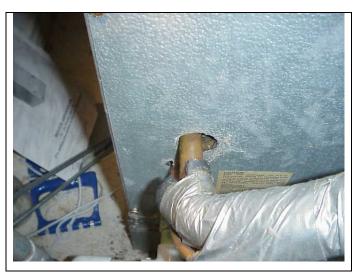
- 1. There is a section of exposed (not insulated) AC suction line near the outside unit.
- 2. There is a section of exposed (not insulated) AC suction line in the hall closet. Water condenses on this section and drips onto the closet flooring.

Exposed AC suction line, hall closet

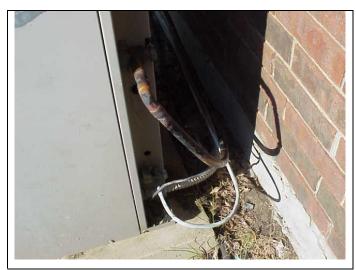
Exposed AC suction line, outside unit

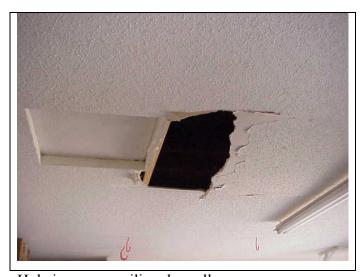
- 5. There is a hole in the garage ceiling drywall. This is noted as a fire safety concern.

Hole in garage ceiling drywall
