**ADDENDUM TO PROPERTY INSPECTION REPORT
PROPERTY INSPECTION AGREEMENT**

ALLIED HOME INSPECTION SERVICES
P. O. BOX 980354
HOUSTON, TEXAS 77098 - 0354
713 / 522 - 0856 800-498-4498

JOHN O. FRANZEN
LICENSED BUILDING INSPECTOR
T.R.E.C. # 1553

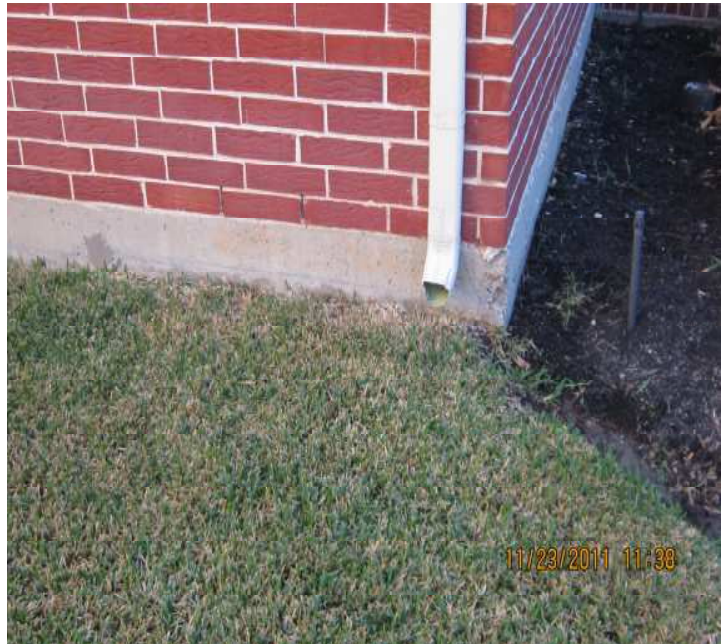
PHOTO NO. 2

- NO. 1 MISSING SPLASH BLOCKS UNDER DOWNSPOUTS. MISSING GUTTERS, DOWNSPOUTS, AND SPLASH BLOCKS ON ALL FOUR SIDES. SEE APPENDIX B-1 & U-3.**

MISSING SPLASH BLOCKS
UNDER DOWNSPOUTS

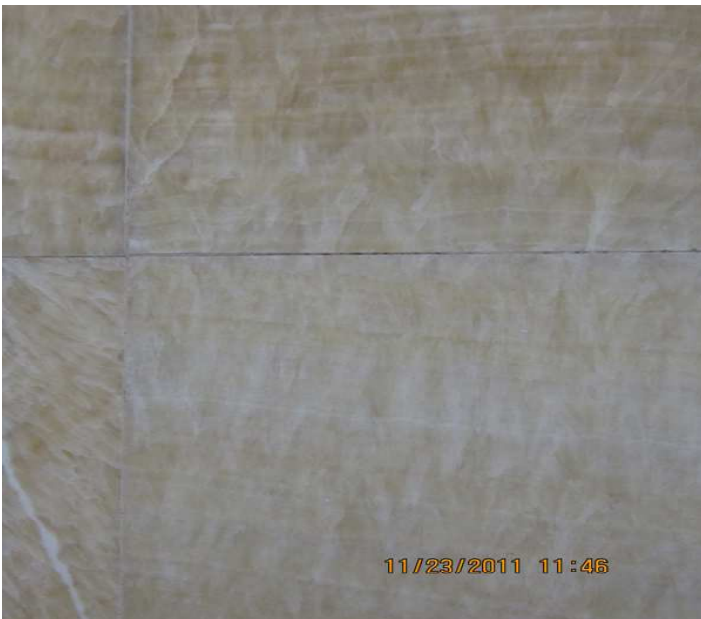
PHOTO NO. 3

- NO. 22 GRASS IS DEAD IN SEVERAL AREAS. NEW SOD IS NEEDED.**
- NO. 23 CRACKS, IN THE ENTRYWAY TILE GROUT, NEED REPAIR**

CRACKS IN TILE FLOOR
GROUT IN ENTRYWAY

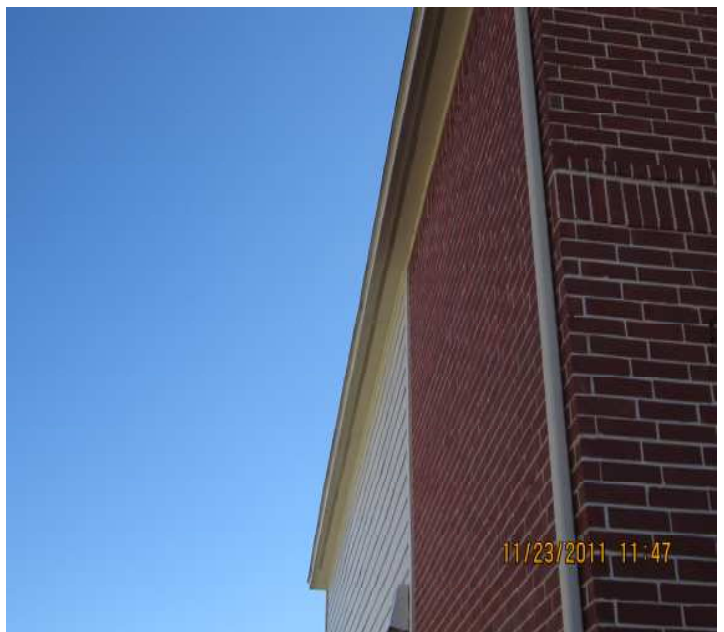
PHOTO NO. 4

MISSING GUTTERS ON
EAST EAVE

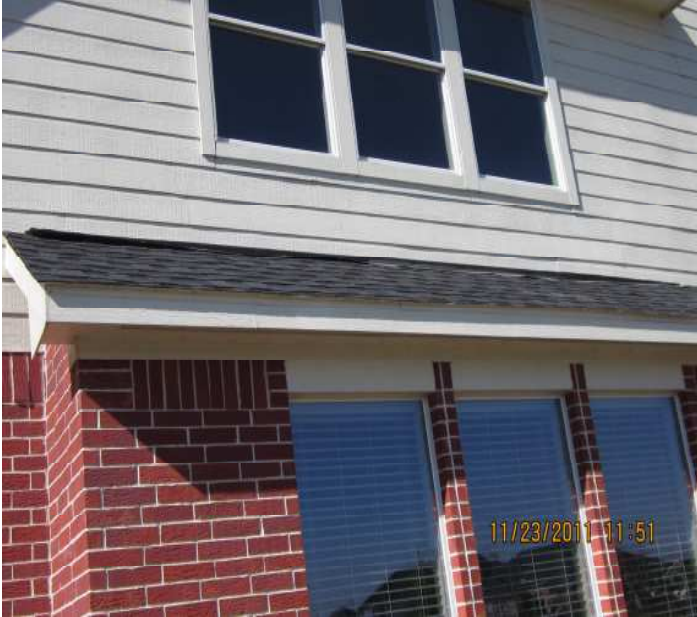
- NO. 2 TURNED UP ROOF SHINGLES ON SOUTH SIDE OF ROOF. METAL ROOF FLASHING, AT THE LOWER BACK ROOF, NEEDS REPAIR.**

**PHOTO NO. 5 DAMAGED ROOF FLASHING
AT LOWER BACK ROOF**

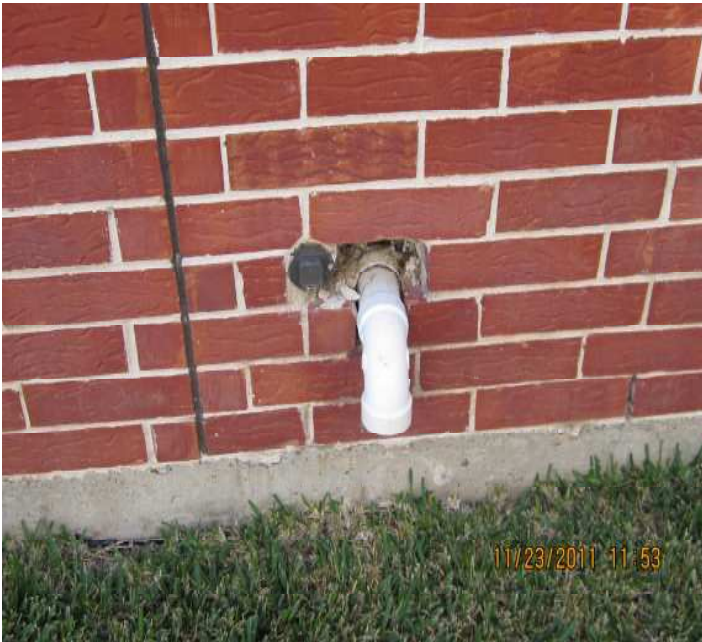
- NO. 4 NORTH SIDE BRICK WALL IS DAMAGED BY DRAIN LINE. EXTERIOR SIDING HAS GAPS UNDER THE BOTTOM EDGES, OPEN SEAMS, AND POPPED OUT NAILS. BOTTOM, OF INTERIOR GARAGE WALLS, ARE DAMAGED IN SEVERAL AREAS. REPAIRS ARE NEEDED**

**PHOTO NO. 7 NORTH BRICK WALL
DAMAGED BY DRAIN**

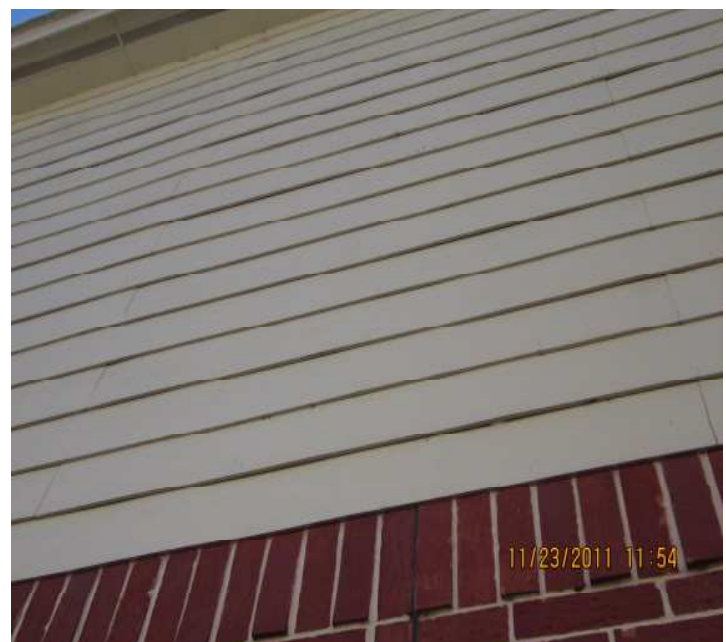
**PHOTO NO. 8 GAPS, OPEN SEAMS, AT
NORTH SIDE SIDING**

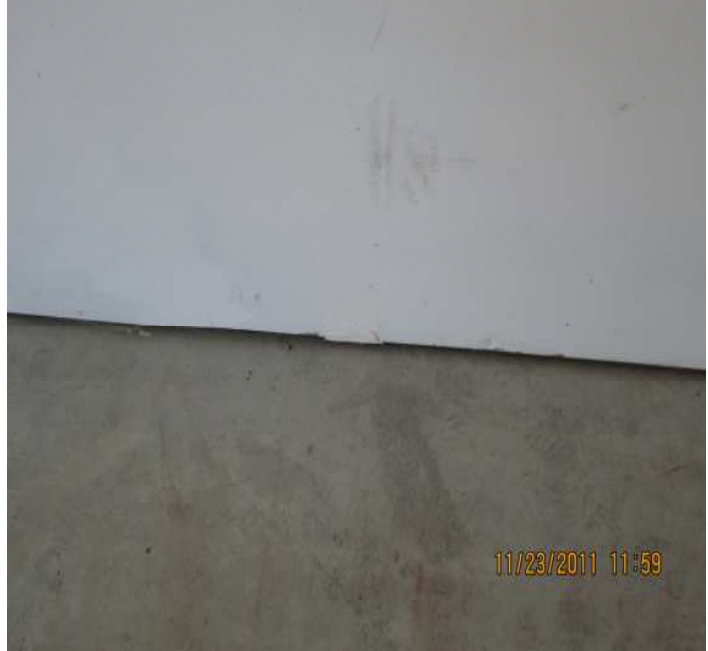
PHOTO NO. 10 INTERIOR GARAGE WALLS ARE DAMAGED AT BOTTOM

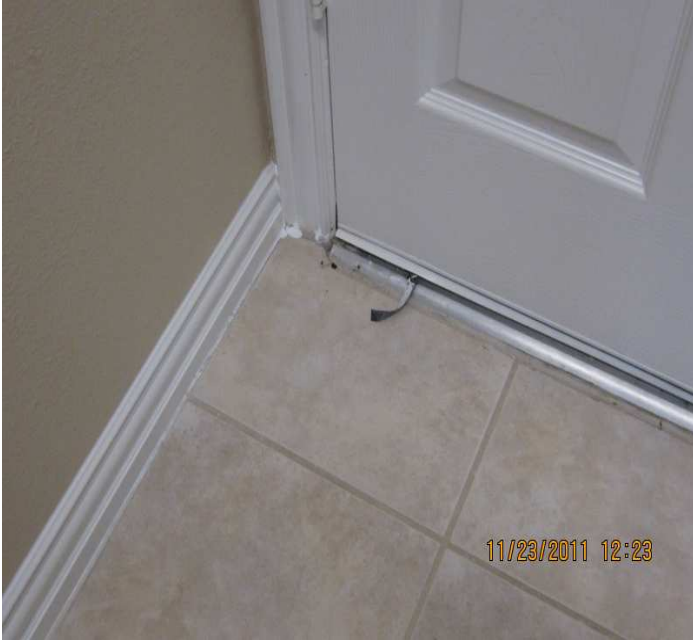
- NO. 5 GARAGE ENTRY DOOR IS MISSING A DEAD BOLT LOCK. GARAGE ENTRY DOOR HAS DAMAGED WEATHER STRIPPING AT THE BOTTOM. REPAIRS ARE NEEDED.**

PHOTO NO. 13 DAMAGED WEATHER
STRIPPING AT GARAGE ENTRY DOOR

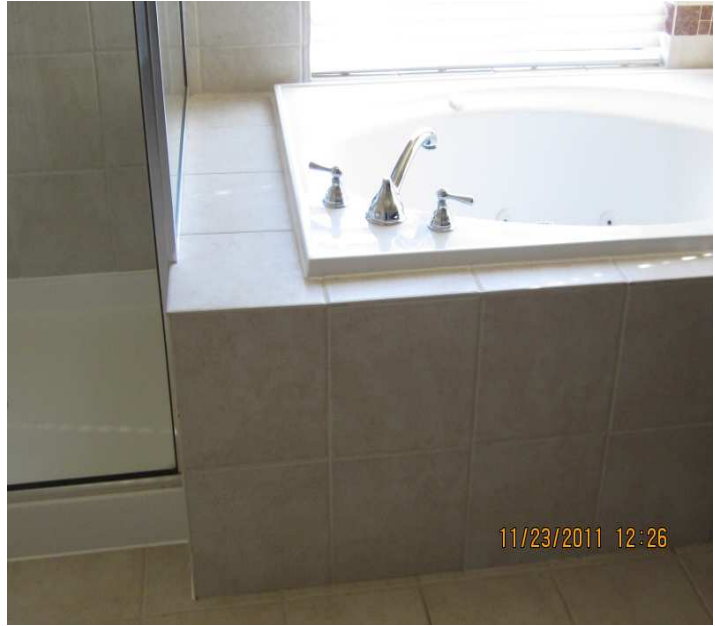
- NO. 13 SPRAY NOZZLE, AT THE KITCHEN SINK, NEEDS REPAIR. TUB, IN THE MASTER BATH, IS MISSING A PLUMBING ACCESS PANEL. SEE APPENDIX K-2 & K-3. HOT & COLD REVERSED AT TUB IN MASTER BATH. SEE APPENDIX K-5. COMMODOE TANK, IN THE UPSTAIRS SOUTH SIDE BATH, IS MISSING AN ANTI-SIPHONING DEVICE. SEE APPENDIX N-2**

PHOTO NO. 14 TUB, IN M. BATH, MISSING
PLUMBING ACCESS PANEL

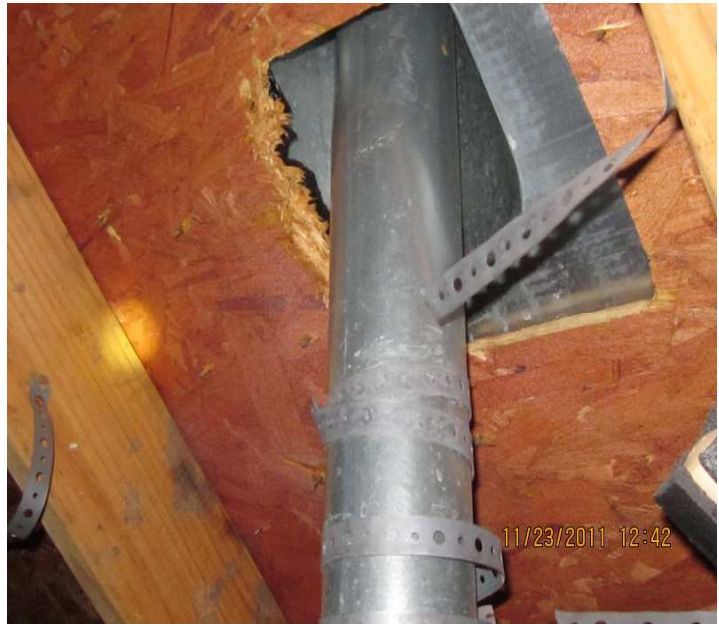
- NO. 15 ONE, OF THE METAL WATER HEATER FLUES, IN THE LOWER ATTIC, NEEDS TO BE STRAPPED TO THE ADJOINING ROOF RAFTERS. GALVANIZED - COPPER PIPING CONNECTIONS, AT THE TOPS OF THE TWO WATER HEATERS, ARE MISSING DIELECTRIC FITTINGS. SEE APPENDIX K-2 & K-3. REPAIRS ARE NEEDED**

PHOTO NO. 18 WATER HEATER FLUE NOT STRAPPED TO RAFTERS

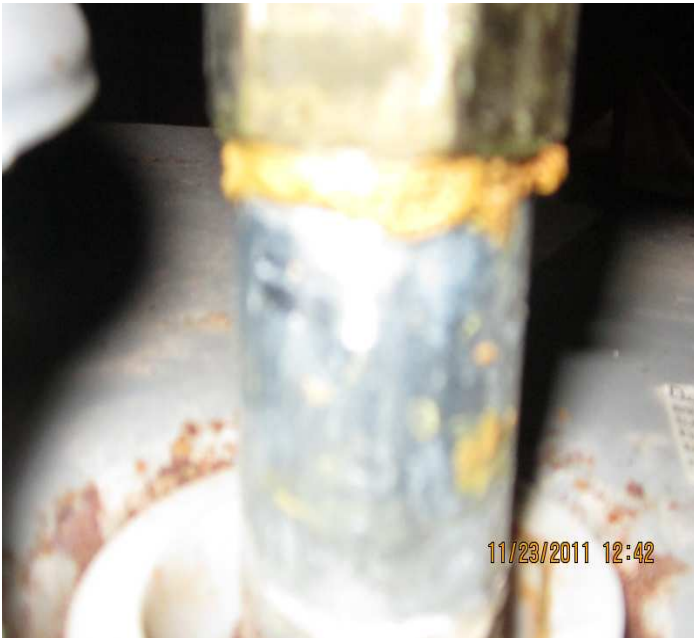
PHOTO NO. 19 WATER HEATER PIPING CONNECTIONS MISSING DIELECTRIC FITTINGS

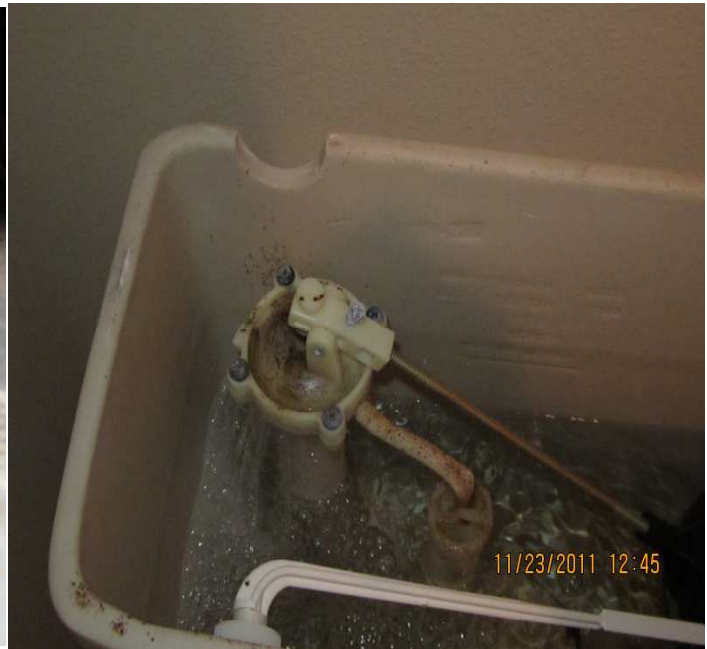
PHOTO NO. 20 COMMODE TANK MISSING ANTI-SIPHONING DEVICE

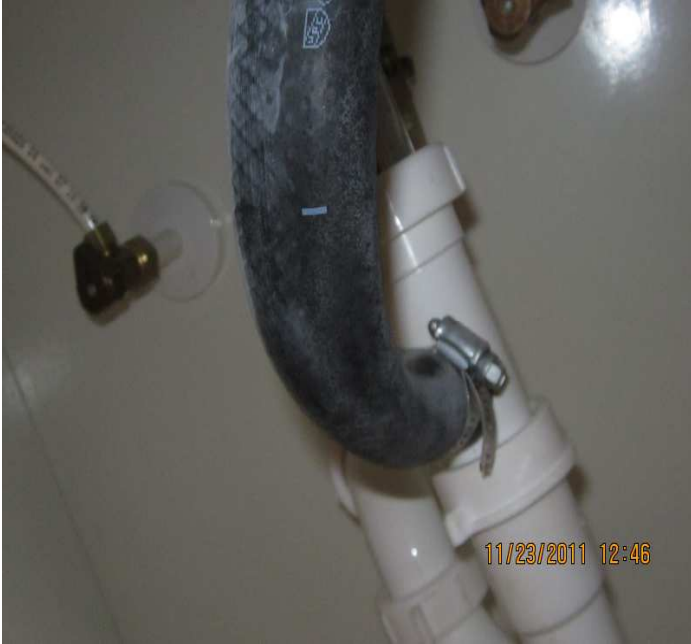
**NO. 11 BOTH METAL A/C DRAIN PANS, IN THE ATTIC, ARE MISSING A
FLOAT SWITCH. SEE APPENDIX CC-2
A/C PRIMARY DRAIN LINE, UNDER THE UPSTAIRS SOUTH SIDE
BATH SINK, IS BADLY CRIMPED. REPAIRS ARE NEEDED.**

PHOTO NO. 21 BADLY CRIMPED A/C PRIMARY
DRAIN LINE UNDER UPSTAIRS BATH SINK

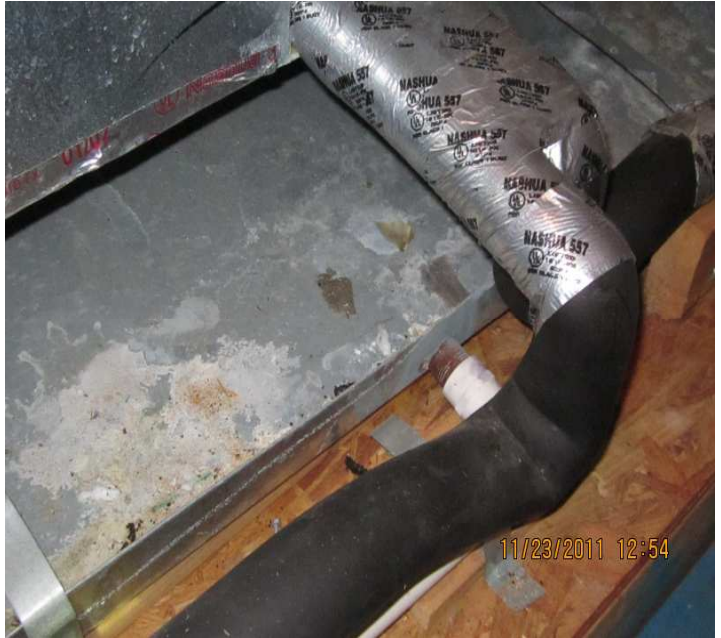
PHOTO NO. 24 A/C DRAIN PAN, IN ATTIC,
MISSING FLOAT SWITCH

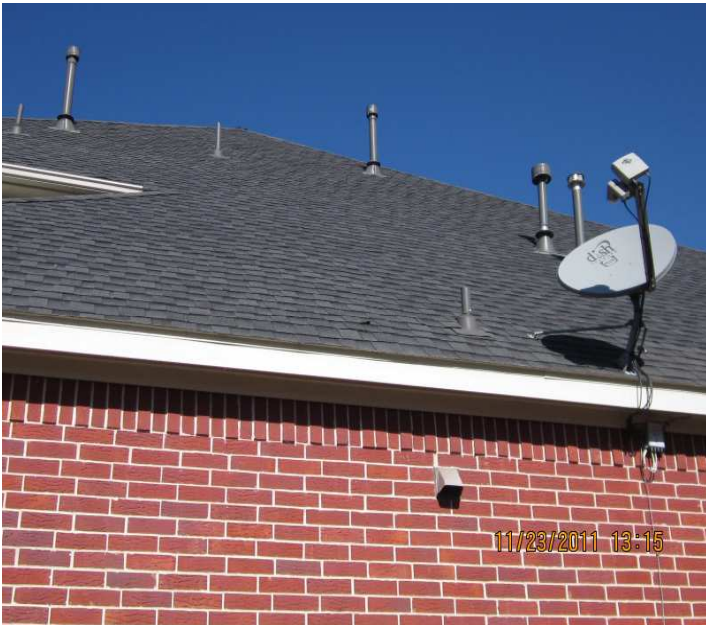
PHOTO NO. 27 TURNED UP ROOF
SHINGLES ON SOUTH SIDE ROOF

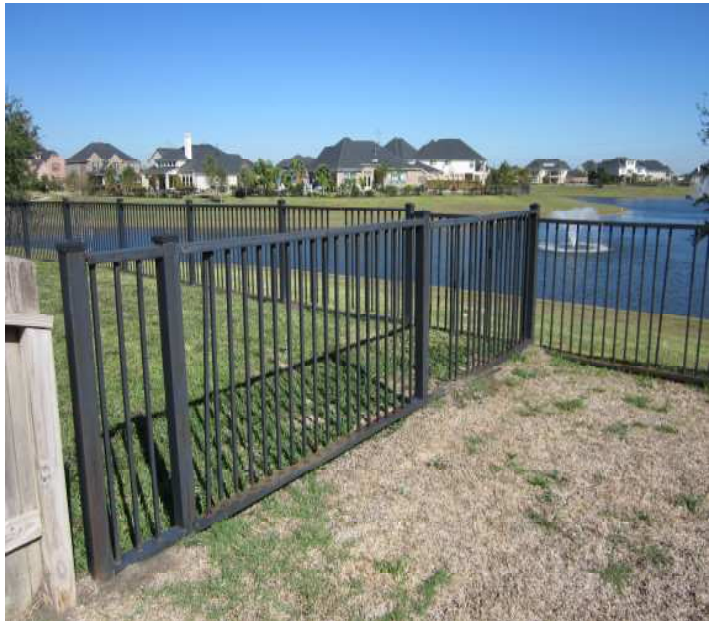
- NO. 7 METAL FENCE, IN THE BACK YARD, IS DAMAGED IN SEVERAL AREAS. REPAIRS ARE NEEDED**

PHOTO NO. 28 DAMAGED METAL FENCE
IN BACK YARD
