# *Torre Inspection Service*

## Property Inspection Report

12345 Me Ave, Some Where, NY 12345  
Inspection prepared for: IR EIFS  
Date of Inspection: 1/25/2012 Time: 9:00 am  
Weather: Clear Outside Temperature 40 Degr'e's

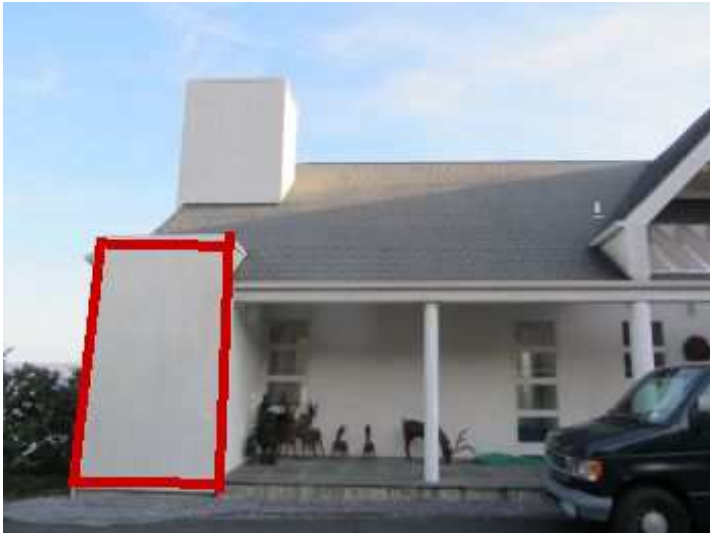
Small part of the wall had front elevated moisture levels, and the wood substrated has been damage by moisture needs to be replaced.

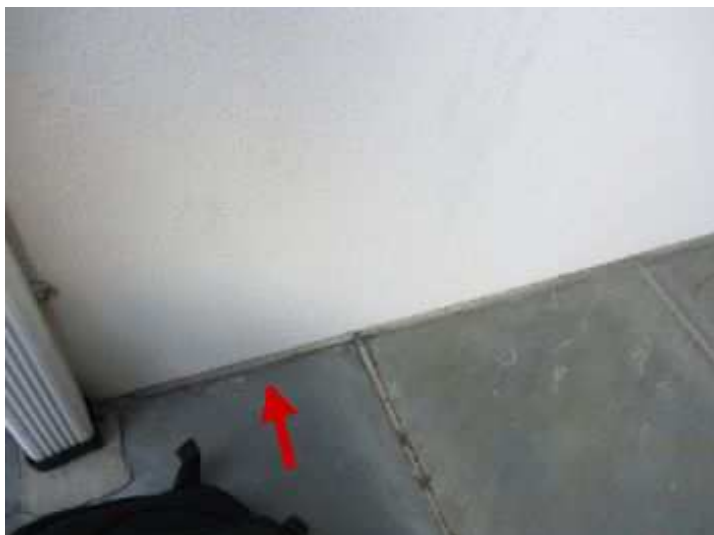
The EIFS is in contact with concrete the system should be at least 2 inches about grade. Water can wick its way into the siding material. This will result in deterioration of the siding material.

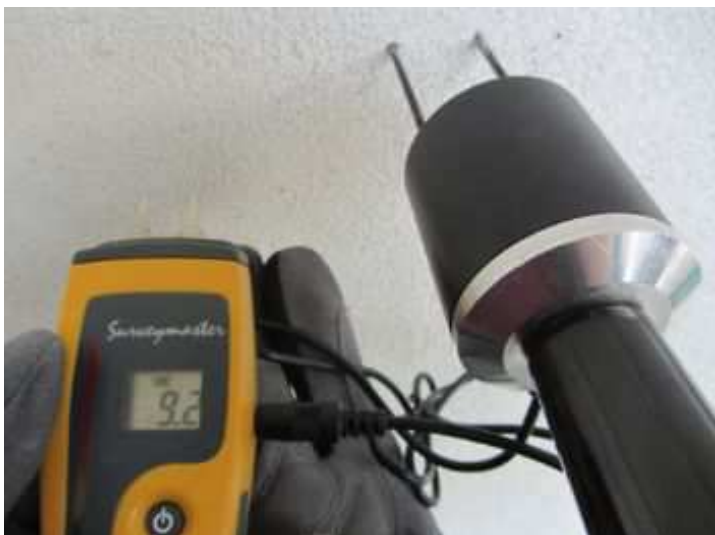
Baseline moisture level from the moisture probe test in dry area was between 7.5% to 9.2% moisture.

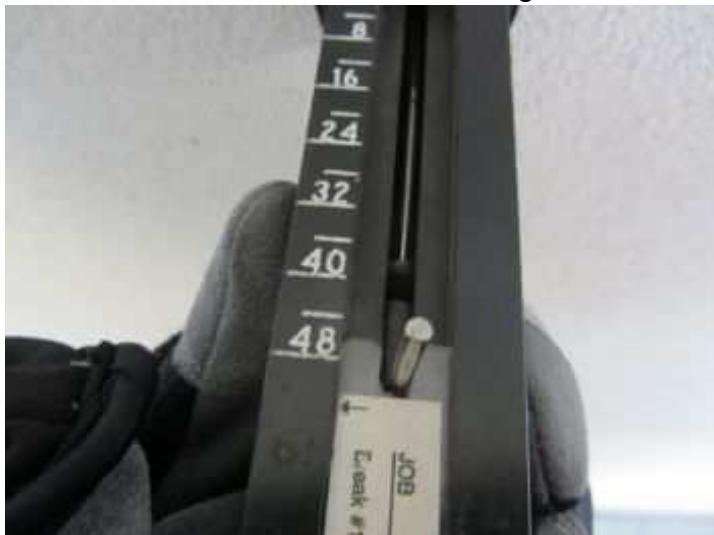
Tests with the Structure Resistance Tester (SRT) was 48 pounds of resistance without any penetration into the wood.

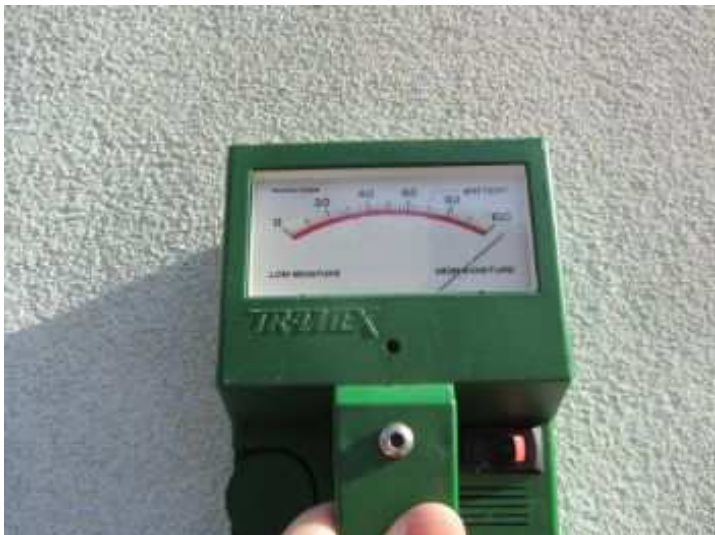
Tramex wet wall detector reading 100%

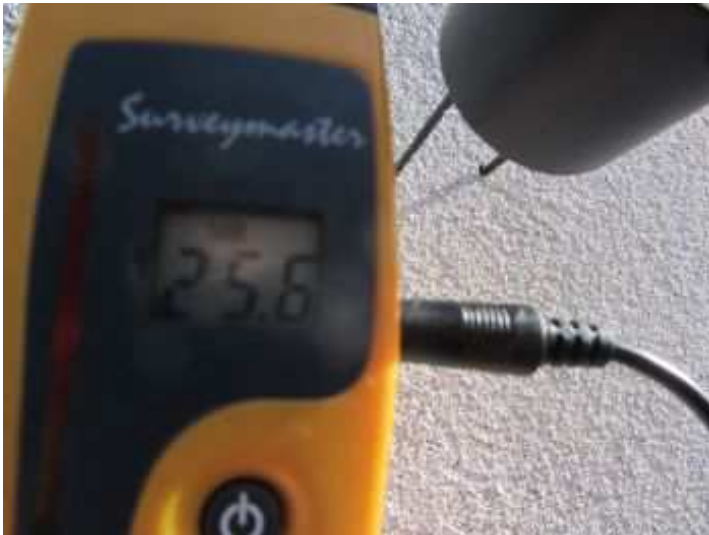
GE Surveymaster moisture meter probe reading between 25.6% moisture.

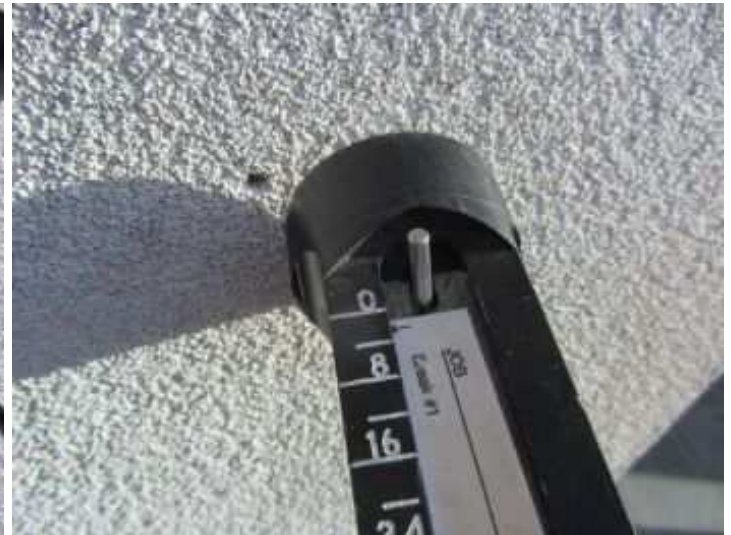
The substrate resistance tester(SRT) measure less then 5 pounds of resistance when popping through the wood substrate on a small area in the front elevation.

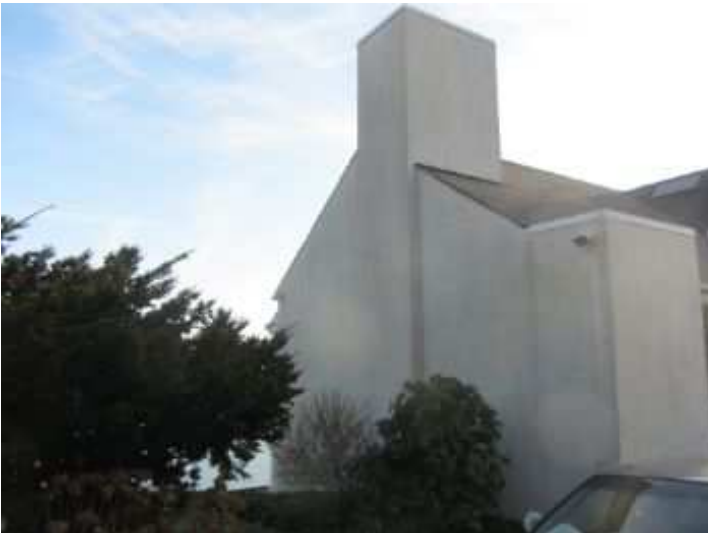
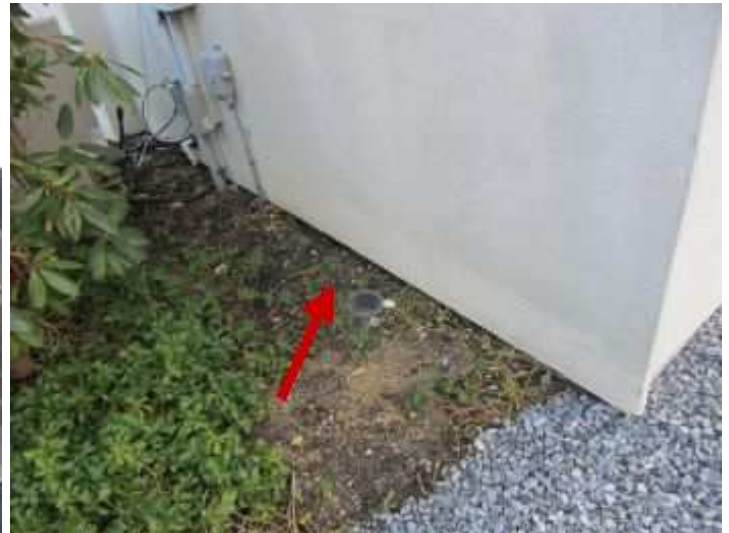
Although the External Insulated Finish System (EIFS) was improperly installed, the system appears to be in acceptable condition, with the exception of the following areas. At a minimum, we recommend having a licensed EIFS contractor make the repairs as noted in each of the following:

- 1) Below grade terminations of EIFS it should always be terminated above grade a minimum of 8 inches of clearance. The terminating below grade can allow moisture to wick up behind the system. This also creates conditions conducive to termites and carpenter ant infestations.

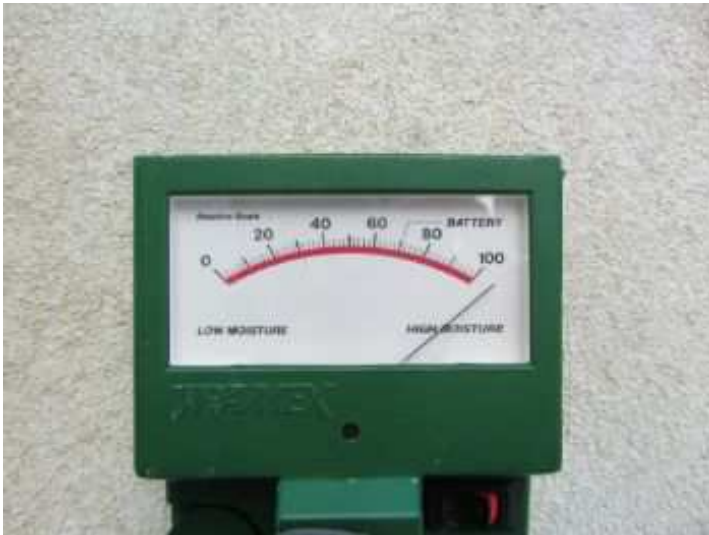
Tramex wet wall detector reading 100%

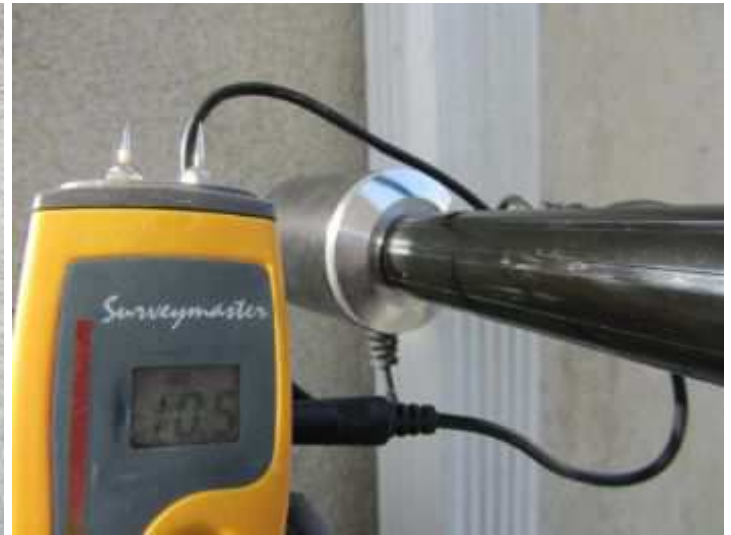
GE Surveymaster moisture meter probe reading between 10.5% moisture.

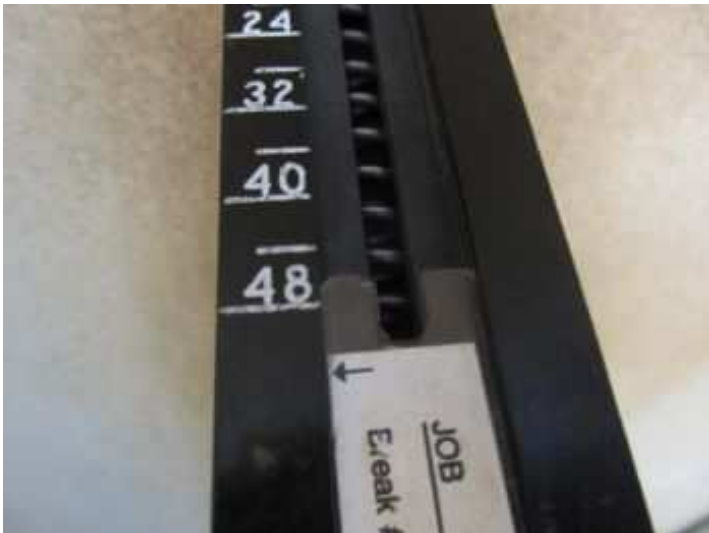
Tests with the Structure Resistance Tester (SRT) was 48 pounds of resistance without any penetration into the wood.

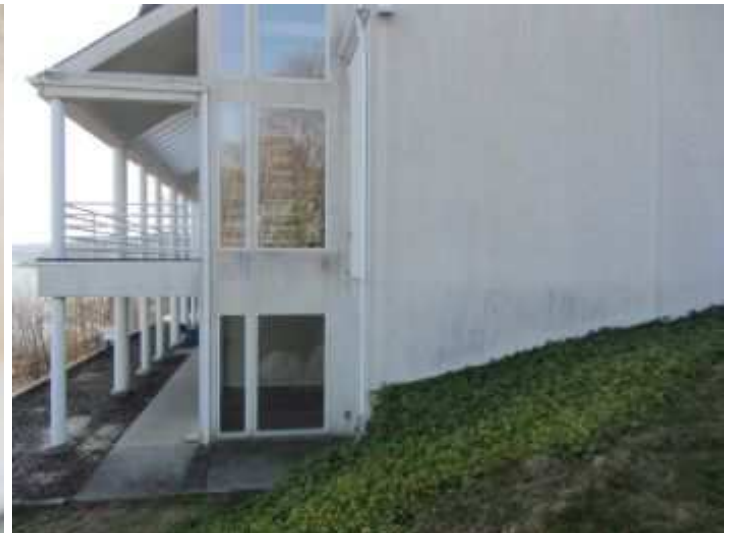
Although the External Insulated Finish System (EIFS) was improperly installed, the system appears to be in acceptable condition, with the exception of the following areas. At a minimum, we recommend having a licensed EIFS contractor make the repairs as noted in each of the following:

- 1) Below grade terminations of EIFS it should always terminated above grade a minimum of 8 inches of clearance. The terminating below grade can allow moisture to wick up behind the system. This also creates conditions conducive to termites and carpenter ant infestations.

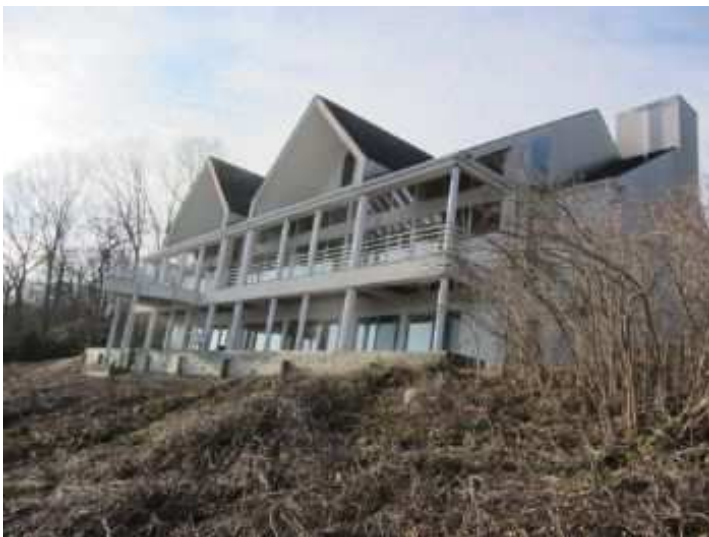
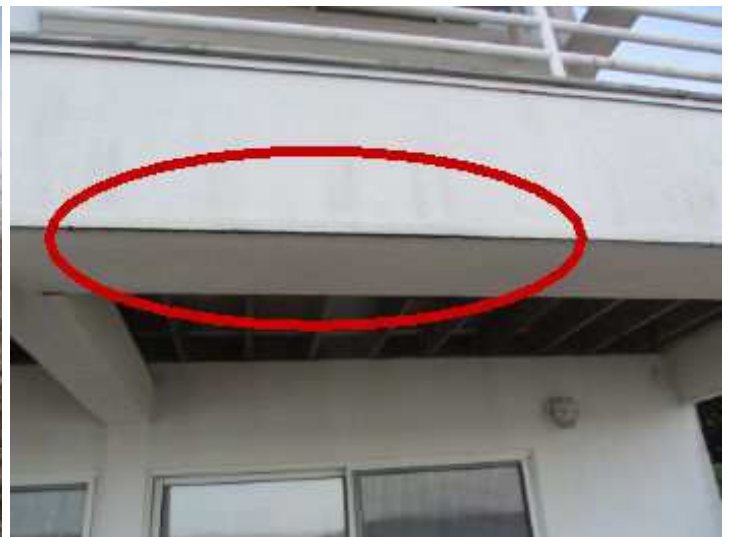
EIFS: Exterior walls of the home were covered with synthetic stucco called Exterior Insulation and Finish Systems (EIFS) which requires repairing all small cracks in the wall system to prevent water entry.

If the cracks are not repaired, this condition can lead to moisture intrusion behind EIFS can cause extensive damage with little or no visual evidence without removal of wall materials. The inspector recommends have a certified EIFS contractor repair the cracks in the EIFS.

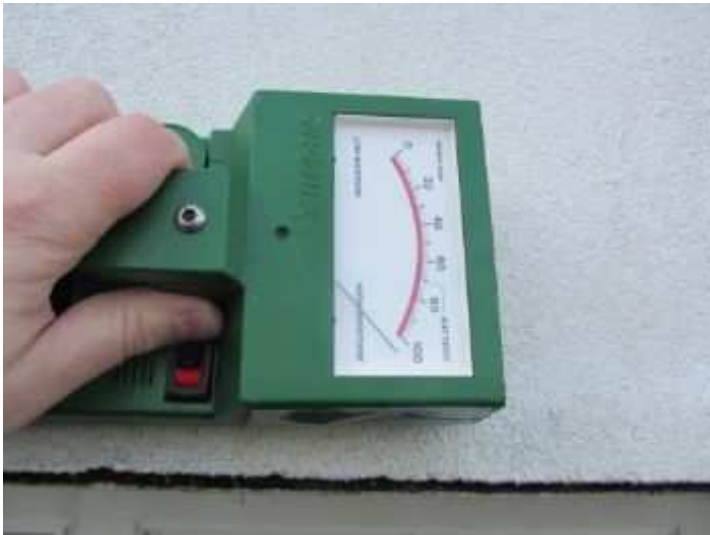
Tramex wet wall detector reading 100%

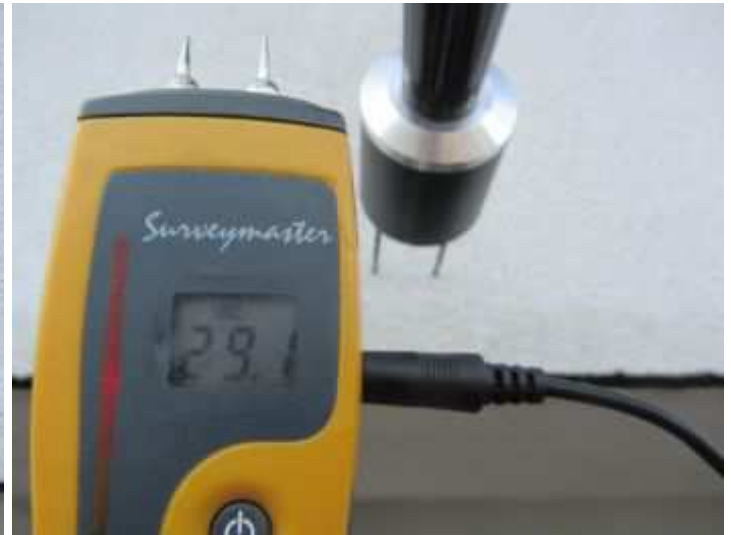
GE Surveymaster moisture meter probe reading between 29.1% to 39.7% moisture

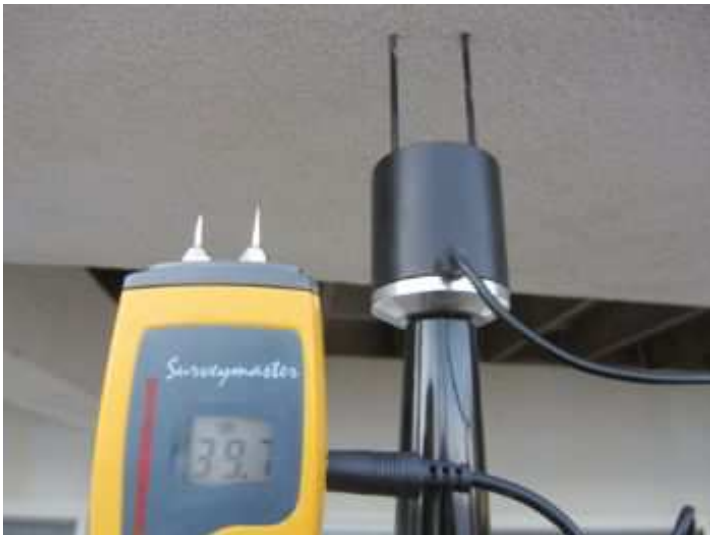
GE Surveymaster moisture meter probe reading between 29.1% to 39.7% moisture

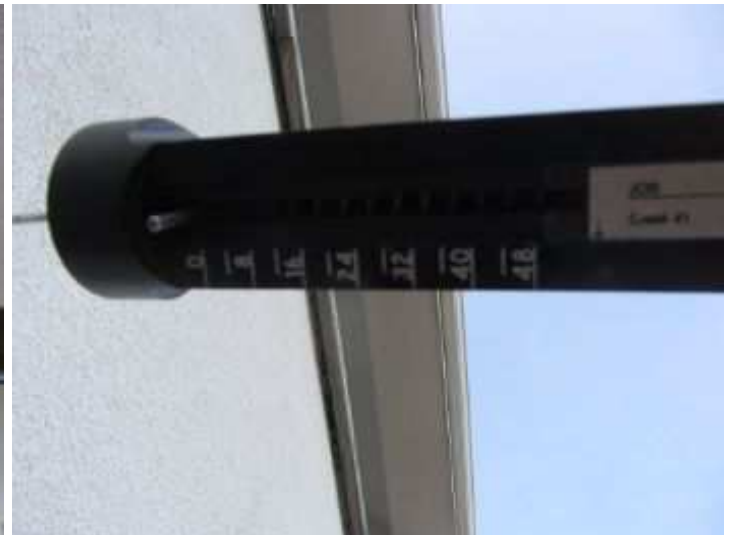
Tests with the Structure Resistance Tester (SRT) was 48 pounds of resistance without any penetration into the wood.

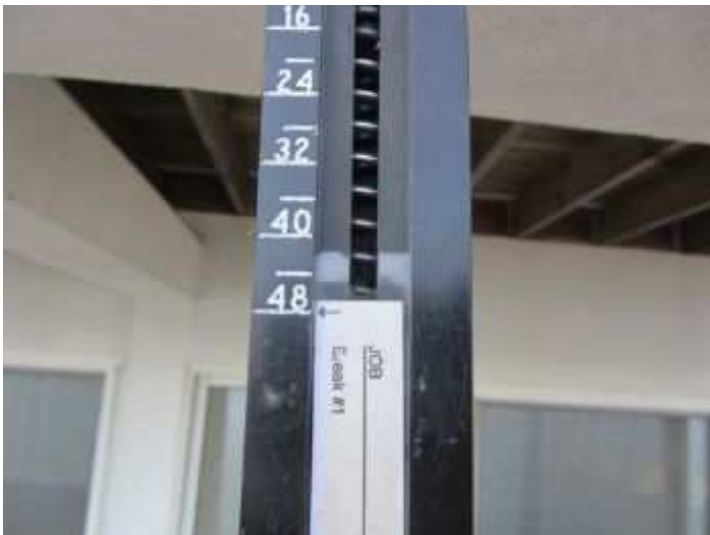
Tests with the Structure Resistance Tester (SRT) was 48 pounds of resistance without any penetration into the wood.

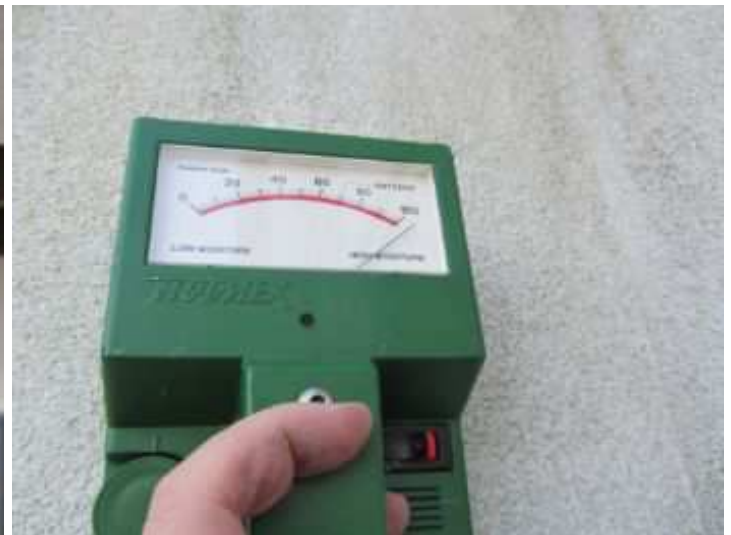
Tramex wet wall detector reading 100%

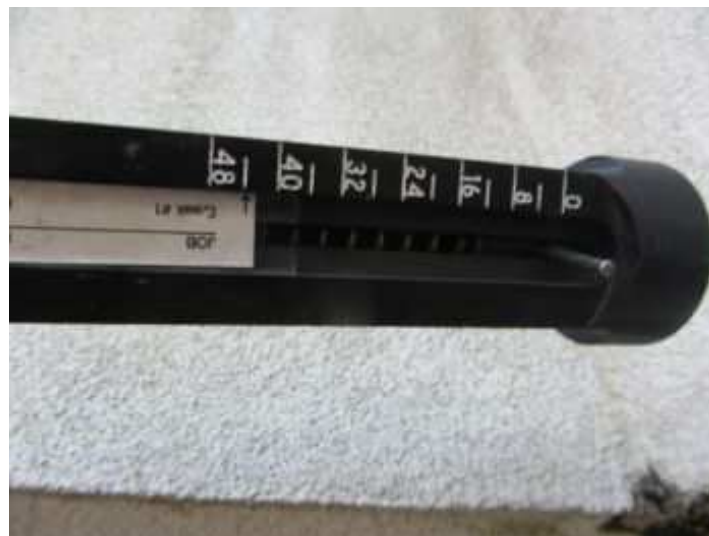
Tests with the Structure Resistance Tester (SRT) was 48 pounds of resistance without any penetration into the wood.

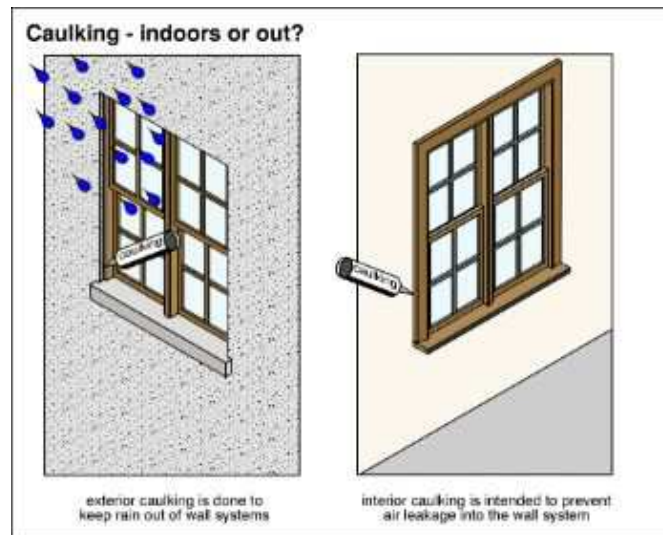
At the time of the inspection, the window exteriors were dependant upon sealant to help prevent moisture intrusion of the wall assembly. Some separation and/or cracking of the installed sealant was visible at the time of the inspection. Areas around exterior windows openings should be examined annually and an appropriate sealant reapplied as necessary.

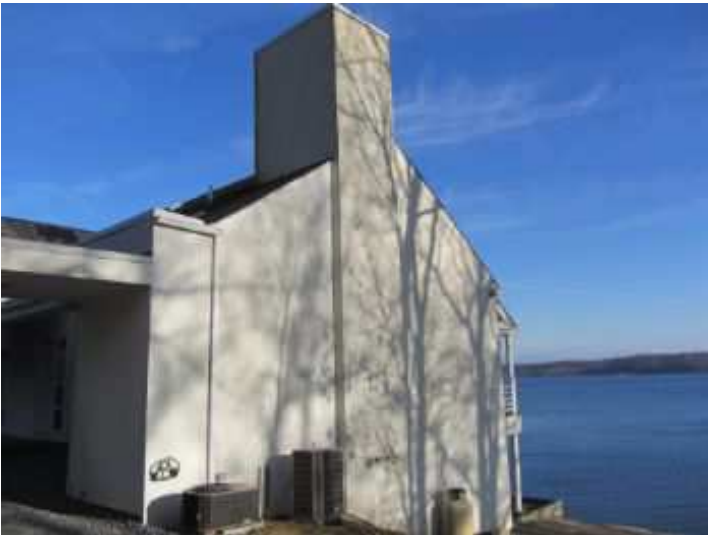
Exterior walls of the home were covered with synthetic stucco called Exterior Insulation and Finish Systems (EIFS) which requires repairing all small cracks in the wall system to prevent water entry.

If the cracks are not repaired, this condition can lead to moisture intrusion behind EIFS can cause extensive damage with little or no visual evidence without removal of wall materials. The inspector recommends have a certified EIFS contractor repair the cracks in the EIFS.

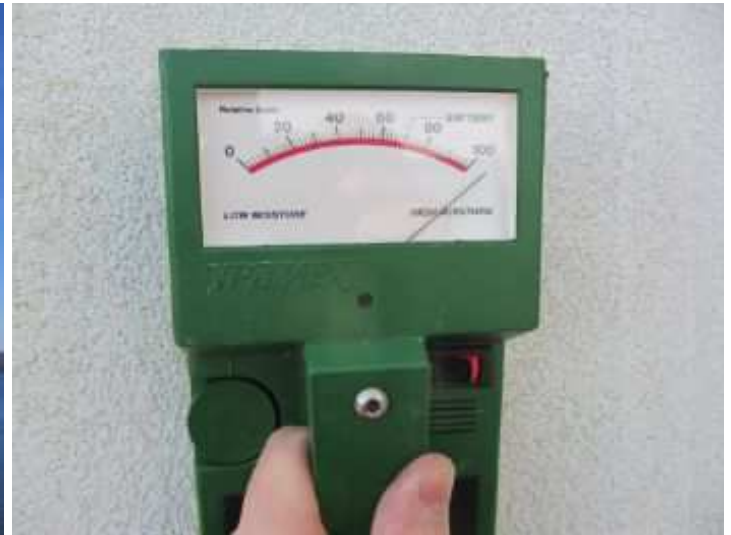
Tramex wet wall detector reading 100%

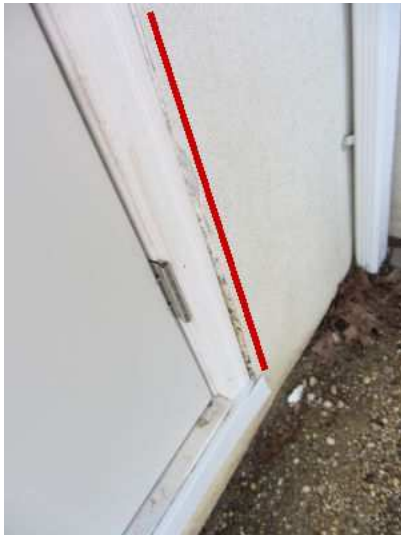
Exterior walls of the home were covered with synthetic stucco called Exterior Insulation and Finish Systems (EIFS) which requires repairing all small cracks in the wall system to prevent water entry.

If the cracks are not repaired, this condition can lead to moisture intrusion behind EIFS can cause extensive damage with little or no visual evidence without removal of wall materials. The inspector recommends have a certified EIFS contractor repair the cracks in the EIFS.

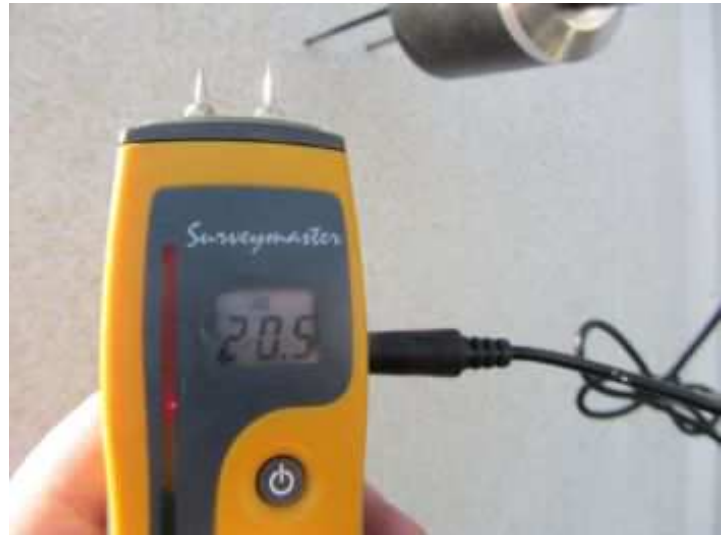
GE Surveymaster moisture meter probe reading between 20.5% moisture.

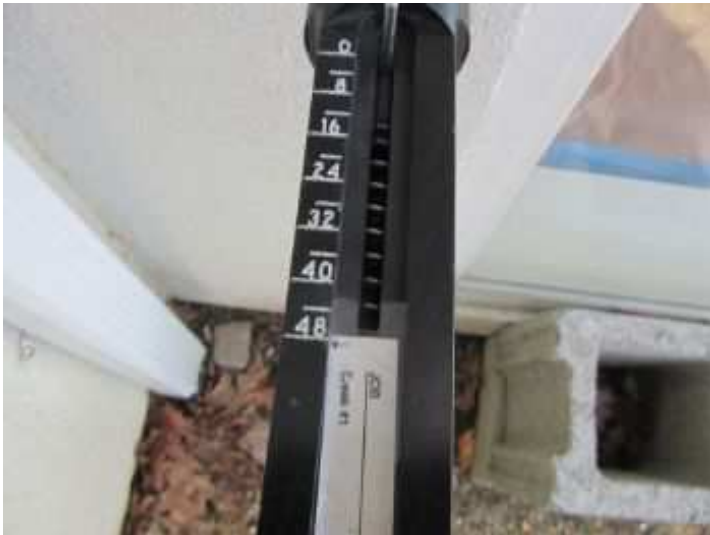
Tests with the Structure Resistance Tester (SRT) was 48 pounds of resistance without any penetration into the wood.

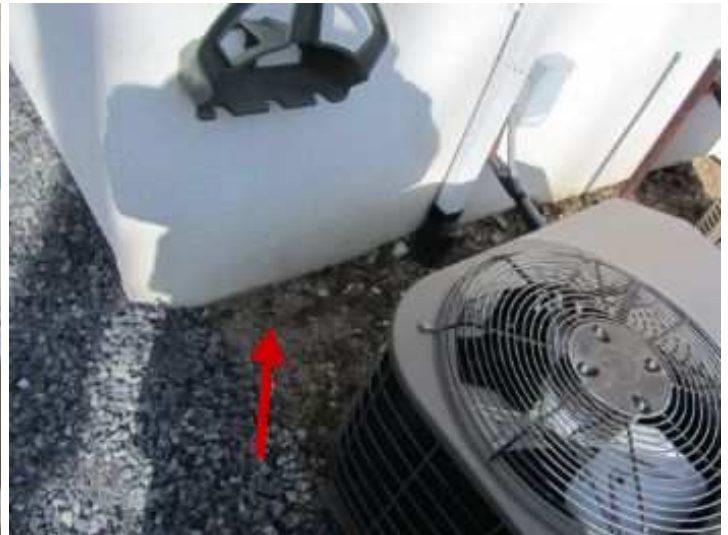
Although the External Insulated Finish System (EIFS) was improperly installed, the system appears to be in acceptable condition, with the exception of the following areas. At a minimum, we recommend having a licensed EIFS contractor make the repairs as noted in each of the following:  
 1) Below grade terminations of EIFS it should always terminated above grade a minimum of 6 to 8 inches of clearance. The terminating below grade can allow moisture to wick up behind the system. This also creates conditions conducive to termites and carpenter ant infestations.

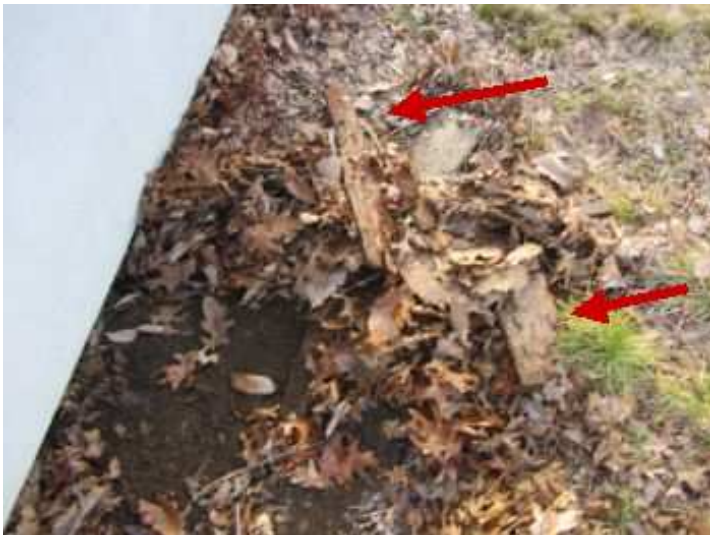
Wood behind the garage should be removed because it is a conducive conditions for termites.

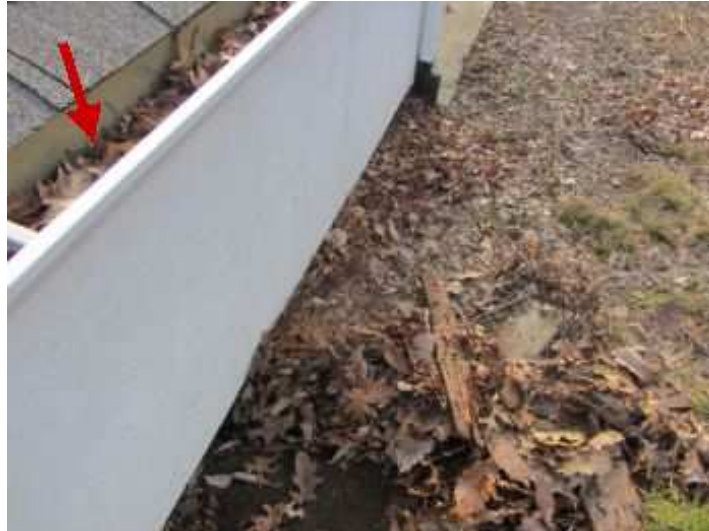
Debris visible in the gutters at the time of the inspection should be removed to allow proper water drainage.

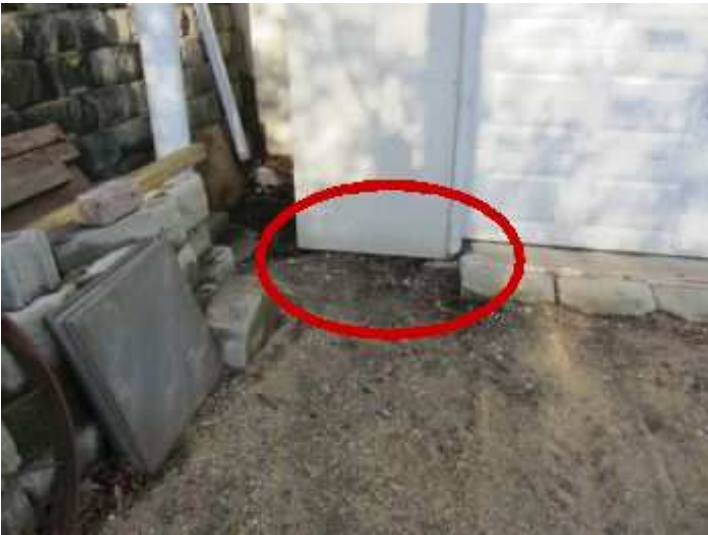
The External Insulated Finish System is too Low to ground, clearance from grade to the lower portions of siding appeared to be the result of inadequate clearance from grade. The standard recommended minimum clearance from grade is 6 to 8 inches.

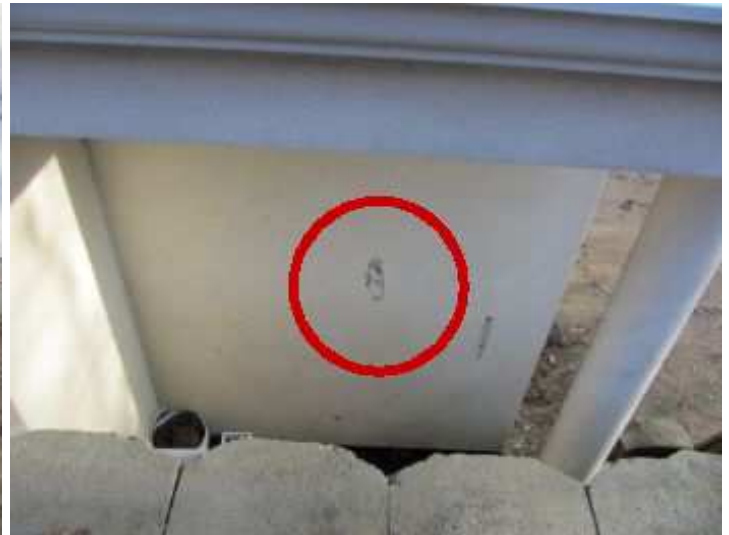
The Exterior Insulation and Finish Systems (EIFS) covering exterior walls of the garage has holes in system that needs to be repair to prevent water entry. These repairs to the EIFS wall system as soon as possible to prevent damage to the wood substrate.

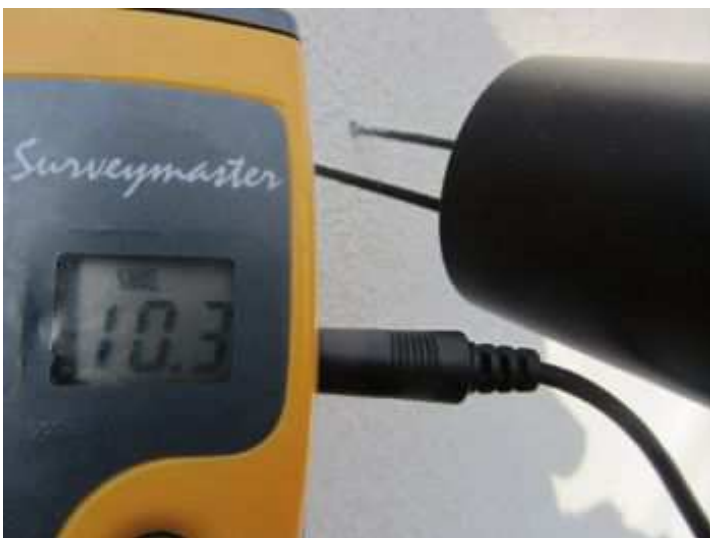
GE Surveymaster moisture meter probe reading between 10.3% moisture.

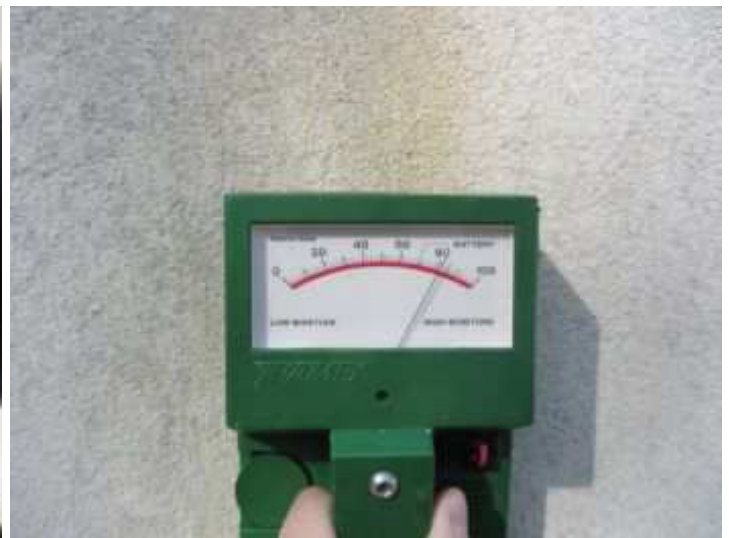
Tramex wet wall detector reading 80%.

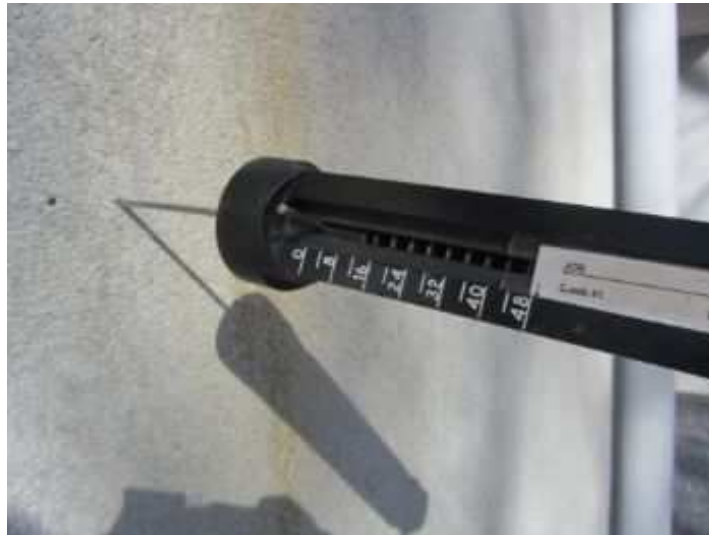
Tests with the Structure Resistance Tester (SRT) was 48 pounds of resistance without any penetration into the wood.

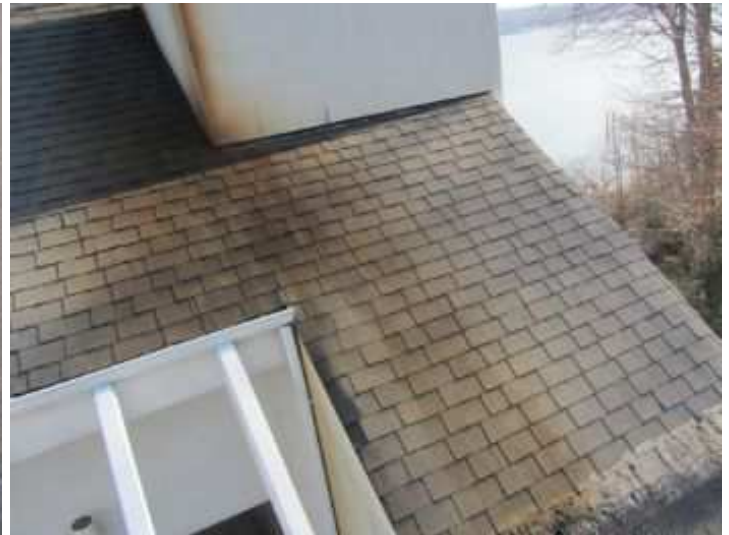
At the time of the inspection, asphalt composition shingles covering the roof of this home appeared to be at or near the end of their useful life. The Inspector recommends that you consult with a qualified roofing contractor to discuss options and costs for replacement.

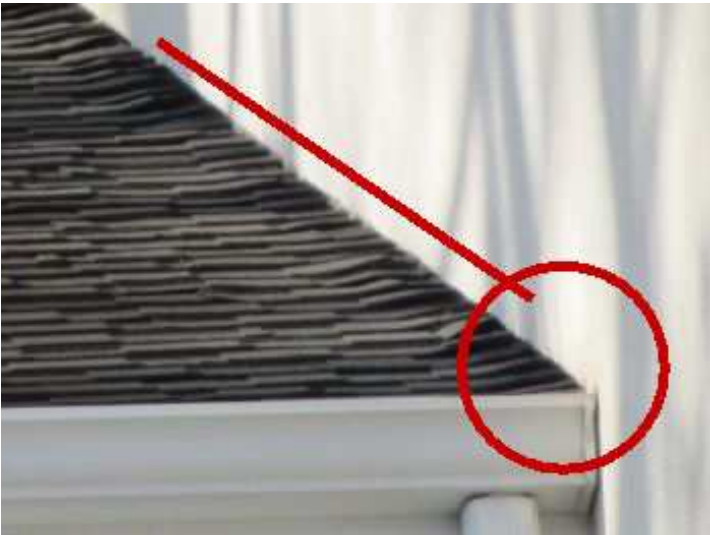
No kick-out or flashings were installed where walls extended past roof edges. This may allow moisture intrusion of the exterior wall covering. Moisture intrusion can damage materials and encourage the growth of microbes such as mold. Roof termination clearance and diverter flashing or kick out flashing. Recommend a licensed roofing contractor repair or install all missing diverter flashing and then have then have a certified EIFS contractor repair the EIFS around the new diverter flashing to prevent future water damage.

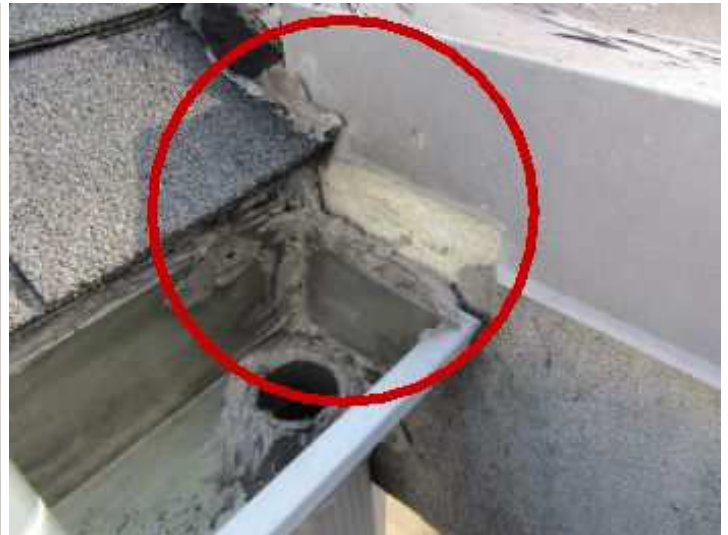
No kick-out flashings were installed where walls extended past roof edges. This may allow moisture intrusion of the exterior wall covering. Moisture intrusion can damage materials and encourage the growth of microbes such as mold. Roof termination clearance and diverter flashing or kick out flashing. Recommend a licensed roofing contractor repair or install all missing diverter flashing and then have then have a certified EIFS contractor repair the EIFS around the new diverter flashing to prevent future water damage.

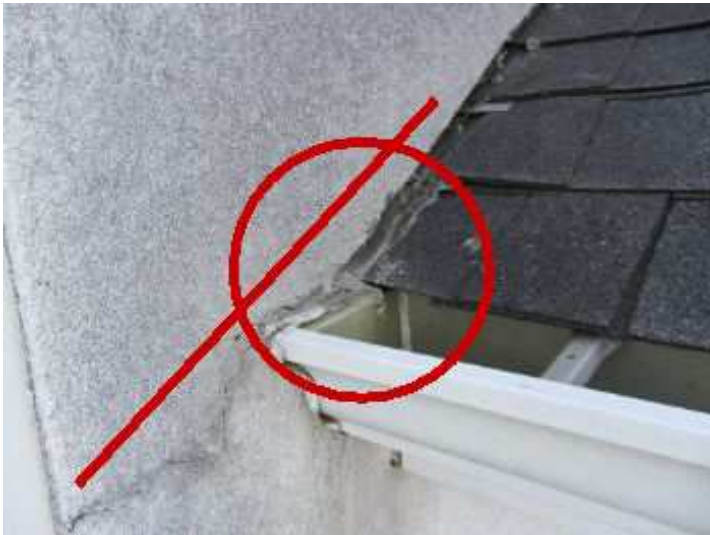
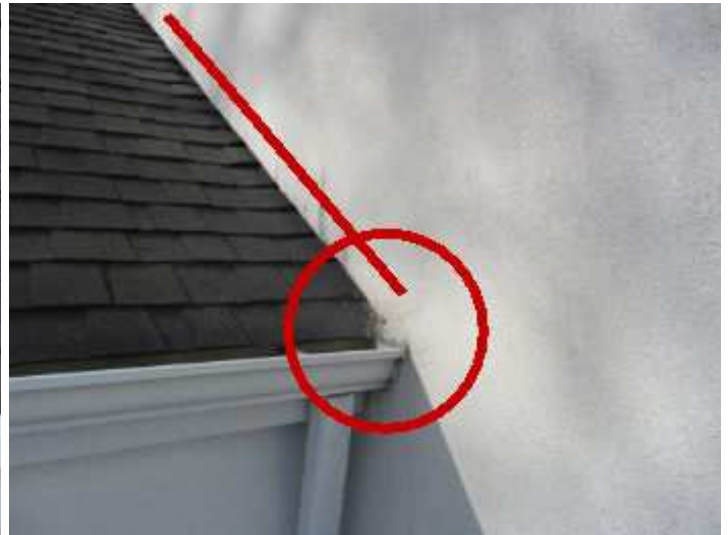
No kick-out flashings were installed where walls extended past roof edges. This may allow moisture intrusion of the exterior wall covering. Moisture intrusion can damage materials and encourage the growth of microbes such as mold. Roof termination clearance and diverter flashing or kick out flashing. Recommend a licensed roofing contractor repair or install all missing diverter flashing and then have then have a certified EIFS contractor repair the EIFS around the new diverter flashing to prevent future water damage.

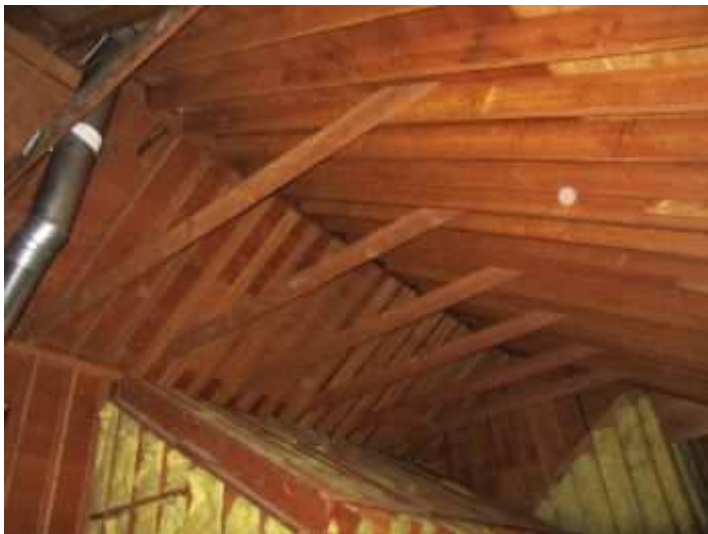
I inspected the attic by entering it. But there is no flooring, and the insulation is covering the joists. I am unable to safely move all around the attic space completely. Inspection restrictions.

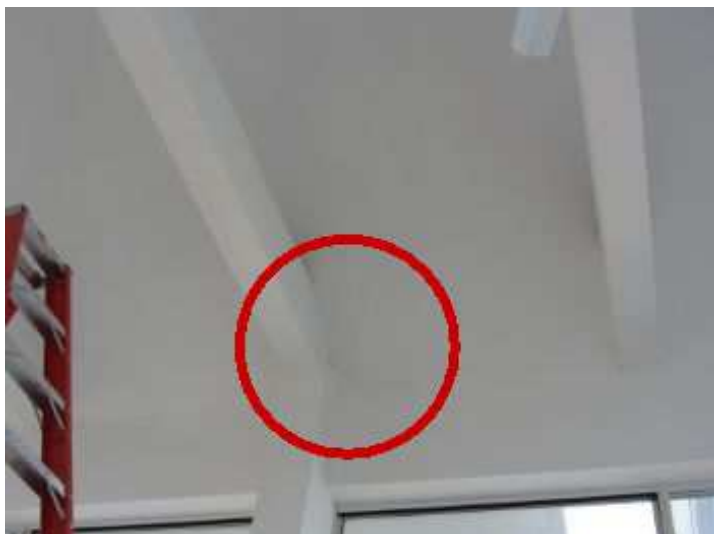
There are two areas on the ceiling where cold spots were detected with the thermal infrared camera, check with moisture meter reading were 5% moisture no moisture present in the cold spots on the ceiling.

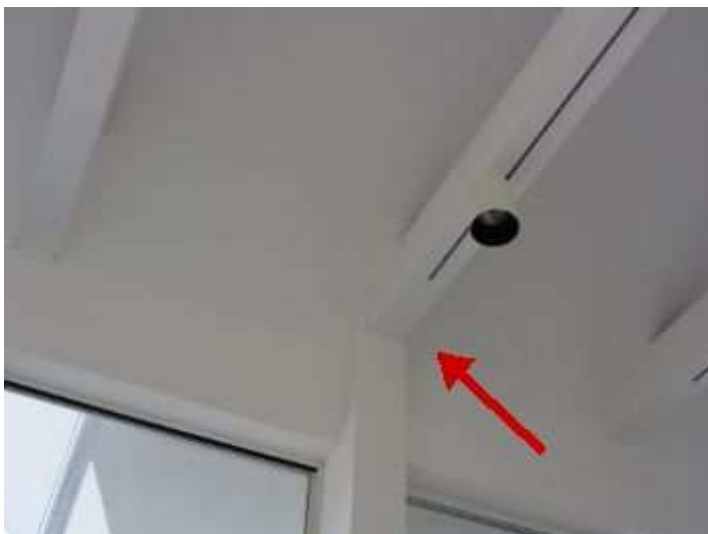
There are two areas on the ceiling where cold spots were detected with the thermal infrared camera, check with moisture meter reading were 5% moisture no moisture present in the cold spots on the ceiling.

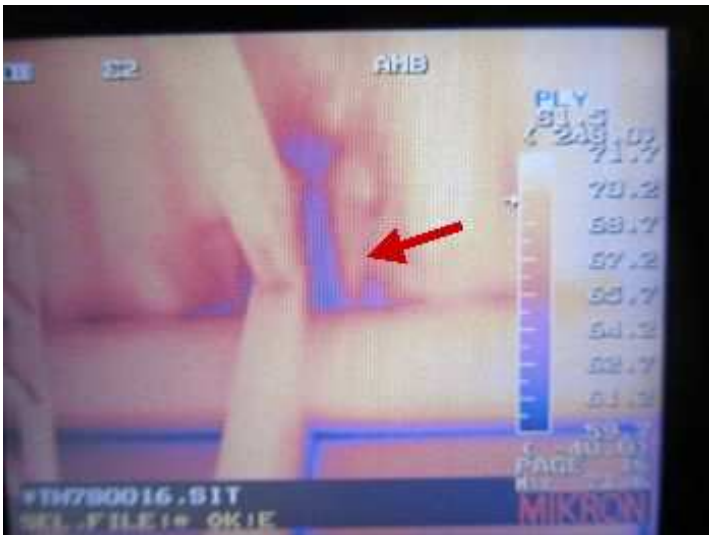
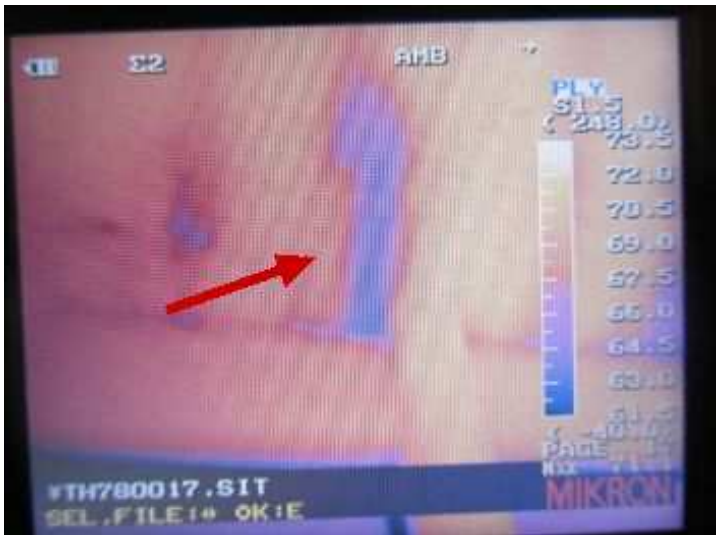
There are two areas on the ceiling where cold spots where detected with the thermal infrared camera, check with moisture meter reading were 5% moisture no moisture present in the cold spots on the ceiling.

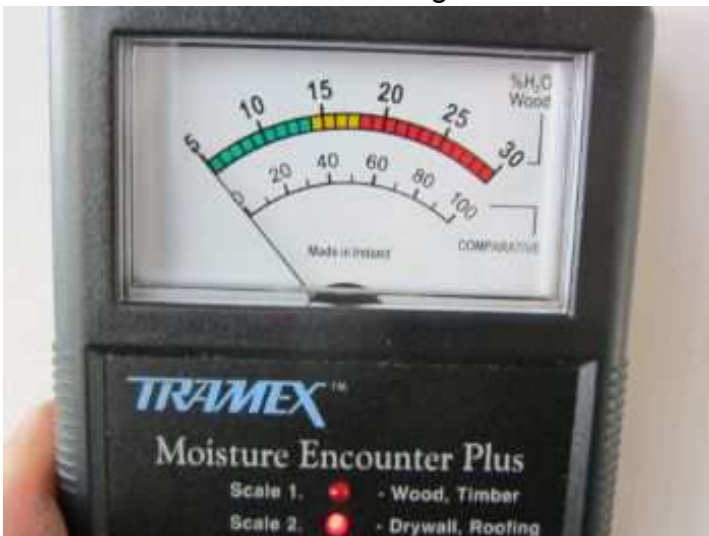
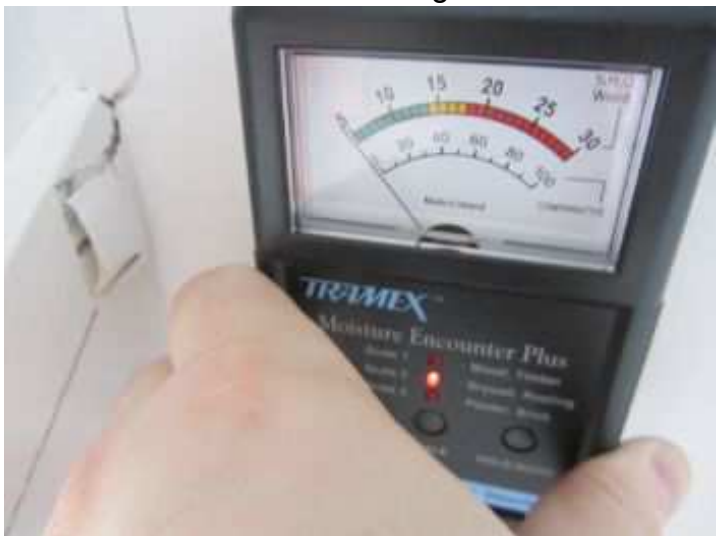
Baseline moisture level on dry drywall is 5% moisture.

There are two areas on the ceiling where cold spots where detected with the thermal infrared camera, check with moisture meter reading were 5% moisture no moisture present in the cold spots on the ceiling.

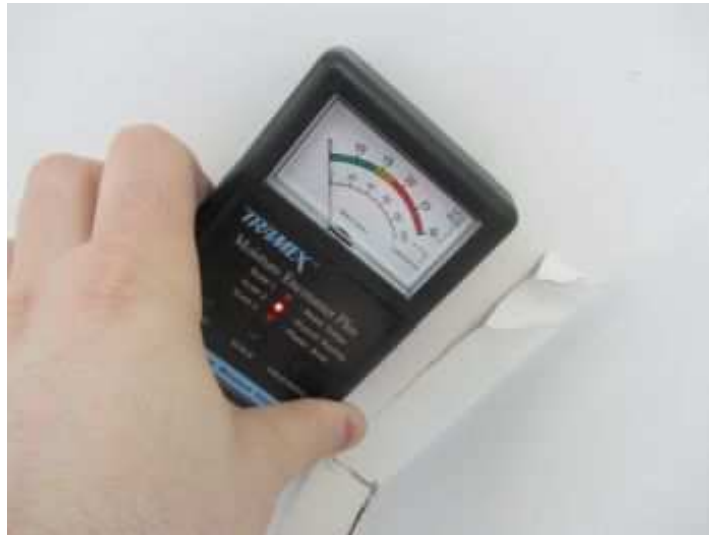
There are two areas on the ceiling where cold spots were detected with the thermal infrared camera, check with moisture meter reading were 5% moisture no moisture present in the cold spots on the ceiling.
