PROPERTY INSPECTION REPORT

Date: 02.07.10

Report ID: 020710AT

Address: 2601 Newhome Lane / Dallas, Texas 75000-1100

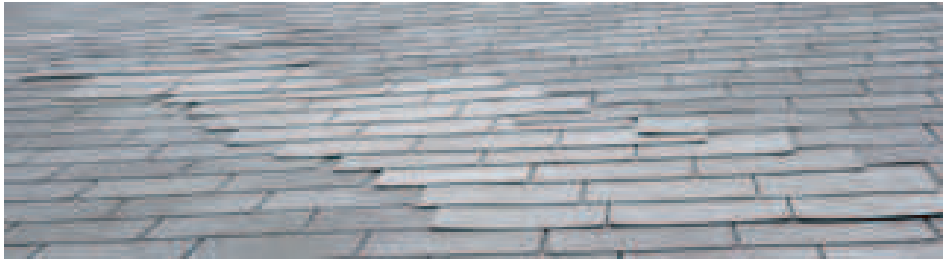
- Roof covering may not be insurable because of its age and/or condition.
- Some advance ceramic granule loss. The granules would roll out from under my shoes.

- Some of the roof decking is swollen from moisture at the drip edge on the east of the front porch.
- Some of the underlayment is not properly installed over the drip edge flashing.

- The original shingles were improperly fastened with staples.
- The roof covering has numerous substandard or amateurish repairs. Numerous shingles are loose. Some of the shingle replacements are not properly aligned and create water traps. There are exposed nail heads in several areas around the roof where nails were driven directly on top of shingles in some misguided effort to hold them down. Considering that the roof covering is likely to be original to the house, it is my opinion that it would be prudent to replace it. The roof covering should not be kept without a second opinion.

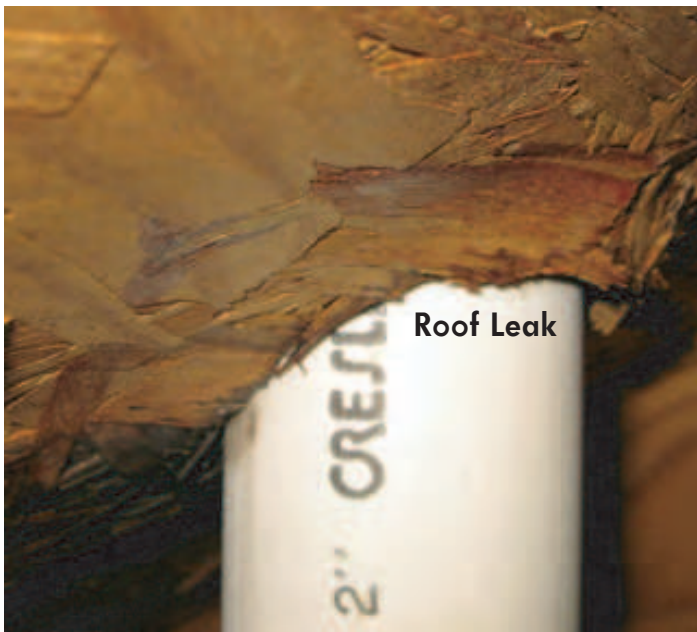
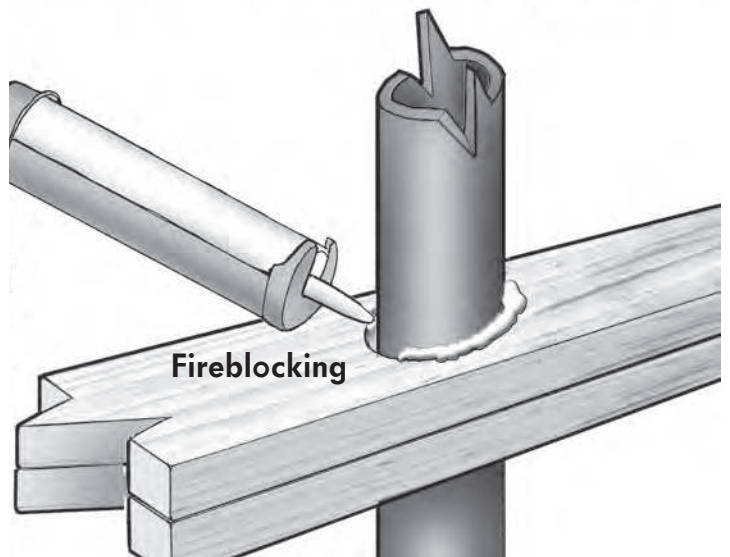
- Insulation or fire-blocking is not present on the pull down attic access ladder. The ladder has not been installed according to the posted instructions.
- The insulation is missing from over the ceiling repair in the den.
- There is a water leak apparent around the hall bathroom plumbing vent-stack.
- Some of the plumbing vent-stacks are not fireblocked where they penetrate the attic floor.
- Some of the rafters do not appear to have a minimum of three nails connecting them to the ridge board.
- The peeling paint on the soffit vent covers and the unidentified organic substance on the soffit over the master bedroom windows & along the west wall indicate that the attic may not have sufficient ventilation. This issue should be addressed when the roof covering is replaced.

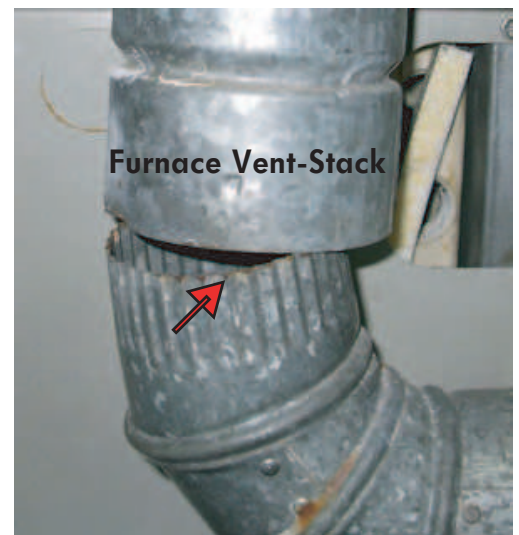
- The peeling paint on the soffit vent covers and the unidentified organic substance on the soffit over the master bedroom windows & along the west wall indicate that the attic may not have sufficient ventilation. This issue should be addressed when the roof covering is replaced.
- Flexible gas line connector improperly enters the furnace.
- Furnace vent stack is misaligned. The furnace vents directly into the attic.
- The gas supply to the furnace does not have a sediment trap.

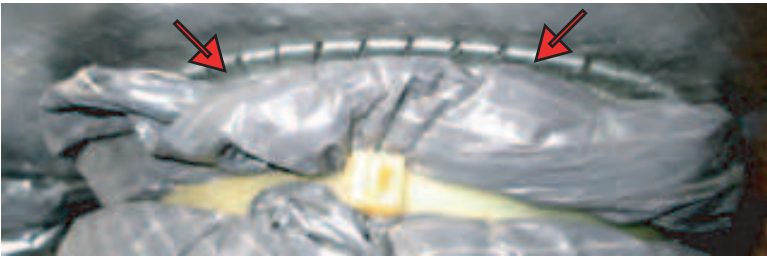
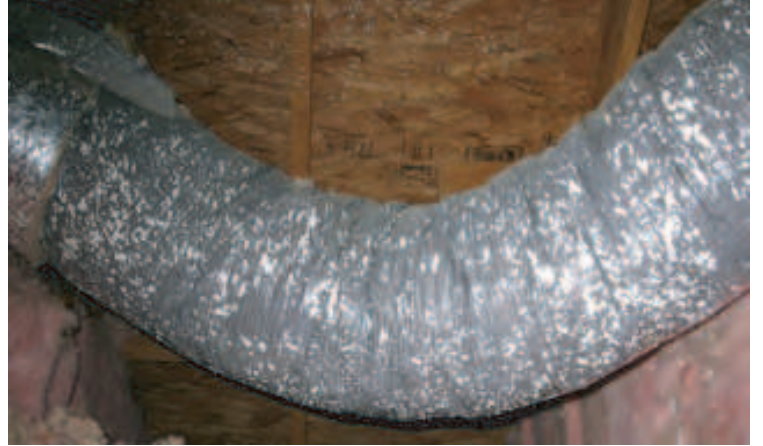
- Dirty air filter.
- Air leak apparent at filter access.
- Some of the duct is laying on the floor in the attic. Some of the air duct is not properly supported and it has more than .5" of sag in it's runs.
- Some air supply duct is leaking air where it is attached to the indoor air handler plenum.
- Some of the air duct transition or connection joints are not properly sealed.

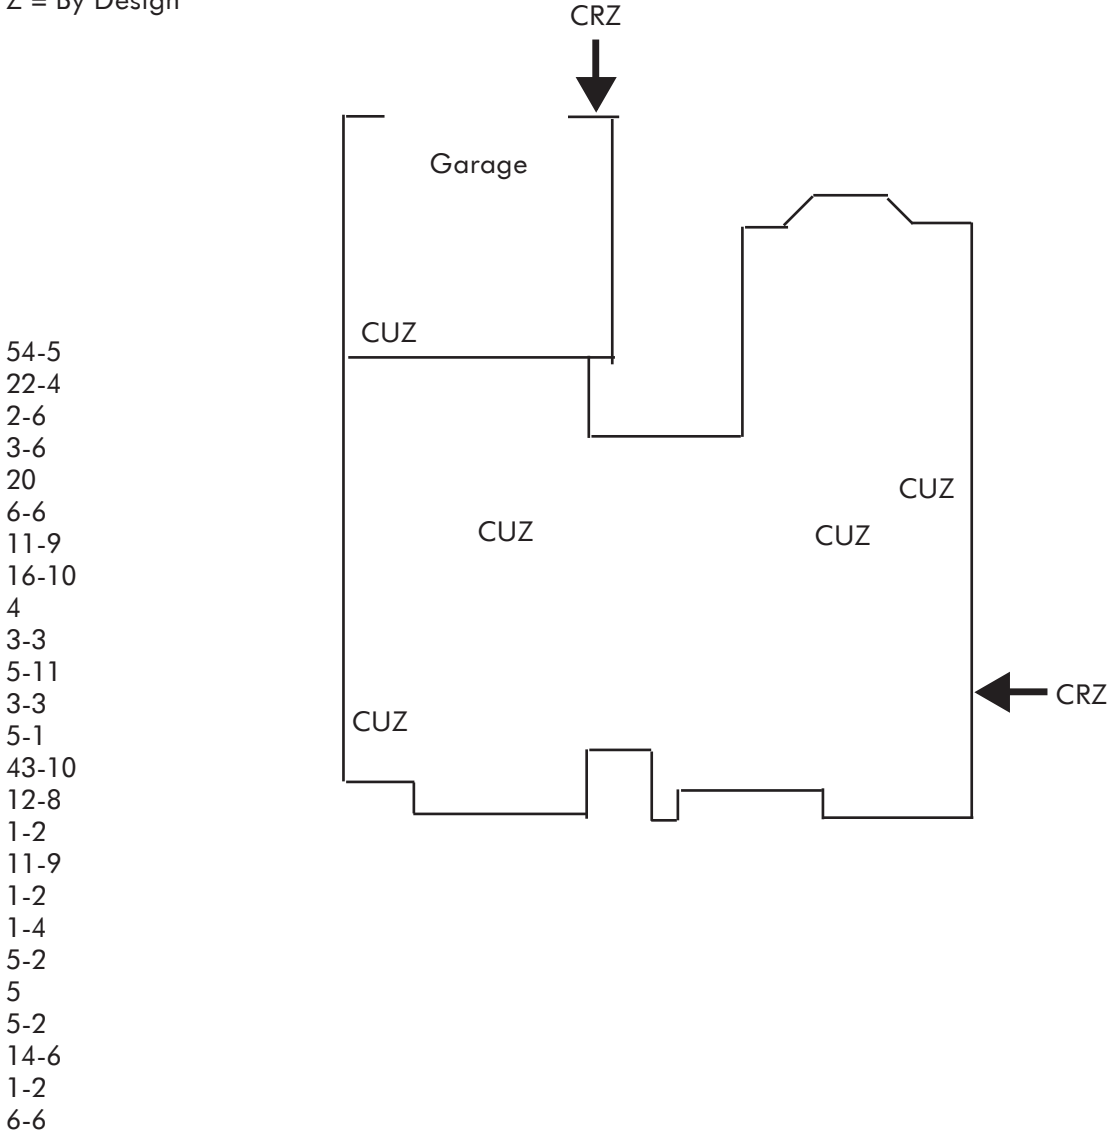
Diagram of Structure(s) Inspected

Because this house has been treated; it would be reasonable to assume that there may be some undetermined or latent wood damage that has not been identified in this report.

269' 7" *
Additional Comments Not to scale / 1" = apx. 16' / Regular monitoring of all structures is recommended.
