PROPERTY INSPECTION REPORT
PROVIDED BY
**A CLOSER LOOK
HOME INSPECTIONS INC.**

PREPARED EXCLUSIVELY FOR
**1517 KATIE CT
NEW LONDON WI 4961**

A CLOSER LOOK HOME INSPECTION REPORT

CLIENT NAME: Craig Baumgartner.
INSPECTION SITE ADDRESS: 1517 Katie Ct.
INSPECTION SITE CITY/STATE/ZIP: New London, WI 54961.
DATE OF INSPECTION: June 17, 2010.
TIME OF INSPECTION: 12:00 PM.
INSPECTION #: 1517 Katie Ct New London.
REAL ESTATE AGENT: Erica Smedema.
CLIENT MAILING ADDRESS: 1517 Katie Ct.
CLIENT CITY/STATE/ZIP: New London, WI 54961.
CLIENT PHONE #: 920 982 7970.
CLIENT FAX #:

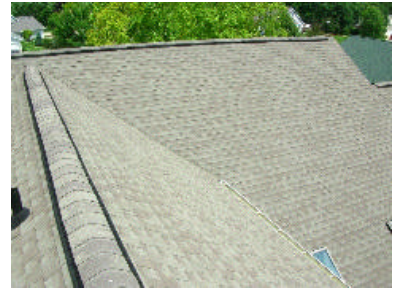
STYLE: Gable.
 PITCH: Medium.
 TYPE: Composition shingles.
 APPROXIMATE AGE: 10 - 15 years.
 ROOF COVERING CONDITION: General condition appears satisfactory with normal signs of weathering/curling and aging. Regular maintenance and inspections are advised. Moss buildup is present. Exposed nail heads present on roof recommend tarring.

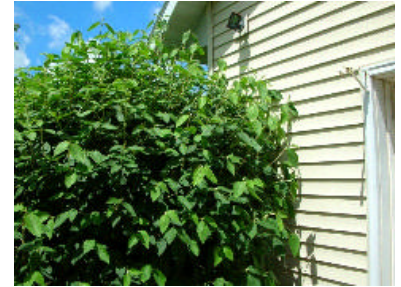
CONDITION: Trim bushes away from structure.

GRADING: Negative grade at foundation recommend Using topsoil, raise the landscape to create a positive slope away from the foundation walls of 1 inch per foot for the first 4 to 5 feet. All added soil must be thoroughly tamped to avoid future settling. Recommend covering the first 4 feet with 5-10 mil. plastic sheeting secured at the wall every 12 inches with lawn staples, then cover the plastic sheeting with decorative stone or mulch for aesthetics. Borders should not restrict water flow away from the foundation or be higher than 1/2 inch above the soil level.

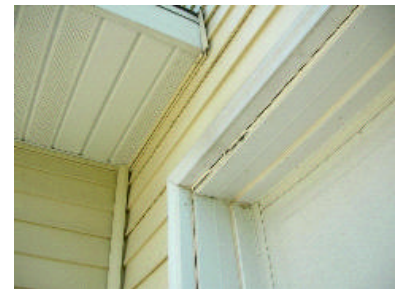
SIDING MATERIAL: Brick, Vinyl siding.
SIDING CONDITION: Satisfactory - May show normal wear and tear.
WALL FRAMING: Not visible.
TRIM MATERIAL: Wood, Metal.
TRIM CONDITION: Satisfactory, Recommend painting/staining.
SOFFIT AND FACIA MATERIAL: Metal.
SOFFIT AND FACIA CONDITION: Satisfactory.
EXTERIOR WINDOW FRAMES: Aluminum covered.
EXTERIOR WINDOWS CONDITION: Satisfactory.
EXTERIOR DOORS Satisfactory.
CAULKING: Marginal, Recommend around, masonry ledges, utility penetrations,

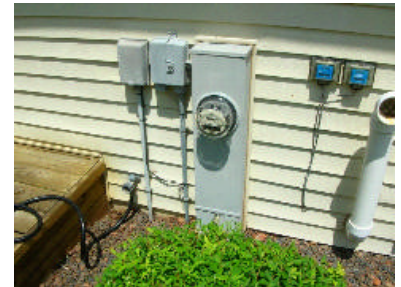
ENTRANCE CABLES: Underground.

CONDITION: Satisfactory.

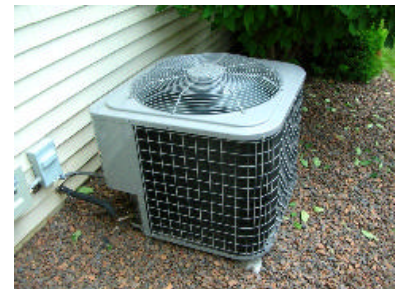
CONDITION: Satisfactory.

BRAND NAME: Carrier.

APPROX. AGE IN YEARS: 2007.

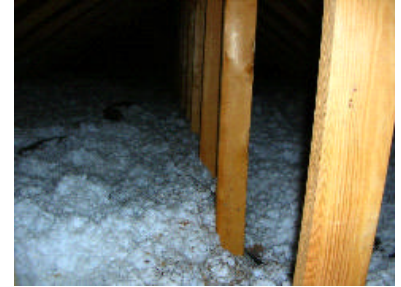
STRUCTURE Roof structure material is wood, Truss framing, Sheathing material is flakeboard.
CONDITION: Satisfactory.
INSULATION TYPE: Fiberglass batts, Fiberglass- Blown.
CONDITION: Marginal, Some insulation is installed unevenly or has been compacted, Evidence of varment Intrusion present.
APPROX. DEPTH AND R-FACTOR: 12 inches + R - 38 +
VAPOR BARRIER Vapor barrier was observed in a small area and appears proper but due to very limited visibility, it is impossible to determine if it is proper throughout attic.

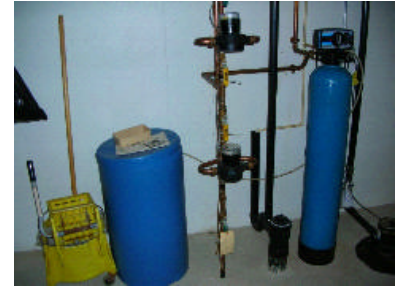
MAIN ENTRY LINE LOCATION Water meter/shut-off is located, at the north side of the basement. Valve not tested.

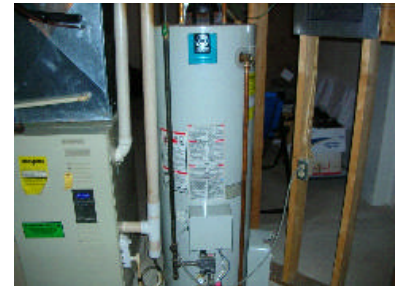
APPROX. AGE: 1994.
TYPE: Gas.
SIZE: 50 Gallons.
LOCATION: Basement.
CONDITION: Carbon deposits are present on water heater. Large amounts of rust and corrosion present on burners.
VENTING: Satisfactory.
FUEL SHUT OFF VALVE LOCATION: The fuel shut off valve is located on the gas line next to water heater.
FUEL LINE CONDITION: Satisfactory.

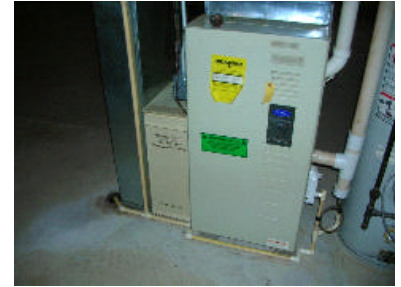
APPROXIMATE AGE IN YEARS: 1994.
LOCATION: Basement.
SYSTEM TYPE: Forced Air.
FUEL TYPE: Natural Gas.
FUEL CONDITION: Satisfactory.
SHUT OFF LOCATION: The fuel shut off valve is located on the gas line next to the furnace .
GENERAL CONDITION: Appears operational.
BURNERS/HEAT EXCHANGERS: Satisfactory.
COMBUSTION AIR: Appears satisfactory.
VENTING: Satisfactory.
PUMP/BLOWER FAN: Satisfactory.
AIR FILTERS: Satisfactory.
CONTROLS: Satisfactory.

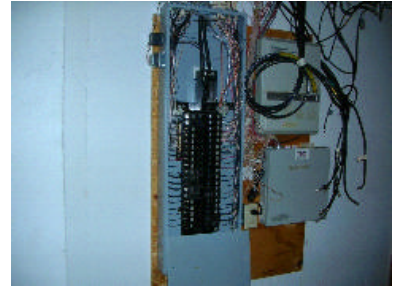
TYPE: Circuit breakers.
MAIN WIRE: Aluminum.
AMPERAGE: 200 amps.
VOLTS: 220 Volt.
BRANCH WIRING: Copper, Aluminum (220 volt OK)
CONDITION: Satisfactory, Multiple wires are connected to a single lug on a circuit breaker.

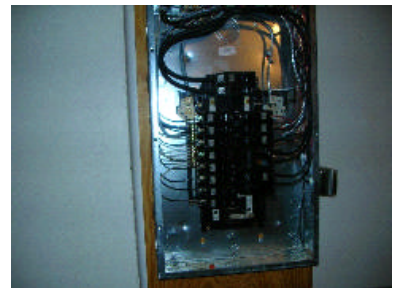
SUB PANEL COMMENTS: Satisfactory, Multiple wires are connected to a single lug on a circuit breaker.
