## **Coastal Protection and Restoration Authority of Louisiana**

## **2008/2009 Annual Inspection Report**

## **MARSH ISLAND HYDROLOGIC RESTORATION PROJECT (TV-14)**

State Project Number TV-14  
Priority Project List 6

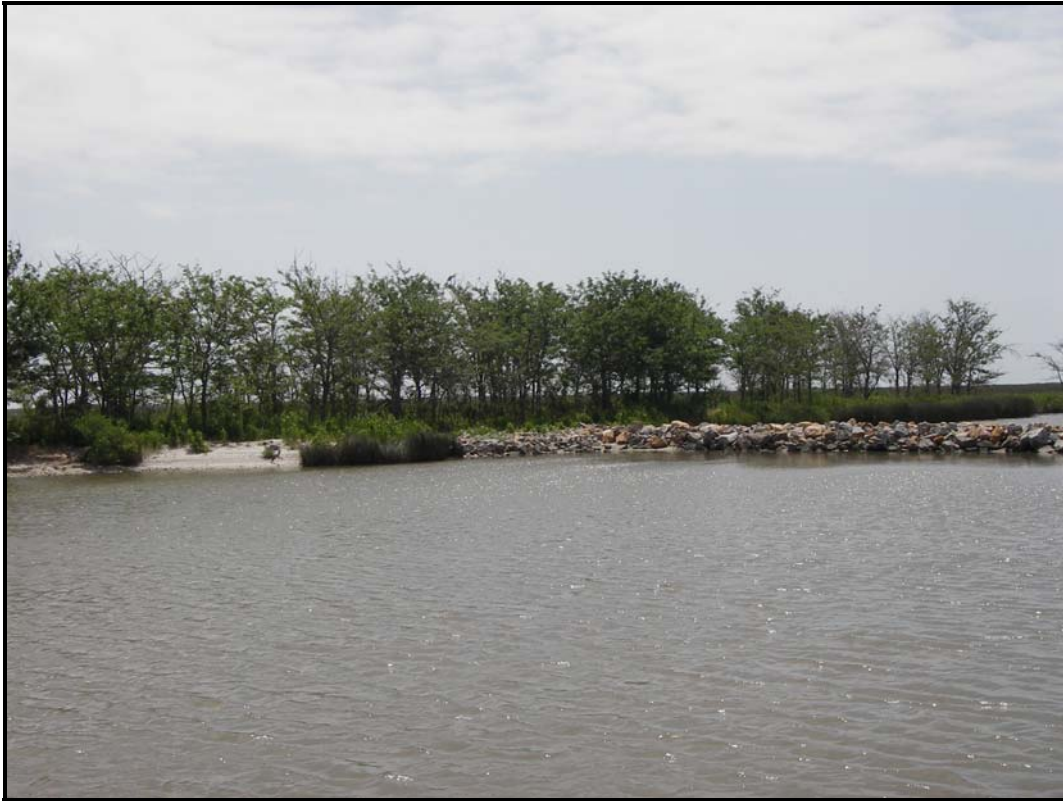
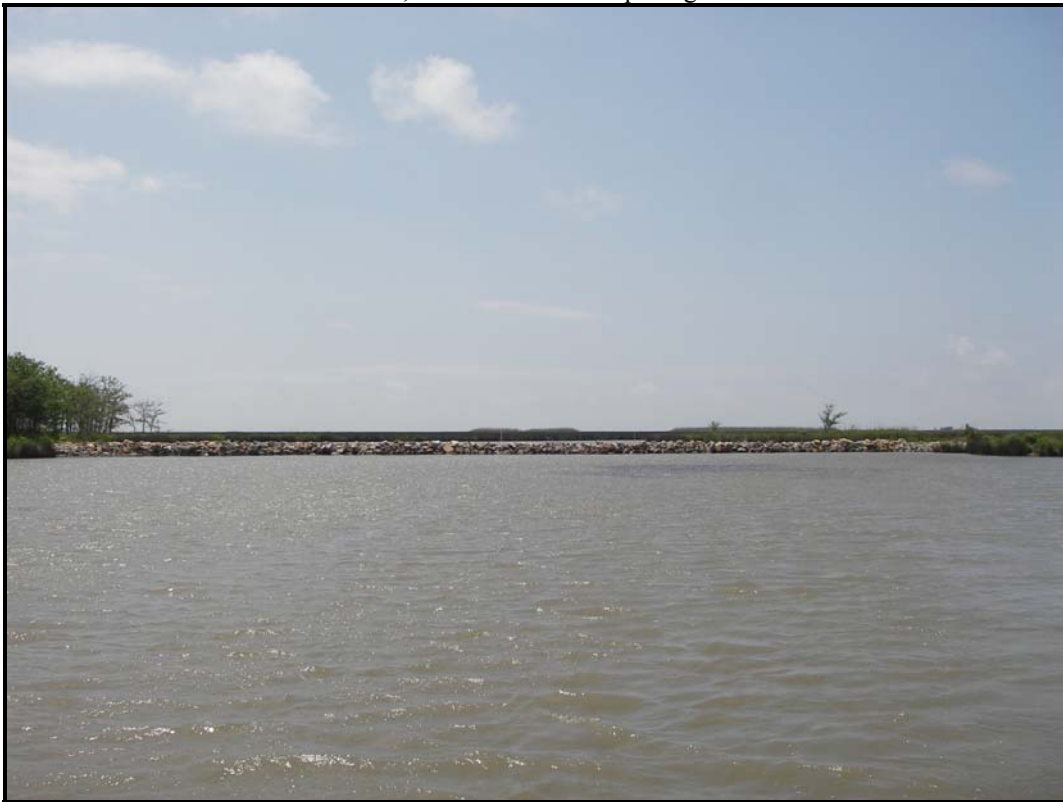
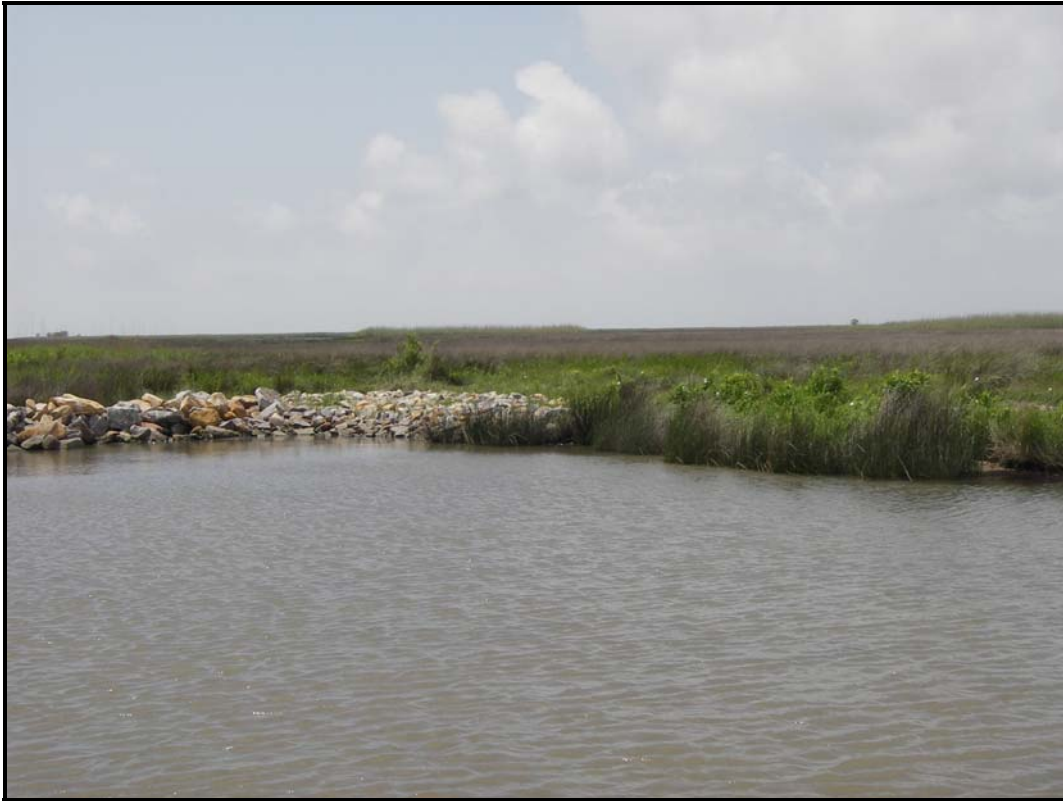
### **Closure No. 1**

The erosion problems and Hurricane Rita damages have been repaired through the recent maintenance project that was completed in February 2009. The dike was capped and bank paving installed on both ends of the closure. This site is in good condition since this work was performed. (Photos: Appendix B, Photos 1-3).

**Photo No.1**, Closure No.1 bank paving east side

**Photo No.2**, Closure No. 1 looking south

**Photo No. 3,** Closure No. 1 bank paving west side

Item	Condition	Physical Damage	Corrosion	Photo #	Observations and Remarks
Steel Bulkhead / Caps	N/A				
Steel Grating	N/A				
Stop Logs	N/A				
Hardware	N/A				
Timber Piles	N/A				
Timber Wales	N/A				
Galv. Pile Caps	N/A				
Cables	N/A				
Signage / Supports	N/A				
Rip Rap (fill)	Good			1,2,3	Closure is repaired
Earthen Embankment	N/A

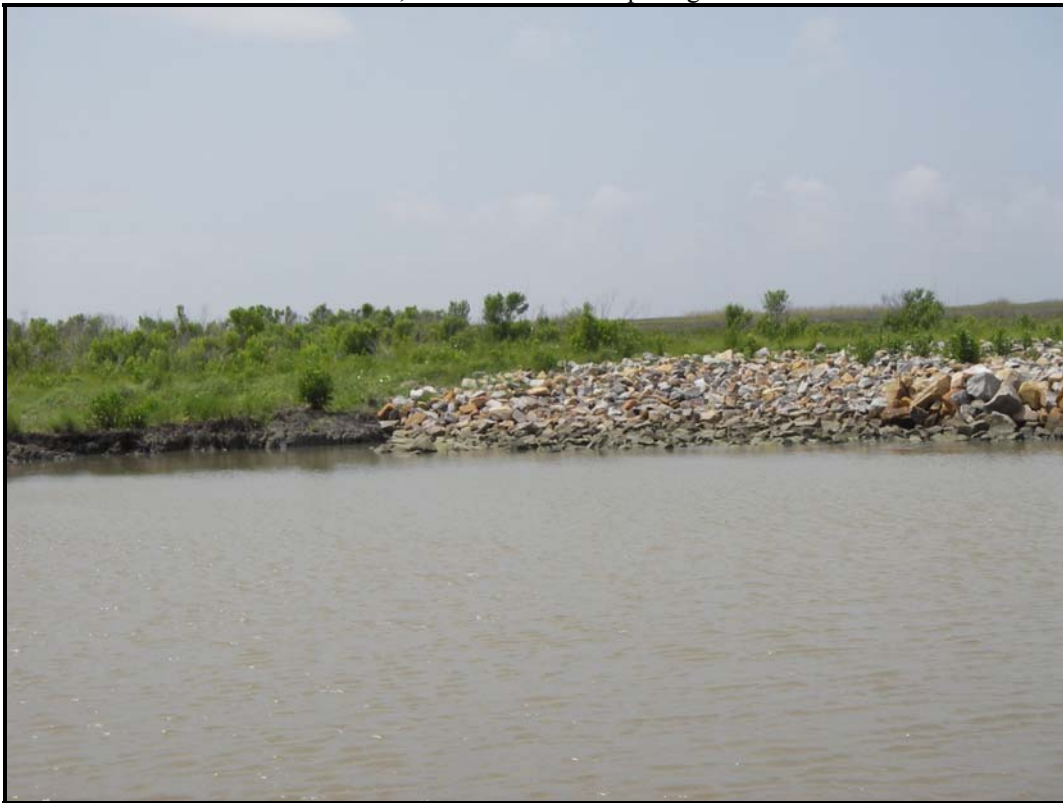
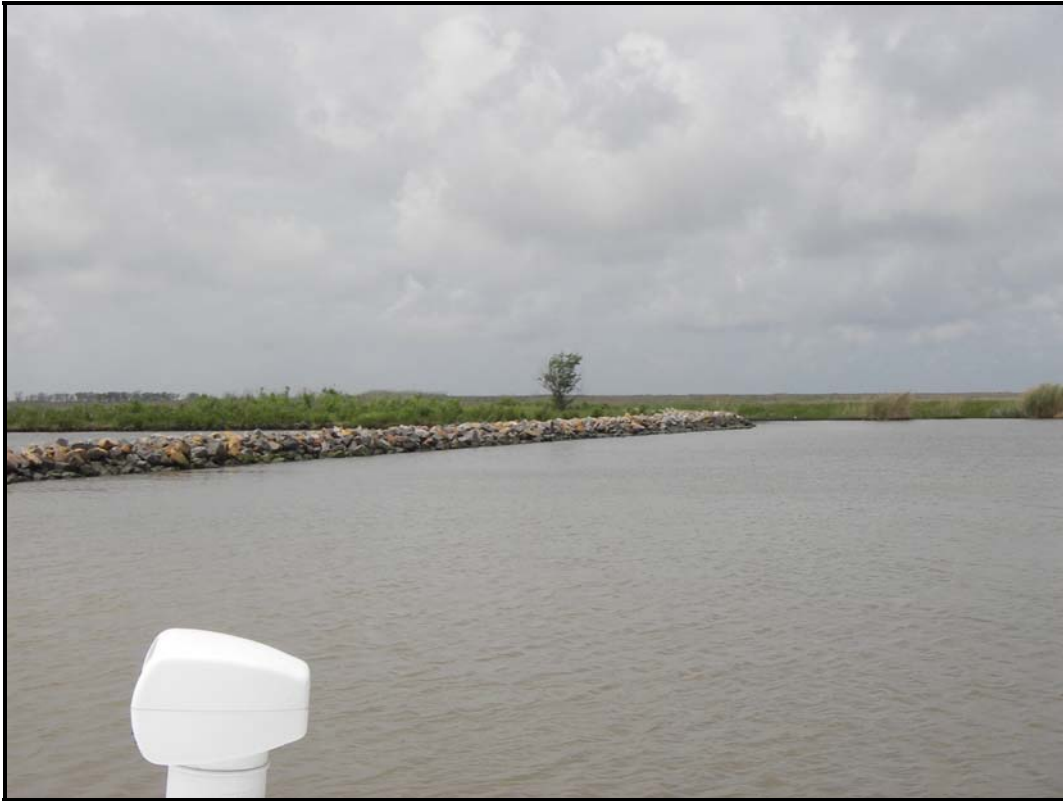
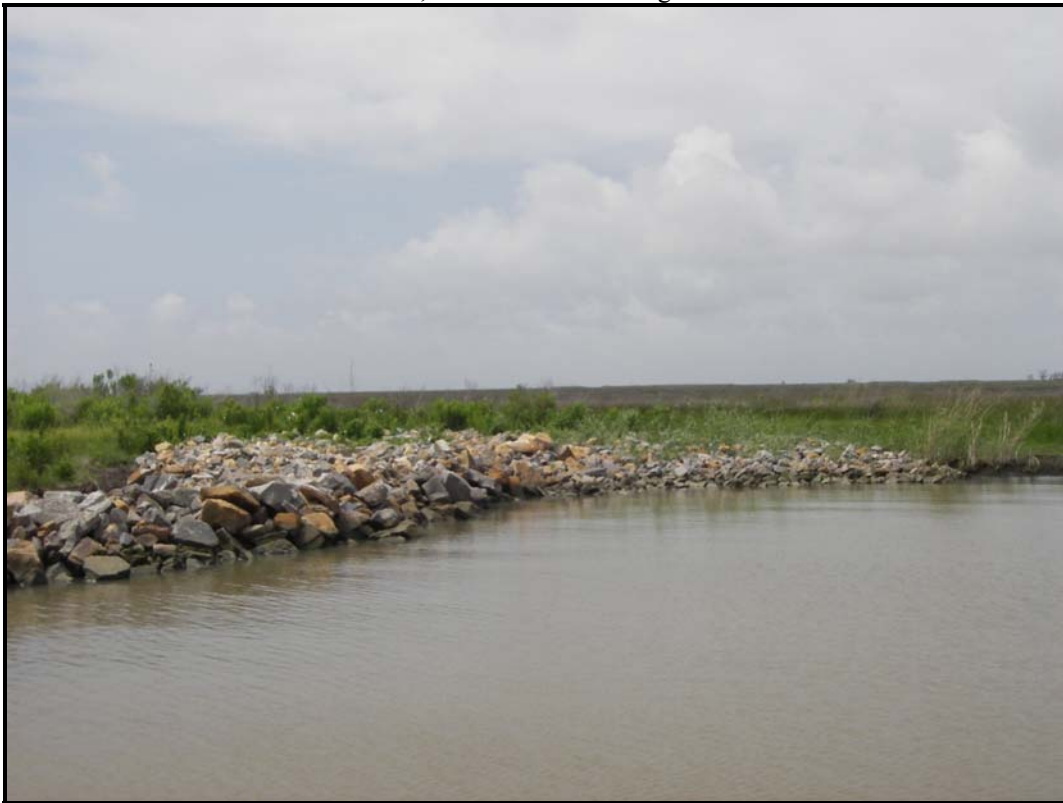
### **Closure No. 2**

The dike was capped and bank paving installed as noted above and is in good condition since the work was performed. (Photos: Appendix B, Photos 4-6).

**Photo No. 4,** Closure No. 2 bank paving east side

**Photo No. 5,** Closure No. 2 looking southwest

**Photo No. 6,** Closure No. 2 bank paving west side

Item	Condition	Physical Damage	Corrosion	Photo #	Observations and Remarks
Steel Bulkhead / Caps	N/A				
Steel Grating	N/A				
Stop Logs	N/A				
Hardware	N/A				
Timber Piles	N/A				
Timber Wales	N/A				
Galv. Pile Caps	N/A				
Cables	N/A				
Signage / Supports	N/A				
Rip Rap (fill)	Good			4,5,6	Closure is repaired.
Earthen Embankment	N/A

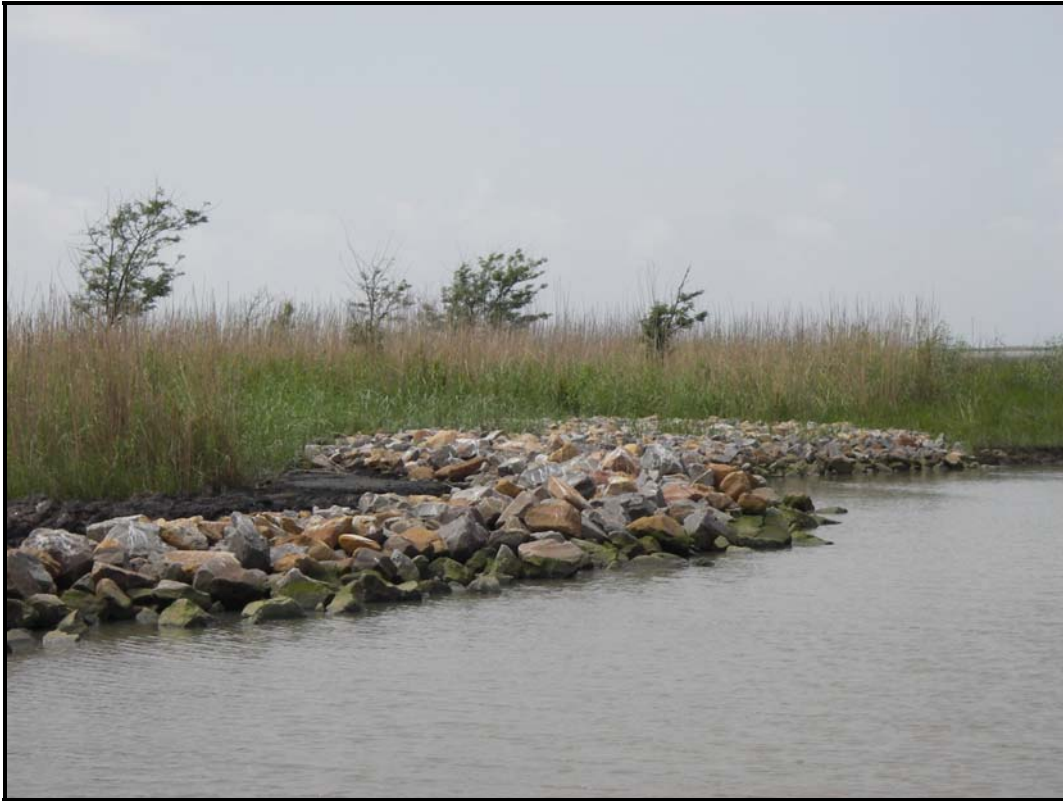
### **Closure No. 3**

The rock closure dike appears in good condition and was extended on the western end along with installing bank paving during the recent maintenance event. Also, it was observed (and confirmed with aerial photography post Hurricane RITA) that a large open water area has developed within the marsh near the western terminus of Closure No. 3 and that the bankline between that point and the eastern end of Closure No. 2 has eroded very severely and such that the “landbridge” between Vermilion Bay on the north of Marsh Island and the northwestern portion of Lake Sand proper is now narrow and may become subject to breaching thus allowing an undesirable water connection between the two bodies of water. OCPR and COE agree that this area is in poor condition and should be considered for maintenance at some point in time. It is recommended that an additional reach of shoreline protection dike be constructed, an estimated 1,500 to 1,800 linear feet, to connect the western end of Closure No. 3 to the eastern end of Closure No. 2. This reach of bank has been recently surveyed and the estimated cost for rock dike and flotation is approximately \$800,000. OCPR and COE agreed that due to this area being of concern but not yet critical status; and budget constraints, this maintenance work would be undertaken at a later time.(Photos: Appendix B, Photo 7).

**Photo No. 7,** Closure No. 3 bank paving west side

Item	Condition	Physical Damage	Corrosion	Photo #	Observations and Remarks
Steel Bulkhead / Caps	N/A				
Steel Grating	N/A				
Stop Logs	N/A				
Hardware	N/A				
Timber Piles	N/A				
Timber Wales	N/A				
Galv. Pile Caps	N/A				
Cables	N/A				
Signage / Supports	N/A				
Rip Rap (fill)	Good			7	Hurricane RITA eroded the marsh between Str. No. 2 & 3, leaving a narrow piece of marsh, and it is recommended that the shoreline between Str. 3 & 4 (+/- 1,500 to 1,800 L.F.) be armored with a rock dike.
Earthen Embankment	N/A

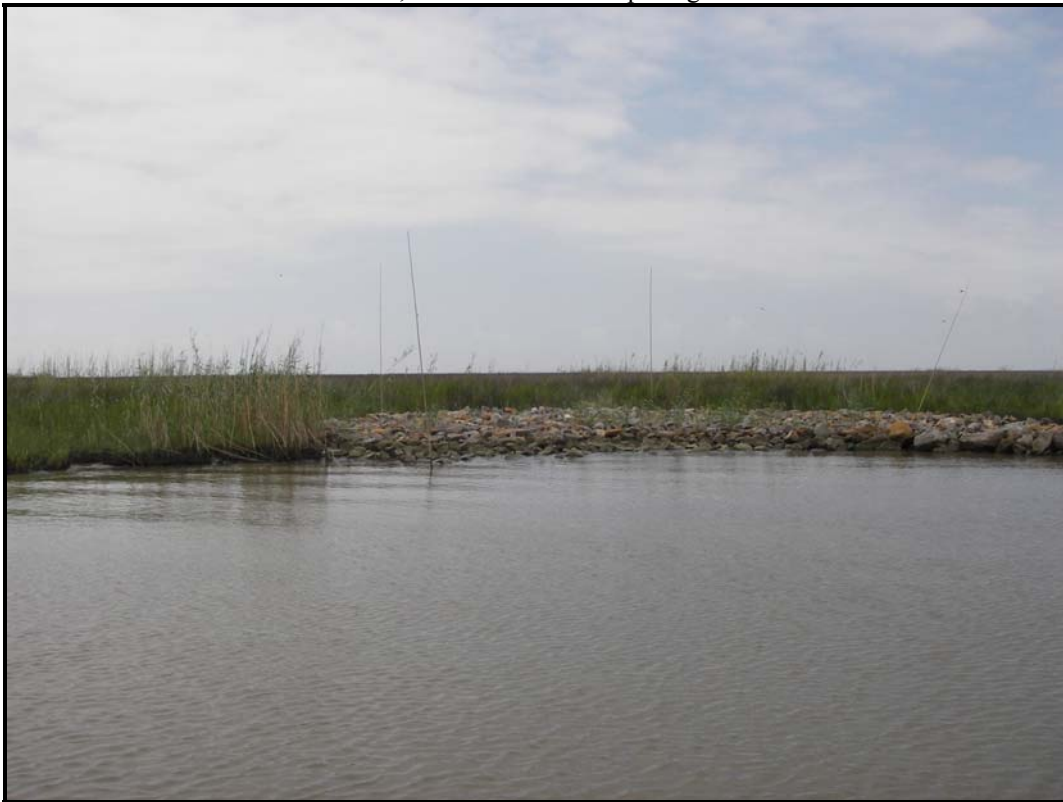
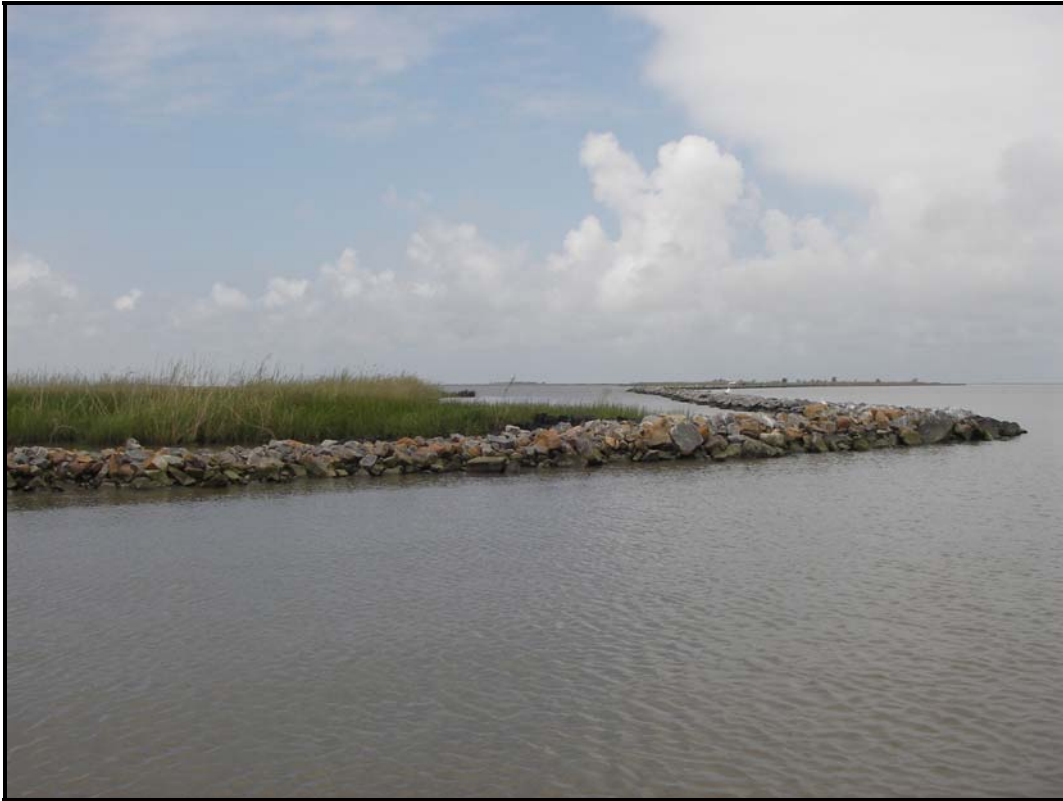
#### **Closure No. 4**

The Lake Sand Dike closure as originally constructed and recently repaired for Hurricane Rita damages, appears in good condition. The dike was capped in those areas where it was below elevation +3.0 as well as extended on the eastern end with bank paving. (Photos: Appendix B, Photos 8-9).

**Photo No. 8,** Closure No. 4 bank paving east side

**Photo No. 9,** Closure No. 4 looking west

Item	Condition	Physical Damage	Corrosion	Photo #	Observations and Remarks
Steel Bulkhead / Caps	N/A				
Steel Grating	N/A				
Stop Logs	N/A				
Hardware	N/A				
Timber Piles	N/A				
Timber Wales	N/A				
Galv. Pile Caps	N/A				
Cables	N/A				
Signage / Supports	N/A				
Rip Rap (fill)	Good			8,9	Lake Sand closure is repaired.
Earthen Embankment	N/A

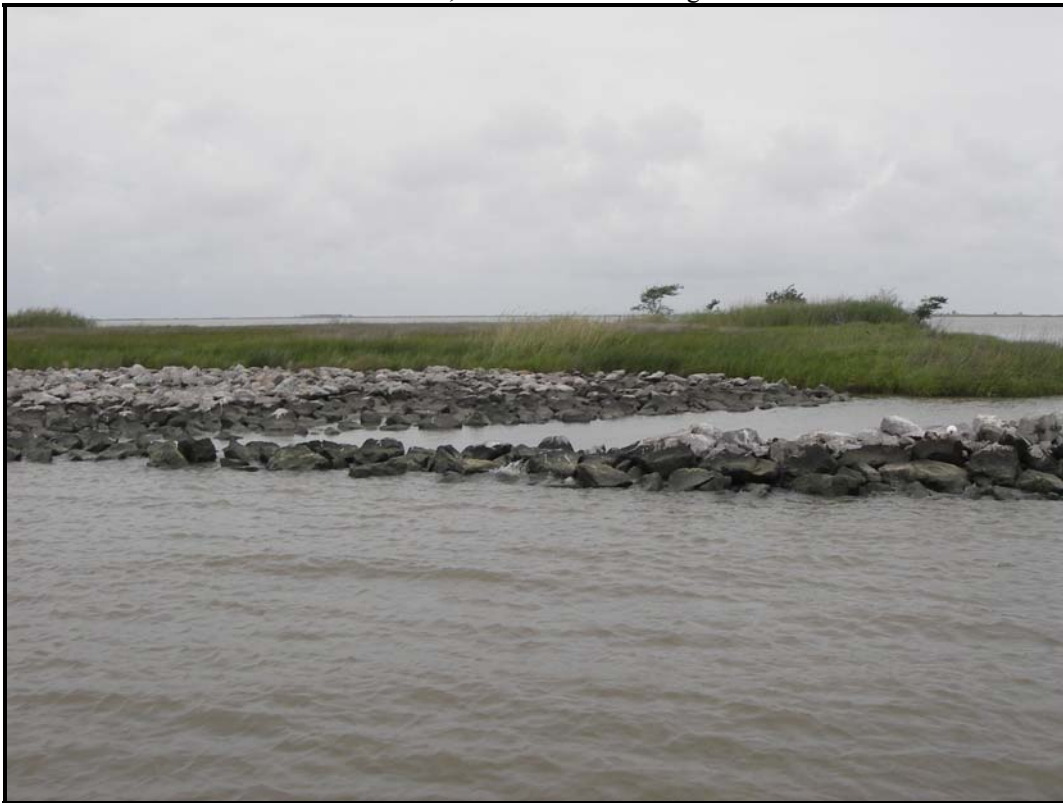
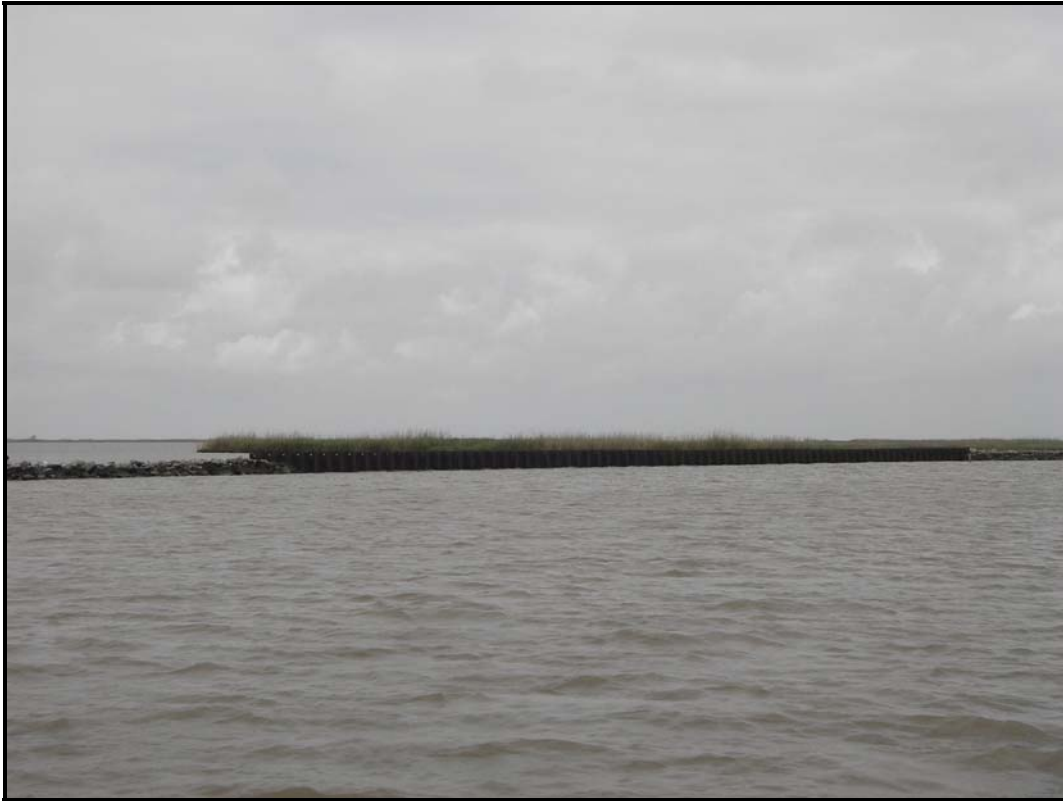
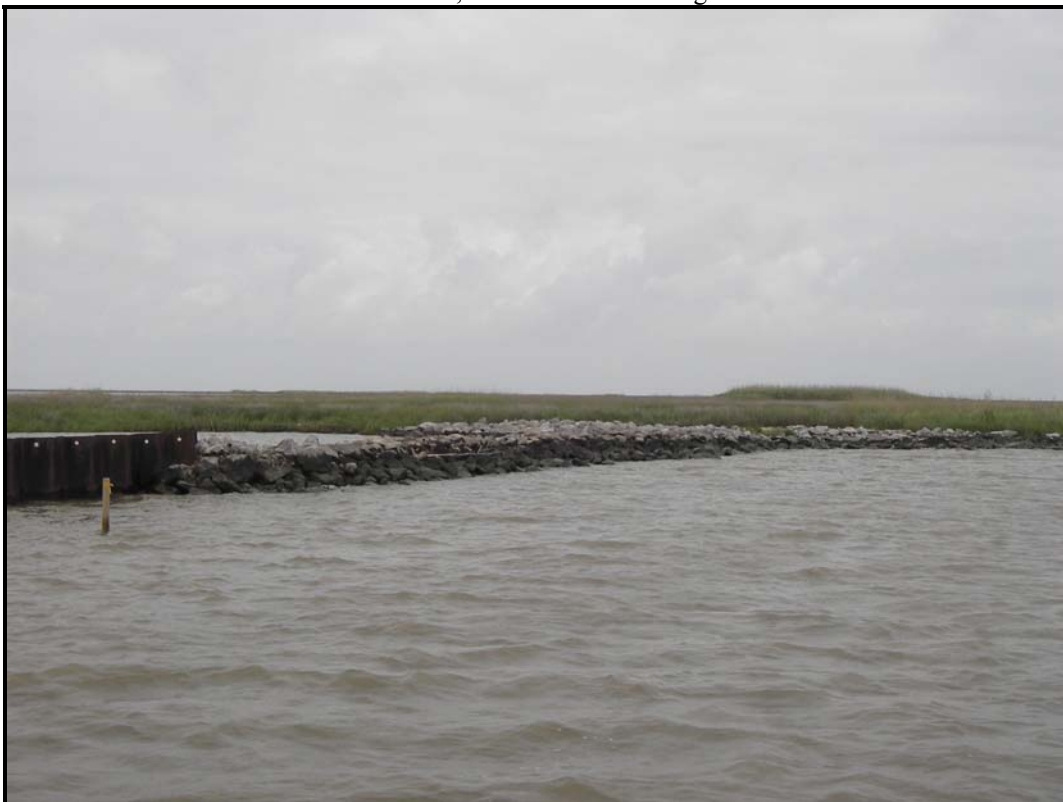
#### **Closure No. 5**

The steel sheet pile, rock riprap wingwalls, and stone bank/marsh paving placed as part of the Hurricane LILI repair project is in good condition and were apparently very effective in preventing additional damage by the erosive action of Hurricane RITA. The staff gage was re-set as part of the recent maintenance event. The overbank marsh areas paved to make same “hard” and paid for with O & M funding needs to be continually evaluated for its effectiveness. (Photos: Appendix B, Photos 10-12).

**Photo No. 10,** Closure No. 5 bank paving south side

**Photo No. 11,** Closure No. 5 looking west

**Photo No. 12,** Closure No. 5 bank paving north side

Item	Condition	Physical Damage	Corrosion	Photo #	Observations and Remarks
Steel Bulkhead / Caps	N/A				
Steel Grating	N/A				
Stop Logs	N/A				
Hardware	N/A				
Timber Piles	N/A				
Timber Wales	N/A				
Galv. Pile Caps	N/A				
Cables	N/A				
Signage / Supports	N/A				
Rip Rap (fill)	Good			10, 11, 12	Staff gage reset.
Earthen Embankment	N/A

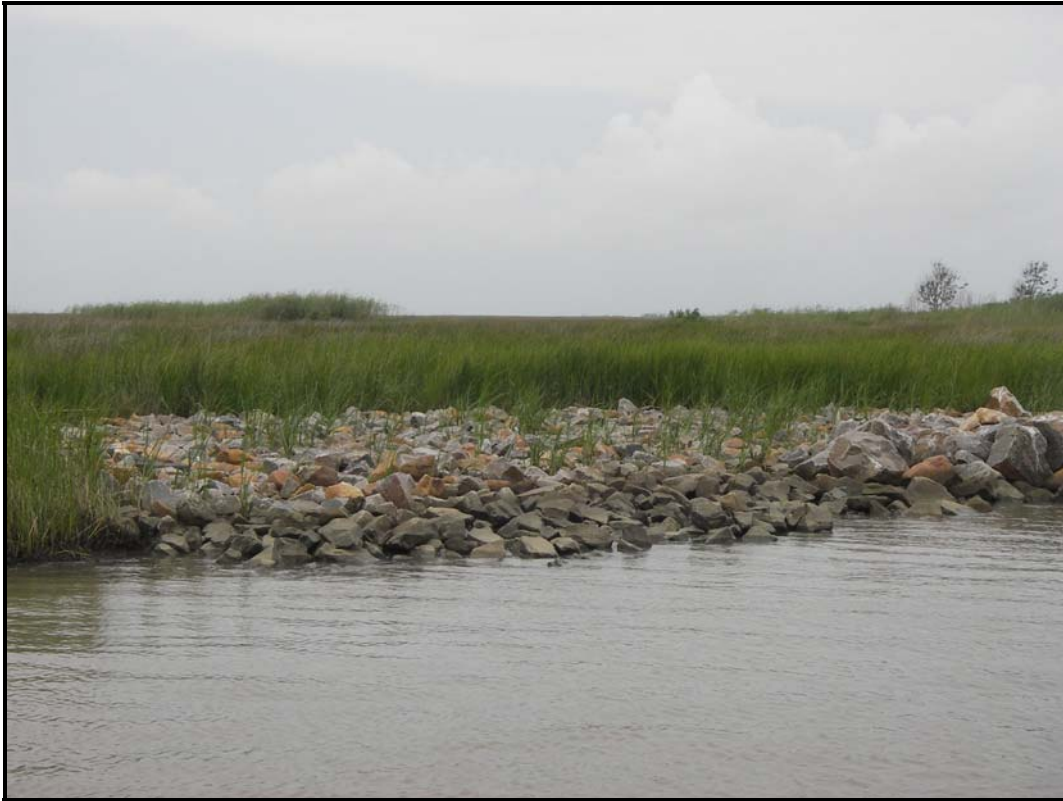
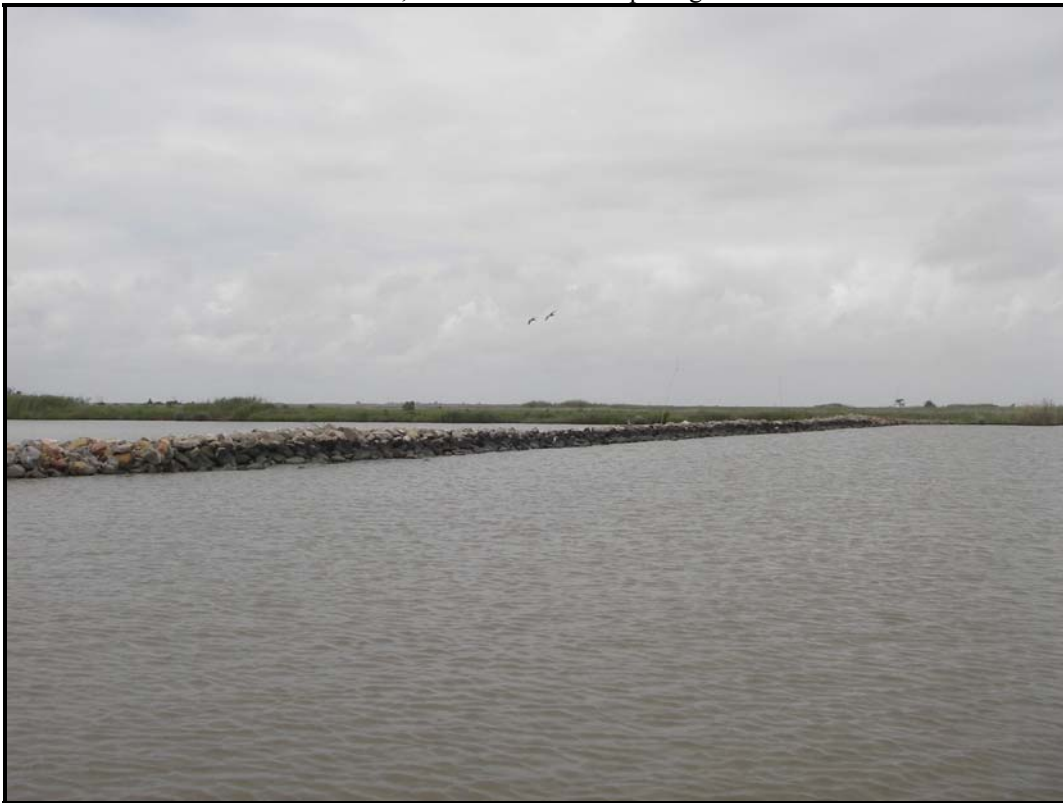
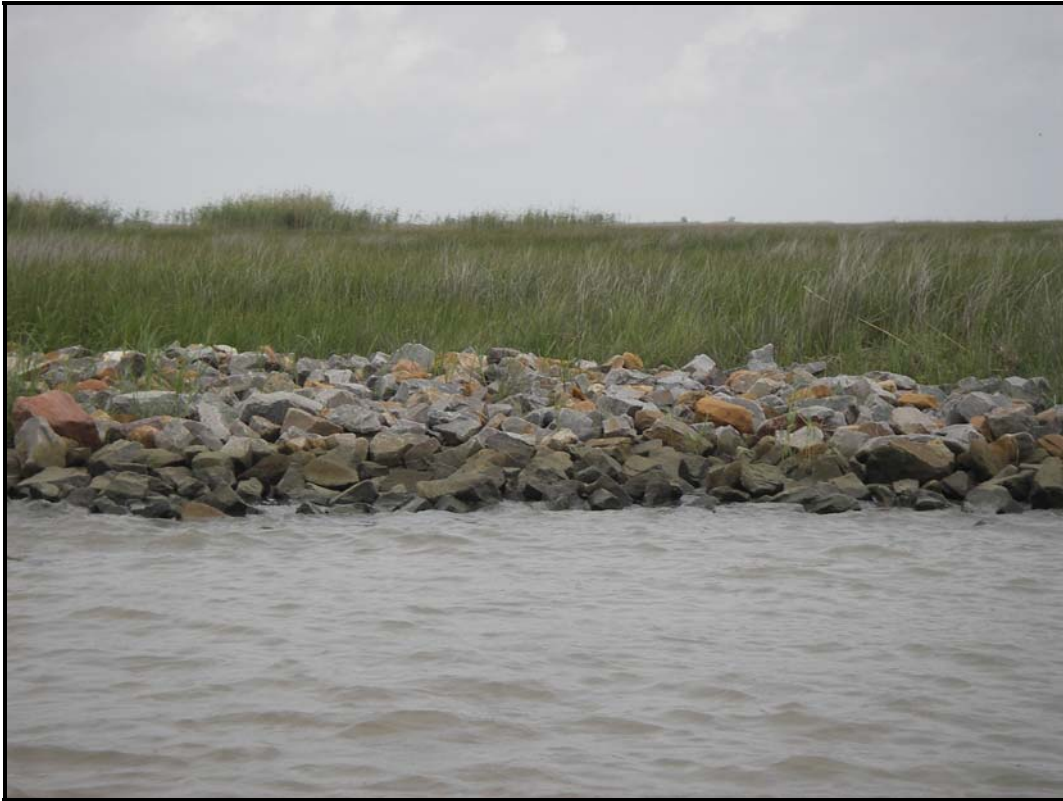
#### **Closure No. 6**

The breach on the southern end of the dike that had occurred prior to Hurricane Rita and subsequently worsened as a result of the tidal surge has been repaired as part of the recent maintenance event. The dike was extended on the northern end and bank paving was installed on both ends of the closure. This site is in good condition since the repairs have been made. (Photos: Appendix B, Photos 13-15).

**Photo No. 13,** Closure No. 6 bank paving south side

**Photo No. 14,** Closure No. 6 looking west

**Photo No. 15,** Closure No. 6 bank paving north side

Item	Condition	Physical Damage	Corrosion	Photo #	Observations and Remarks
Steel Bulkhead / Caps	N/A				
Steel Grating	N/A				
Stop Logs	N/A				
Hardware	N/A				
Timber Piles	N/A				
Timber Wales	N/A				
Galv. Pile Caps	N/A				
Cables	N/A				
Signage / Supports	N/A				
Rip Rap (fill)	Good			13,14,15	Breach has been repaired.
Earthen Embankment	N/A

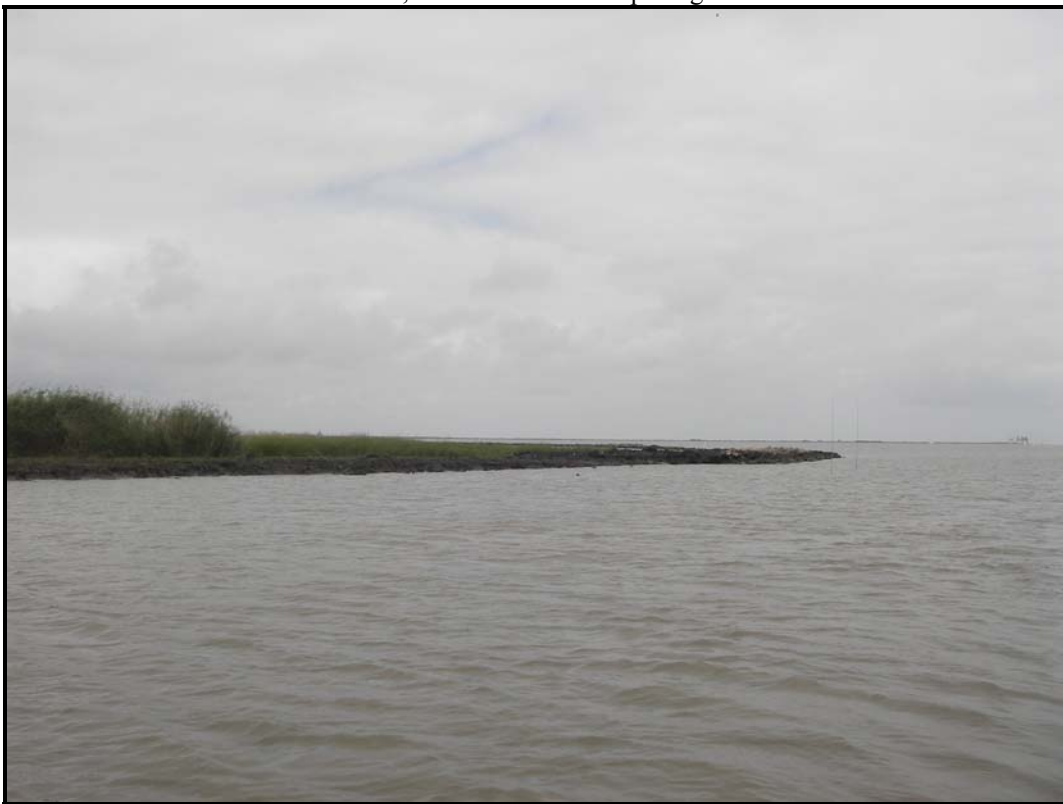
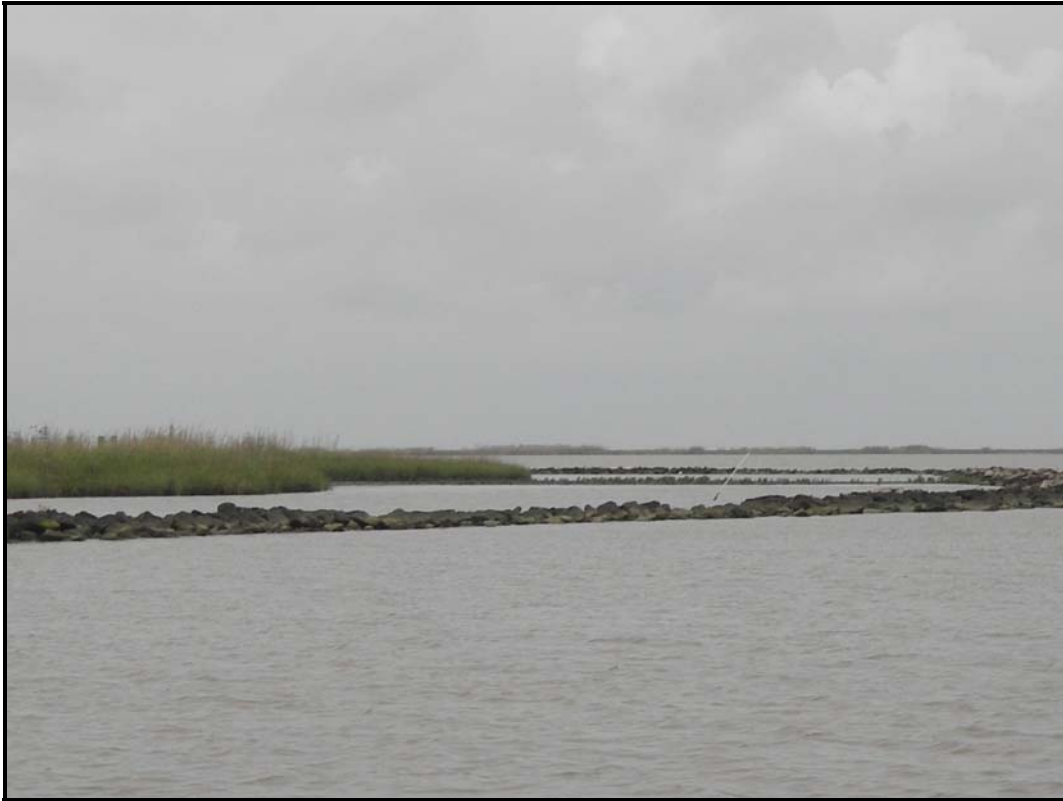
#### **Closure No. 7**

This closure site is in good condition and spoil material from the dredging of the north-south canal in 2008 was placed along the eastern end of the rock dike in an effort to stabilize this section of shore. In addition dredge spoil material was pumped behind the rock dike as part of this same access dredging and a small area of marsh creation was formed which is now starting to vegetate. (Photos: Appendix B, Photos 16-17).

**Photo No. 16,** Structure No. 7 spoil material connecting to rock dike

**Photo No. 17,** Structure No. 7 marsh creation behind rock dike starting to vegetate

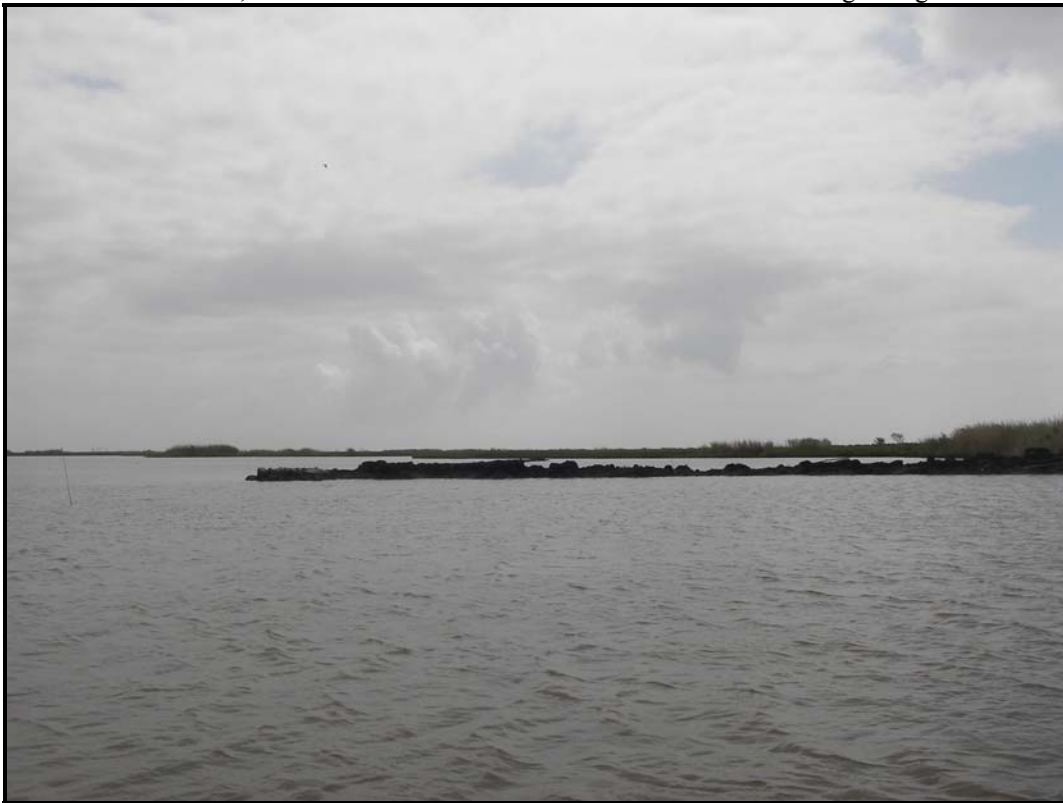
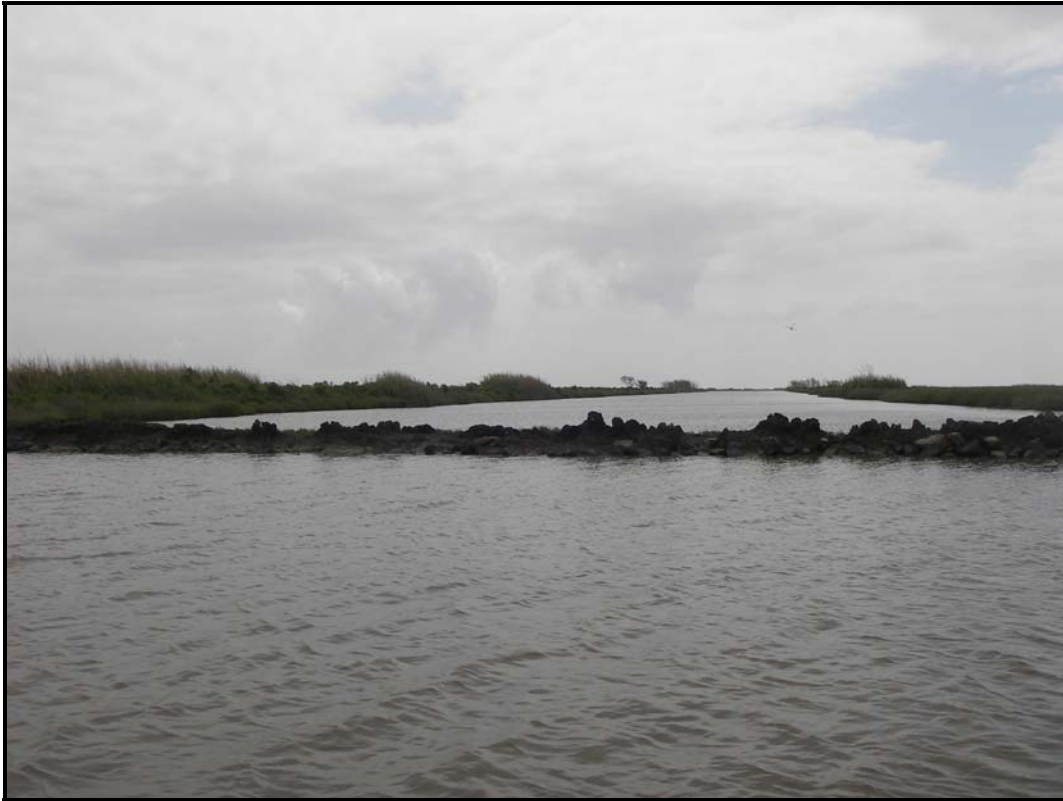
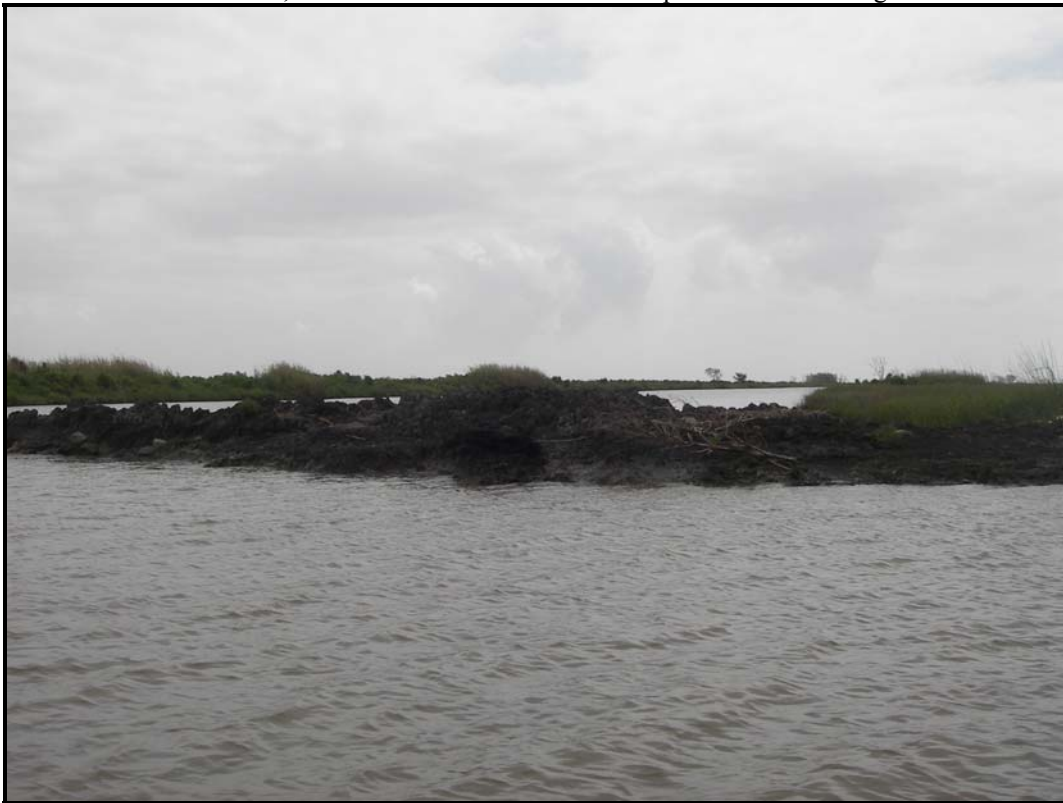
#### **Closure No. 8**

This closure site is in good condition since the existing breach on the south side of the closure was repaired as noted in the 2008 maintenance event noted above in Section IV. Spoil material was placed to close off the breach and also placed on top of the existing rock dike. Spoil material was also placed from the north end of the rock dike towards the bay to make a connection to the existing mitigation rock dike along the bayshore. (Photos: Appendix B, Photos 18-20).

**Photo No. 18,** Closure No. 8 spoil material connecting to rock dike at bay shore

**Photo No. 19,** Closure No. 8 rock covered with spoil material looking east

**Photo No. 20,** Closure No. 8 breach repair with spoil material

Item	Condition	Physical Damage	Corrosion	Photo #	Observations and Remarks
Steel Bulkhead / Caps	N/A				
Steel Grating	N/A				
Stop Logs	N/A				
Hardware	N/A				
Timber Piles	N/A				
Timber Wales	N/A				
Galv. Pile Caps	N/A				
Cables	N/A				
Signage / Supports	N/A				
Rip Rap (fill)	Good			18, 19, 20	Breach has been repaired.
Earthen Embankment	N/A

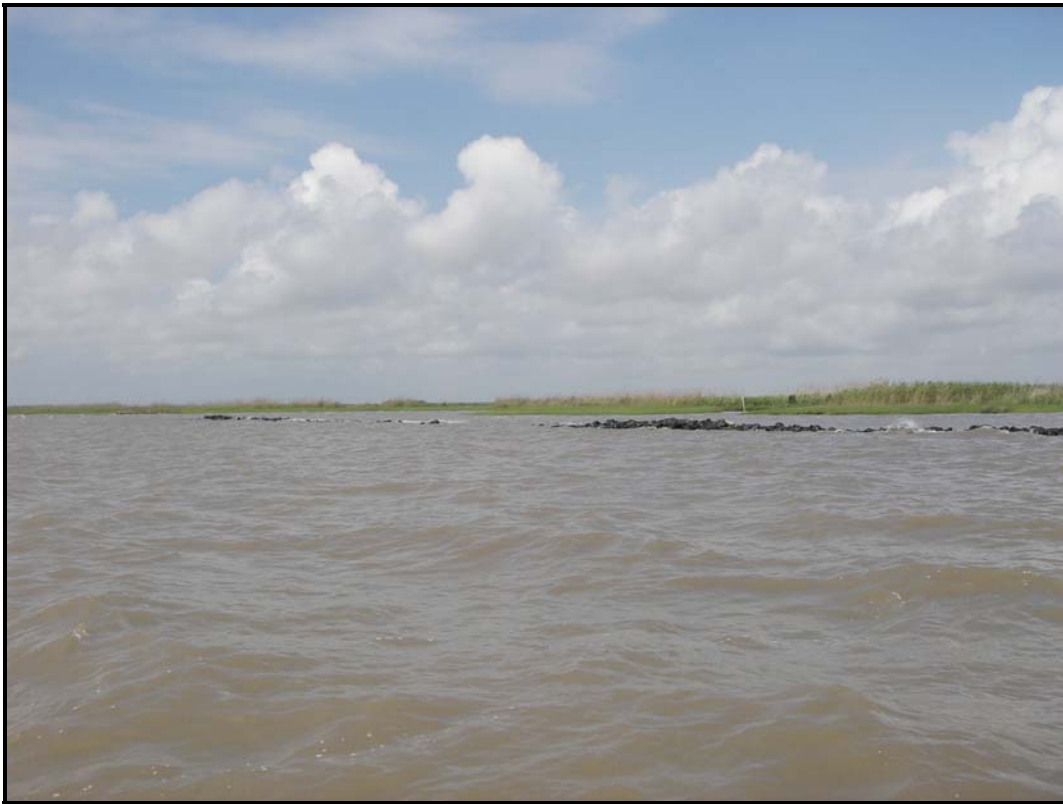
#### **Closure No. 9**

The rock riprap shoreline protection dike constructed on the south shoreline of Marsh Island was noted to now sit out further into the waters of the Gulf as discussed in the last inspection. Conditions were such that the feature was functioning well and that sediment had accreted and a growth of marsh vegetation had extended over the new fill. This rock shoreline feature will still function as a breakwater and extend the life of the earthen pipeline closure to the north. It was discussed that perhaps each end of the current rock riprap dike be extended to the east and to the west, or perhaps construct extensions on each end of the existing stone to the northwest and northeast alignment directions to the shoreline from erosion of the earthen pipeline closure. Conditions at this location need to be evaluated and a design for some east and west extensions of the current dike concluded after some study. (Photos: Appendix B, Photo 21).

**Photo No. 21,** Structure No. 9 rock dike, new vegetation along bay shore in background

Item	Condition	Physical Damage	Corrosion	Photo #	Observations and Remarks
Steel Bulkhead / Caps	N/A				
Steel Grating	N/A				
Stop Logs	N/A				
Hardware	N/A				
Timber Piles	N/A				
Timber Wales	N/A				
Galv. Pile Caps	N/A				
Cables	N/A				
Signage / Supports	N/A				
Rip Rap (fill)	Fair			21	Hurricane RITA has eroded the marsh/sediment behind the rock plug and has exposed the earthen keyway to further erosion. The rock dike needs to be extended on each end and tie back into existing shoreline.
Earthen Embankment	N/A
