## RC Certified Inspections

# Inspection Report

Any Street USA

**Inspection date:** 4/28/2014

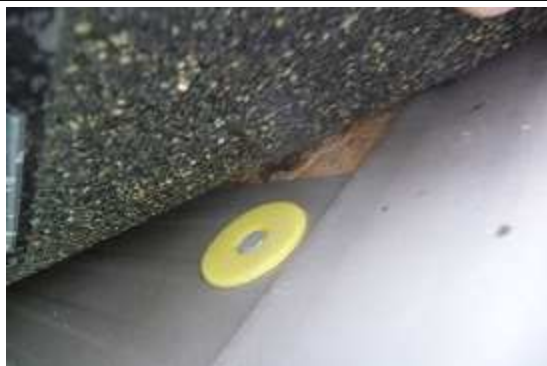
1. There is not any visible felt paper under the shingles at the Gable roof area above the front porch entry on the North slope.

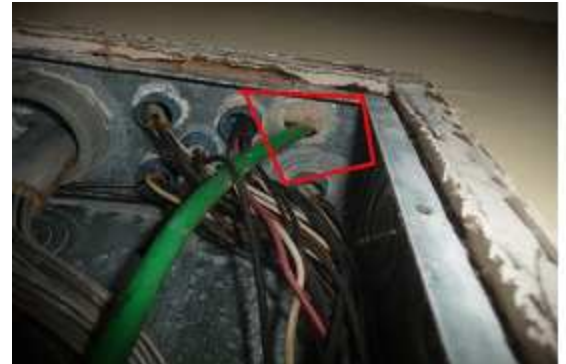
1. There are two missing electric cable connectors at the top of the main electric panel. At the ground wire on the left top corner and at the ground cable at the top right corner. Even though these don't carry current the openings around them has to be sealed off per National Electrical Code.

2. There has been a lot of moisture entering the main electric panel from the top and the neutral bar's are heavily rusted on the right side as well as several of the breakers. This is a electrical safety concern and a licensed electrician needs to evaluate the breakers and may have to replace the neutral bar and make clean connections for the neutral wires and ground wires.

3. The front cover for the main electric panel does not fit flush onto the main electric panel surfaces. Per NEC, the panel must fit flush against the electric panel edges. The drywall will need to be cut back to achieve this. There appears to be mold growth on the drywall at the top and top left corners that has to be cut out anyway.

\* Need to find out where and how the water is entering at the top of the electric panel.

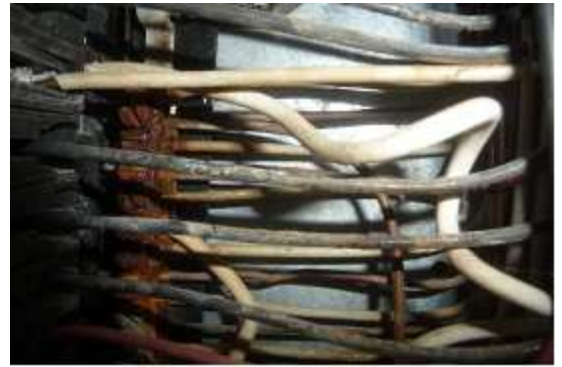
Another shot of the water damage and rested connections at the neutral bar

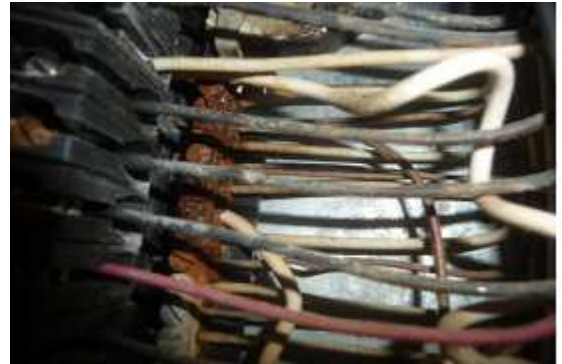
Water damage in rusting to the neutral bar connections and the breakers.

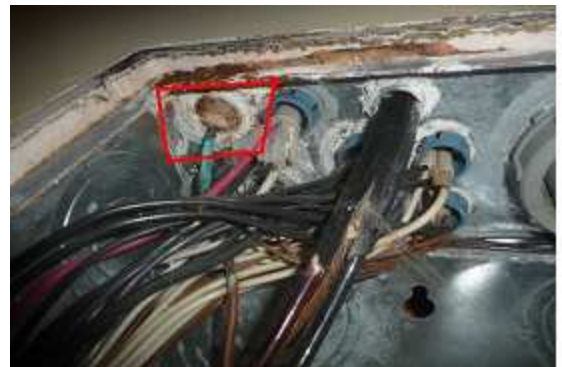
Missing cable connector at top left corner

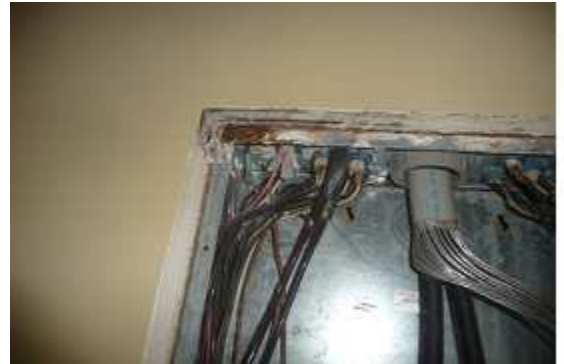
\* Water moisture noted inside the electric panel was also noted in the defects/Safety section of this report

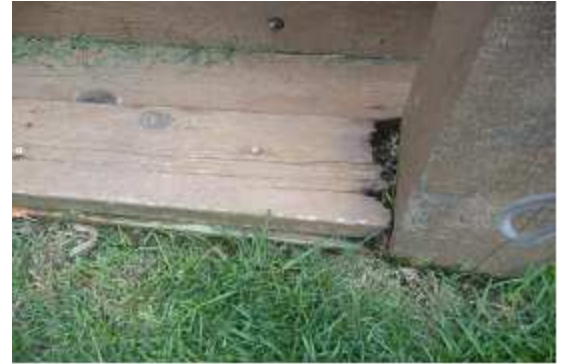
1. The deck stairs bottom step is rotted.
2. The deck ledger board is not lag bolted to the house and is a safety issue.
3. The deck ledger board is not have any visible flashing installed.
4. The deck post are in contact with the soil and should be checked regularly for decay and or insect damage.

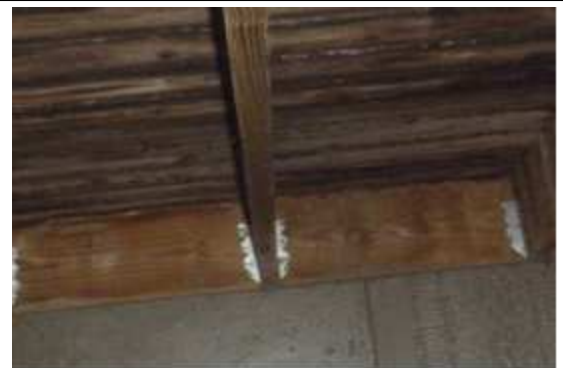
The deck ledger board is not lag bolted to the home and there is not any visible flashing.

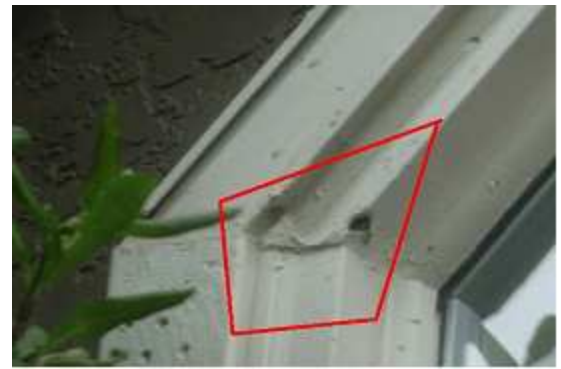
1. Rotted trim boards at the Family room top North window and also at the lower South center trim.
2. The siding is rotted above and below the Northwest bedroom North window.
3. The basement North side window is missing the exterior trim and brick molding.
4. The basement West window South of the basement exterior door has rotted trim and missing trim also.
5. The exterior brick mold trim at the breakfast nook door is rotted and the siding is also rotted at the hand side of the door and the siding is swelled at the upper portion bottom edges of the same area.
6. The garage South side upper siding bottom edges of the siding is rotted.
7. The garage North corner roof support is rotted where it mounts against the vertical trim board.
8. The picture Windows above the front entry area has rotted brick molding.

\* Wherever there may be wood rot noted in the report, there could be further damage that is not visible until the top material is removed.

\* The rotted siding under the Northwest bedroom North window area could be allowing water intrusion into the wall cavity. Further investigation is recommended. See the Wall Section in this report.

\* We recommend caulking around the exterior light fixtures clockwise from 8 o'clock to 4 o'clock.

\* We recommend using a quality urethane caulk and seal where the front porch concrete meets any siding and trim.

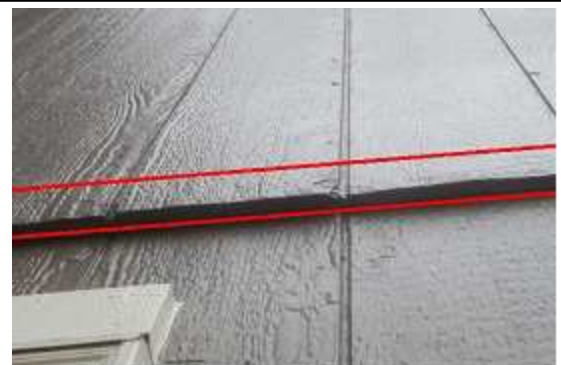
Bottom edges of the siding starting to rot above the breakfast nook exterior door.

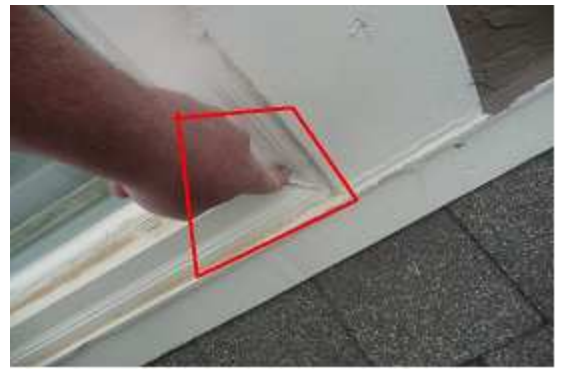
Picture Windows above the front entry area have rotted brick mold trim

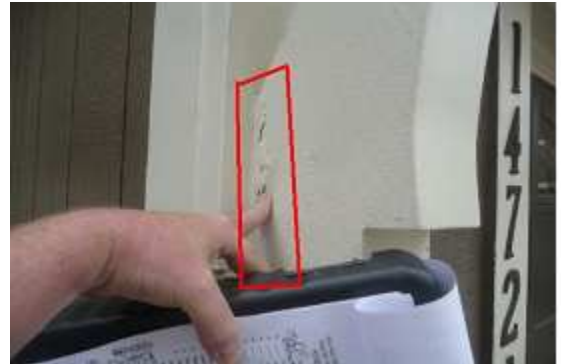
Garage North corner roof support is rotted

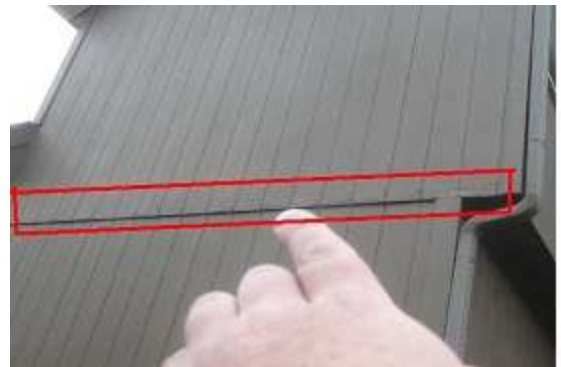
Garage South side upper siding bottom 4 to 6 inches of the siding is rotted.

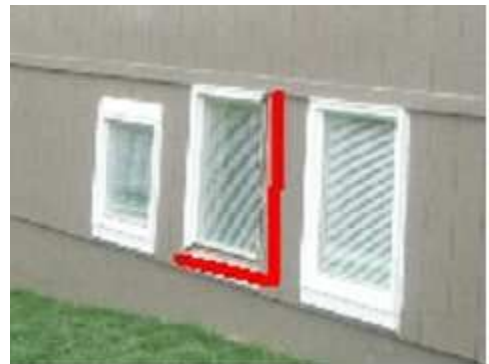
Basement North side window is missing trim

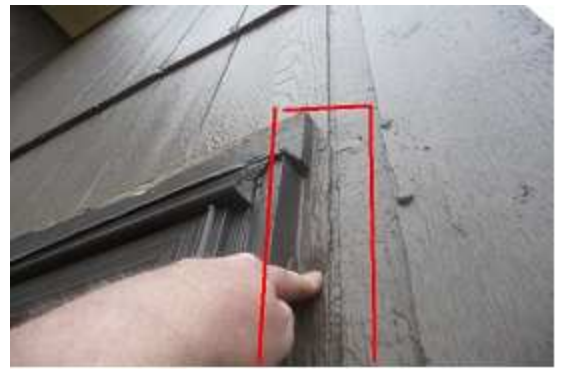
Rotted siding at the side of the breakfast nook exterior door.

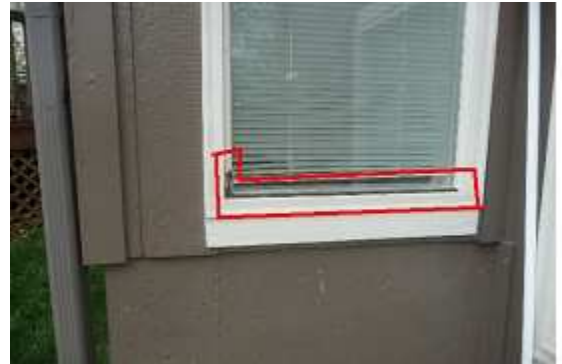
Rotted and missing trim at the basement picture window at the patio area.

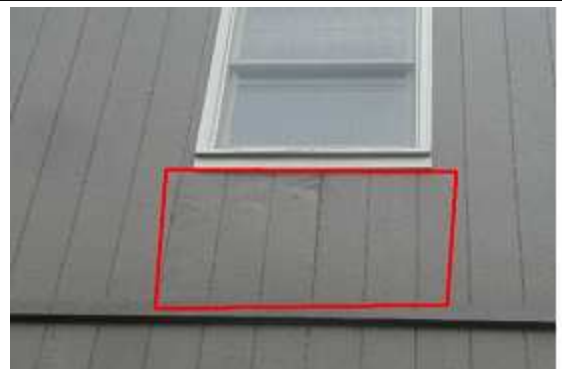
Rotted siding under the Northwest bedroom North window

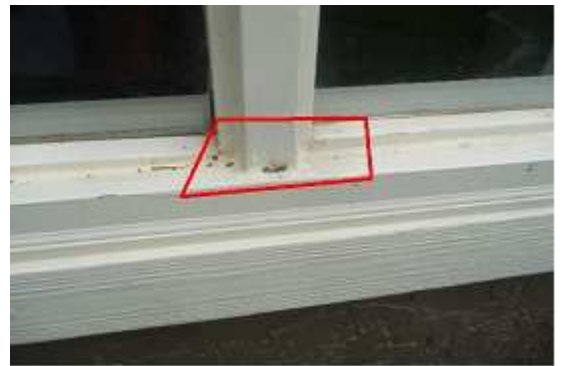
Rotted lower section of the center trim of the Family room window.

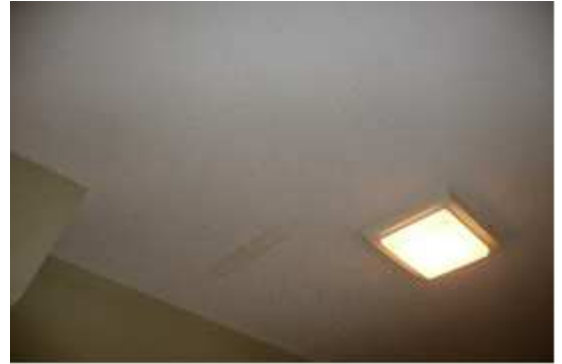
1. There is evidence of water staining above the kitchen exhaust fan area, in the Southeast bedroom full bath area,

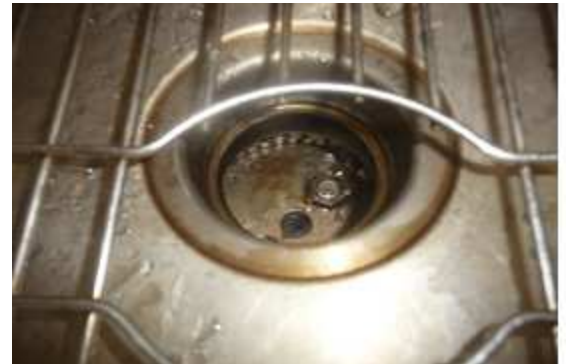
1. The kitchen garbage disposal rubber splash guard is missing and needs a new installed now.
2. Evidence of leakage at the garbage disposal drain pipe connections and there is a bowl setting under it to catch the water.
3. Evidence of leakage at the kitchen sink black drain pipe rubber boot connector and also at the connector were the black drain pipe in the white drain pipe.
4. All of the bathroom sinks are missing the sink stoppers.
5. There are multiple chips in the whirlpool tub bottom surface area that should be properly sealed with the correct material.

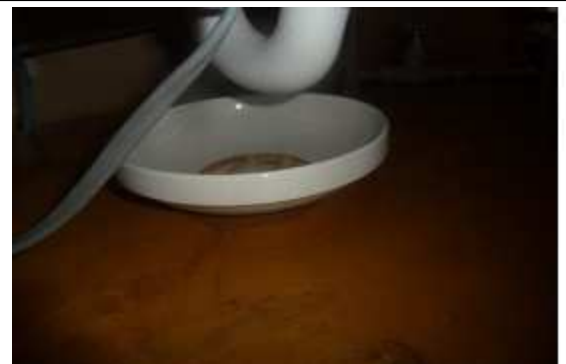
Evidence of leakage at the garbage disposal drain pipe connections

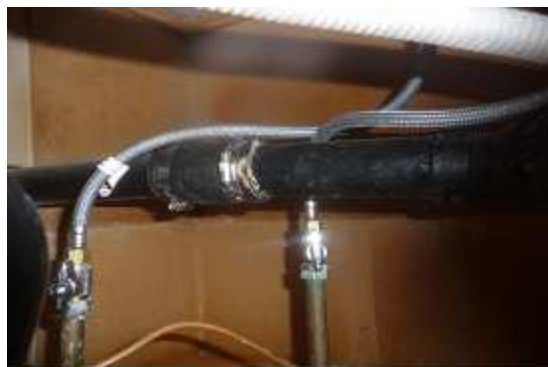
Evidence of leakage at the kitchen sink black drain pipe rubber boot connection

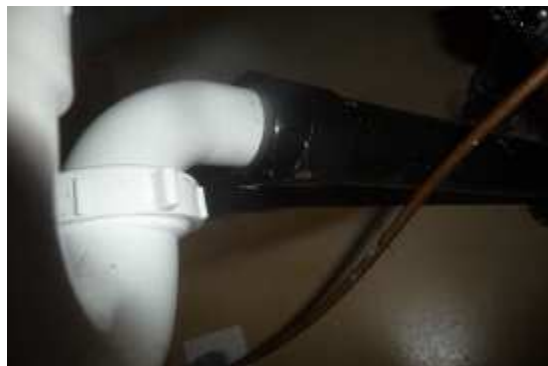
Evidence of leakage at the kitchen sink white drain pipe to black pipe connection.

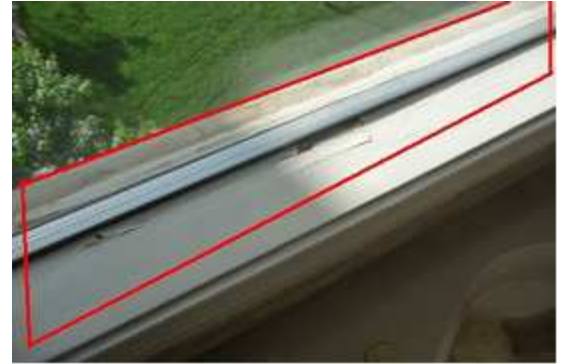
5. The breakfast nook center window sill is rotted as well as the South Windows. There is a possibility of mold growth in the wall cavity below these Windows.

\* The above Windows can very well have mold growth in the wall cavities between the Windows and the floors, so the drywall needs to be removed 12 inches beyond the affected areas. When this type of work is being performed, the areas need to be contained and properly HEPA vacuumed and the wall cavities sprayed and scrubbed with a liquid mold antimicrobial. There should also be a HEPA Negative Air machine running in the work area to filter the air of possible airborne mold spores. I know from experience that window replacement contractors and exterior wood rot contractors are not set up as mold remediation is to prevent the possibility of air contamination for mold. The mold remediation should be performed prior to any window replacements but then the rotted siding in the rotted Windows need to be replaced immediately after the work is completed.\* We are certified mold remediation and can take care of this work if requested.

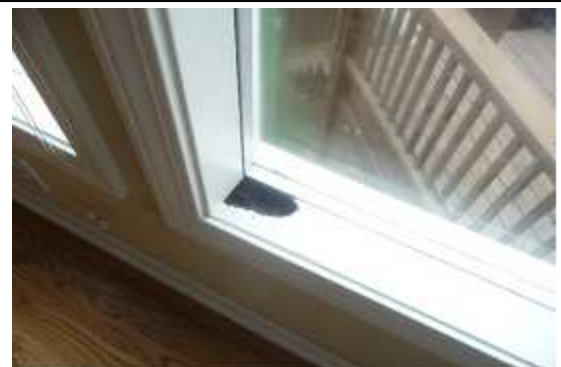
Rotted interior breakfast nook window casement

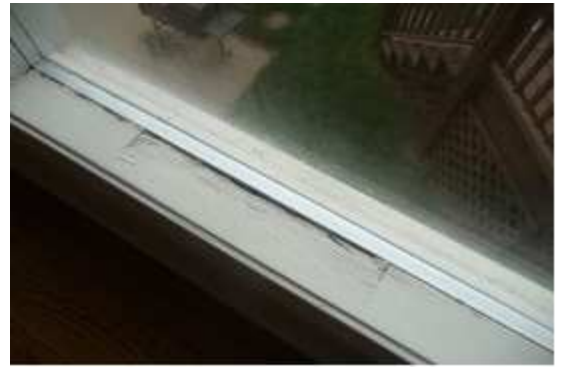
Rotted interior breakfast nook window casement

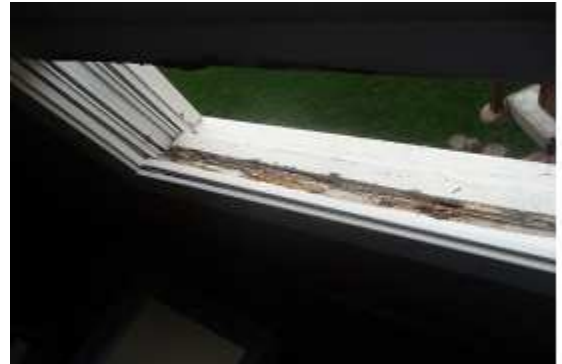
Rotted bedroom window sill

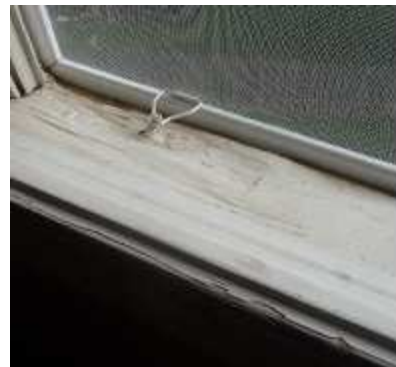
Rotted bedroom window sill

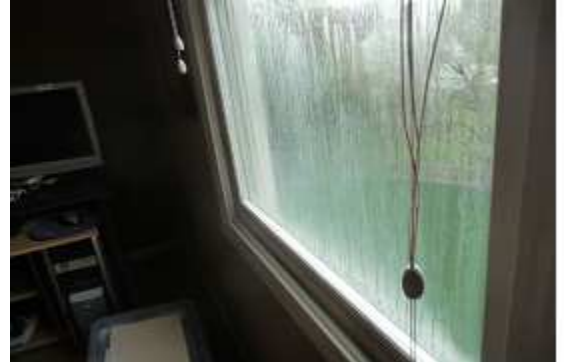
The Windows Thermal Pane Integrity shows evidence of failure and fogging at: Basement bedroom double hung window, Master bedroom West wall South window, Northeast bedroom, Breakfast nook center Picture window and South window, Living room South top window, Basement North wall small picture window, next to basement exterior door,
