**ADDENDUM TO PROPERTY INSPECTION REPORT  
PROPERTY INSPECTION AGREEMENT  
SAMPLE INSPECTION REPORT**

**ALLIED HOME INSPECTION SERVICES**

COUNTY                    GALVESTON  
KEY MAP NO.  
TYPE OF STRUCTURE:        CONDO  
APPROX. AGE OF STRUCTURE: 23 YEARS

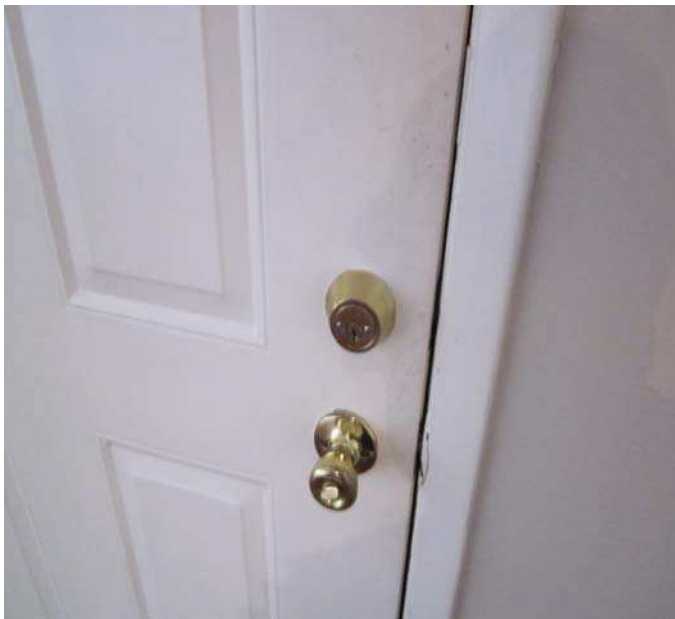
**PHOTO NO. 3**

**NO. 5**      **DEAD BOLT LOCK, ON THE FRONT ENTRY DOOR, IS NOT A KEYLESS TYPE. SEE APPENDIX J. REPAIRS ARE NEEDED FRONT ENTRY DOOR HAS DAMAGED WEATHER STRIPPING. REPAIRS ARE NEEDED. BACK EXIT DOOR, OF THE GARAGE, IS BADLY DAMAGED AT THE BOTTOM. THIS DOOR NEEDS TO BE REPLACED. BACK EXIT DOOR, OF THE GARAGE, IS MISSING A THRESHOLD. REPAIRS ARE NEEDED PATIO SCREEN DOOR IS DAMAGED. THE FRONT STORM DOOR IS BADLY DAMAGED AND NEEDS TO BE REPLACED. MISSING OR DAMAGED DOOR STOPS IN SEVERAL AREAS.**

**DEAD BOLT LOCK ON  
FRONT ENTRY DOOR NOT KEYLESS**

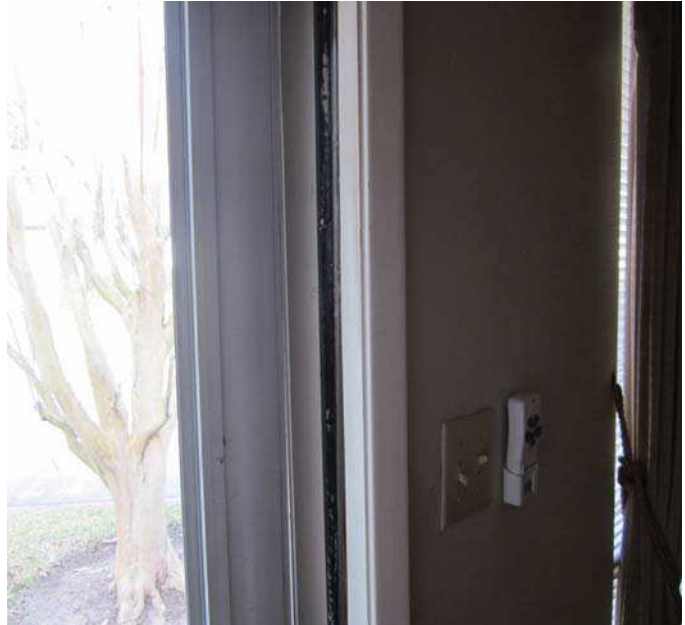
**PHOTO NO. 4**

**DAMAGED WEATHER  
STRIPPING ON FRONT ENTRY DOOR**

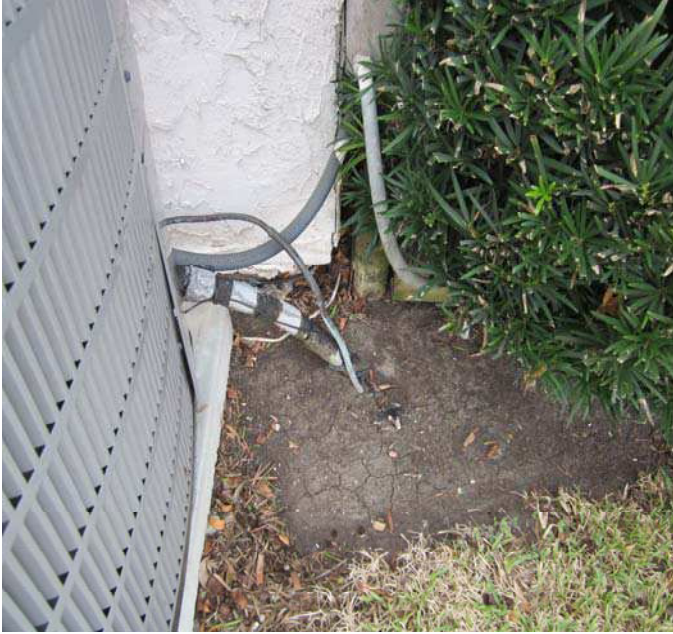
**PHOTO NO. 5**

- NO. 12      A/C CONDENSER UNIT, ON THE NORTH SIDE, IS MISSING AN ELECTRICAL OUTLET WITH A WEATHER-PROOF COVER AND GFCI PROTECTON. LIQUID LINE, AT THE CONDENSER UNIT, IS MISSING A DRYER. A/C LINES, LEAVING THE CONDENSER UNIT ARE ROUTED UNDER GROUND TO THE SOUTH SIDE OF THE UNIT. THESE A/C LINES NEED TO BE ENCLOSED IN PLASTIC PIPE. MAJOR REPAIRS ARE NEEDED**
- NO. 13      A/C SECONDARY DRAIN LINE, THAT IS COMING OUT OF THE NORTH SIDE WALL, NEEDS TO BE RELOCATED OVER A WINDOW.**
- NO. 14      METAL A/C DRAIN PAN, IN THE ATTIC, IS MISSING A FLOAT SWITCH. SEE APPENDIX CC-2. REPAIRS ARE NEEDED**

**A/C LINES GOING INTO  
THE GROUND**

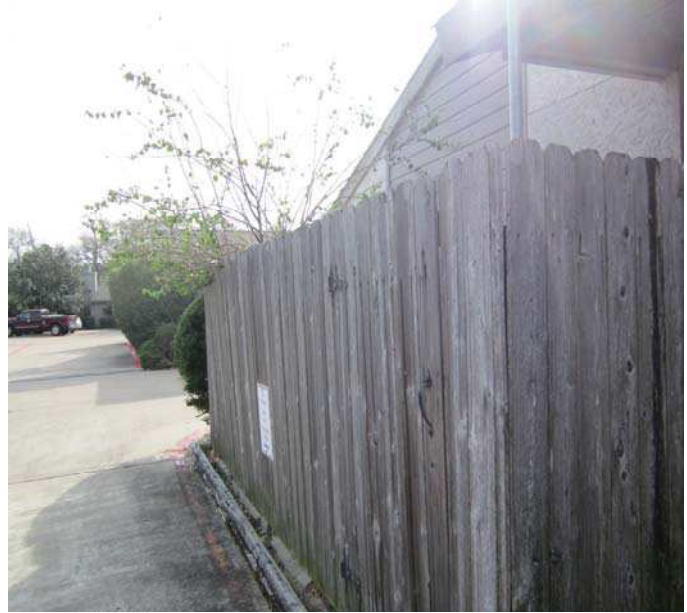
**PHOTO NO. 6**

**NO. 7**      **WOOD FENCE IS DAMAGED AND LEANING IN SEVERAL AREAS FENCE PROBABLY NEEDS TO BE REPLACED.**

**DAMAGED AND LEANING FENCE  
IN BACK**

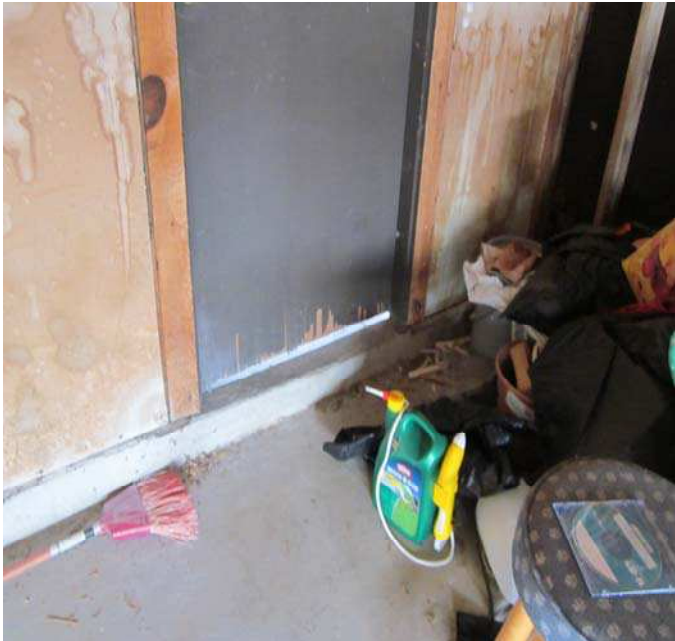
**PHOTO NO. 7**

**BADLY DAMAGED BACK  
EXIT DOOR OF GARAGE**

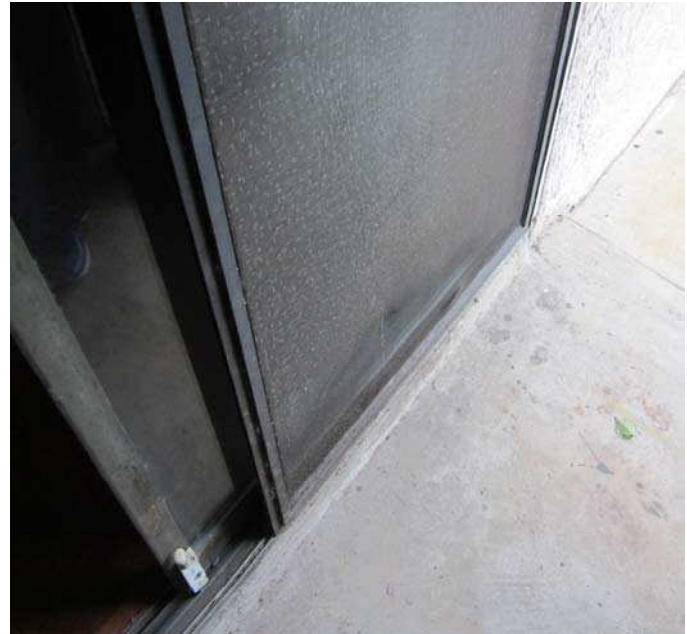
**PHOTO NO. 8**

**DAMAGED BACK SLIDING  
SCREEN DOOR**

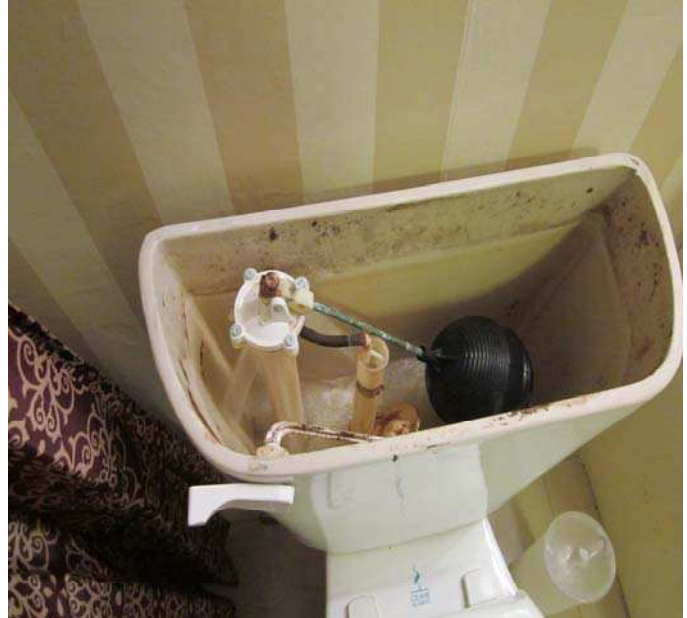
PHOTO NO. 14 COMMODE TANK MISSING ANTI-SIPHONING DEVICE

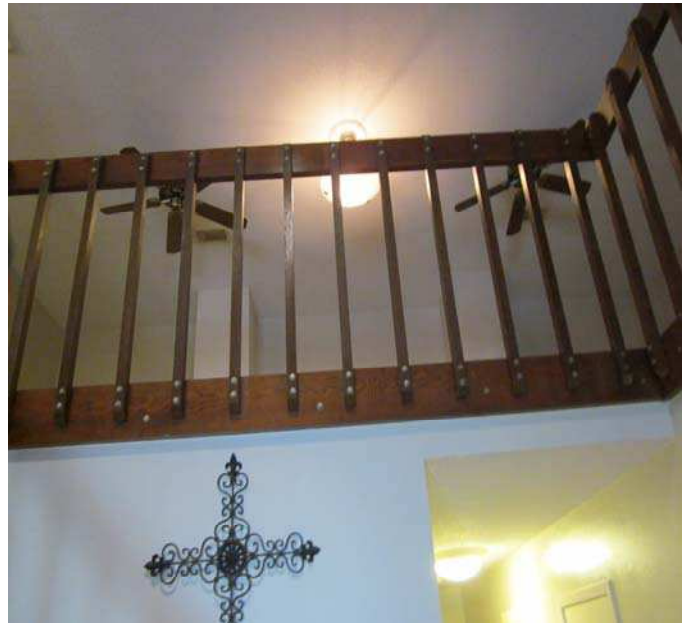
**NO. 6**      **STAIRWAY IS MISSING A CONTINUOUS HAND RAIL AT THE TOP. THE PRESENT SETUP POSES A SAFETY HAZARD. REPAIRS ARE NEEDED. UPSTAIRS GUARD RAIL SEPARATION DOES NOT MEET THE "4-INCH" RULE. SEE APPENDIX G. REPAIRS ARE NEEDED.**

PHOTO NO. 16 GUARD RAIL SEPARATION DOES NOT MEET "4-INCH" RULE

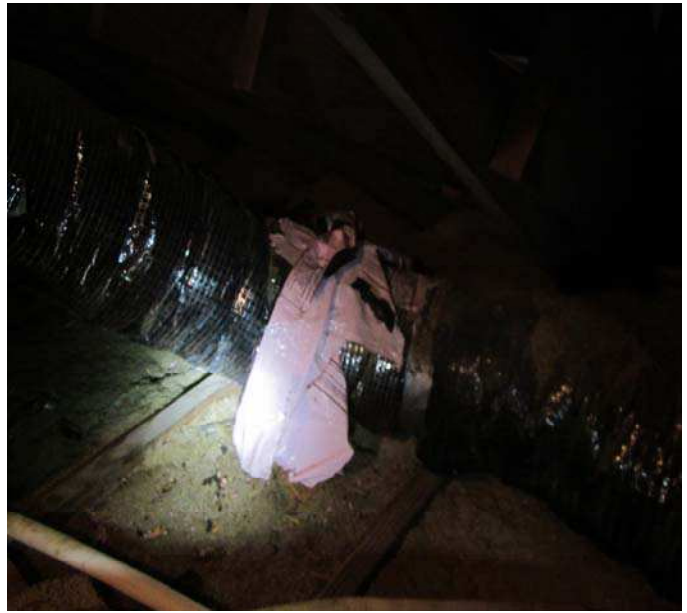
PHOTO NO. 18      BADLY DAMAGED DUCT WORK  
IN ATTIC

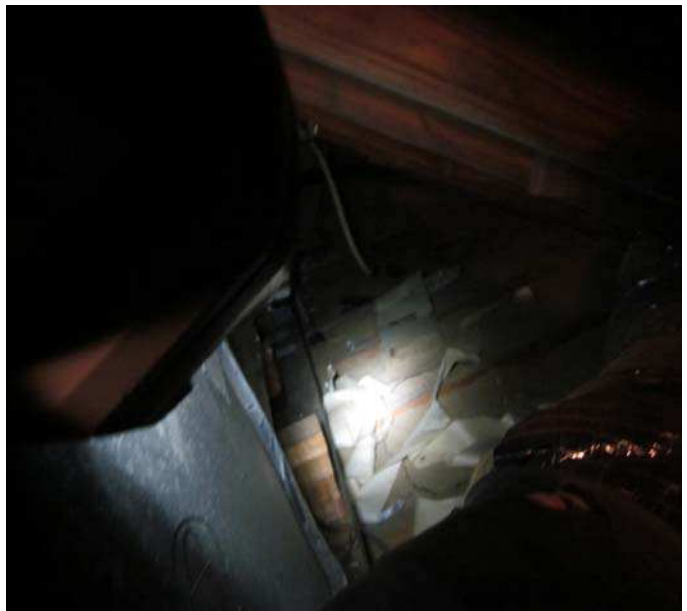
PHOTO NO. 20      A/C DRAIN PAN MISSING  
FLOAT SWITCH

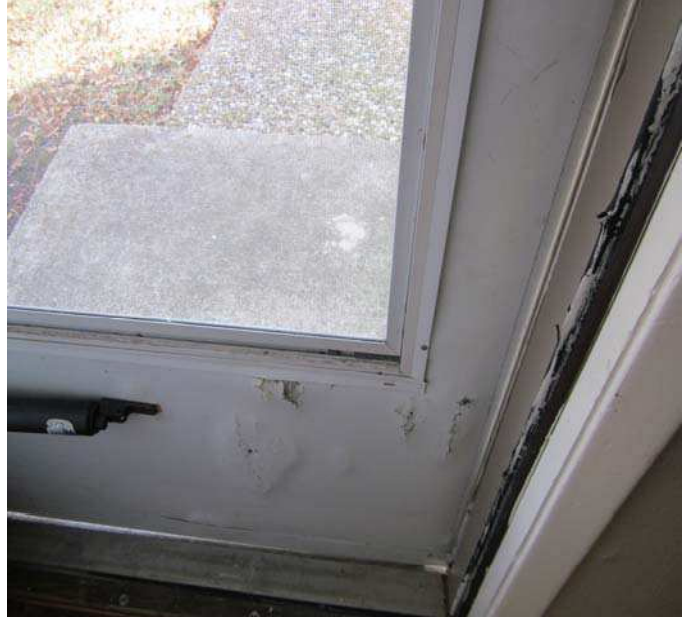
**PHOTO NO. 22**

**BADLY DAMAGED FRONT  
STORM DOOR**
