**ADDENDUM TO PROPERTY INSPECTION REPORT
PROPERTY INSPECTION AGREEMENT
SAMPLE REPORT**

ALLIED HOME INSPECTION SERVICES
P. O. BOX 980354
HOUSTON, TEXAS 77098 - 0354
713 / 522 - 0856

JOHN O. FRANZEN
LICENSED BUILDING INSPECTOR
T.R.E.C. # 1553
www.alliedinspecthouston.com

ADDRESS: HOUSTON, TX.
COUNTY HARRIS
KEY MAP NO.
TYPE OF STRUCTURE: SFH
APPROX. AGE OF STRUCTURE: 4 YEARS

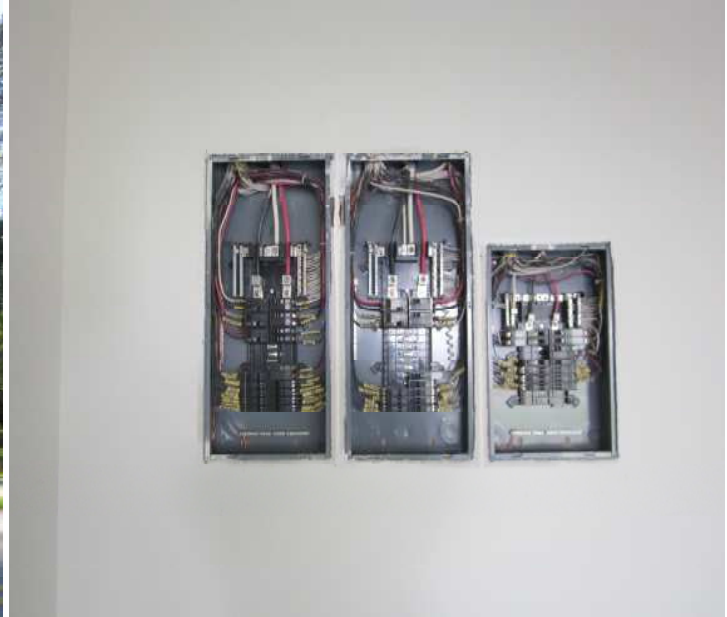
PHOTO NO. 2

- NO. 6 THERE ARE APPROX. TWO CROSS CONNECTIONS IN THE SUB-PANEL
 BREAKER BOX IN THE GARAGE. THESE CROSS CONNECTIONS
 NEED TO BE TRACED BY A LICENSED ELECTRICIAN TO DETERMINE
 IF THIS CIRCUIT SHOULD BE ROUTED THROUGH A BREAKER.
 SUB-PANEL BREAKER BOXES, IN THE GARAGE, HAVE FIVE (5)
 ARC-FAULT BREAKERS. ALL 15 & 20 AMP CIRCUITS, THAT SERVE
 LIVING AREAS, ARE MISSING ARC-FAULT PROTECTION. SEE
 APPENDIX M-2 & NEC 210.12.**

**SUB-PANEL BREAKER BOXES
INSIDE GARAGE**

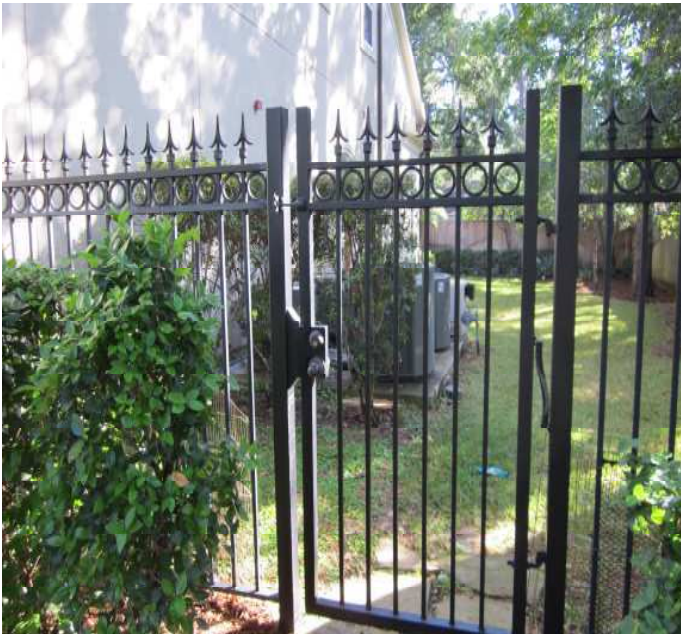
PHOTO NO. 3

- NO. 4 NORTH SIDE GATE DOES NOT CLOSE PROPERLY.
 LOCK ASSEMBLY, ON THE EAST SIDE GATE, ALSO NEEDS
 REPAIR.**
- NO. 5 TREE LIMBS, OVER THE ROOF, NEED TO BE CUT BACK**

**SOUTH SIDE GATE LOCK
NEEDS REPAIR**

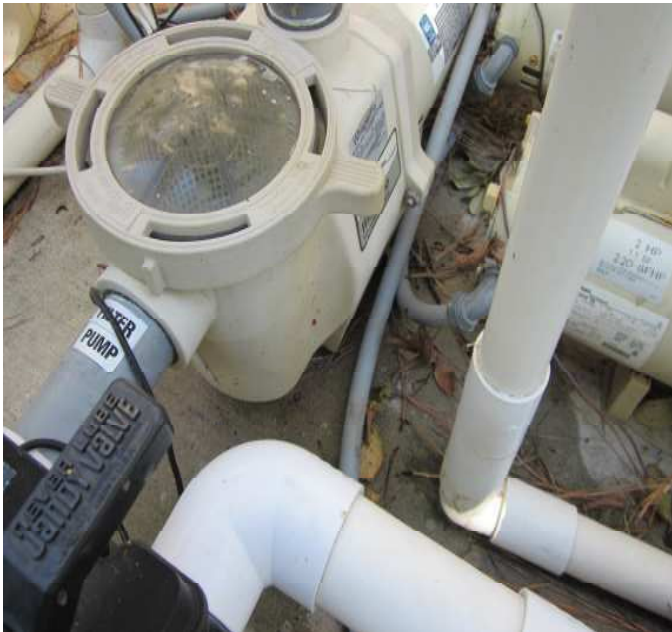
PHOTO NO. 7

- NO. 16 SKIMMER BASKETS, ARE FULL OF DEBRIS AND PINE NEEDLES. THERE APPEARS TO BE A LEAK UNDER THE POOL PUMPING EQUIPMENT. GAS POOL HEATER HAS A LOT OF RUST BUILDUP. REPAIR AND POSSIBLE REPLACEMENT IS NEEDED. GATES, TO THE POOL AREA, ARE MISSING A SPRING-LOADED SELF-LATCHING TYPE LOCK. POOL IS MISSING BASIC SAFETY EQUIPMENT EXIT DOORS, TO THE POOL AREA, ARE MISSING A SEPARATE TYPE ALARM SYSTEM. SEE APPENDIX V-1, V-2, V-3, & V-7 REPAIRS ARE NEEDED.**

LEAK AT POOL PUMPING EQUIPMENT

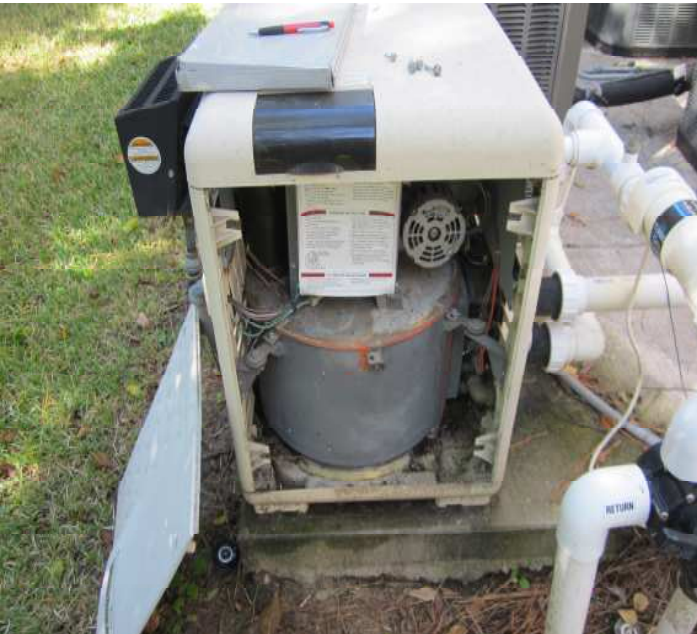
PHOTO NO. 11

- NO. 15 ONLY TWO, OF THE 12 SPRINKLER ZONES ARE LABELED. THE SPRINKLER HEADS, LOCATED BY THE POOL PUMPING EQUIPMENT, NEED TO BE RELOCATED. THEY ARE RUSTING OUT THE POOL HEATER AND THROWING WATER ON THE ADJACENT STUCCO WALL REPAIRS ARE NEEDED.**

**POOL HEATER BEGINNING
TO RUST OUT**

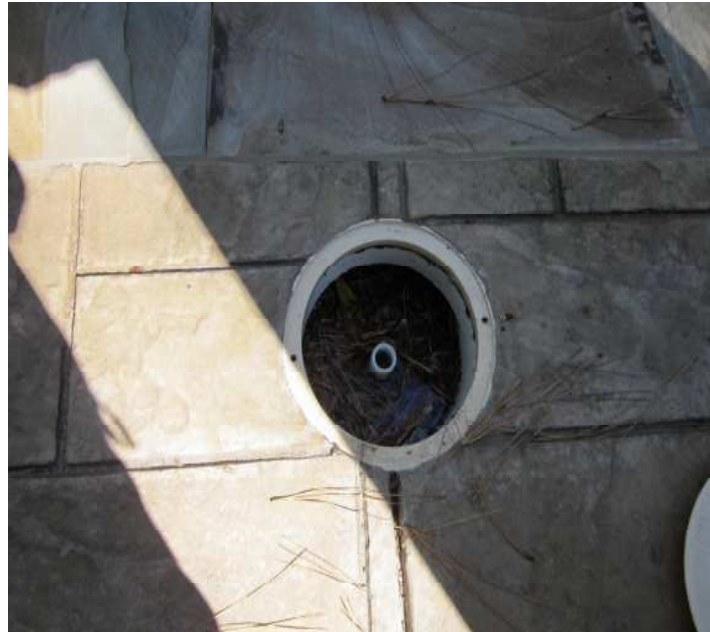
PHOTO NO. 12

**POOL SKIMMER BASKET
FULL OF DEBRIS & PINE NEEDLES**

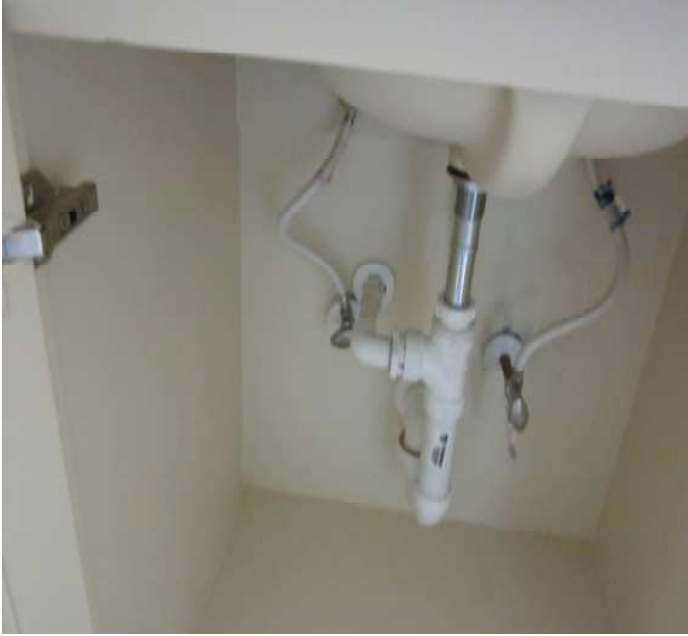
NO. 9 ELECTRICAL DISCONNECTS, AT THE CONDENSER UNITS ON THE SOUTH SIDE, NEED TO BE RELOCATED A MINIMUM OF 15 INCHES TO THE SIDE OF THE CONDENSERS. SEE APPENDIX E3305.2 ALL FOUR A/C PRIMARY DRAIN LINES, UNDER THE BATH SINKS, ARE NOT INSULATED. REPAIRS ARE NEEDED.

**PHOTO NO. 13 A/C PRIMARY DRAIN LINE,
UNDER BATH SINK, NOT INSULATED**

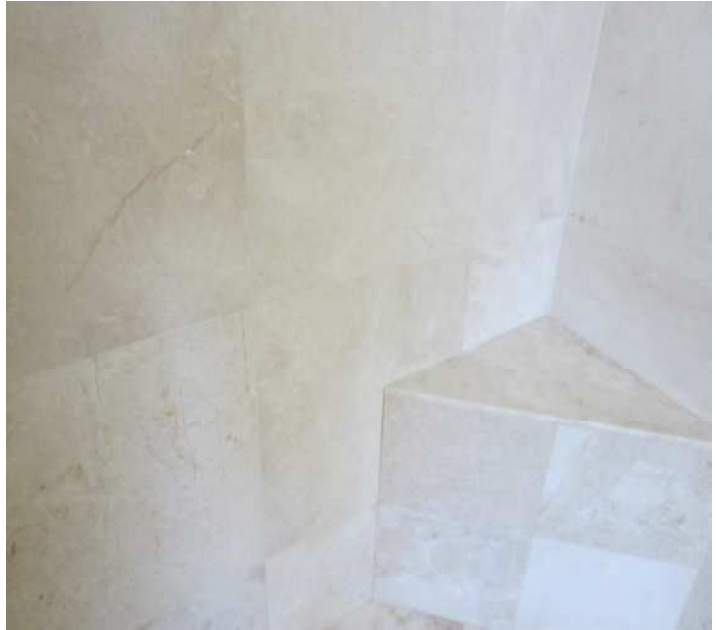
- NO. 10 CERAMIC TILE, AT THE BENCH OF THE MASTER BATH SHOWER, NEEDS REPAIR. THERE ARE GAPS IN THE GROUT. COMMODE, IN THE MASTER BATH, NEEDS REPAIR. TUB, IN THE MASTER BATH, IS MISSING A PLUMBING ACCESS PANEL. SEE APPENDIX K-2 & K-3
KITCHEN SINK IS MISSING AN ANTI-SIPHONING DEVICE. IT IS REQUIRED DUE TO THE PRESENCE OF THE SPRAY NOZZLE. SEE APPENDIX N-2. OTHER BATH TUBS ARE ALSO MISSING A PLUMBING ACCESS PANEL.**

**PHOTO NO. 14 CERAMIC TILE, IN SHOWER OF
M. BATH, NEEDS REPAIR AT BENCH**

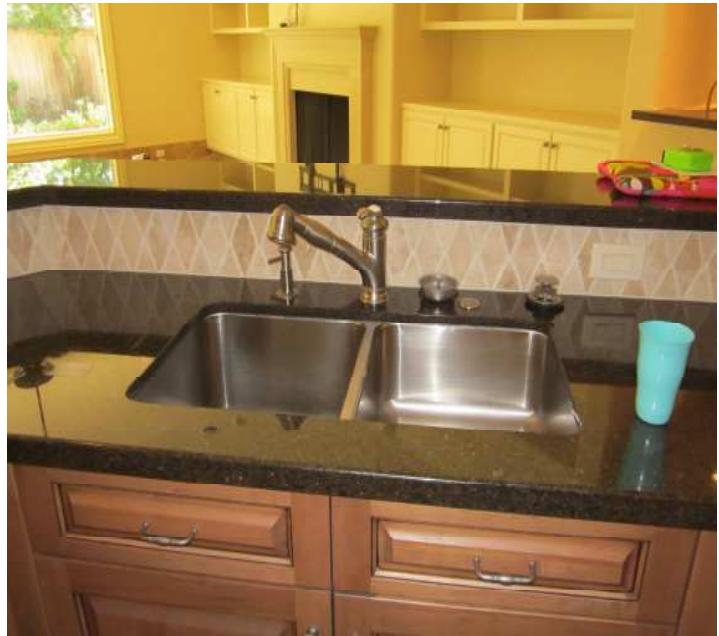
**PHOTO NO. 16 KITCHEN SINK MISSING
ANTI-SIPHONING DEVICE**

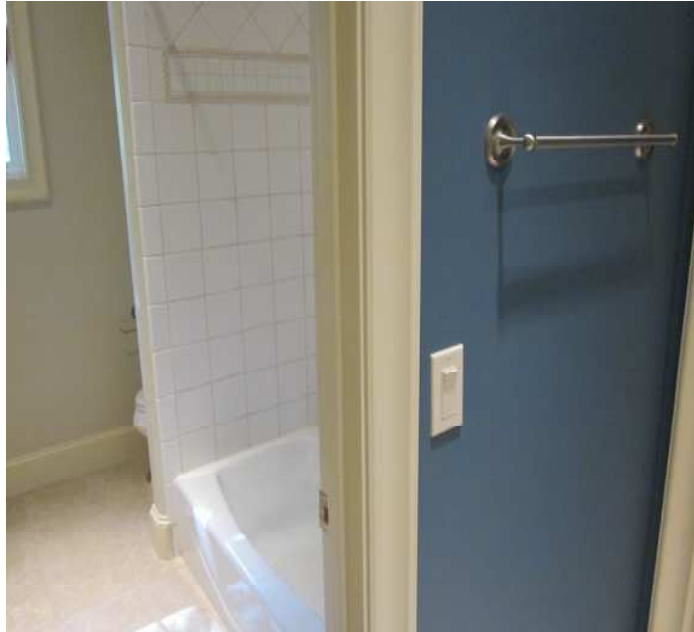
- NO. 7 ALL 15 & 20 AMP WALL RECEPTACLES NEED TO BE CHANGED
 TO TAMPER-RESISTANT TYPE RECEPTACLES. SEE APPENDIX 406.11
 WALL SWITCH, IN THE UPSTAIRS SOUTH SIDE BATH, CAN BE
 REACHED WHILE STANDING IN THE TUB. THE PRESENT SETUP POSES
 A SEVERE SAFETY HAZARD. THIS WALL SWITCH NEEDS TO BE
 RELOCATED AWAY FROM THE TUB.**

PHOTO NO. 19 WALL SWITCH TOO CLOSE TO TUB IN UPSTAIRS BATH

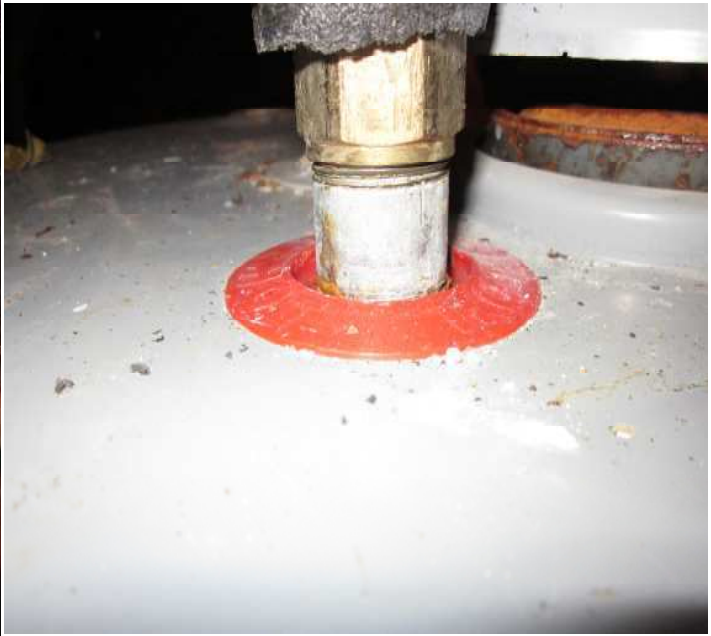
- NO. 11 GALVANIZED - COPPER PIPING CONNECTIONS, AT THE TOPS OF ALL FOUR WATER HEATERS, ARE MISSING DIELECTRIC FITTINGS. SEE APPENDIX K-2 & K-3. REPAIRS ARE NEEDED**

PHOTO NO. 22 WATER HEATER PIPING
MISSING DIELECTRIC FITTINGS

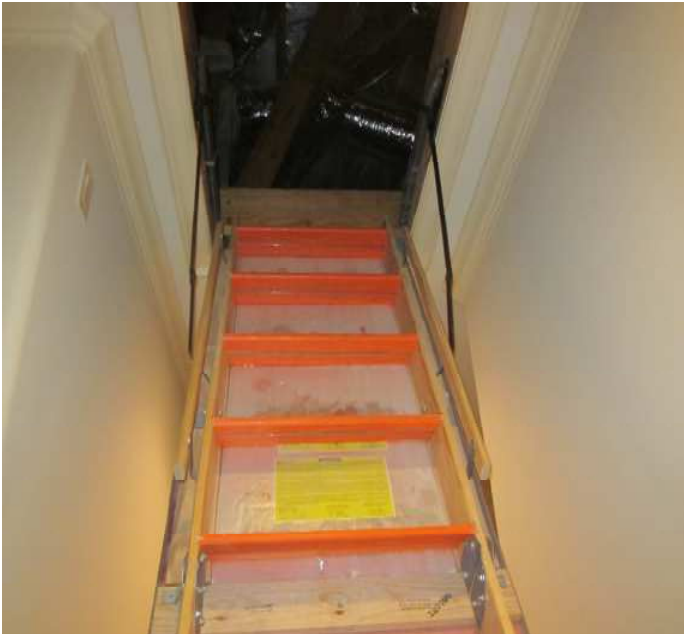
**NO. 2 INSULATION IS LAYING IN THE ATTIC ON VENT FAN ASSEMBLIES. THE PRESENT SETUP POSES A FIRE HAZARD. THE INSULATION NEEDS TO BE PULLED BACK FROM THESE AREAS. SEE APPENDIX JJ-4 & S-3.
SPRINGS, ON THE ATTIC ACCESS LADDER, ARE MISSING SAFETY WIRE.**

**PHOTO NO. 27 ATTIC ACCESS LADDER
IN UPSTAIRS HALLWAY**
