**ADDENDUM TO PROPERTY INSPECTION REPORT
PROPERTY INSPECTION AGREEMENT
(SAMPLE REPORT)**

**ALLIED HOME INSPECTION SERVICES
P. O. BOX 683124
HOUSTON, TEXAS 77268 - 3124
281 / 440 - 7939**

**JOHN O. FRANZEN
LICENSED BUILDING INSPECTOR
T.R.E.C. # 1553**

TYPE OF STRUCTURE: TOWNHOME

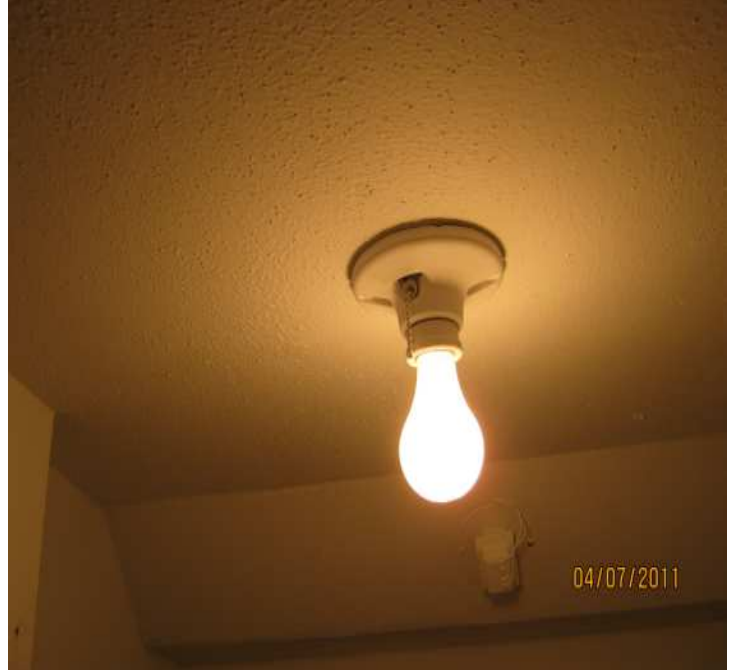
**NO. 7 ALL 15 & 20 AMP WALL RECEPTACLES NEED TO BE CHANGED
TO TAMPER-RESISTANT TYPE RECEPTACLES. SEE APPENDIX 406.11
REFRIGERATOR OUTLET, IN THE KITCHEN, IS TIED TO THE GFCI.
IT SHOULD NOT BE CONNECTED TO A GFCI CIRCUIT. REPAIRS
ARE NEEDED. CLOSET LIGHT FIXTURES ARE MISSING GLOBES.**

**PHOTO NO. 2 CLOSET LIGHT FIXTURES
MISSING GLOBES.**

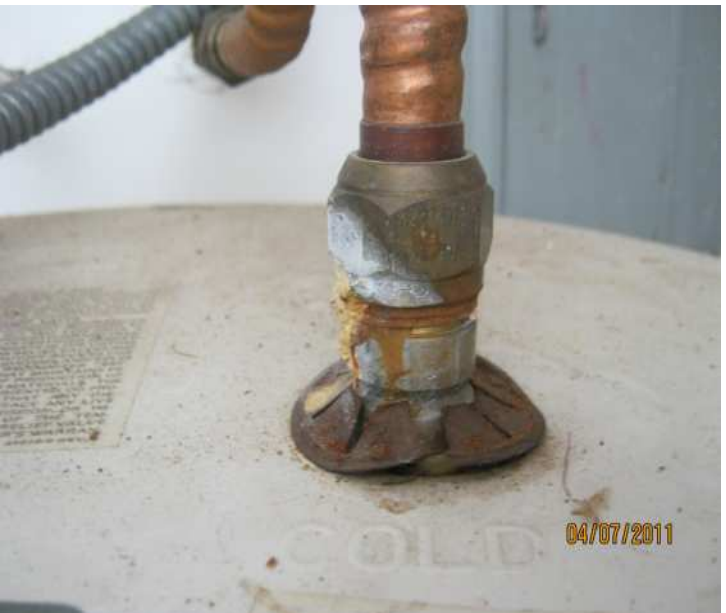
**NO. 11 GALVANIZED - COPPER PIPING CONNECTIONS, AT THE TOP OF THE
WATER HEATER, ARE MISSING DIELECTRIC FITTINGS. SEE
APPENDIX K-2 & K-3. WATER HEATER IS MISSING A DRAIN PAN WITH
A SEPARATE DRAIN LINE THAT IS ROUTED TO THE OUTSIDE WITH
A TURN DOWN. SEE APPENDIX JJ-7. SEE PHOTO PAGES
PIPING CONNECTION, AT THE TOP OF THE WATER HEATER, IS
CORRODED. REPAIRS ARE NEEDED.**

**PHOTO NO. 4 CORRODED PIPING
CONNECTION AT TOP OF WATER HEATER**

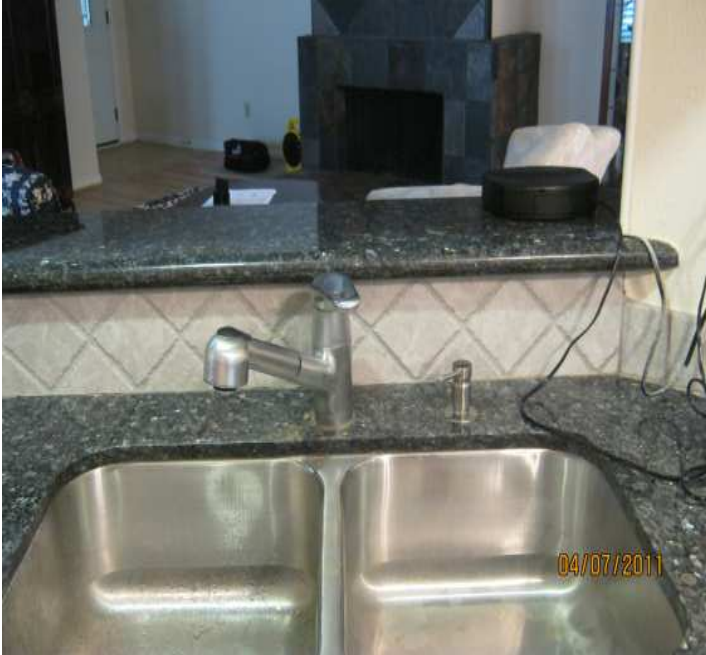
**PHOTO NO. 5 KITCHEN SINK MISSING
 ANTI-SIPHONING DEVICE**

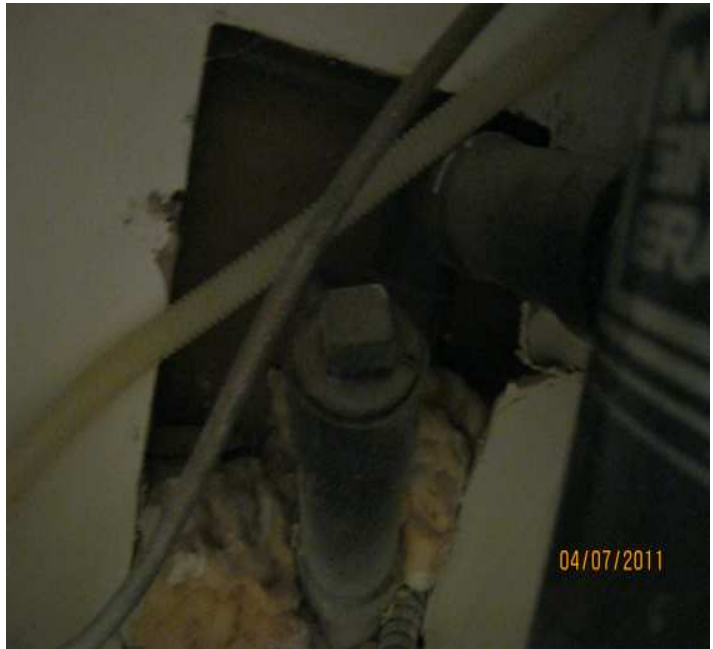
**NO. 2 DINING ROOM WALL, UNDER THE KITCHEN BAR, IS WATER DAMAGED.
SEE PHOTO PAGES. BACK WALL, UNDER THE KITCHEN SINK, HAS
A LARGE HOLE IN IT. SEE PHOTO PAGES. REPAIRS ARE NEEDED.**

**PHOTO NO. 6 HOLE IN BACK WALL UNDER
 KITCHEN SINK**

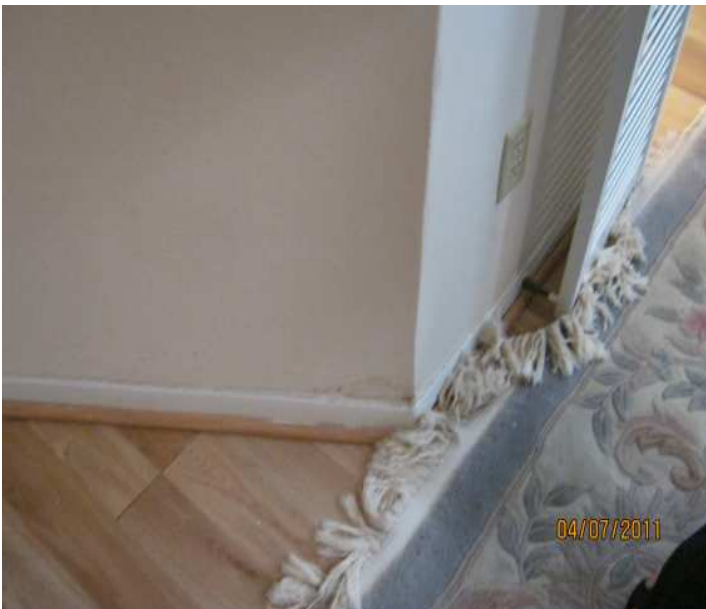
**PHOTO NO. 7 DAMAGED BACK WALL OF
 DINING ROOM BY KITCHEN**

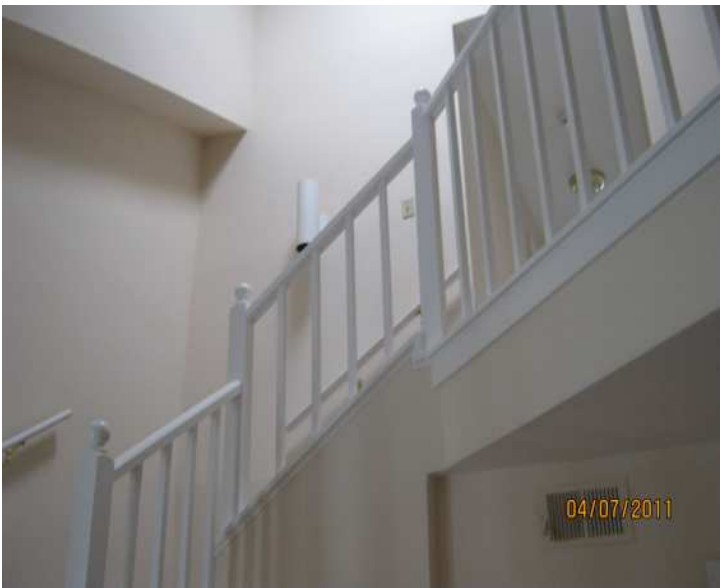
NO. 5	GUARD RAIL, ON BOTH THE STAIRWAY AND UPSTAIRS HALLWAY, DOES NOT MEET THE "4-INCH" RULE. SEE PHOTO PAGES. SEE APPENDIX G. REPAIRS ARE NEEDED.
--------------	---

**PHOTO NO. 8 STAIR GUARD RAIL DOES NOT
 MEET "4-INCH" RULE**

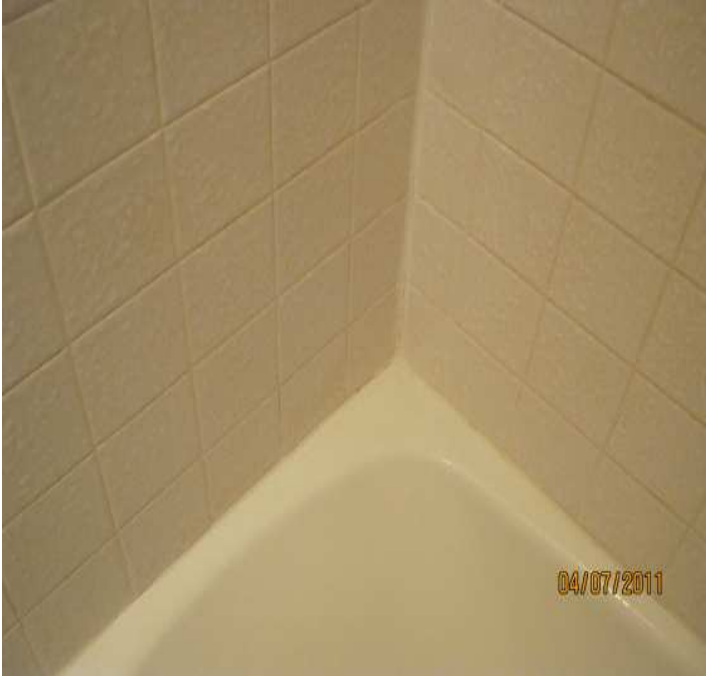
NO. 10	THERE IS LOW WATER PRESSURE AT THE KITCHEN SINK, REPAIRS ARE NEEDED. MISSING BACKFLOW PREVENTERS ON ALL OUTSIDE HOSE BIBBS. SEE APPENDIX D. CERAMIC TILE, OVER THE TUB IN THE MASTER BATH, NEEDS REPAIR. CERAMIC TILE, IN THE SHOWER OF THE UPSTAIRS BATH, NEEDS REPAIR. KITCHEN SINK IS MISSING AN ANTI-SIPHONING DEVICE. IT IS REQUIRED DUE TO THE PRESENCE OF THE SPRAY NOZZLE. SEE APPENDIX JJ-2.
---------------	--

**PHOTO NO. 9 DAMAGED CERAMIC TILE
OVER TUB IN MASTER BATH**

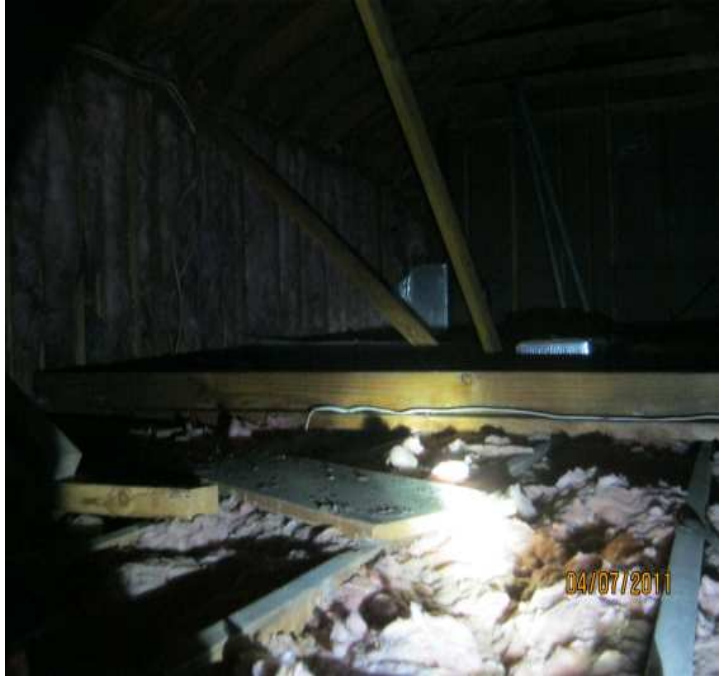
**NO. 13 BATH VENT FAN FLUES, IN THE ATTIC, ARE NOT VENTED TO THE
OUTSIDE. SEE APPENDIX E-3 SEE PHOTO PAGES. REPAIRS
ARE NEEDED.**

**PHOTO NO. 10 BATH VENT FAN FLUES IN
ATTIC, NOT VENTED TO OUTSIDE**

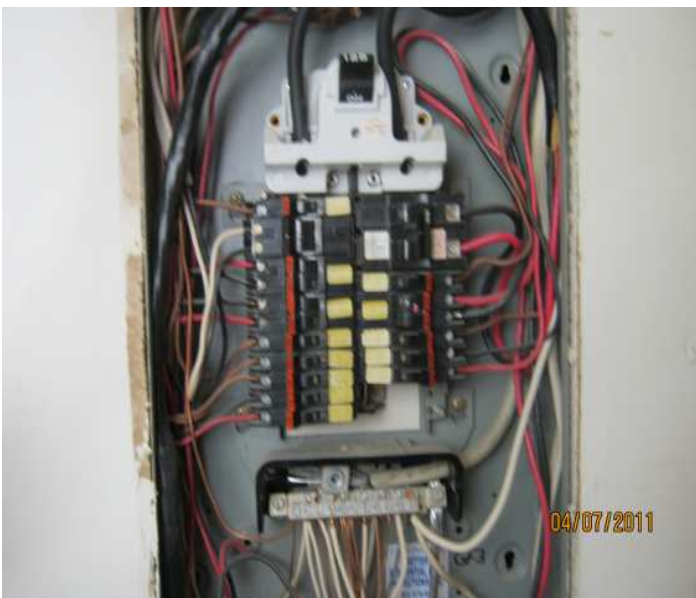
**NO. 6 THERE ARE LOOSE - BROKEN ALUMINUM GROUND WIRES AT THE
BOTTOM OF THE BREAKER BOX. ALL, OF THE BREAKERS, NEED
TO BE LABELED PROPERLY. WIRES, THAT ARE LEAVING THE
BREAKER BOX, ARE BUNDLED TOGETHER. THIS IS AN OVER-HEATING
ISSUE. THESE WIRES NEED TO BE SPREAD OUT. ALL 15 & 20 AMP
CIRCUITS, THAT SERVE LIVING AREAS, ARE MISSING ARC-FAULT
BREAKERS. REPAIRS ARE NEEDED. SEE APPENDIX A-2, A-3, A-4,
JJ-3, M-2, Y, Y-2, Y-3, AND NEC 210.12 THERE IS NO EVIDENCE OF ANY
PIG-TAILING OF THE ALUMINUM BRANCH WIRING.**

**PHOTO NO. 11 BREAKER BOX INSIDE
CARPORT CLOSET**

**AS DISCUSSED DURING THE INSPECTION, IT IS STRONGLY
RECOMMENDED THAT THE FPE BREAKER BOX BE REPLACED AND
UPGRADED TO MEET ALL CURRENT NEC AND CITY OF HOUSTON
ELECTRICAL CODES. ESTIMATED COST IS \$2,000 - \$2,500.**
