**ADDENDUM TO PROPERTY INSPECTION REPORT  
PROPERTY INSPECTION AGREEMENT  
(SAMPLE REPORT)**

**ALLIED HOME INSPECTION SERVICES**

**JOHN O. FRANZEN  
LICENSED BUILDING INSPECTOR  
T.R.E.C. # 1553**

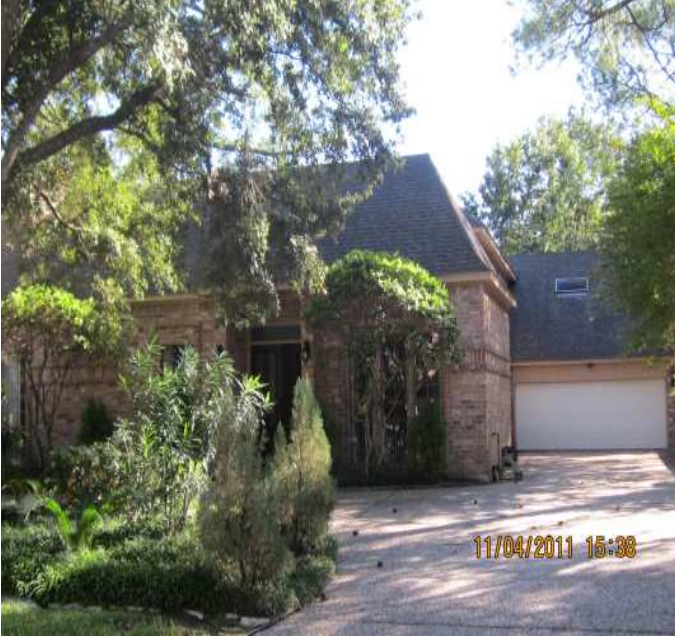
**PHOTO NO. 2**

**MISSING GUTTERS ON FRONT  
EAVE**

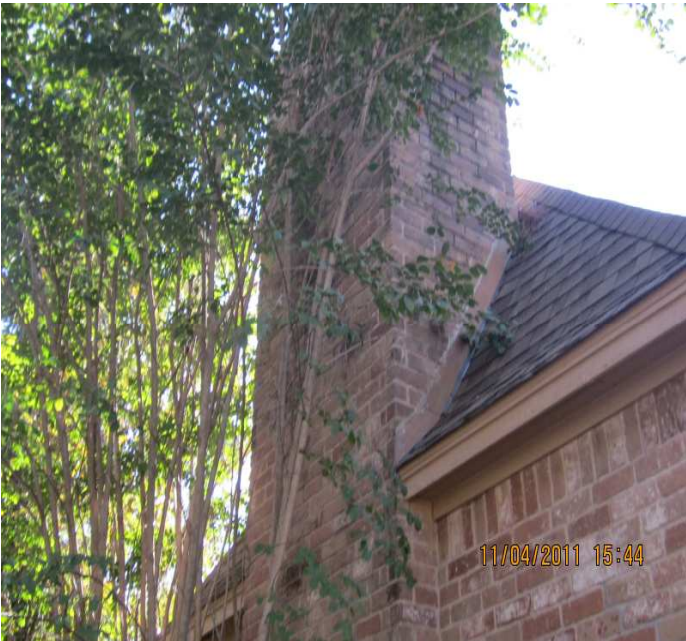
**PHOTO NO. 3**

**TREE LIMBS AGAINST  
THE CHIMNEY ON EAST SIDE**

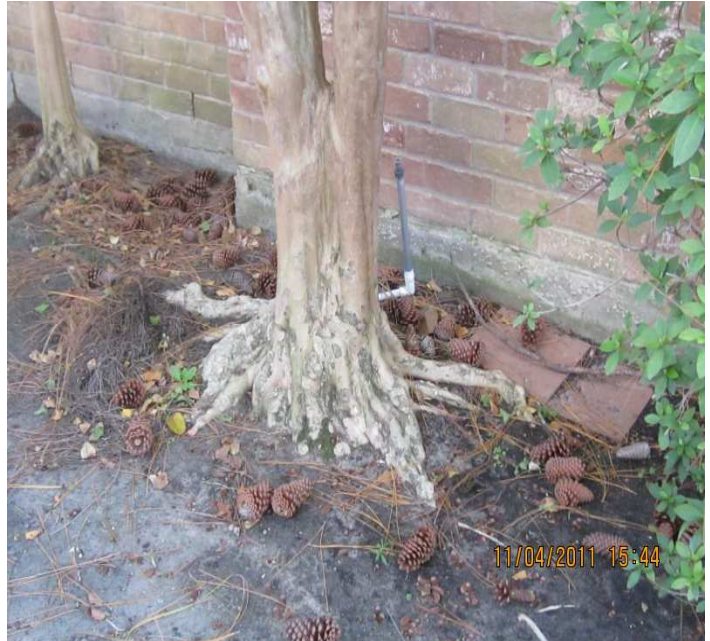
**PHOTO NO. 4**

**HEAVY TREE ROOT  
ENCROACHMENT ON EAST SIDE**

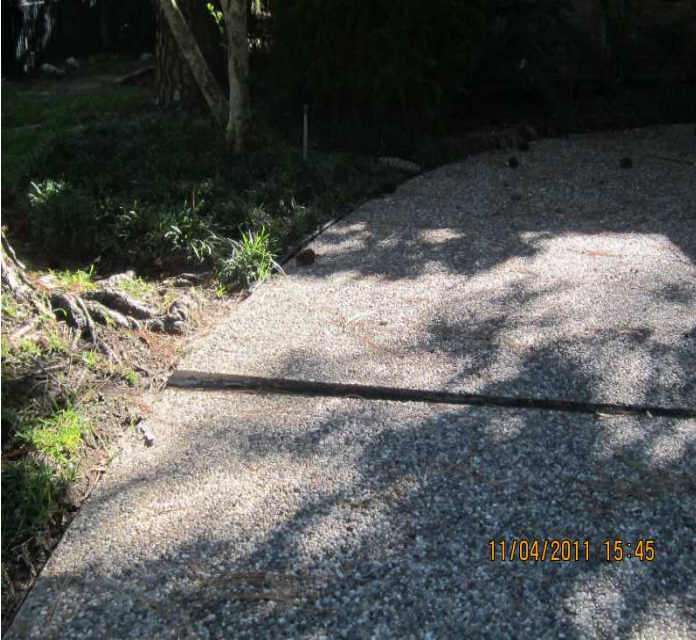
PHOTO NO. 5 DRIVEWAY BREAKING UP

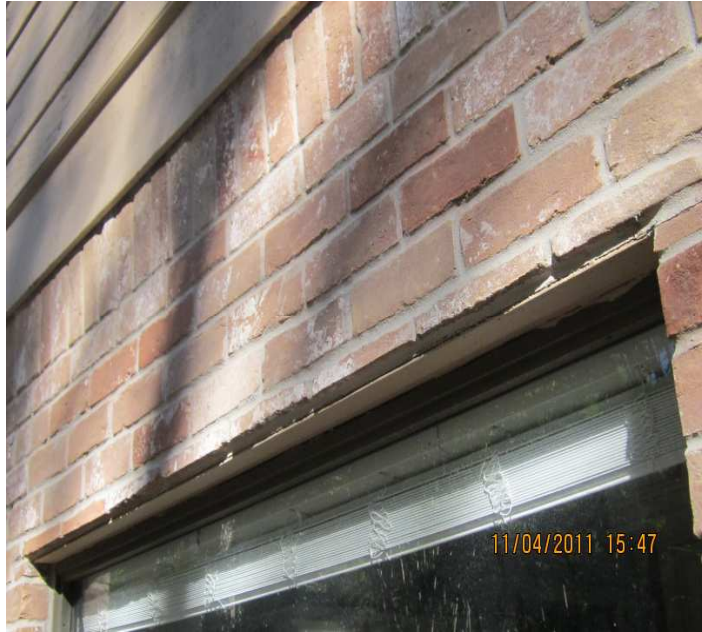
PHOTO NO. 6 MISSING WEEP HOLES ON BRICK OVER WINDOWS

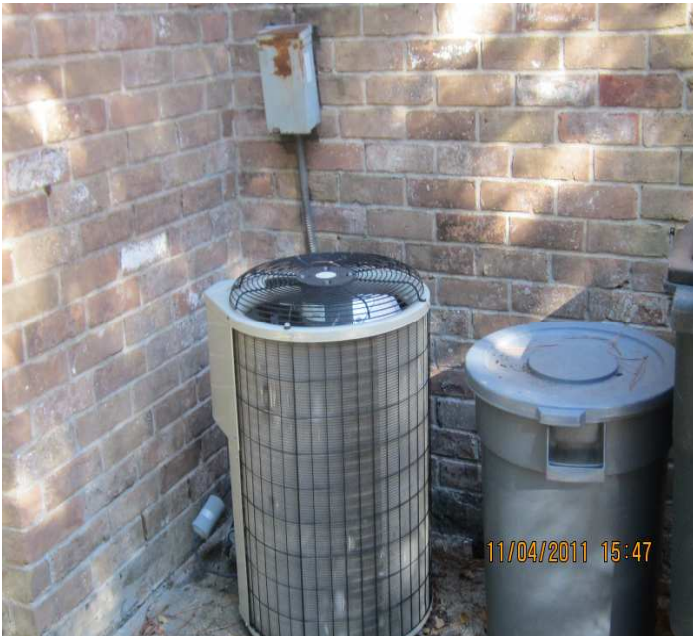
PHOTO NO. 7 WEST SIDE A/C UNIT

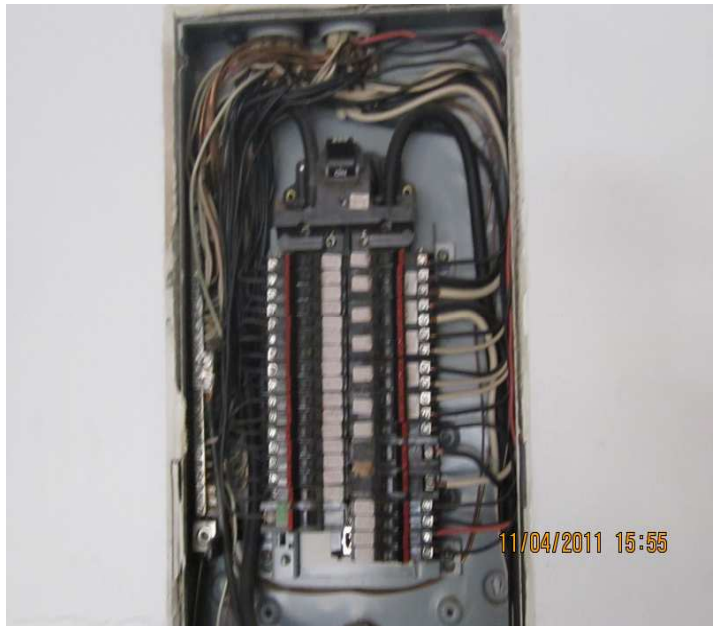
PHOTO NO. 8 BREAKER BOX INSIDE GARAGE

<b>NOTE:</b>	
<b>AS DISCUSSED DURING THE INSPECTION, IT IS STRONGLY RECOMMENDED THAT THE FPE BREAKER BOX BE REPLACED AND UPGRADED TO MEET ALL CURRENT NEC AND CITY OF HOUSTON ELECTRICAL CODES. ESTIMATED COST IS \$2,500 - \$3,000.</b>

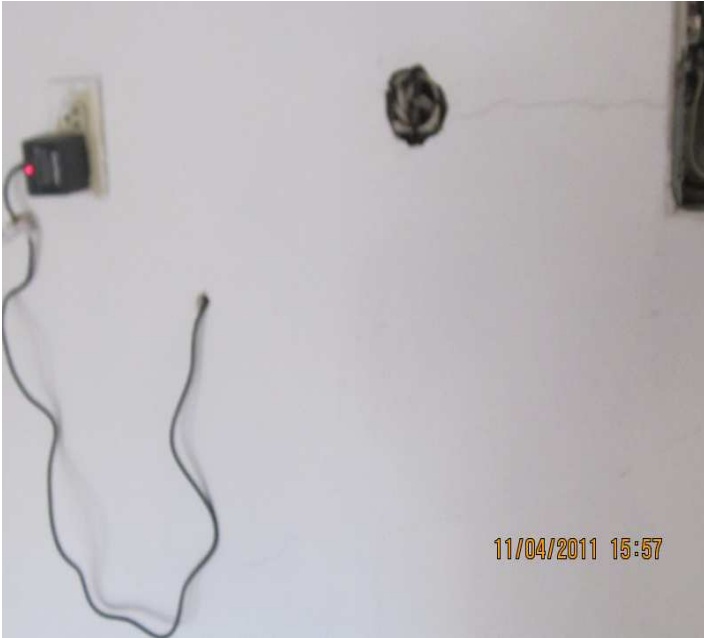
PHOTO NO. 9 BACK INTERIOR WALL OF GARAGE IS DAMAGED

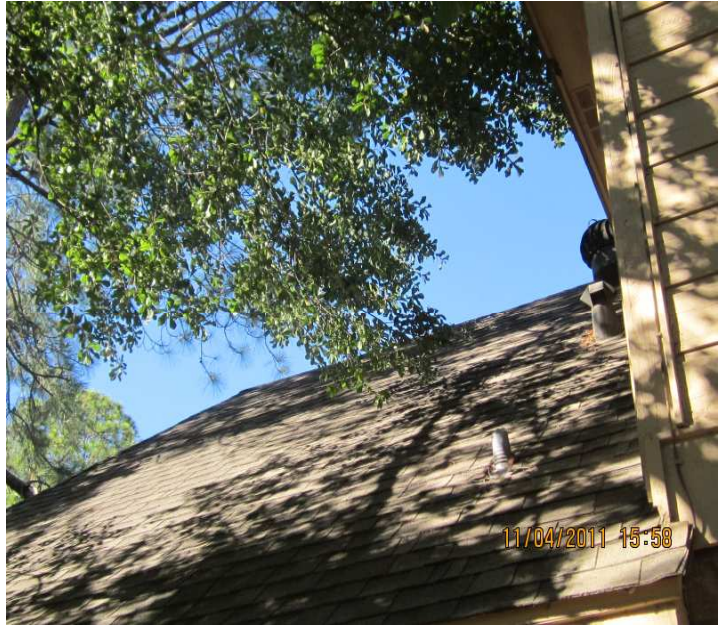
PHOTO NO. 10 TREE LIMBS OVER ROOF

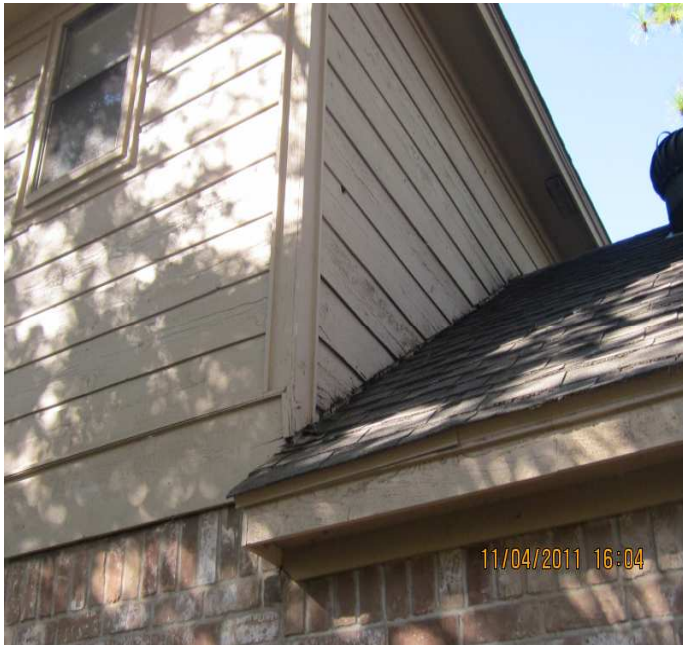
PHOTO NO. 11 DAMAGED EXTERIOR SIDING UPPER BACK EAST SIDE

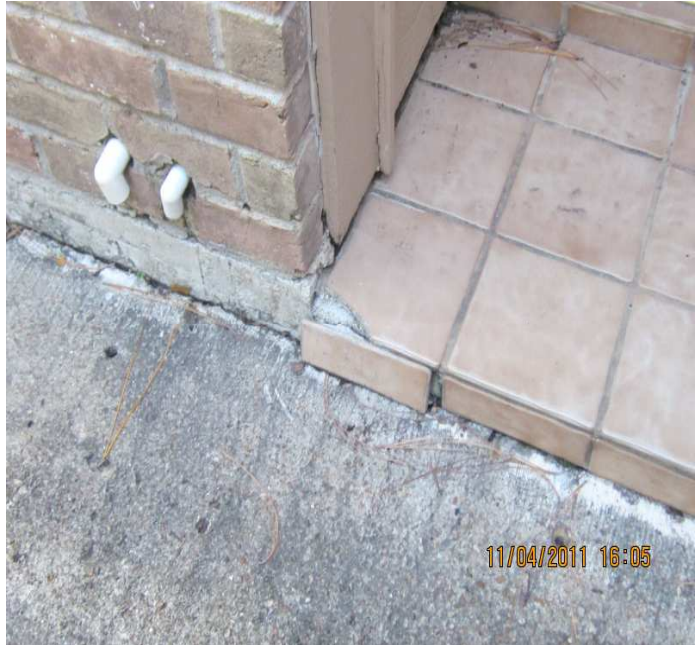
PHOTO NO. 12 DAMAGED TILE FLOORING ON WEST SIDE PORCH

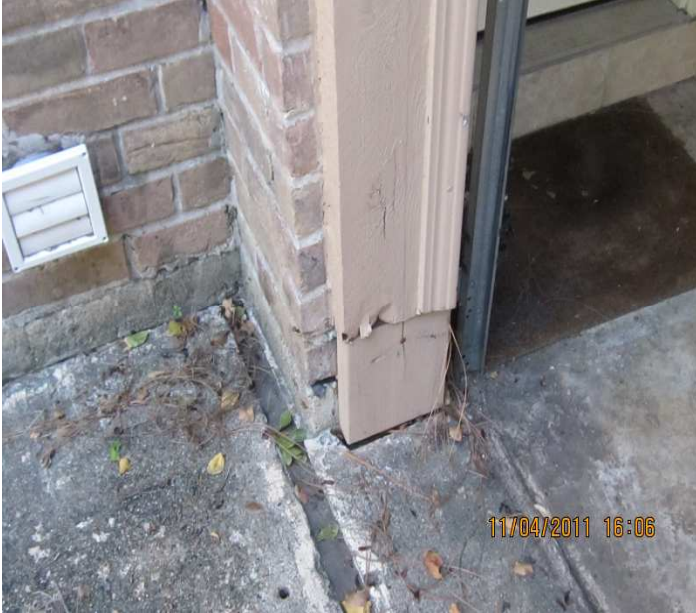
PHOTO NO. 13      ROTTING OUT VERTICAL  
GARAGE DOOR FRAME BOARDS

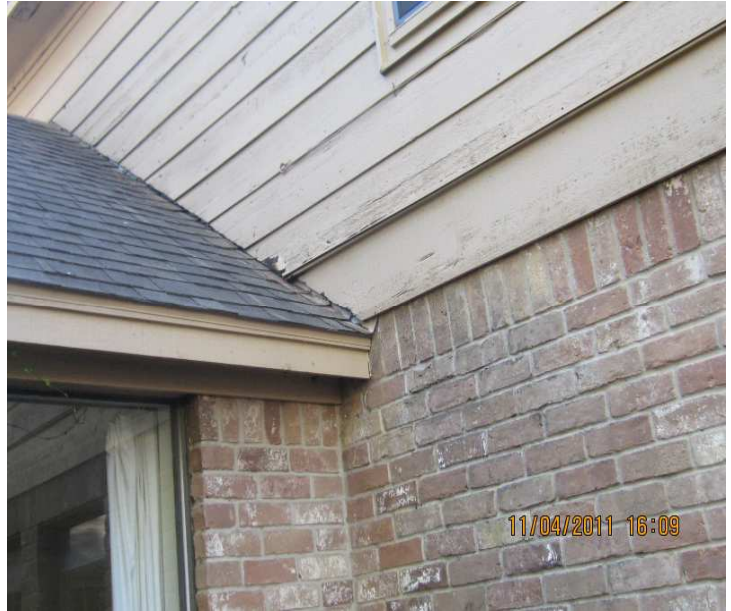
PHOTO NO. 14      DAMAGED SIDING AT  
FRONT EAST SIDE

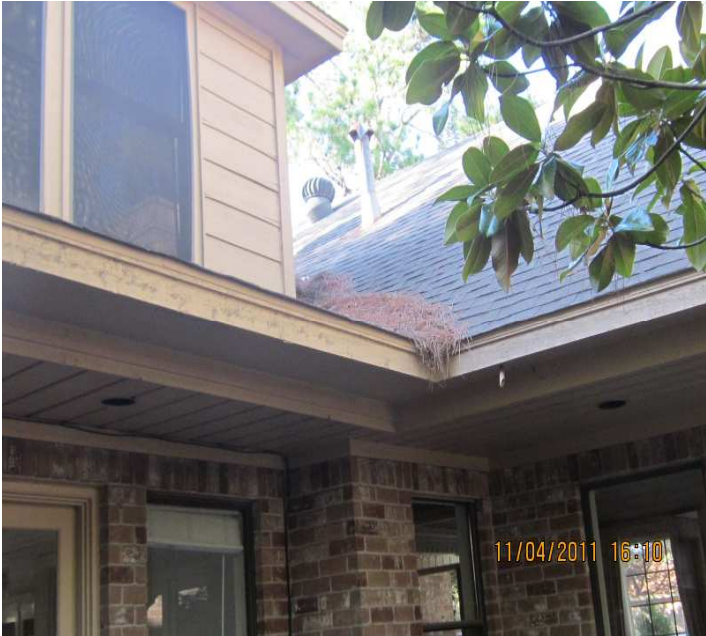
PHOTO NO. 15      PINE NEEDLES IN ROOF  
VALLEYS

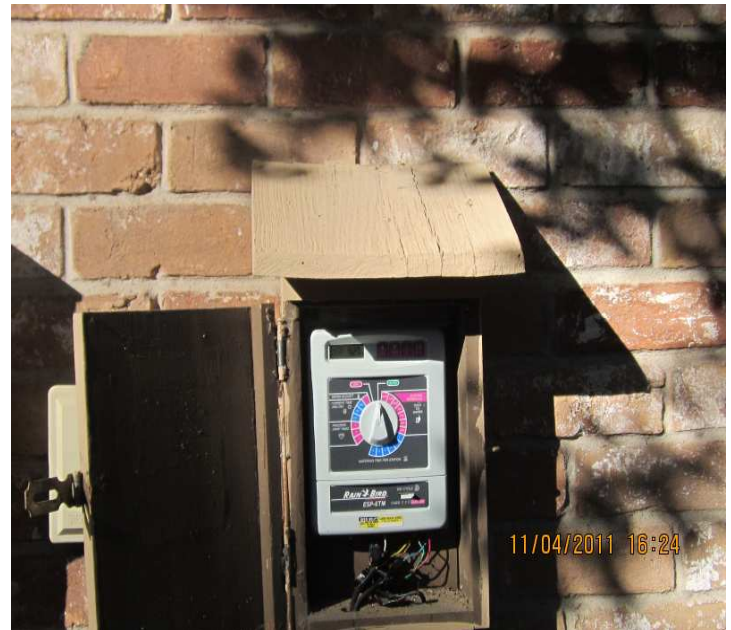
PHOTO NO. 16      SPRINKLER CONTROL BOX  
OUTSIDE BACK WALL OF GARAGE

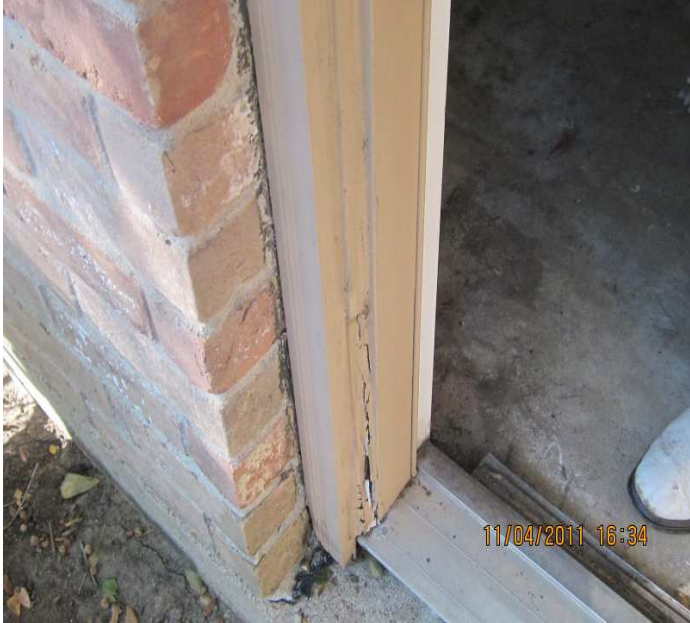
PHOTO NO. 17 DAMAGED DOOR FRAME  
AT BACK EXIT DOOR OF GARAGE

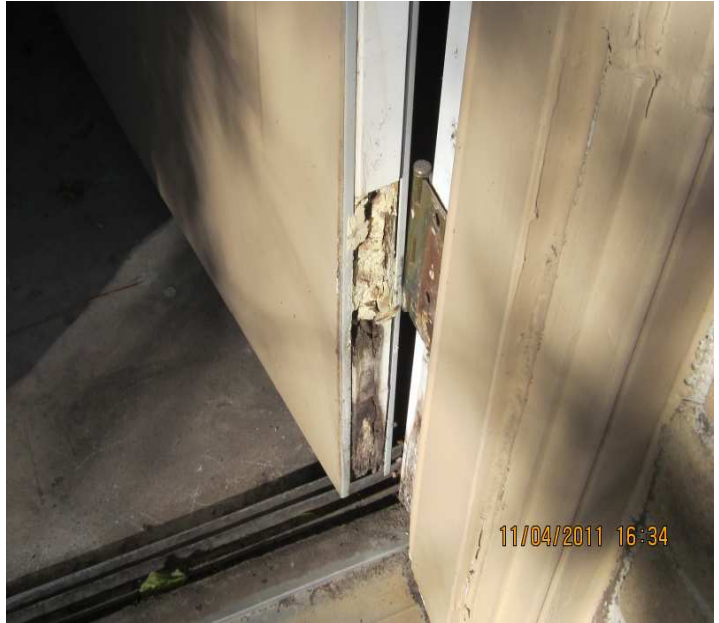
PHOTO NO. 18 DAMAGED BACK EXIT DOOR  
OF GARAGE

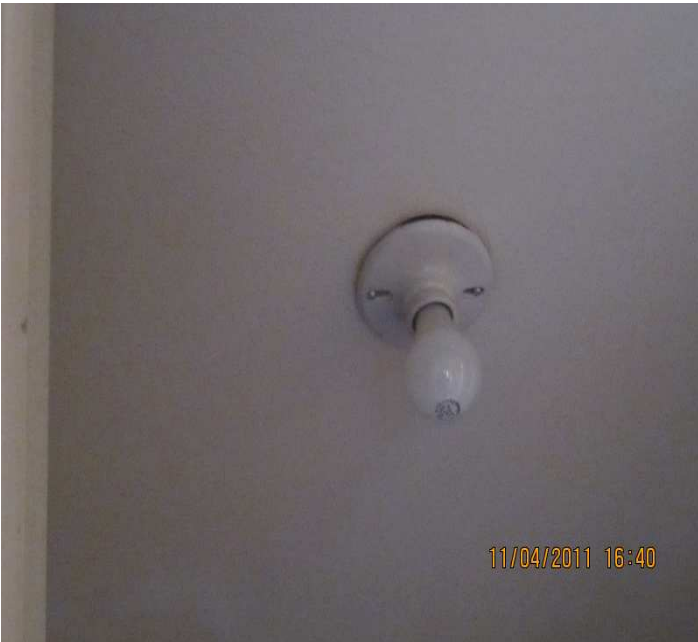
PHOTO NO. 19 CLOSET LIGHT FIXTURES  
MISSING GLOBES

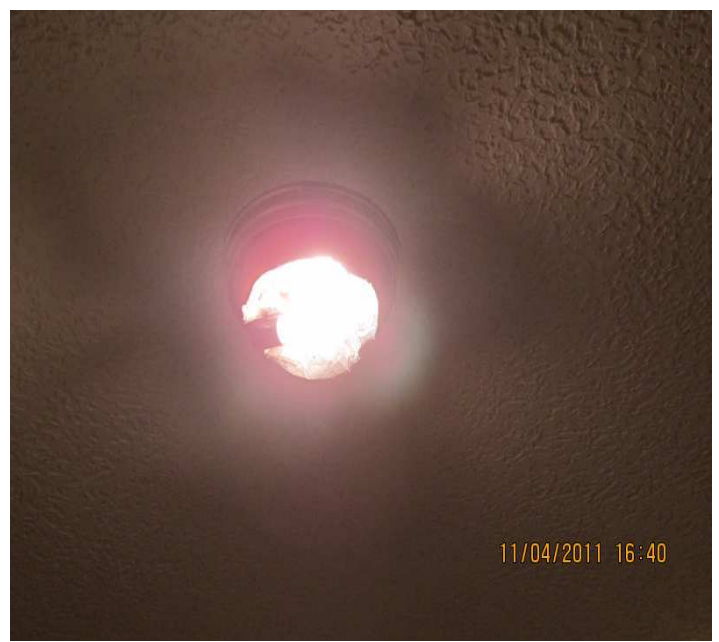
PHOTO NO. 20 BROKEN LIGHT FIXTURE  
IN UTILITY ROOM

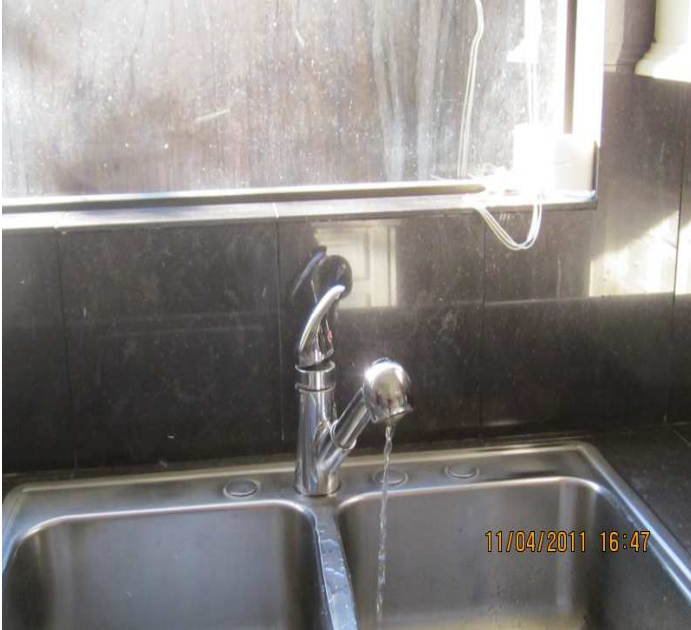
PHOTO NO. 21      KITCHEN SINK MISSING  
ANTI-SIPHONING DEVICE

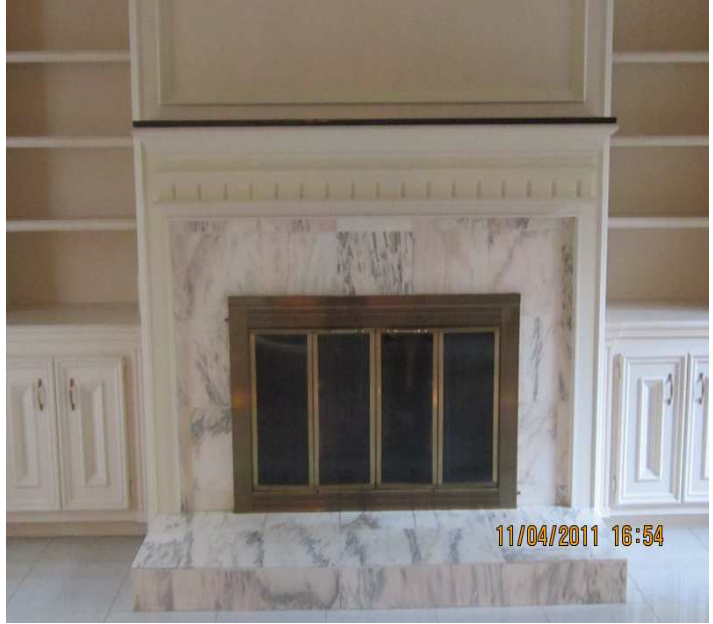
<b>J. FIREPLACE / CHIMNEY</b>		
<b>NO. 8</b>	<b>MASONRY FIREPLACE, IN THE LIVING ROOM, IS MISSING A CLIP ON THE DAMPER. THE CLIP IS REQUIRED DUE TO THE PRESENCE OF THE GAS LOGS. REPAIRS ARE NEEDED. CHIMNEY IS MISSING A CHIMNEY CAP AND SPARK ARRESTOR.</b>	<b>\$500.00 TO \$600.00</b>

PHOTO NO. 22      FIREPLACE IN LIVING ROOM

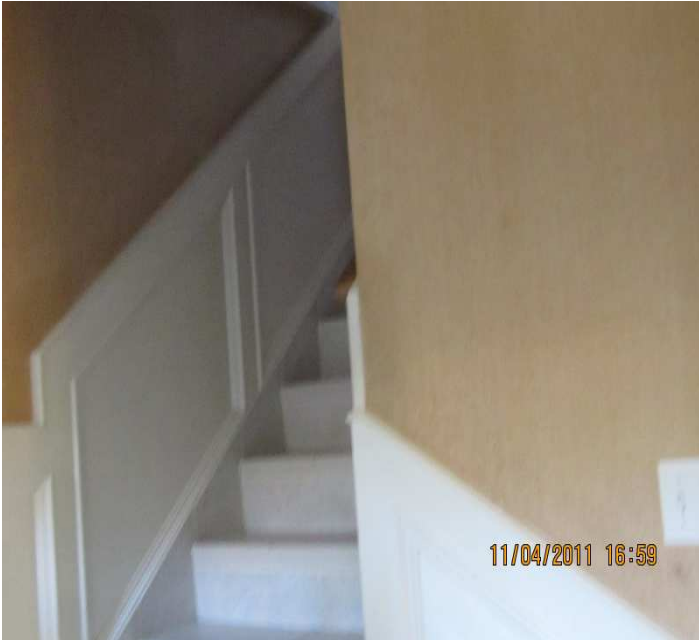
PHOTO NO. 23      STAIRWAY MISSING  
CONTINUOUS HAND RAIL

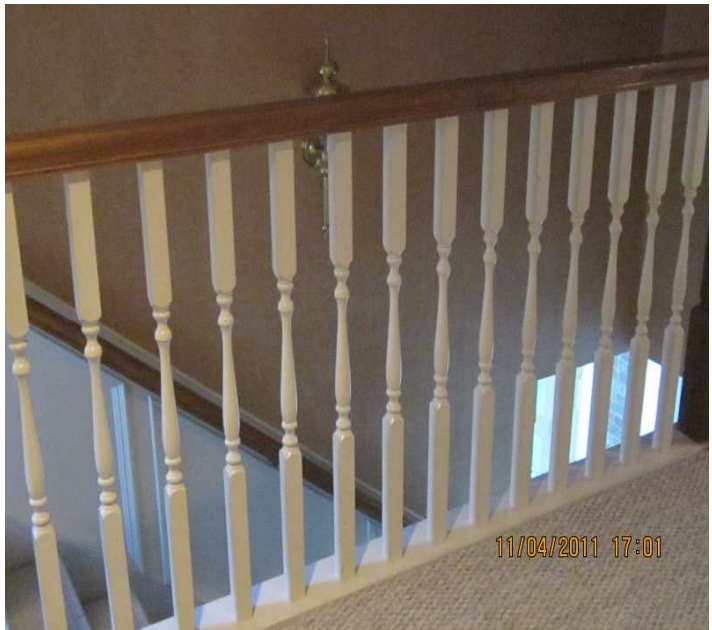
PHOTO NO. 24      GUARD RAIL, IN UPSTAIRS  
GAME ROOM, DOES NOT MEET "4-INCH" RULE

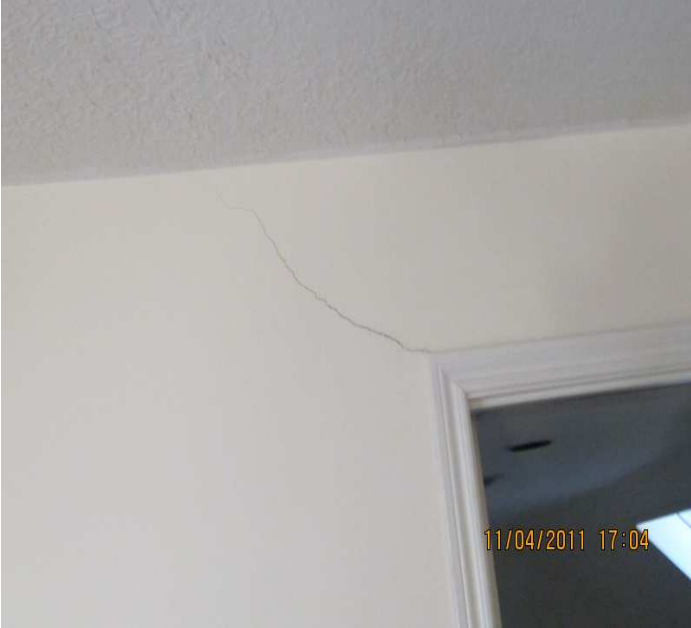
PHOTO NO. 25 ANGLE CRACK OVER  
UPSTAIRS BACK BEDROOM DOOR

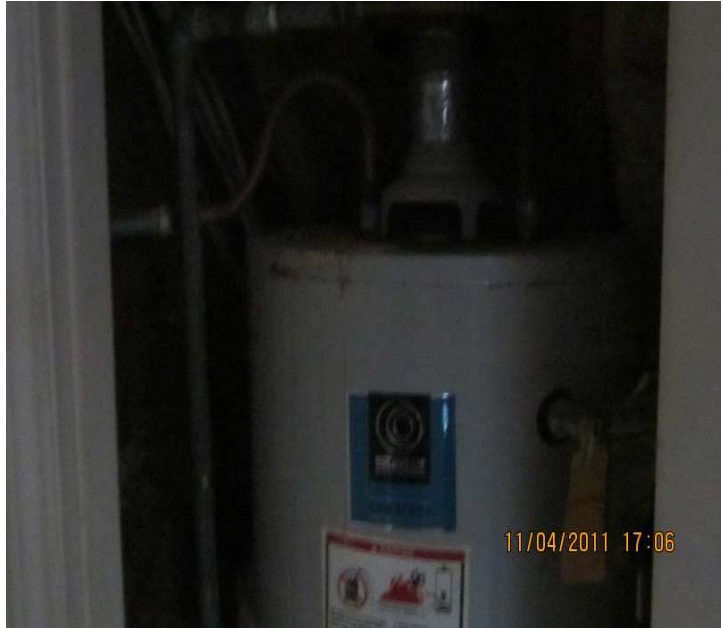
PHOTO NO. 26 BACK SIDE GAS WATER  
HEATER

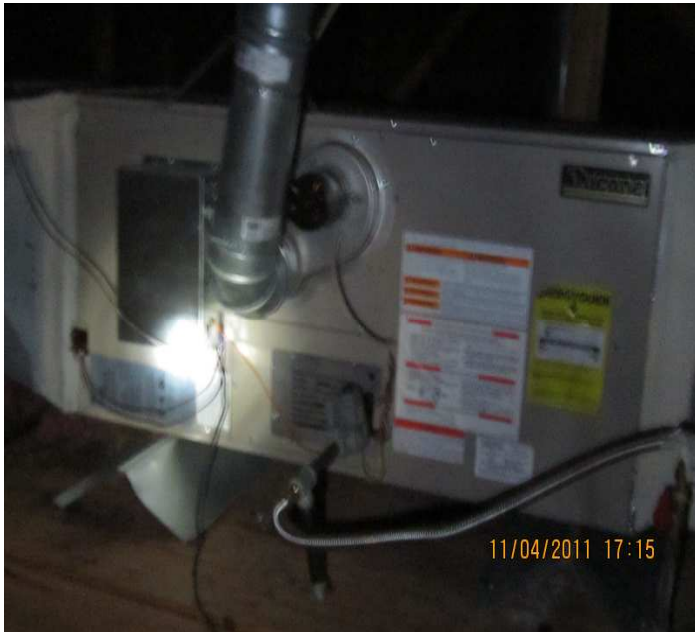
PHOTO NO. 27 ONE, OF TWO A/C - FURNACE  
UNITS IN TOP ATTIC

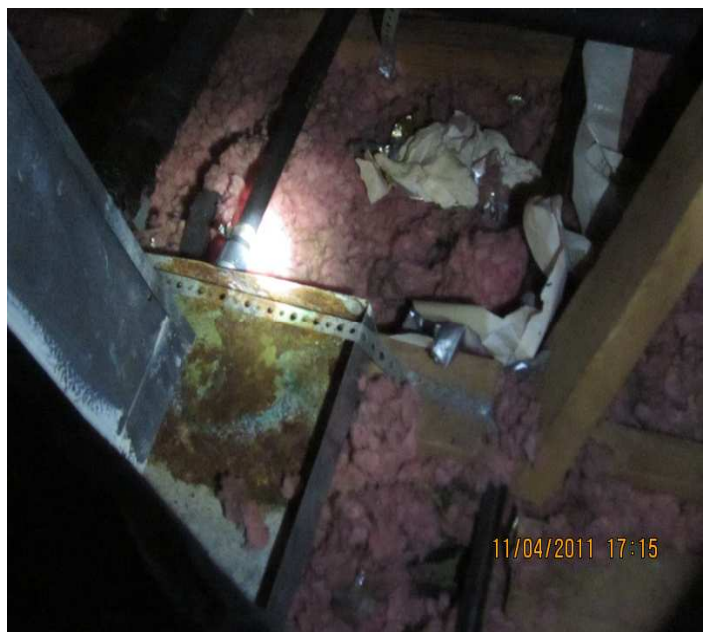
PHOTO NO. 28 A/C DRAIN PAN FULL OF  
RUST & MISSING FLOAT SWITCH

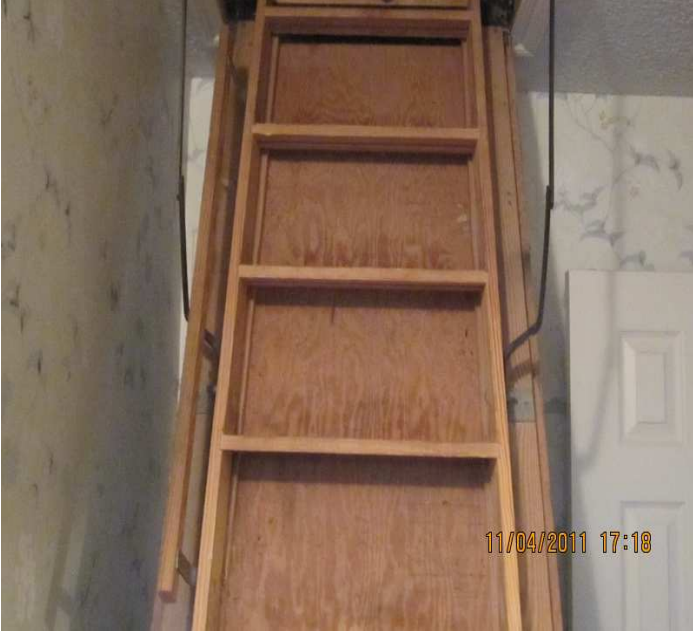
PHOTO NO. 29      ATTIC ACCESS LADDER  
IN UPSTAIRS FRONT BATH

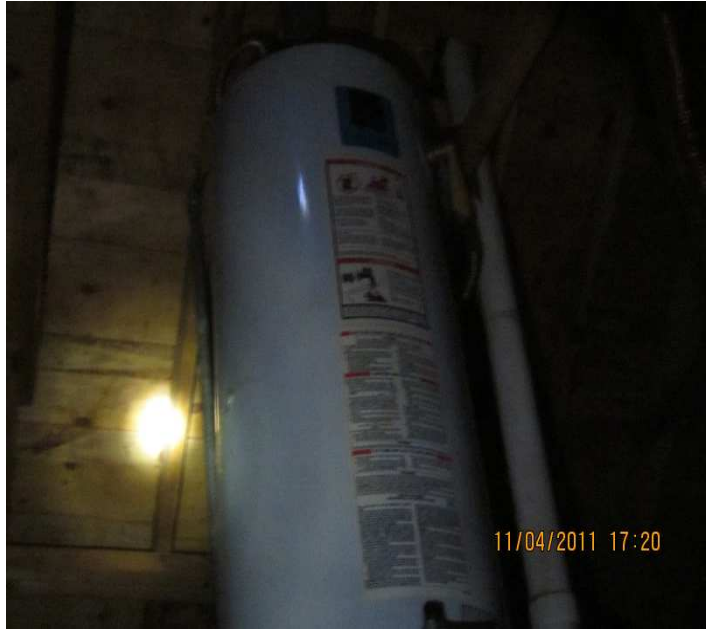
PHOTO NO. 30      GAS WATER HEATER IN  
TOP ATTIC

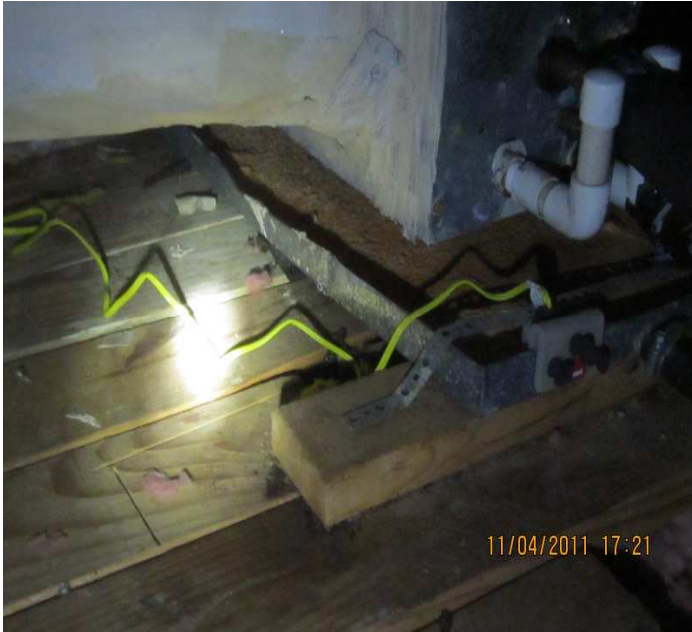
PHOTO NO. 31      A/C DRAIN PAN FULL OF  
RUST

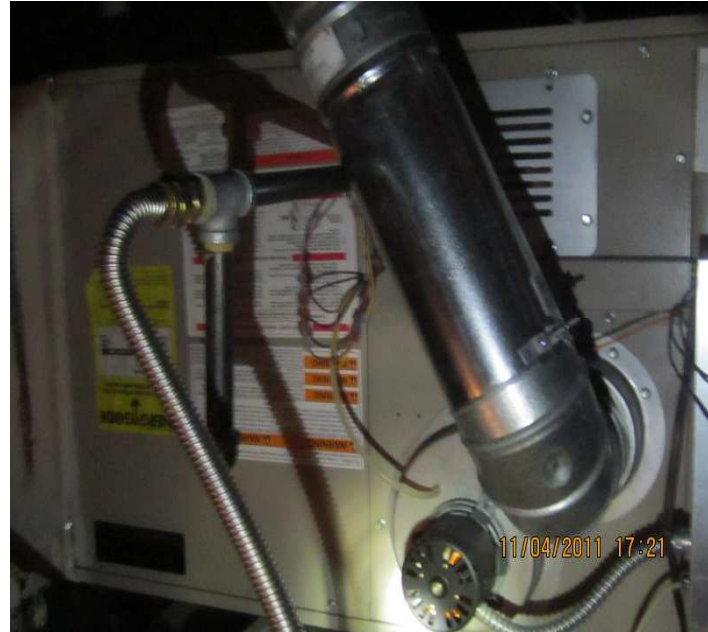
PHOTO NO. 32      NEWER A/C - FURNACE  
IN TOP ATTIC

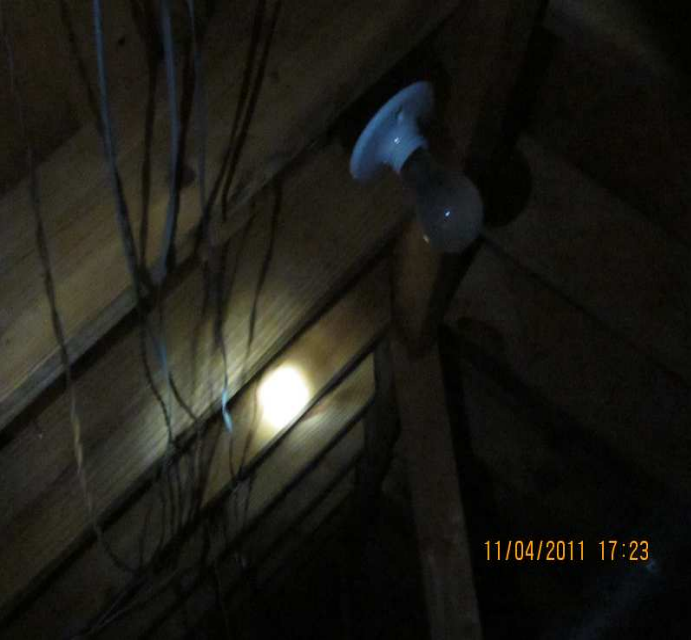
**PHOTO NO. 34**

<b>NO. 16</b>	<b>DUCTWORK, IN THE ATTIC, IS LAYING ON TOP OF EACH OTHER. THIS CAUSES SWEATING INSIDE THE DUCTWORK WHICH CAN LEAD TO MOLD FORMATION. THE DUCTWORK IS OLD AND PROBABLY NEEDS TO BE REPLACED.</b>	<b>\$1,000.00 TO \$1,300.00</b>
---------------	--	---

**OLD DUCTWORK IN ATTIC  
TOUCHING EACH OTHER**
