A+ HOME INSPECTIONS

HOME INSPECTION REPORT

Evaluation of property located at: **123 Easy Street, Nashville, TN**
Inspection is performed for: **Mr. and Mrs. Buyer**
Time of the inspection is: **February 26, 2010 9:30 AM to 12:40 PM**

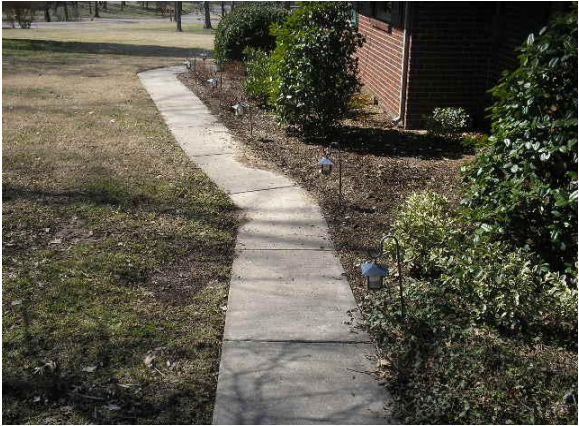
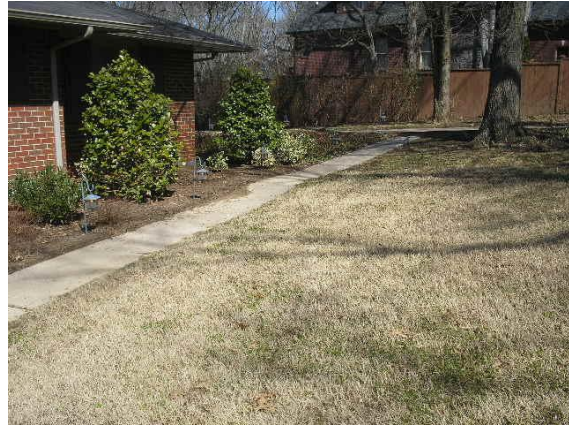
1. This home is built on a lot, which slopes from front right to rear left. So, water runs down toward the front right and right end of the house.
2. Mud has washed onto the front sidewalk.

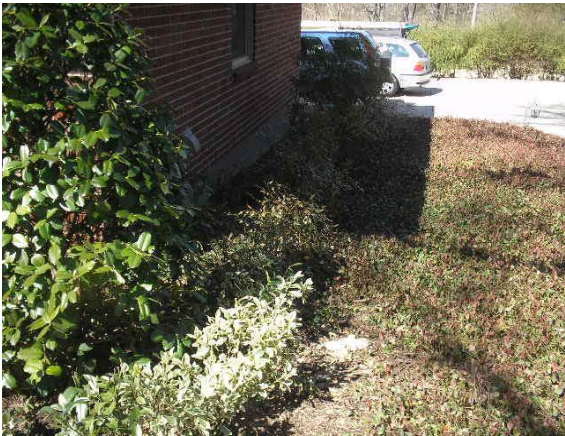
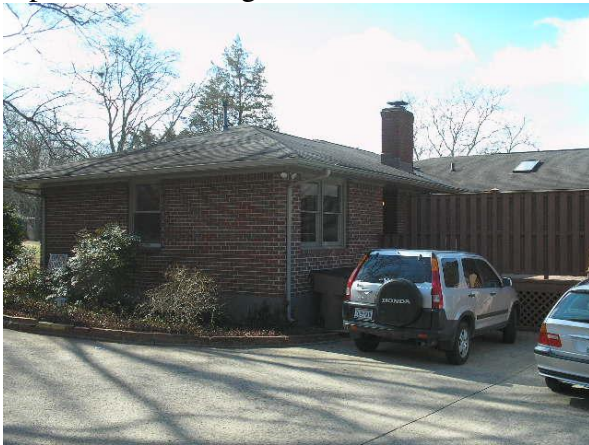
3.
4. Ground is actually sloping toward the house in places, like on right end of house.

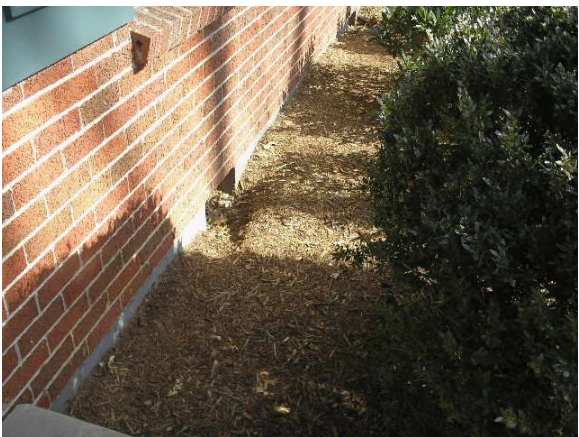
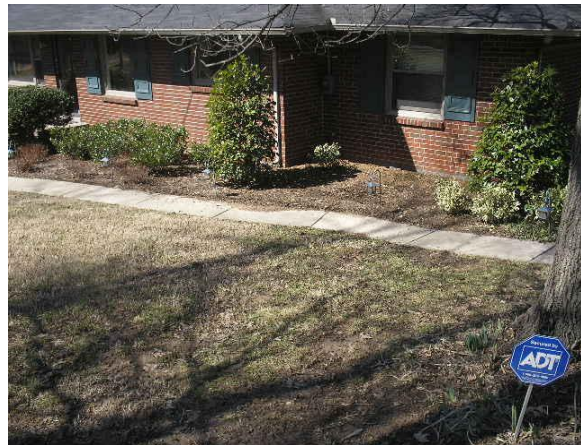
5.
6. The ground should slope away from the house continuously at least one inch per foot for ten feet minimum. It is flat right up against the house in places on all four sides.
7. Building codes 401.3, 406.3.5 and 1806.5.5 require the ground surface to slope AWAY from the foundation 6" minimum drop in 10'-0" of horizontal distance. It is recommended that the ground slopes away from the house at least 1" per foot for at least 10'-0".
8. Adding sloping compacted clay dirt up against house to any low lying areas around the foundation where ground settles, will help kick water away from house. Do not cover any crawl space vents with dirt or mulch. Half-circle wells are already needed around some crawl space vents.

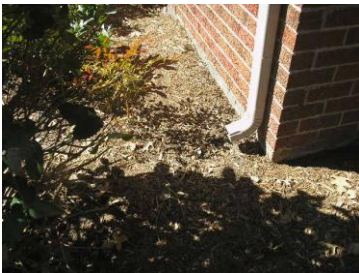
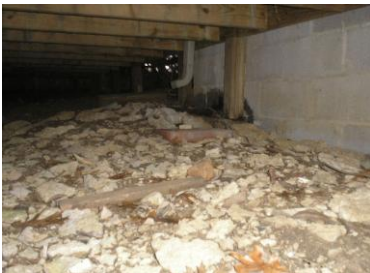
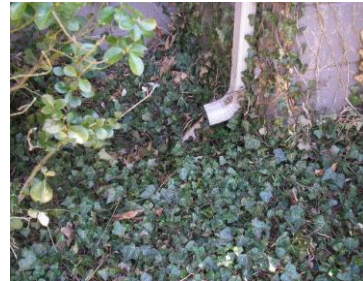
1. Add downspout extensions. There are no downspout extensions or splash blocks on several downspouts; like on the front corners, under deck,

- 2.
3. Add downspout extensions where the downspouts dump out under the deck.
4. I recommend adding solid downspout extension pipes on downspouts to direct the roof water away from the foundation. Secure extensions to downspouts with non-corrosive screws.
5. Bury the downspout extensions and cover their drain ends with screens or pop-up drains.

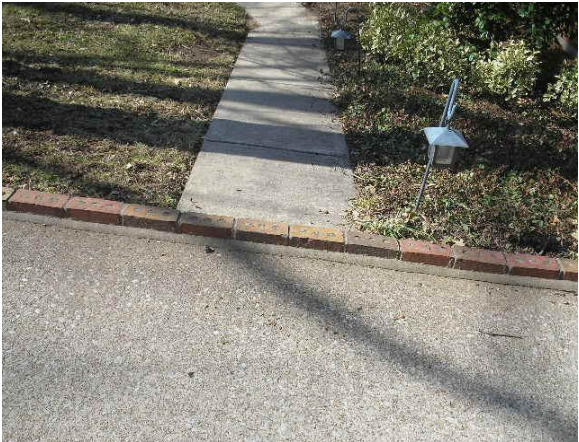
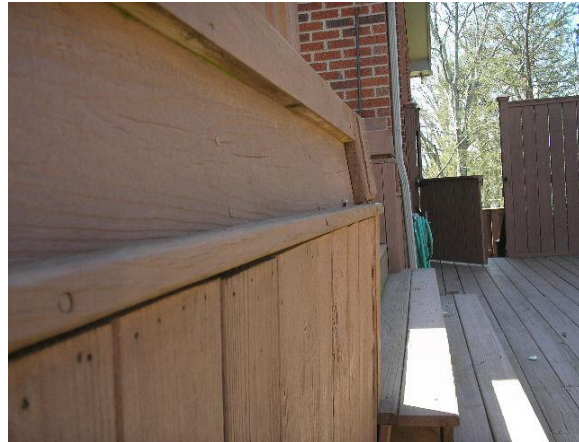
1. Trip hazard noted on the front walk where there is a row of bricks laid over the front walk at the driveway. Trip hazard is a brick high. Other trip hazards on the front walk noted at cracks.

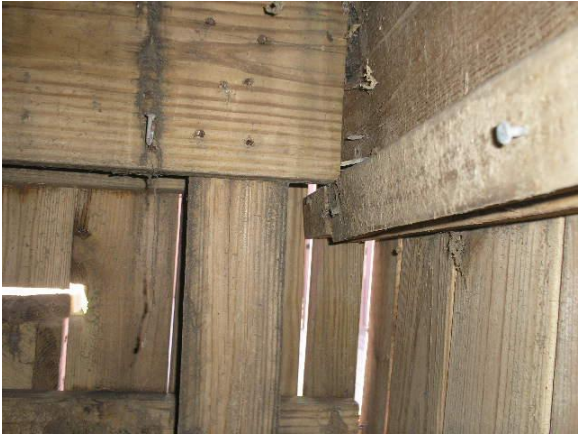
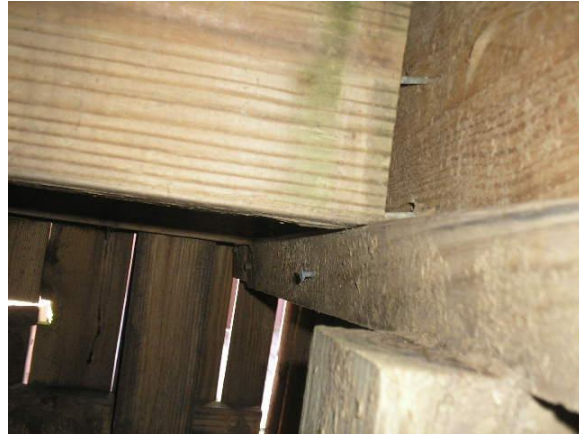
- 2.
3. Deck is unsafe at this time! It should not be used until made safe!

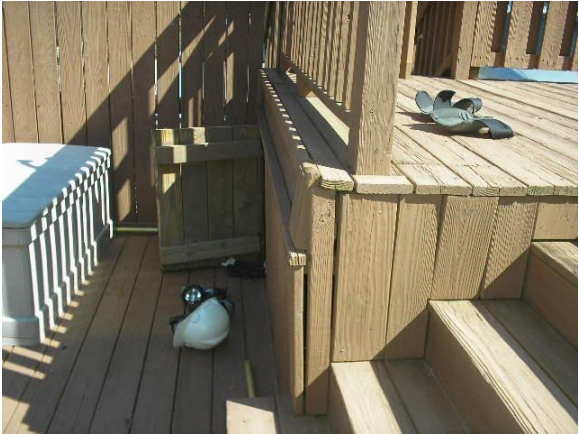
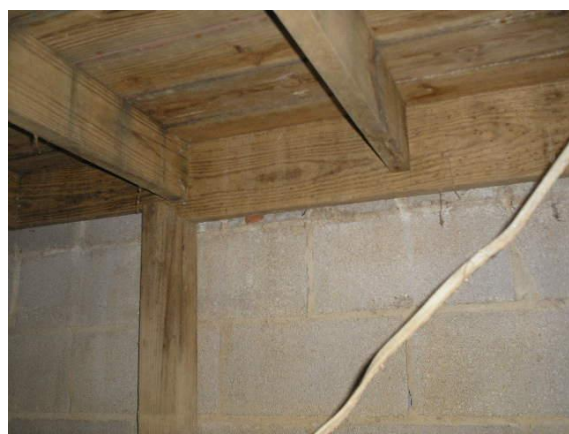
- 4.
- 5. Deck is unsafe, and needs repairs immediately, before use. For example, at the step down of the deck, a few wood floor joists are about to slip off their 2x2 wood ledger strip supports where the wall is bowed out.

- 6.
- 7. Metal Simpson joist hangers are needed throughout under deck.
- 8. Under the deck, the 2x2 wood ledger strips should have 3 nails under the ends of each joists, and they do not.
- 9.
- 10. Some deck posts are barely sitting on blocks that are just sitting on the ground.

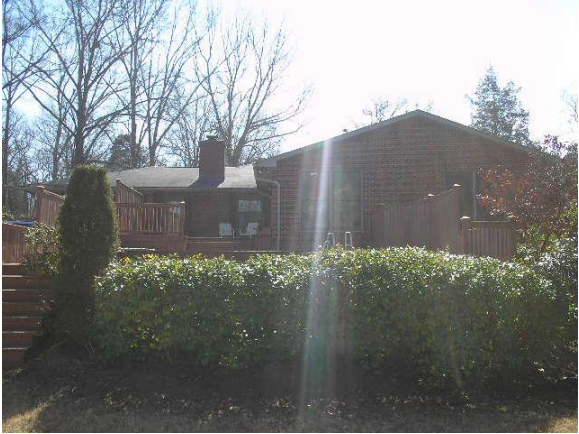
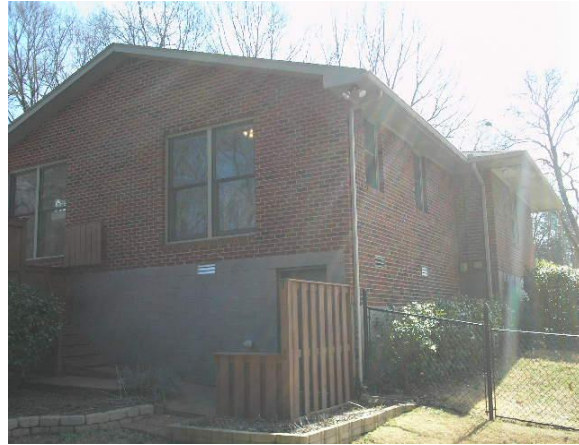
- 18.
19. Common cracking noted on concrete driveway, walks, and front porch.
20. Seal off under the outside package HVAC unit and its metal shroud to help keep rodents out of crawl space. Use heavy screen wire outside and sheet metal in crawl space. No signs of rodents were seen in the crawl space at this time, but there are daylight holes into crawl space at this HVAC unit at this time.
21. Some of the wood latticework is broken on the deck.
22. All shrubs should be trimmed at least 12" to 24" from the house to allow proper air circulation around the walls. Vines and other climbing plants can damage exterior surfaces by trapping moisture and by promoting another path for insects to enter the home. Outside electric panels must have at least 36" clearance in front of them for safety.

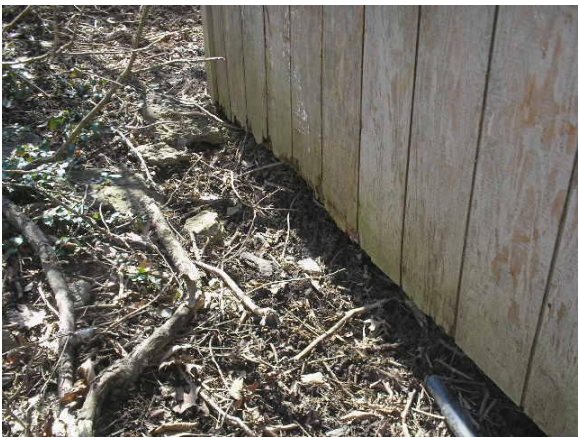
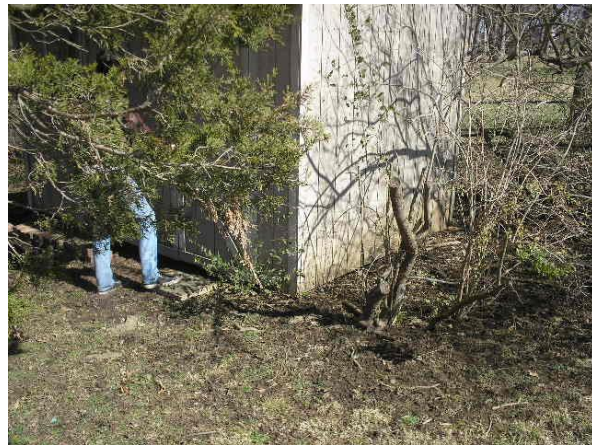
- 23.
- 24. Wood siding on the shed is touching the ground, which invites termites. There should be at least 6" clearance between ground and wood.

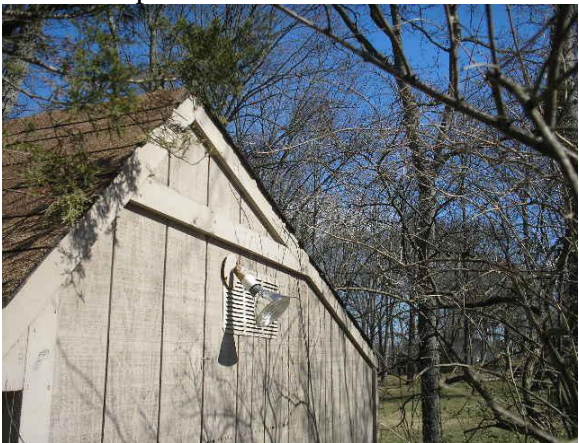
- 25.
- 26. There is termite damage on the rear edge of the shed.
- 27. There is a pile of wood behind the shed that can invite termites.

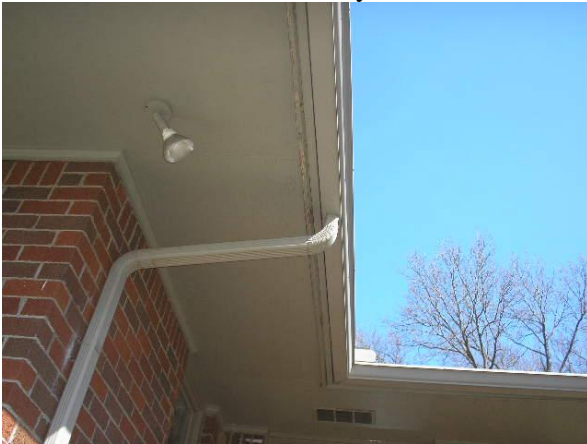
- 9.
10. Rear left master window wood sash is rotted at bottom of its lower glass pane. This is the window above the crawl space door. Wood mullion and nosing between the windows has been cut off and patched.
11. There has been some rot, and there is some bare wood showing on the fascia board under the front left soffit. Gutters may have overflowed from clogged downspouts.

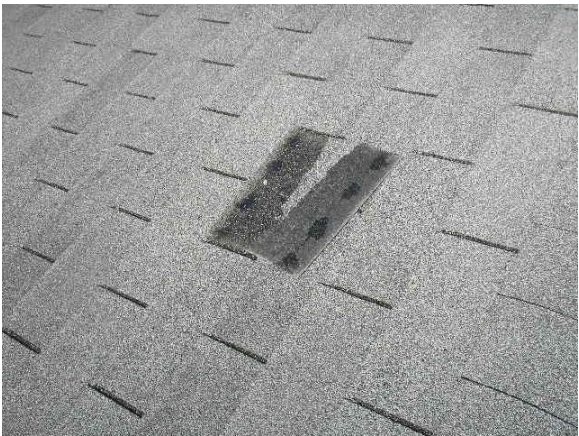
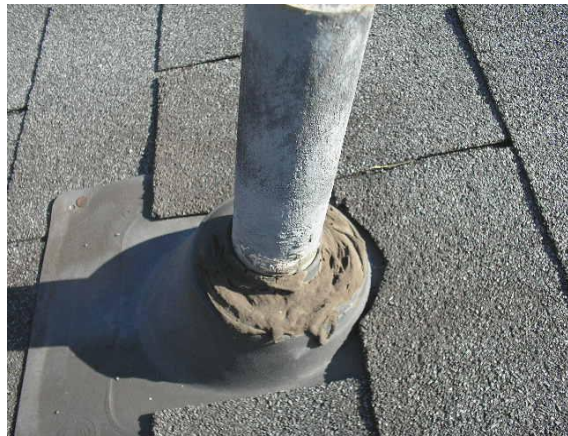
1. One shingle is flipped up and torn off on the left side of the rear addition, near where the rear addition roof meets the main roof.

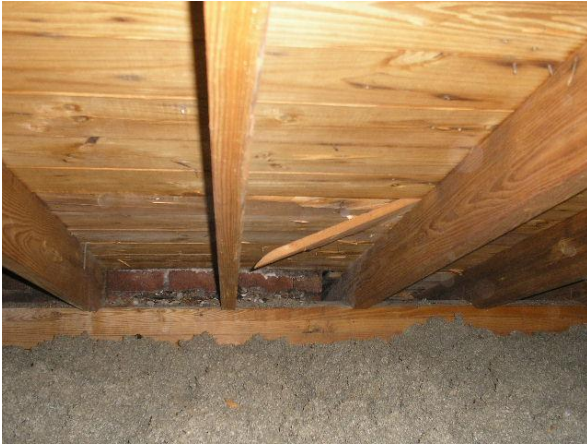
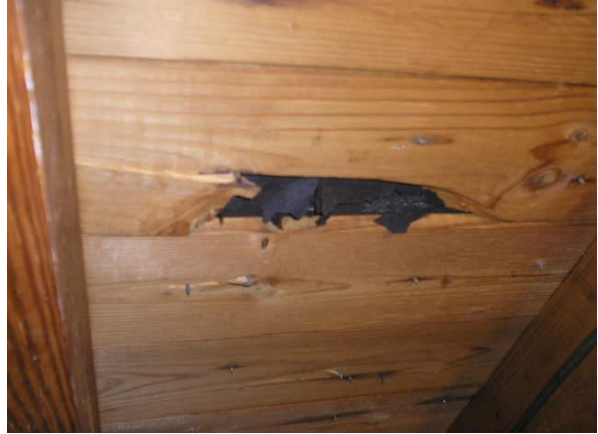
- 4.
5. Seal up gaps in metal flashing around chimney.
6. Some roof planks are busted in the attic, which is common, but should be repaired. If someone steps on these spots, they could step through the roof.

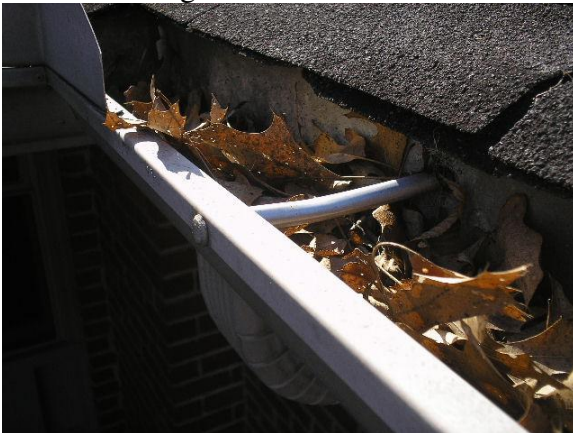
1. Clean out the gutters.

- 2.
3. Add leaf guards.
4. Gutters, downspouts and drains are often ignored. Poor maintenance on these items can cause more damage to house exteriors and foundations than possibly any other component. Gutters and downspouts should be cleaned at least once a year and kept in good condition to ensure the water flows through the gutters to the downspouts and well away from the house.

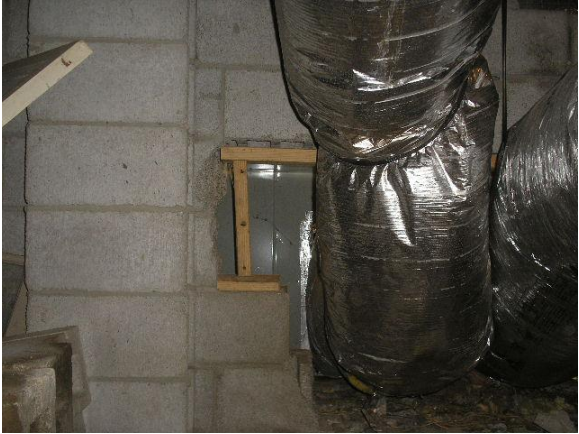
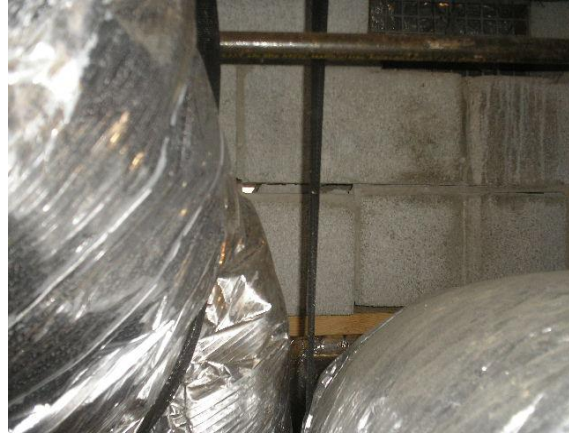
1. Cracking and settling noted in the left concrete block foundation wall above where a large

hole is knocked through the foundation wall for the ductwork to enter crawl space from the outside package HVAC unit outside. In the crawl space, this concrete block foundation wall needs to be supported better above where the blocks have settled about 1" here.

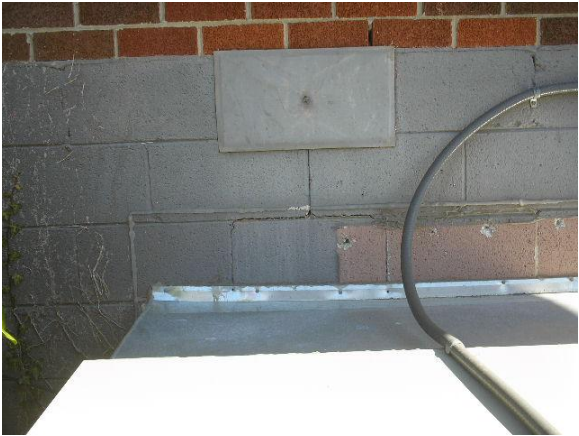
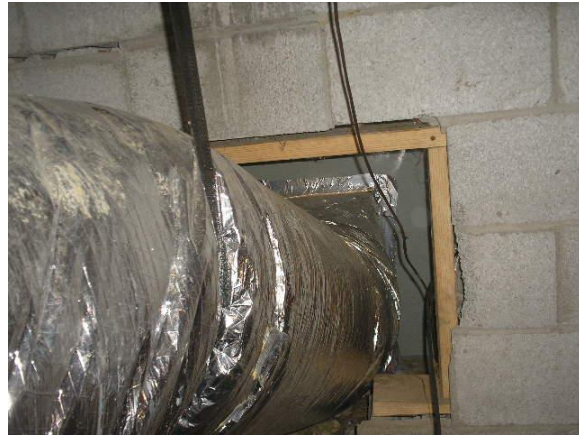
Common cracking noted in the concrete block foundation wall by the crawl space door. Patch cracks.

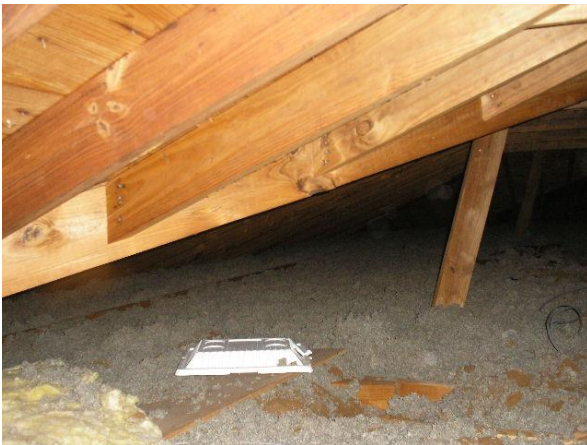
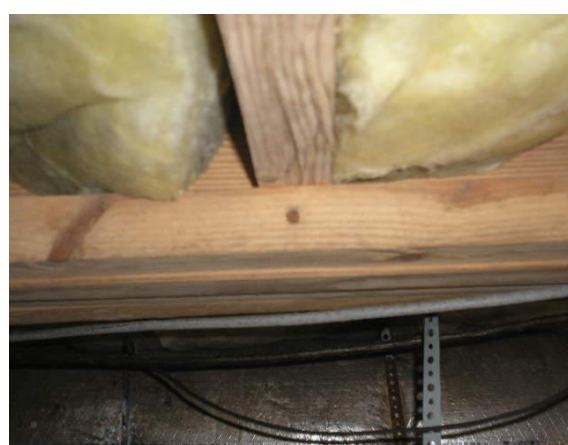
6. In attic, the front right valley rafter is sagged a little in middle where there is a large knot that is cracked and partially separated. Add a 2x4 wood stud kicker with a stiff-back, under the weak sagged spot under this front right valley rafter. Set the bottom of the support on top of a wall below.

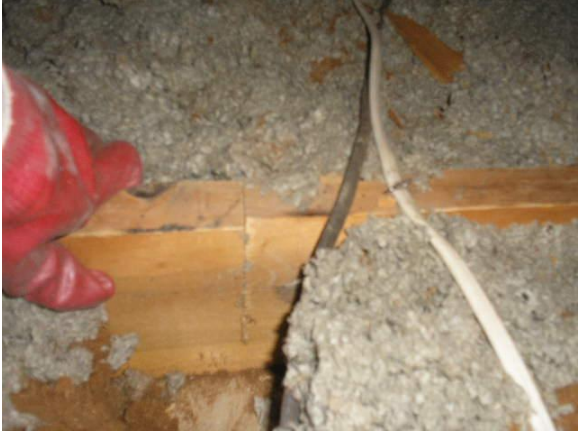
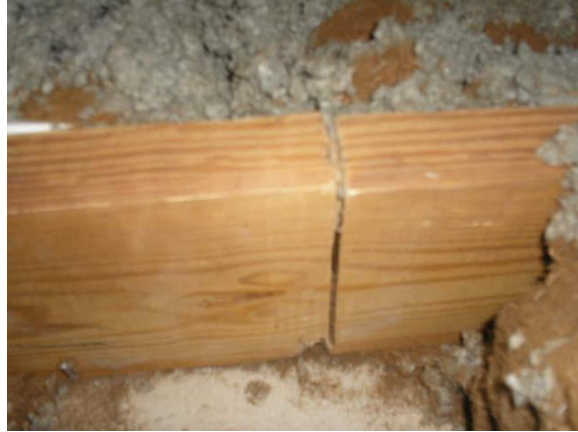
9. In the left center attic, some 2x6 ceiling joists are cut almost all the way in two.

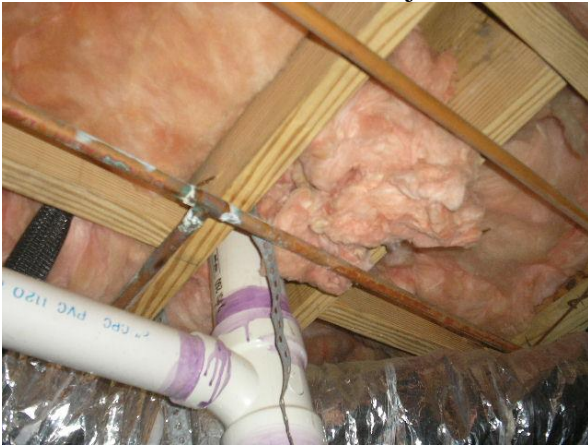
11. Under the master commode in the crawl space, a floor joist has been cut completely in two, and blocking added. Add metal Simpson joist hangers on all perpendicular connections at these headers, cut ends of floor joist and blocking.

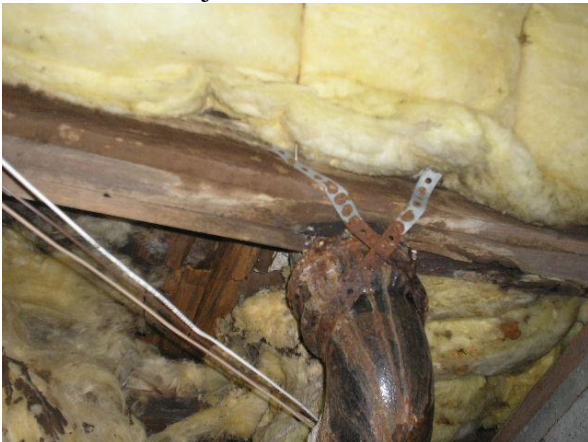
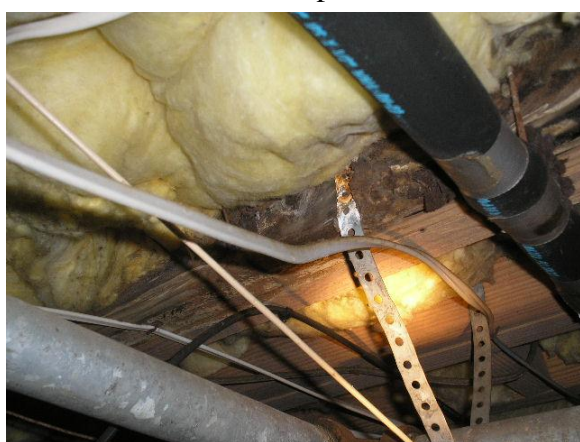
13. Floor and floor joist are rotted some under hall bath. Reinforce rotted spots here.

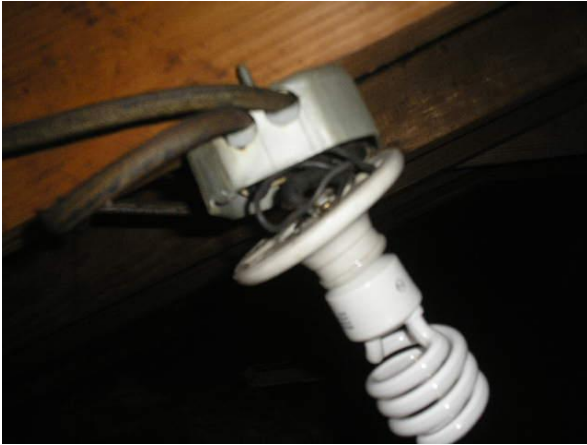
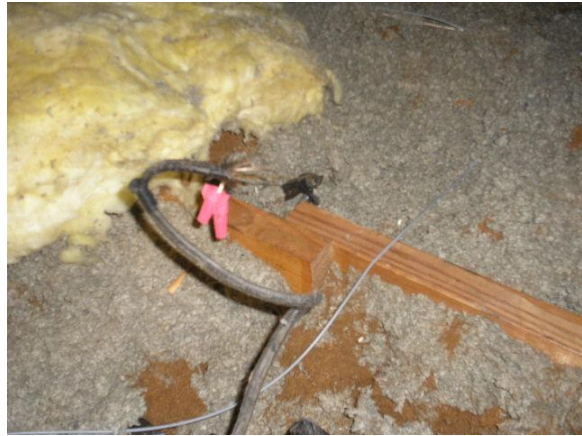
12. Attic light is hanging partially by its wires.

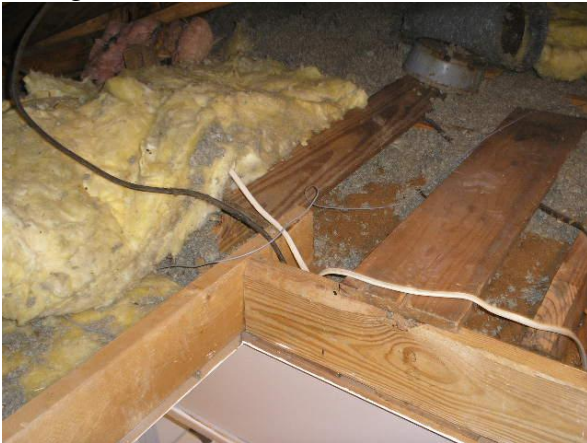
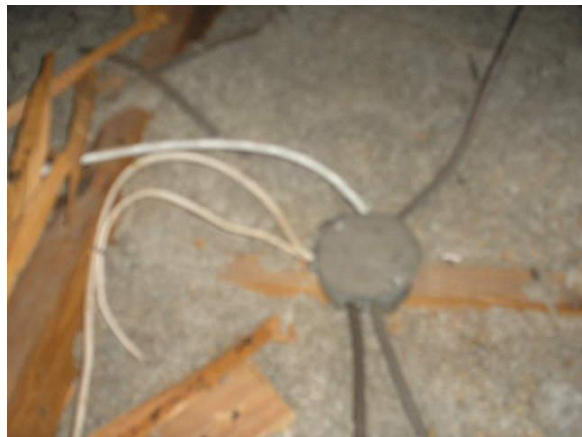
13.
14. There is some frayed wiring by the attic access hole. There is not supposed to be any exposed wiring within 6 feet of the attic access hole. Repair and protect wires.

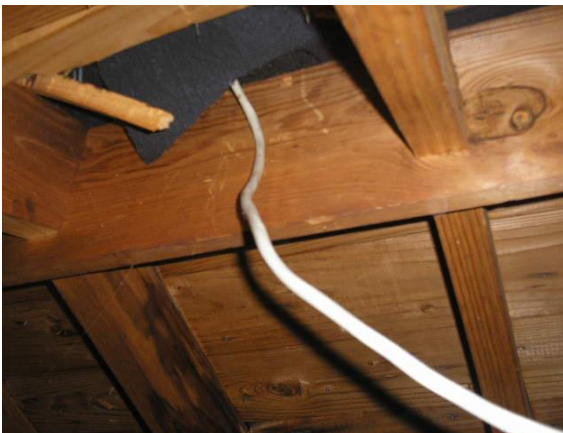
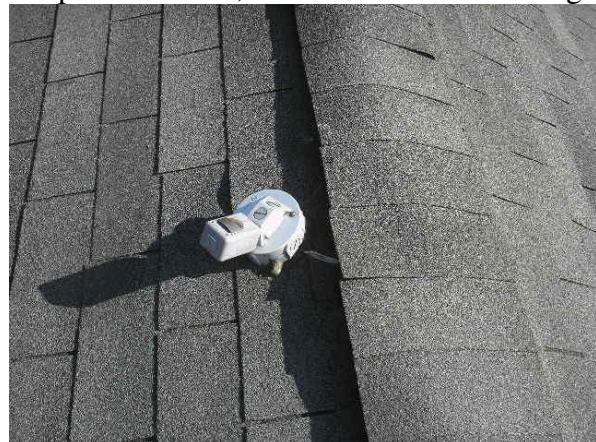
15.
16. In the attic, the electrical wiring needs to be stapled down flat. It is a trip hazard!
17. In the attic, wires need to be stapled within 12" of covered junction boxes; like in the left attic.
18. In the attic, there is a wire running up out the continuous ridge vent to a photocell on the roof, in front of the sky light. Wire should be stapled to rafters, and rated for direct sunlight.

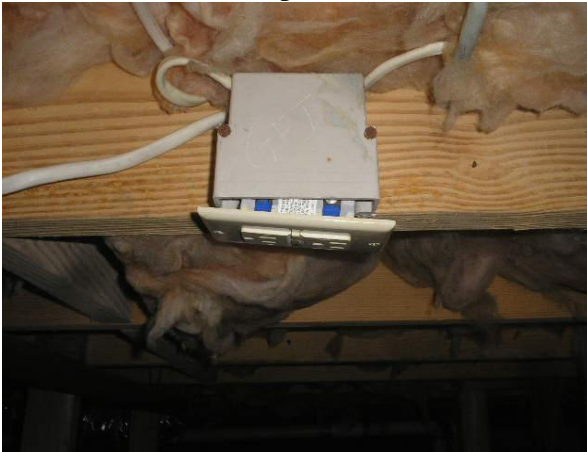
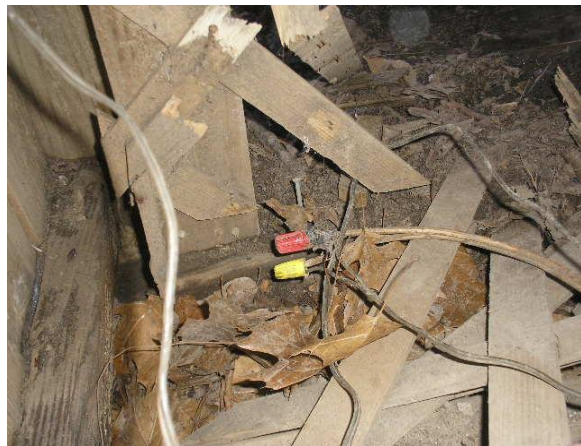
- 22.
23. There is an open slot in the bottom of the main electric panel in the laundry. Install blank or breaker in the open slot.
24. Electric panel is low to the floor in the laundry room, since this used to be the garage.
25. In the walk-in crawl space, a GFCI outlet is hanging out of its box on the floor joist.

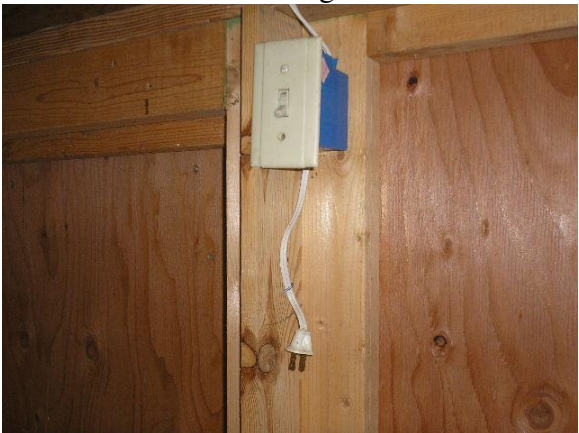
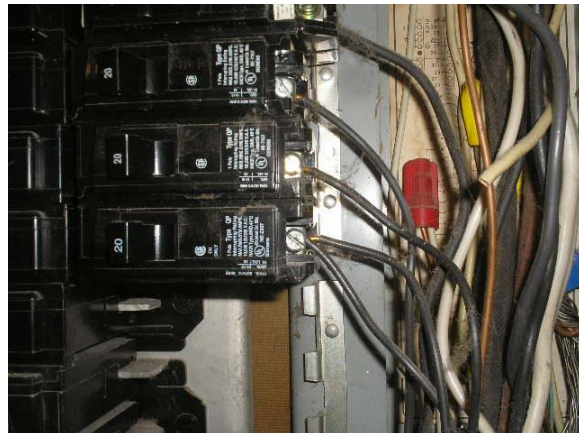
- 26.
27. There are exposed electric wires and splices under deck that are not in conduits, and do not appear rated for exposed exterior use. All wire splices should be in covered junction boxes.
28. Wiring in the shed appears to just be an extension cord run to a light switch. I do not recommend this since it is small wires, and are not grounded. There is no power on to shed at this time. It appears it has been powered by running an extension cord to it from the house. We did not test the wiring in the shed.

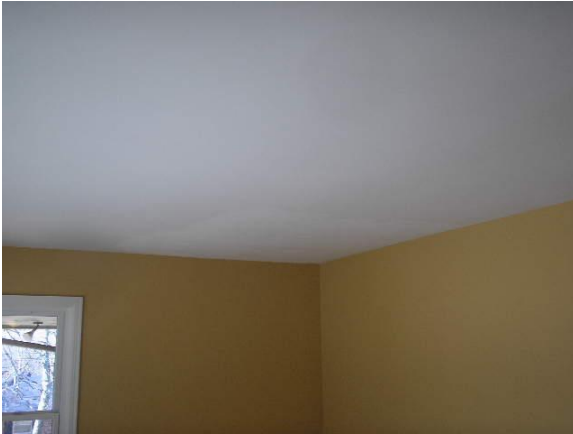
1. Different color white paint noted on the ceilings in the living room and dining room.

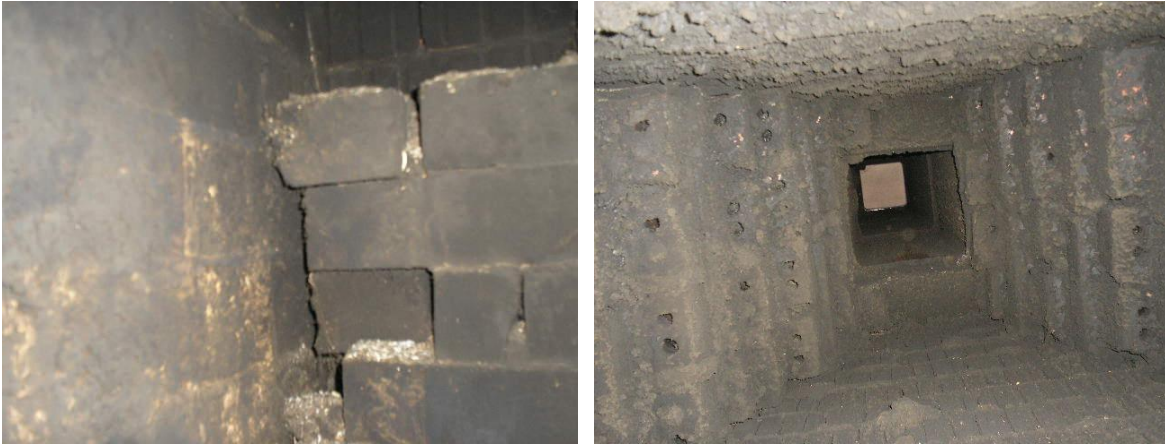
1. There are several gaps inside the fireplace between bricks. Do not use fireplace, until repairs are made.

- 2.
3. Fireplace does not have a damper. It is open right up the chimney. It has glass doors.
4. I recommend that you consult with a licensed fireplace/chimney contractor to determine whether the fireplace is in safe working condition prior to using the fireplace. I do not test the fireplace/chimney or comment on its efficiency or operation. It is important that a fireplace/chimney is cleaned on a regular basis to prevent a buildup of flammable materials and ensure its safe operation.

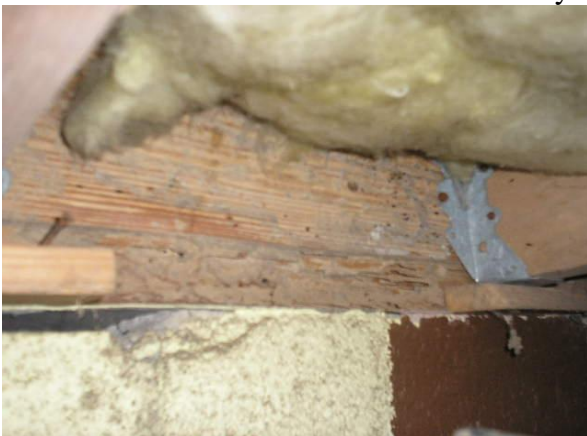
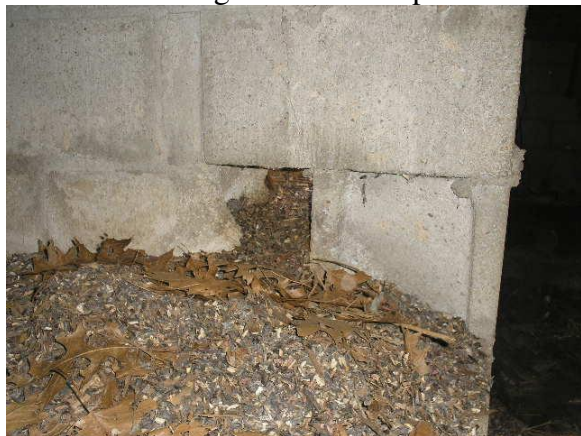
1. Hall bath commode is leaking into the crawl space. There is water on top of the plastic. See **PLUMBING** notes above.
2. Floor is rotted out under the hall bath commode some.
3. There has been a leak under the right hall bath sink. There is some mold-like substance and rot on the wood floor joists. See **STRUCTURAL** notes above.
4. There is some fungus in the bottom edges of some floor joists, like in the rear center crawl. This fungus can severely damage wood floor joists. Get the vapor barrier over the ground better.
5. There is termite damage in the floor joist/beam under the wall between the old garage and the house. This can be seen above near where you crawl into the right rear crawl space.

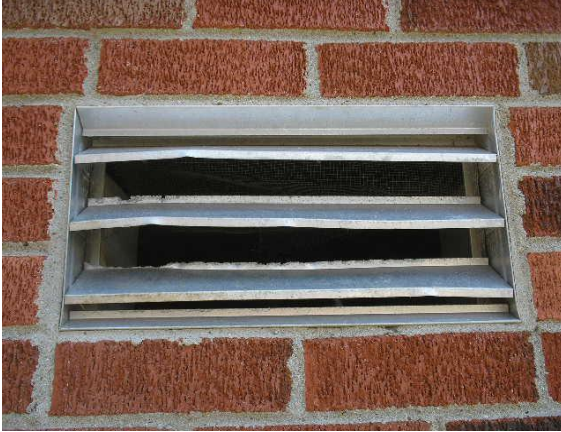
7. There is about a 6" hole under the left side of the front porch where rodents can enter the crawl space. Get this sealed up permanently.
8. Support the copper water tubing running through the right crawl.
9. Per the disclosure, there was some water under the addition in 1994.
10. Replace crawl vents with ones that can be easily opened and closed, and have screens.
11. Some screens are missing or torn out of some crawl space vents now.

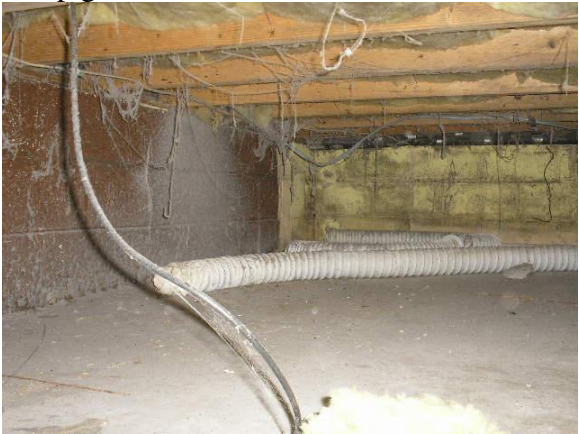
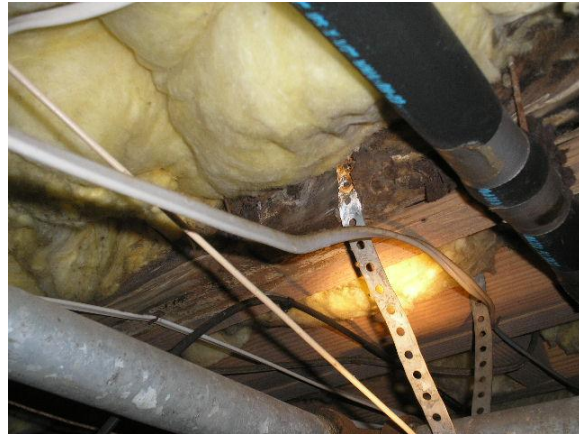
1. There is some mold-like substance on exposed portions of most of the wood floor joists, and on bottom of the batt insulation between the floor joists. It appears worse above the bare damp ground.

- 2.
3. Per a specialist I know, it is best to remove the mold than to treat it with Tim Bore or Bore Care like several pest companies now do.
4. Mold is a fungus---a parasitic plant lacking chlorophyll, a rigid cell wall, leaves, true stems & roots. Mold is multicellular, and it is composed of thread-like hyphae.
5. Molds spores can cause serious health problems even if the spores are dead or dormant (inactive while waiting for more moisture to resume growth).
6. Even the smell of dead or dormant mold can make some mold-sensitive persons ill.
7. There are no legal mold exposure limits.
8. Sampling for mold can be referred to a qualified microbiologist.
