PROPERTY INSPECTION REPORT

Concerning: 1234 Customer Street, Bee Cave, TX 78738

By: Cliff Mark # 7704 TREC & U453 HUD

March 27, 2012

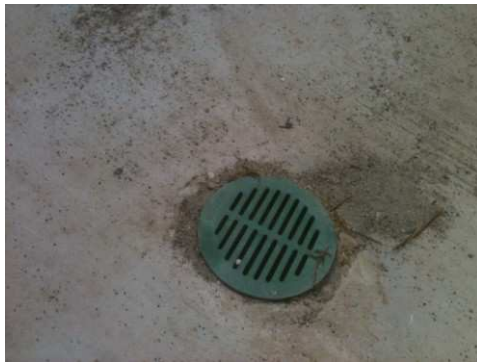
- Grading is not 100% complete.
- The drainage features of the interior 'courtyard' appear to be suitable but the grate in the courtyard is elevated so that drainage will take longer than expected and a puddle may develop as a result.
- The left side terminus of the presumed courtyard drainage pipe has a 'cap' that is loose and needs to be secured.

Drain grate too high for effective drainage in courtyard

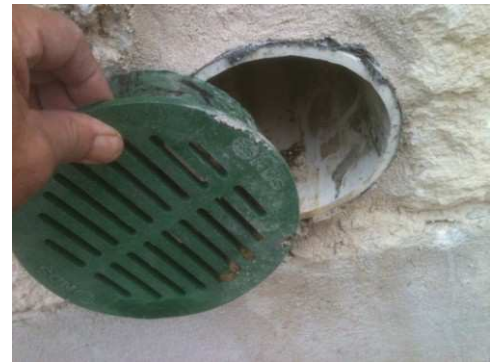
Drain grate not secured to drain terminus along left side

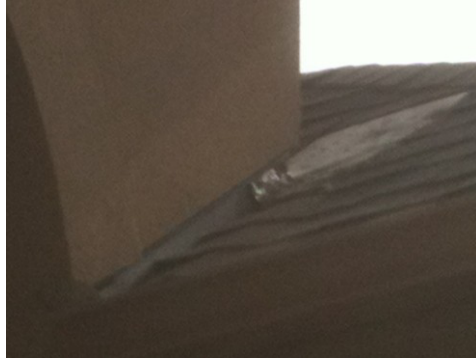
Note of Concern: There is a piece of 'tape' or other material on the flashing and painted over at the valley above the entry. This appears to be an unnecessary addition to this roof and removal is recommended as it may impede suitable flow of water through this area (see picture below).

Tape or other foreign object in run-off path at roof

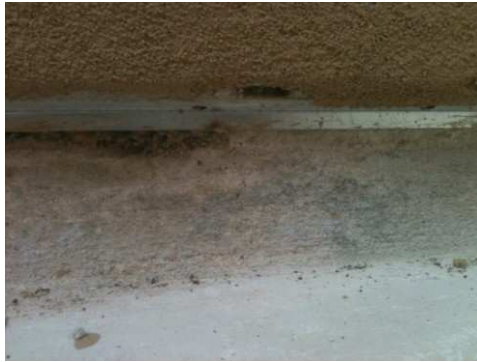
Courtyard weep screed needs work in some areas

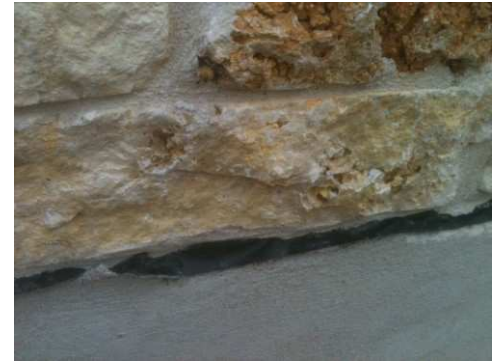
- It is recommended that the moist stop overlap be trimmed up under the bottom course of stone down the left side and other possible locations around the stone exterior.
- Around much of the courtyard, the bottom runs of weep screed extend past the foundation as much as an inch which will allow intrusion of insects and which is cosmetically problematic in such a ‘high visibility’ area.

Moist stop protruding past lower course of stone

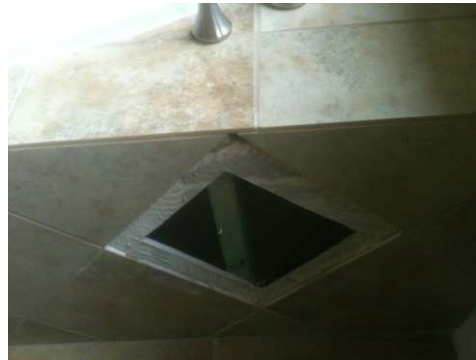
Interior walls are performing as intended from a structural point of view and no significant cracks, holes or blemishes were observed except to note a missing tile and sheetrock in the master bathtub skirting.

Missing tile and sheetrock at master tub skirt

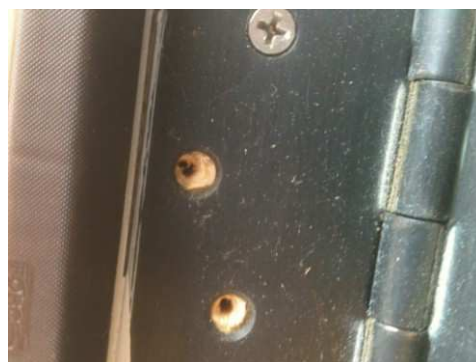
G. Doors (Interior & Exterior) *Comments:* Most exterior doors are latching and weather stripped as intended but the fixed half of the front door has missing hinge screws (4 total in three different hinges) and this fixed door bottom latch hole has been expanded (re-drilled) so that the door is loose even when latched.

Missing hinge screws at fixed door hinge front door

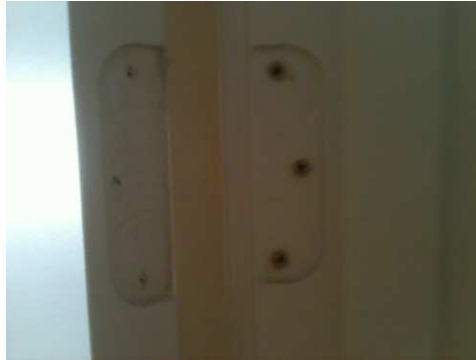
Interior doors are plumb and level and operating as expected except to note that an entire hinge is missing on the left hand water heater closet door.

Missing hinge at garage water heater door (left)

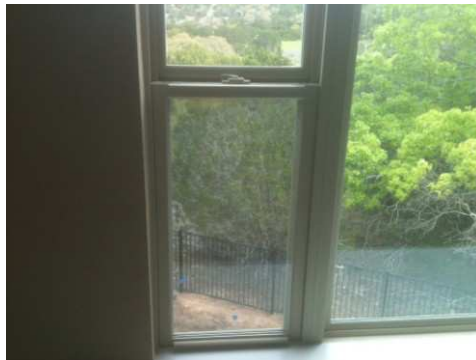
- Minimum egress and rescue requirements per IRC for a bedroom window require 5.7 square feet ‘clearance’ at a window not at grade. The two small windows in the master bedroom of this home measure 14” (wide) by 26” (high) or 2.52 square feet. As a result, these do not conform to this IRC standard. Nearby master bathroom windows conform to this 5.7 square foot requirement and may provide suitable egress or rescue but the bedroom windows do not conform.

Master bedroom window measures 14” w X 26” h

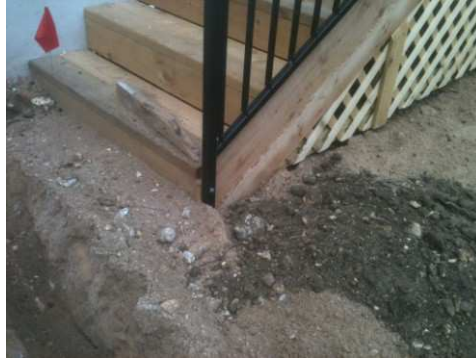
- It also appears that there is a sprinkler head planned for right at the bottom of these stairs (rather than a landing) and this water source may keep the wood stair parts under moisture and also accelerate decay and/or deterioration of the stair bottom.

Soil-covered stair base and sprinkler flag (ill-advised)

- The concrete base at the bottom of the stringer is currently covered by soil and it is recommended that this base (or bases) be uncovered so as to eliminate accelerated deterioration due to soil or moisture.

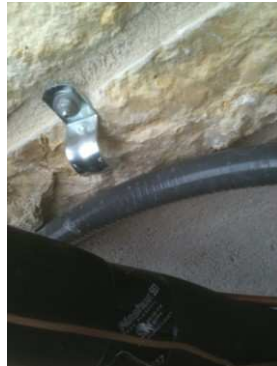
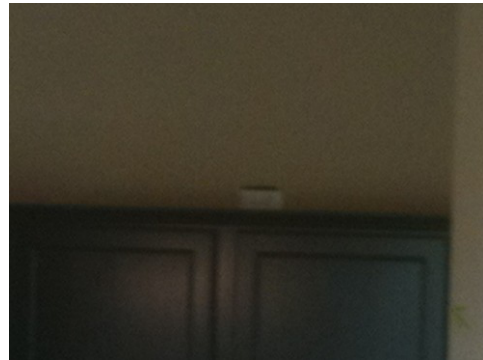
- There is a broken bulb in the master vanity light fixture closest to the bedroom in the master bathroom.
- There is a broken outlet cover at the front right corner of the garage (interior).
- The outlet cover above the refrigerator cabinets in the kitchen does not fit properly.
- The electrical line for the exterior condensing unit needs to be re-strapped to the stone wall.

AC conduit no longer strapped (2 locations) Outlet cover above frig cabinets doesn't cover opening

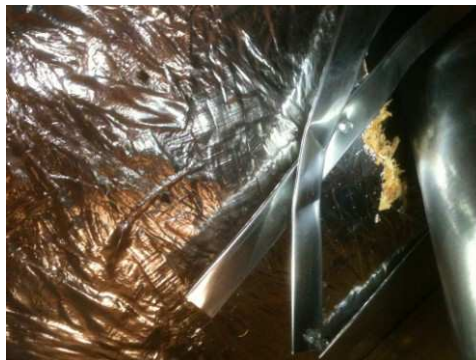
- The heating unit flue vent pipe has a loose strap where it leaves the attic and travels through the roof decking. As a result, this flue vent pipe is less than one inch from flammable materials. Re-securing the strap should solve this problem.

Strap not secure – flue pipe too close to wood decking

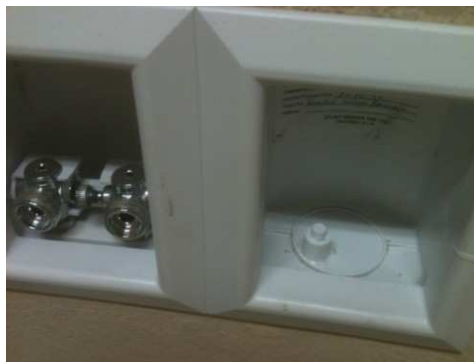
Drain plug as washer/drain box to be removed

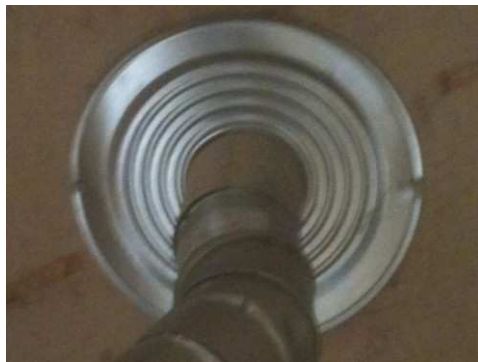
Draft stop could use two more screws for better seal

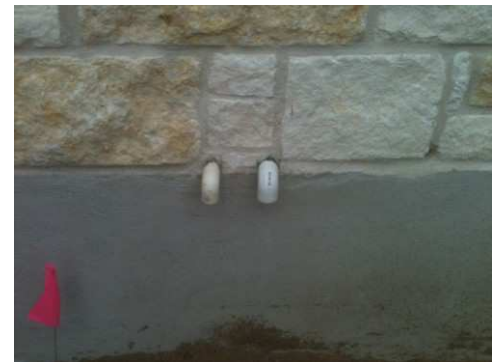
T&P terminus 12-15" above grade (should be 6")

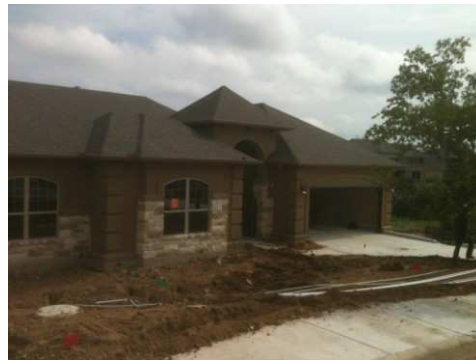
- K. Irrigation System** *Comments:* This system is in the process of being installed but is not completed at the time of the inspection. No inspection could be completed.

Irrigation and final grade not completed as of 3/27/12

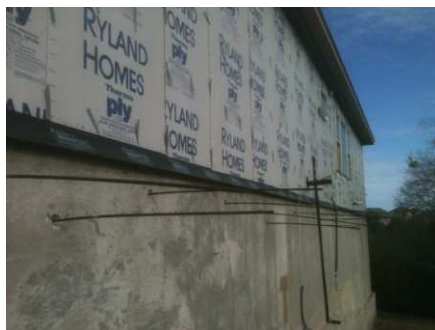
- (1) Usually the post-tension cable ends have been cut off and temporarily 'patched' by this phase of construction. Their continued presence constitutes a safety hazard for all workmen and raises the question as to whether the post-pour tensioning has been completed (usually at about 10 days after pour).

Post-tension cables not completed

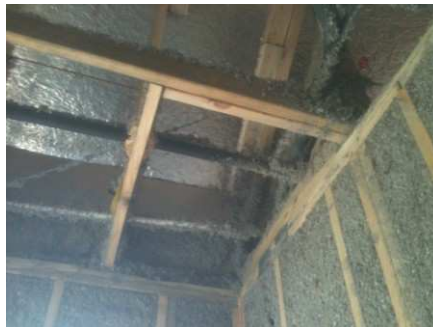
- (4) 'Dead wood' or sheetrock ceiling nailers are needed in the master bathroom closet window wall (two locations – both ceiling corners). There may be missing dead wood above the left side hall bathtub as well.

Dead wood needed in master bath closet

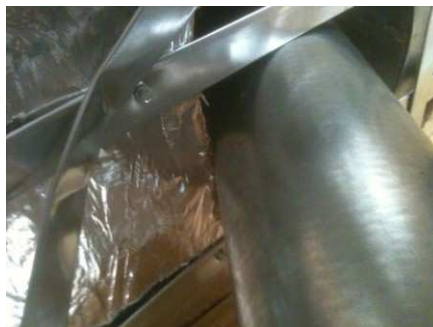
- (5) The heating unit flue vent pipe is touching wood and current standards require that this flue vent pipe be at least one-inch clear of flammables.

Heating unit flue vent pipe touching wood

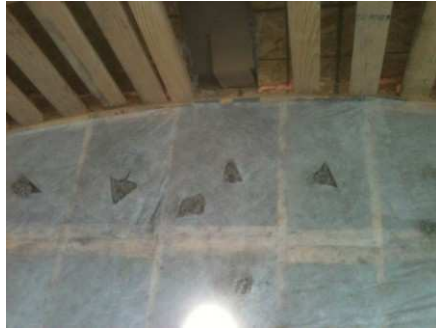
- (6) The top of the cook-top arch may not be completed now that the effective exhaust is side-wall rather than roof-top. See appliance details for further understanding.

Cook-top arch unframed at center of arch

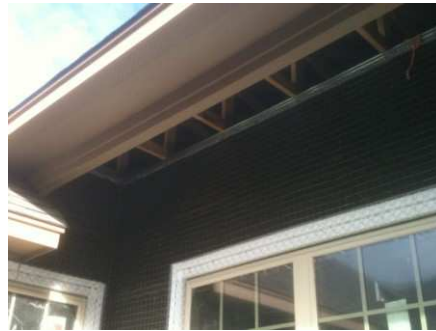
- (7) The soffit above the entry door (courtyard wall) is not complete yet and will be the actual ventilation source for the attic not the current perforated soffit in place.

Incomplete soffit above front door

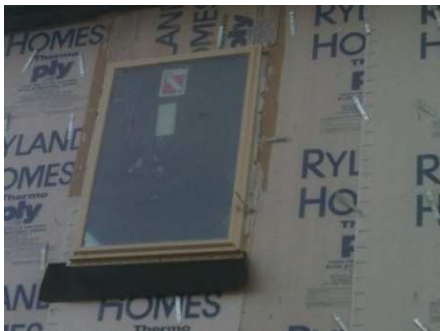
- (8) The window at the rear left corner of the structure has incomplete exterior flashing (fortiflash) and needs to be reviewed and properly completed prior to brick or stone veneer.

Incomplete window flashing rear left corner

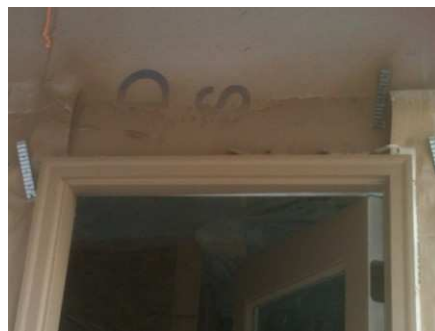
Incomplete flashing at top rear patio door

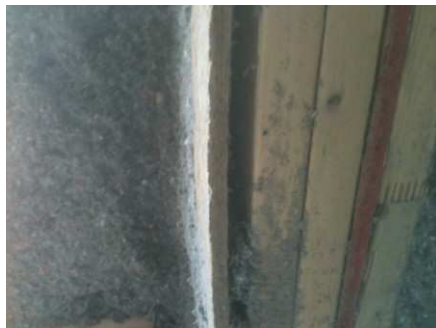
- (9) The breakfast room door also has incomplete flashing at the top of the frame.
- (10) The breakfast room window pop-out feature has a piece of OSB board that is warping on the return of the window (right side of window).

Warped return at breakfast window (OSB)
