# The Uniform Building Inspection Report™

**Single Family Residence:**  
1234 Your Street, Your City, CA 94596

**Inspection Date:**  
8/4/2009, 9:00:00 AM

**Report Number:**  
90804a

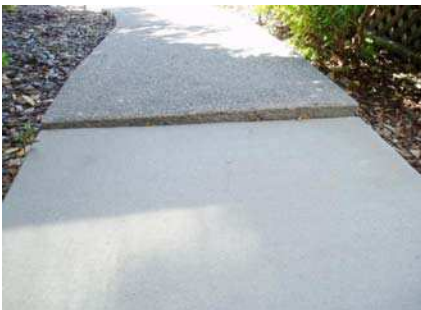
Photo: 0220 (1)

[C] 0220: Trip or safety concern.  
Uneven walkway noted at left side of the structure. Caution advised. The situation or problem could be, or could become, hazardous under certain circumstances.  
See Photo(s) 0220.

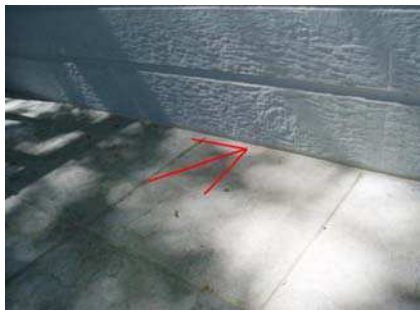
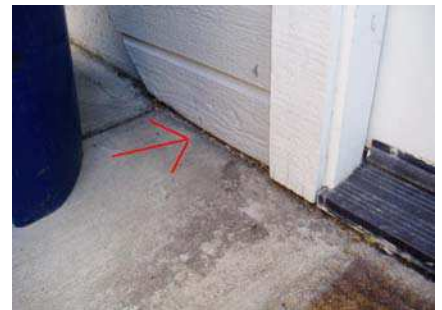
[N] [B] 0240: Entry tile is against pressed wood product siding.  
This type of installation may lead to siding damage

in this area. No damaged noticed at the time of inspection at the visible areas.

The bottom edge of the siding is with less than the recommended distances in places. 2" above pavement and 4" above the ground is recommended. The photo is an example at the right side of the garage along the walkway. Adjustments recommended.  
See Photo(s) 0240.

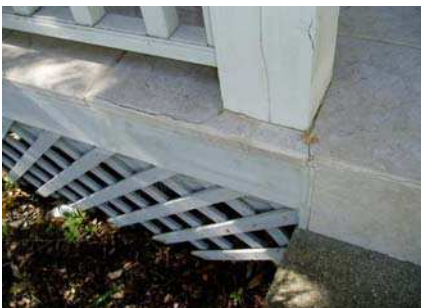
Photo: 0270 (1)

[N] 0270: Wood deck covered with tile.  
Several cracks found in the entry tile and grout. The condition of the wood decking below the tile is not known.  
See Photo(s) 0270.

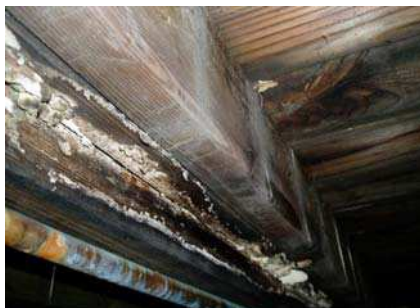
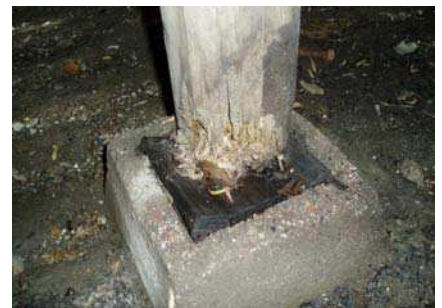
[R] 0270.03: Wood deck deteriorated.  
Noted at a number of areas of the support system. The planks are weathered and loose in places. It is recommended that the finding and all associated components be reviewed and corrected as needed, by a qualified licensed contractor.  
See Photo(s) 0270.03.

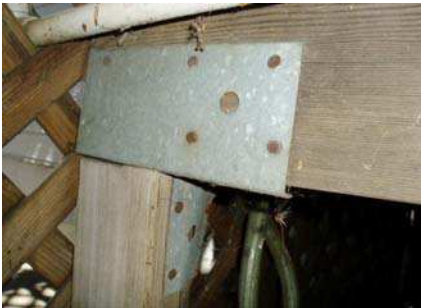
Photo: 0270.04 (1)

[N] 0270.04: Wood deck faulty.  
There is an indication of improper fasteners used at the metal deck framing attachments evident by rusting nail heads. Discretion advised. The

significance of the situation, problem or defect is uncertain. Further study is advised.  
See Photo(s) 0270.04.

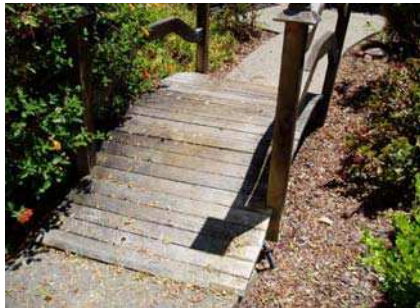
Photo: 0270.10 (1)

[A] 0270.10: Wood walkway damaged.  
Noted at the back bridge. Repair or alteration usually improves component appearance and should decrease deterioration.  
See Photo(s) 0270.10.

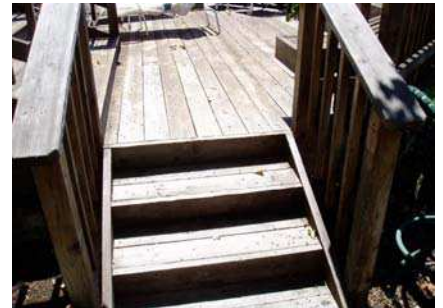
Photo: 0290.02 (1)

[U] 0290.02: Exterior steps handrail improper.  
Recommend installing a grippable handrail at the back stairways. Modification or addition is generally considered an upgrade which may improve safety.  
See Photo(s) 0290.02.

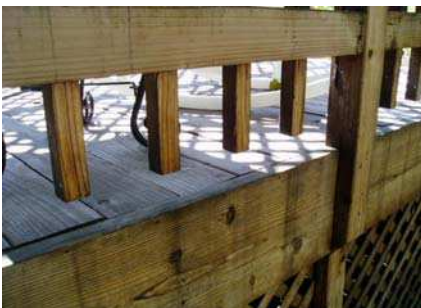
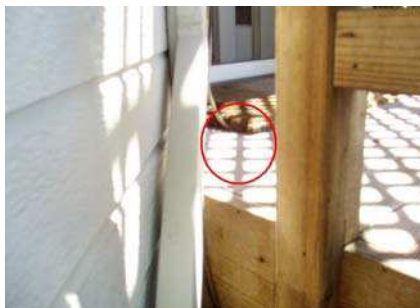
[B] 0290.11: Patio/deck guardrail improper.  
Baluster spacing is more than 4". This is a building standard. Adjustments recommended if conformance is desired. Noted at the back decking.  
See Photo(s) 0290.11.

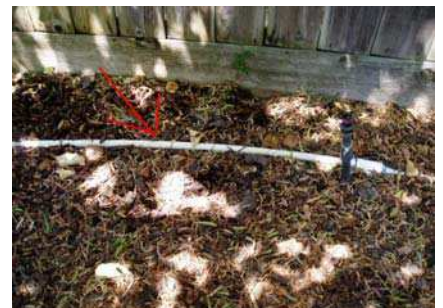
Photo: 0380.03 (1)

[P] 0380.03: Irrigation pipeline unprotected where could be damaged.  
A section of piping is above the ground and exposed to damage. Installing below the ground is recommended. Noted at the back right.  
See Photo(s) 0380.03.

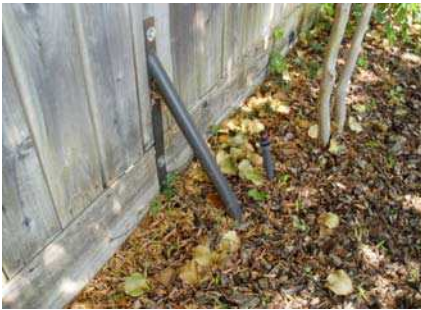
Photo: 0500 (1)

[U] 0500: Fence post(s) loose or broken.  
There is an indication of damaged fence posts evident by the added metal bracing. Be prepared to replace sections of damaged fencing in the near future.  
See Photo(s) 0500.

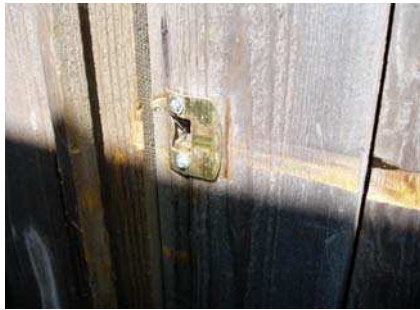
Photo: 0630.02 (1)

[E] 0630.02: Gate(s) not latchable.  
Noted at the right side gate. Repair, alteration or replacement usually improves the efficiency of the component or system.  
See Photo(s) 0630.02.

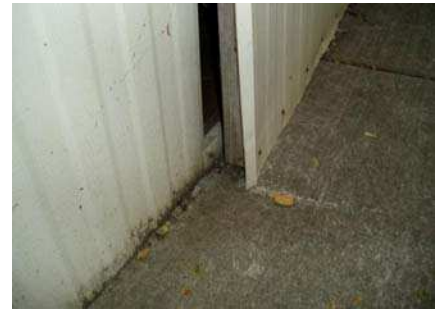
Photo: 0710.01 (1)

[E] 0710.01: Shed in need of repairs and maintenance.  
The door drags on the walkway. Repair, alteration or replacement usually improves the efficiency of the component or system.  
See Photo(s) 0710.01.

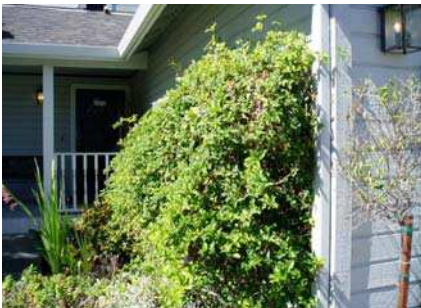
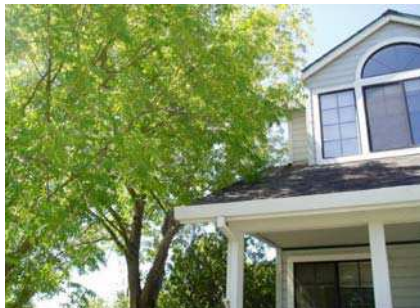
[P] 0860: Tree limb / shrubbery against building.  
Recommend keeping all vegetation from touching the structure. Noted mostly with ivy at the left side of the garage and tree limbs at the left side of the main structure. Correction or modification decreases the probability of excessive deterioration.  
See Photo(s) 0860.

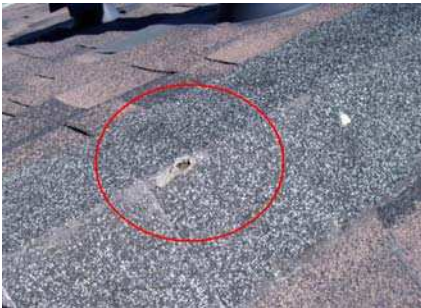
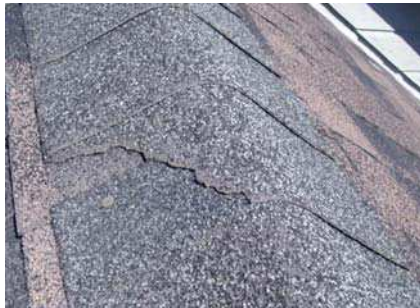
[P] 1000: Roof repairs / general maintenance needed.

Several areas of damage found to roofing in places. The photos are examples. Correction or modification decreases the probability of excessive deterioration.

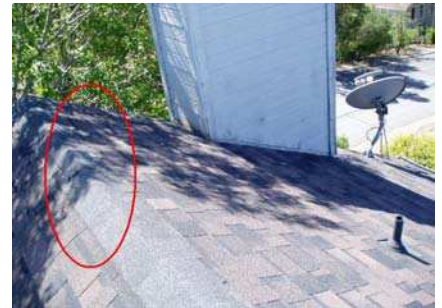
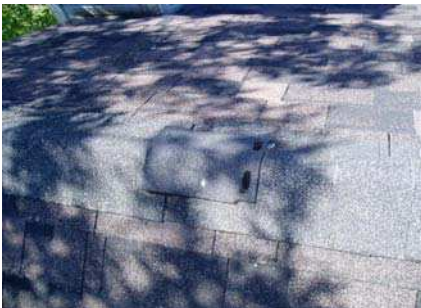
[N] 1070: Patch or other prior repairs noted.

Noted near the ridge area above the chimney. Discretion advised. The significance of the situation, problem or defect is uncertain. Further study is advised.

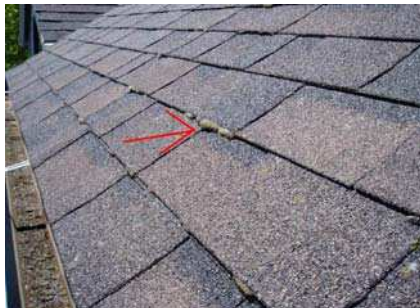
Photo: 1180 (1)

[N] 1180: Moss growth noted on front upper roofing.

Discretion advised. The significance of the situation, problem or defect is uncertain. Further study is advised.

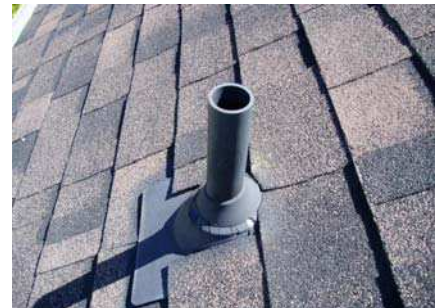
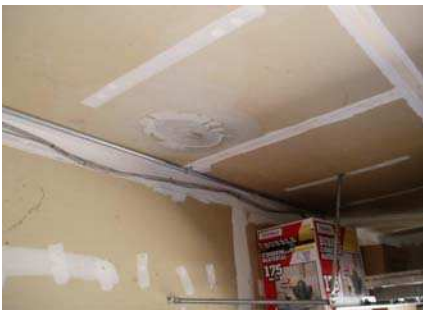
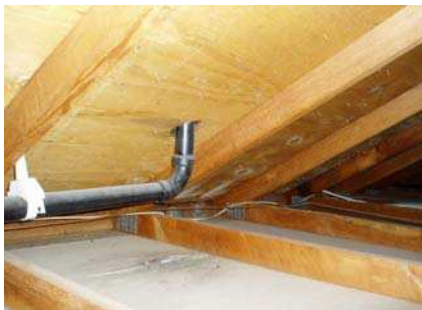
[N] 1200: Seal pipes, vents, and conduits at jack penetrations.

There is an indication of roof leaks evident by the

stains found at the garage ceiling below the right plumbing vent. Further review and repairs recommended.  
See Photo(s) 1200.

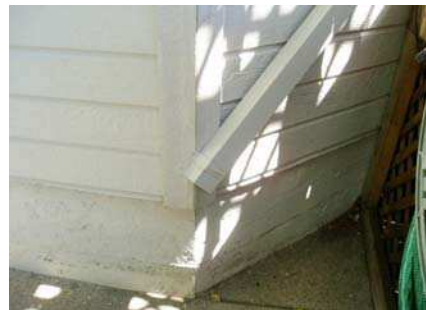
Photo: 1280.13 (1)

[P] 1280.13: Downspout part(s) appear to be missing.  
The diverter piece is missing at the end of the downspout. Recommend extending the downspout pass the bottom edge of the siding. Noted at the back of the structure.  
See Photo(s) 1280.13.

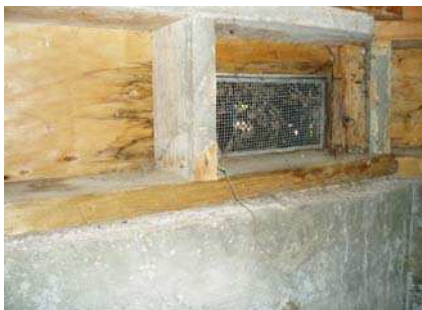
Photo: 1310.02 (1)

[N] 1310.02: Siding sheathing with water stains.  
This was noticed in the sub-area under the kitchen eating area at the left vent opening. Discretion advised. The significance of the situation, problem or defect is uncertain. Further study is advised.  
See Photo(s) 1310.02.

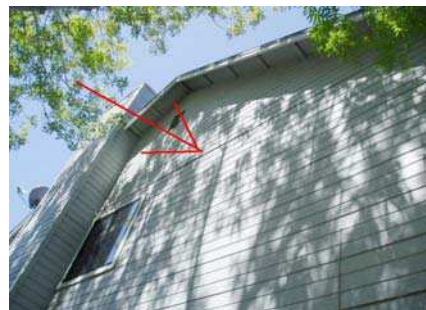
Photo: 1310.04 (1)

[R] 1310.04: Siding damaged.  
Noted at the left side above the upper window. It is recommended that the finding and all associated components be reviewed and corrected as needed, by a qualified licensed contractor.

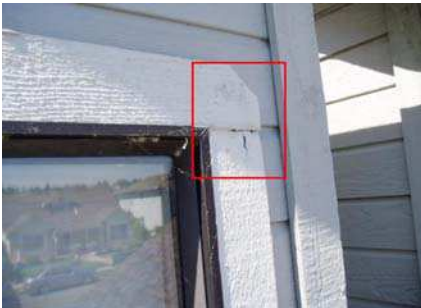
Photo: 1430.12 (1)

[R] 1430.12: Window trim damaged.  
Rotted wood trim noted at the top right corner of the front left upper window. It is recommended that the finding and all associated components be reviewed and corrected as needed, by a qualified licensed contractor.  
See Photo(s) 1430.12.

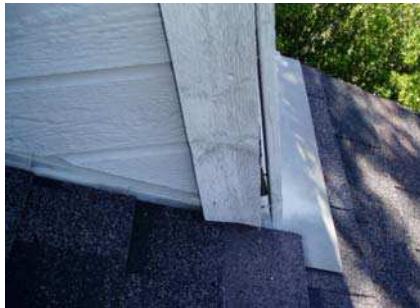
Photo: 1430.21 (1)

[P] 1430.21: Siding trim loose.  
Noted at several locations. The photo is an example at the back right side of the chimney. Securing and sealing is recommended. Correction or modification decreases the probability of excessive deterioration.  
See Photo(s) 1430.21.

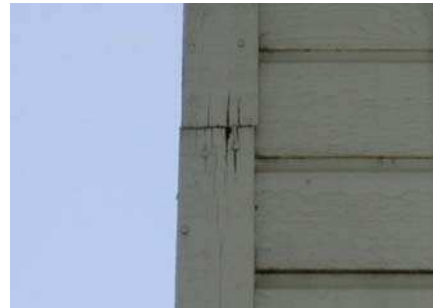
Photo: 1430.22 (1)

[P] 1430.22: Siding trim weathered.  
The photo is an example at the chimney front left below the roof line. Correction or modification decreases the probability of excessive deterioration.  
See Photo(s) 1430.22.

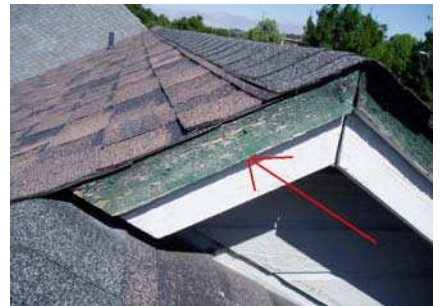
Photo: 1900.02 (2)

[P] 1900.02: Overall painting recommended.  
The photos are examples where the painting is weathered. Correction or modification decreases the probability of excessive deterioration.  
See Photo(s) 1900.02.

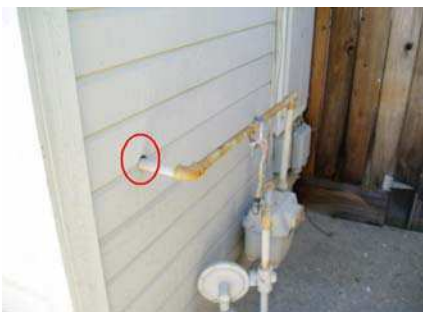
Photo: 1910 (1)

[P] 1910: Caulking, sealing and general repairs to siding / doors / windows needed.  
Small gaps noted at wood trims to stucco junctures in many places. Caulking as needed recommended.

Recommend adding a drip loop to all wires as they enter the structure in places. This will help prevent moisture from entering. Several areas with a questionable drip loop.

Caulking recommended at all exterior light fixtures to stucco along top and sides but not on bottom.  
Correction or modification decreases the probability of excessive deterioration.

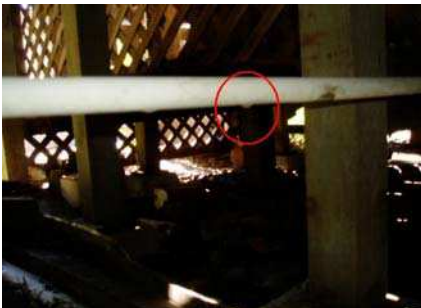
Photo: 4430 (1)

[N] 4430: Water pipes or fittings leaking.

There is an indication of a water leak evident by water along the bottom of the pipe. Noted on the plastic pipe under the back deck. The exact

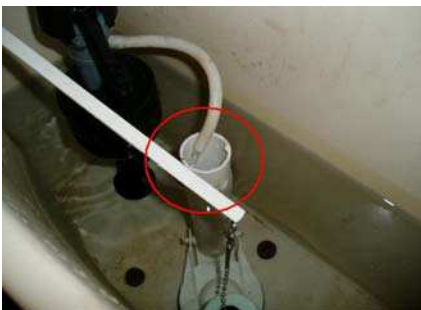
Photo: 4650 (1)

[U] 4650: Supply / waste cross connection potential noted. Recommend installing a device for the toilet fill tube to be 1" above the water fill line. Noted at downstairs and upstairs hall toilet tanks. Modification or addition is generally considered an upgrade which may improve safety or efficiency. See Photo(s) 4650.

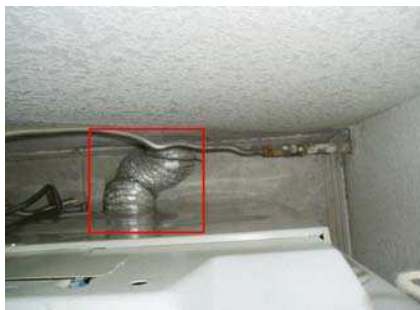
Photo: 4810.21 (1)

[U] 4810.21: Dryer vent improper. A foil flex vent is in use between the dryer and the wall connection. Recommend venting the dryer using a metal flex vent. See Photo(s) 4810.21.

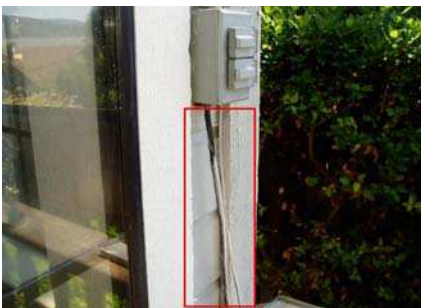
Photo: 5370.06 (1)

[B] 5370.06: Use or placement of flexible cord questionable. Noted at the back deck lighting and paddle fan where the cord is plugged into the outlet. Adjustments recommended. See Photo(s) 5370.06.

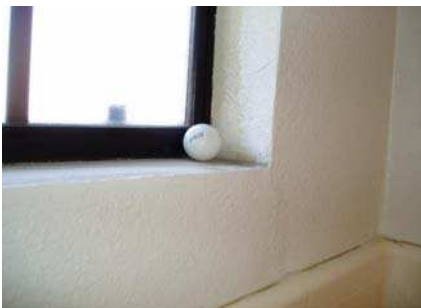
Photo: 6880 (1)

Noted at the upstairs hall bath. Correction or modification decreases the probability of excessive deterioration.

See Photo(s) 6880.

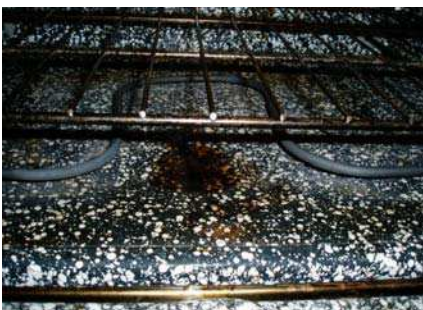
Photo: 8050 (1)

[A] 8050: Oven needs cleaning. See Photo(s)

8050.
