**Re: GE-Pittsfield/Housatonic River Site  
East Street Area 2-South (GEC150)  
Summary of September 2010 Inspection Activities – City Recreational Area**

GENERAL ELECTRIC COMPANY  
 PITTSFIELD, MASSACHUSETTS  
**FINAL COMPLETION REPORT FOR THE  
 CITY RECREATIONAL AREA**

**INSPECTION SUMMARY AND CHECKLIST  
CITY RECREATIONAL AREA**

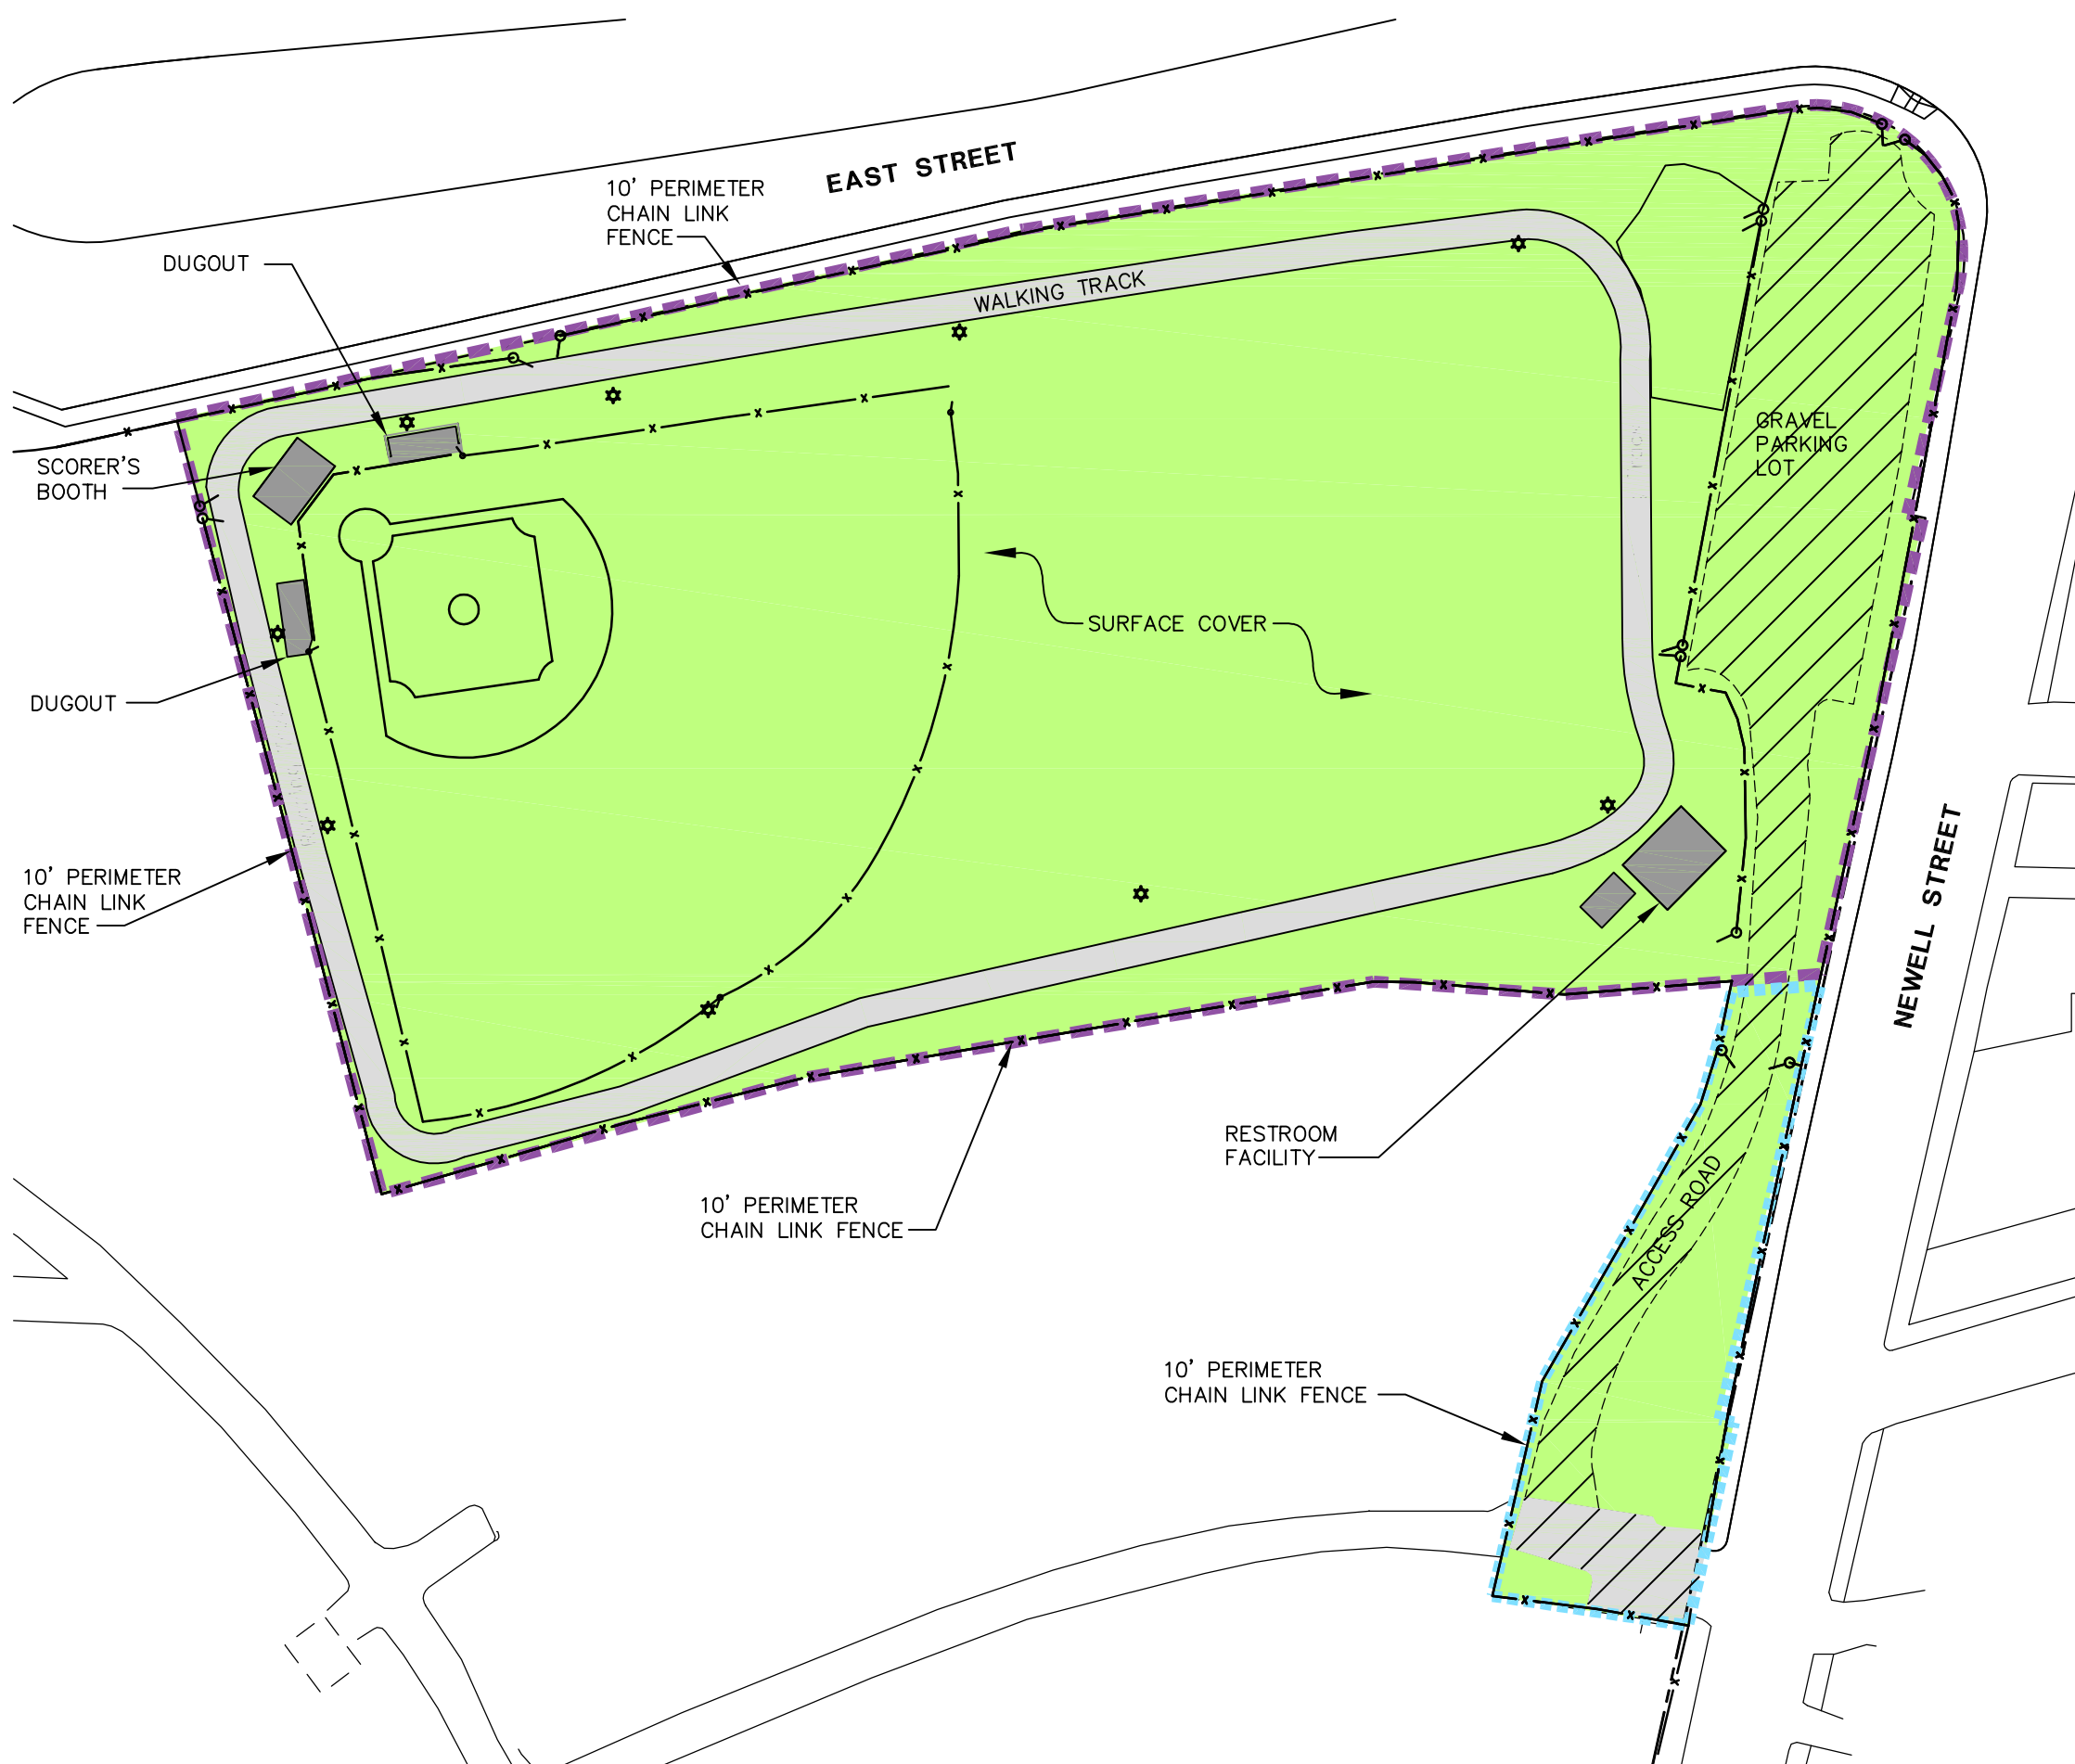
FIGURE  
**3**

The September 2010 inspection was performed in accordance with the Post-Removal Site Control requirements specified in the *Final Completion Report for the City Recreational Area* (Final Completion Report), which was submitted to EPA on July 31, 2008 and approved by EPA on August 27, 2008. This inspection included observations of the soil cover and the perimeter fencing, as shown on Figure 3 of the Final Completion Report, a copy of which is attached hereto.
