Report # 11-6025

Date: 6/2/2011

BUILDING INSPECTION REPORT
(Residential)

Description: Single Family Residence
Building faces: East

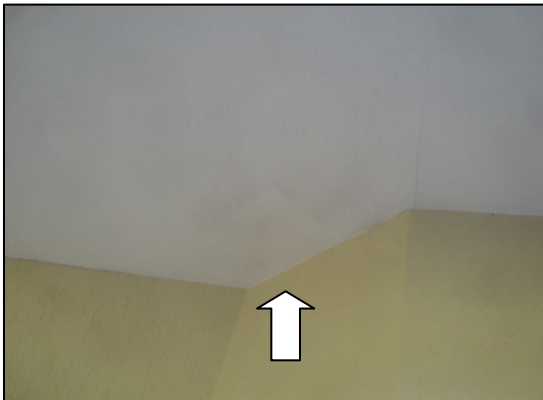
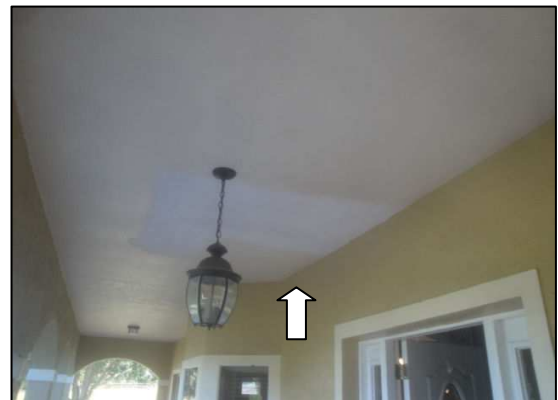
Front porch ceiling has unfinished repair patches from roof leakage. Requires drywall repair.

Evidence of prior leakage is present in the form of tarred in flashing around front and right side of porch roof. Water damaged ceiling is below.

ceiling damage on front porch requiring repair/finish work

Recommend water testing to ensure leak is not active and repair appropriately.

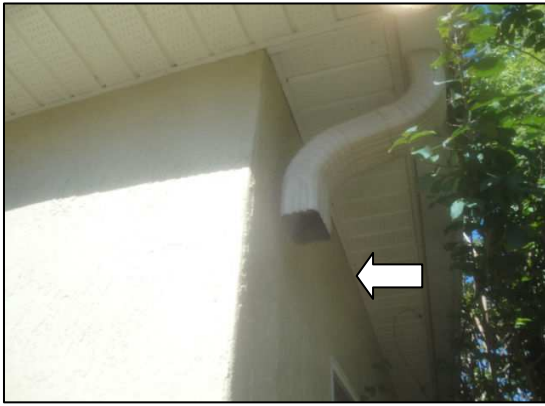
Gutter at rear is not installed. Requires repair.

gutter not installed

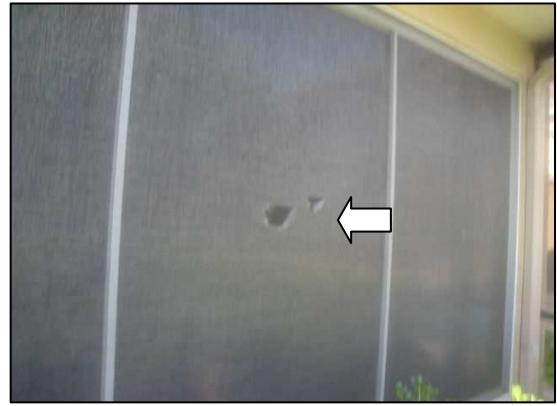
Rear porch has torn screen and window panels, requires repair.

torn panels

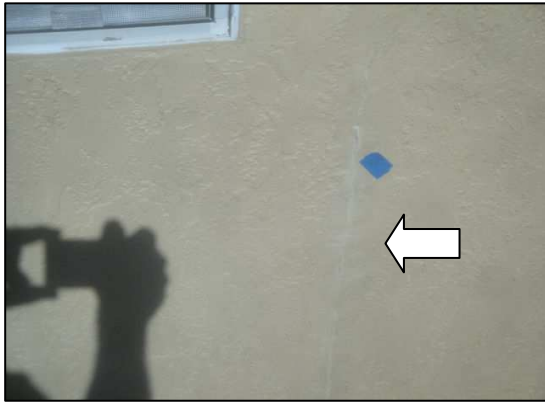
Crack is present at rear requires sealing.

crack requiring sealing

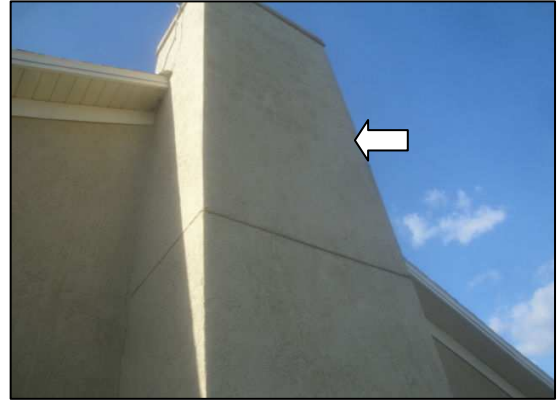
Crack at upper area of chimney exhibits loose stucco. Requires stucco repair.

loose stucco requiring repair

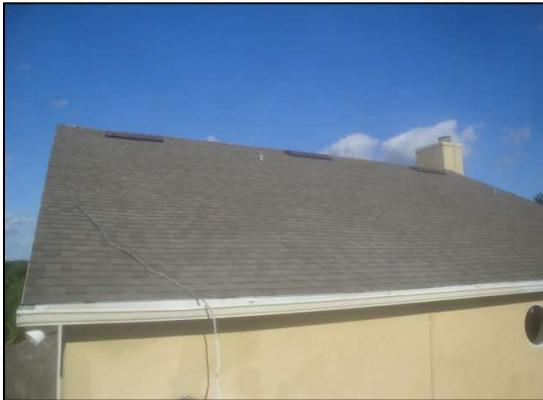
Roof is in serviceable condition, with wear indicative of its age. Roof appears to be original. Life expectancy is approximately 10 years.

shingles in fair condition

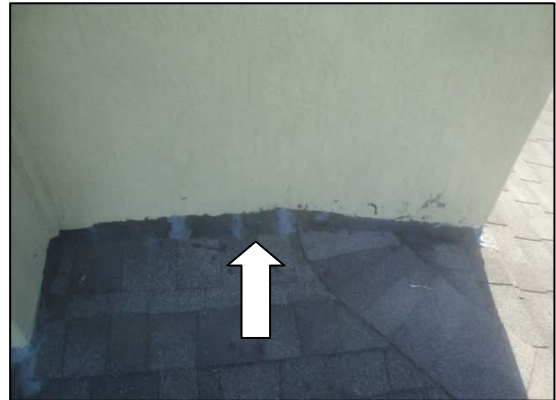
tarred in flashing

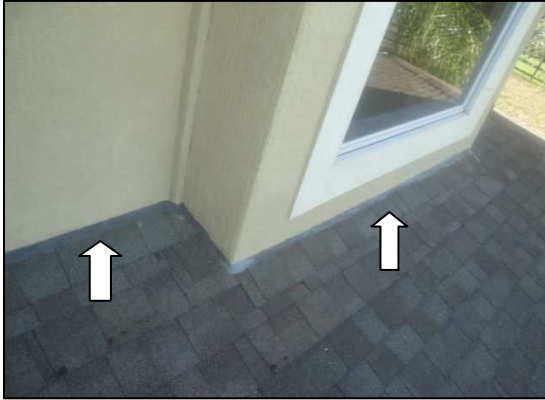
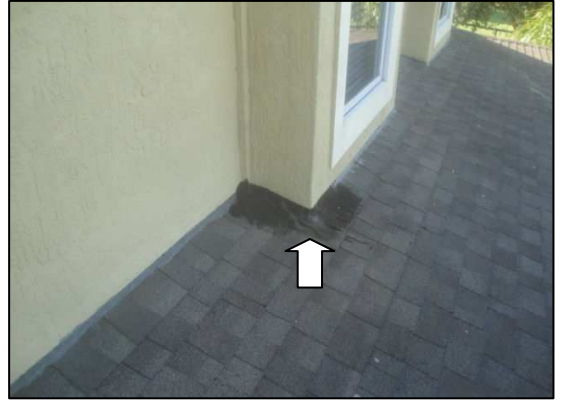
tarred in flashig

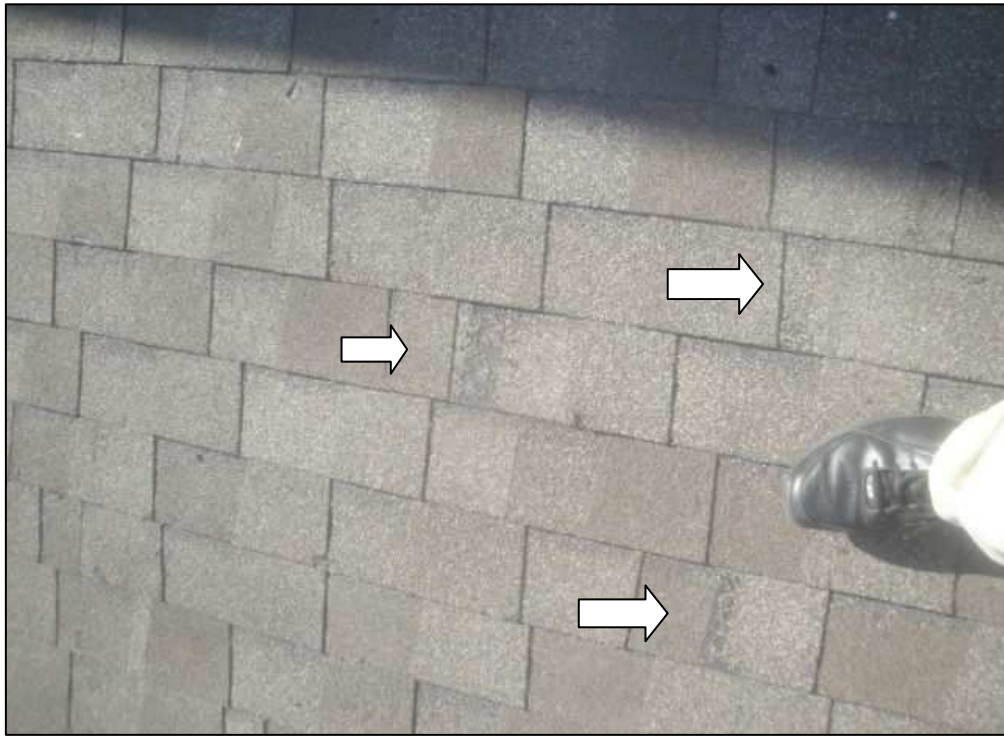
example of wear on shingles

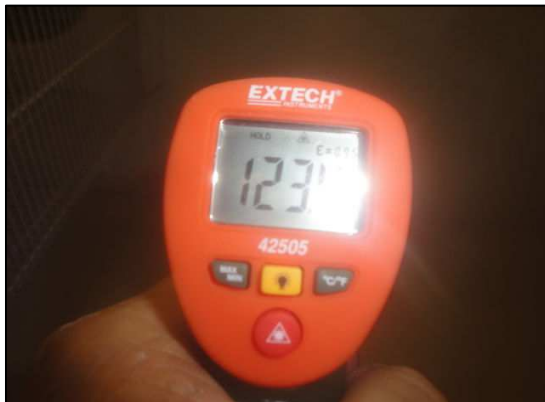
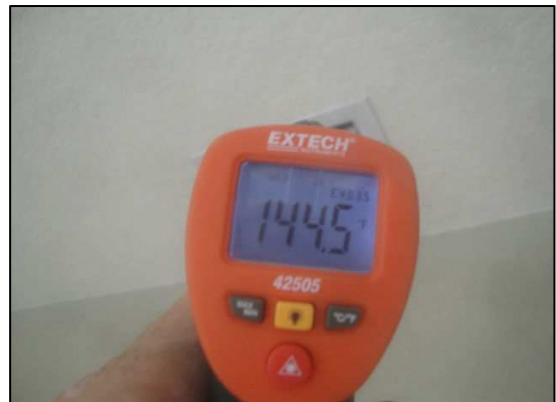
Upper system did exhibit a minimum 15 degree temperature differential in both heat and cool mode.

Lower system did exhibit a minimum 15 degree temperature differential in heat mode but did NOT in cool mode. Requires further investigation/repair.

temperatures recorded during heat mode

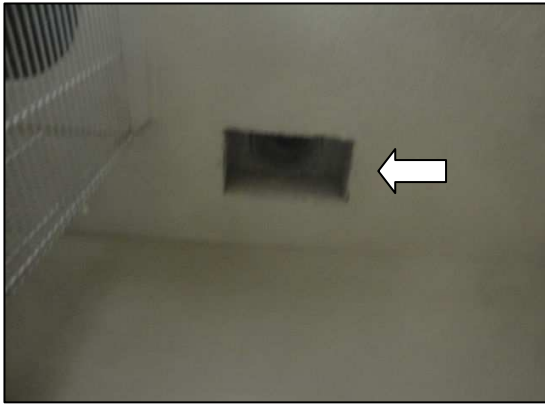
Supply grill is missing in utility room. Requires installation.

missing grill cover

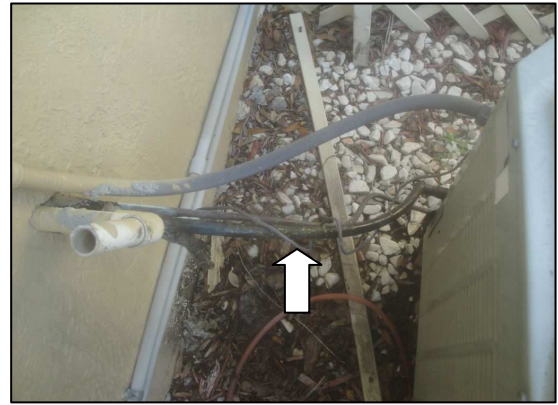
Freon lines are not insulated, requires repair.

missing suction line insulation

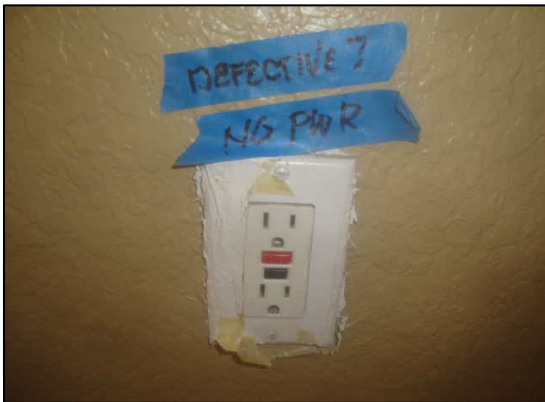
Gfci receptacle in garage will not reset. Requires further investigation/repair.

gfcı will not reset

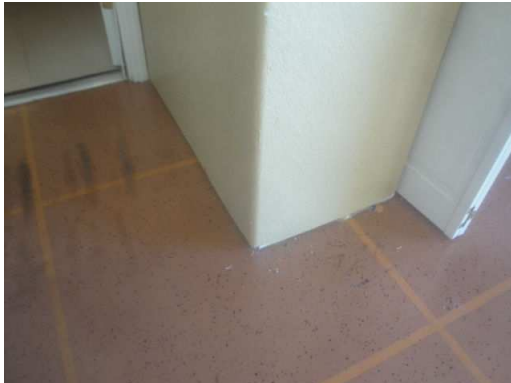
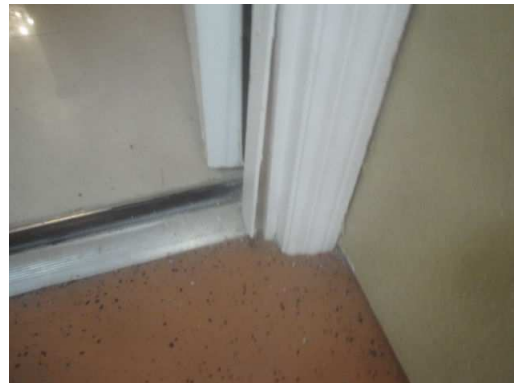
Baseboards are missing at right side of garage.

missing baseboards

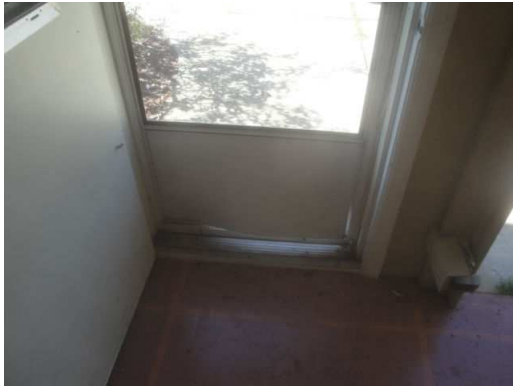
Storm door at garage is damaged.

damaged storm door

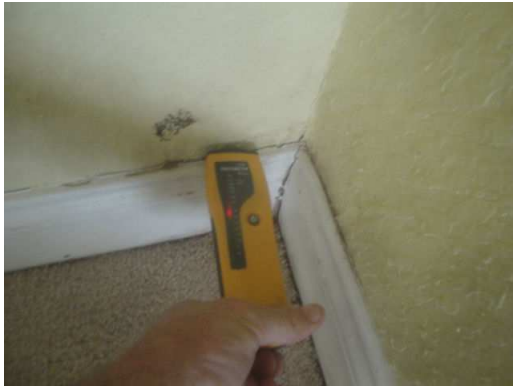
Wall intrusion is present at corner in guest room. Moisture meter did indicate moisture in wall. Mold is present at wall. Requires further investigation to find source of leakage and mold remediation in this area.

water intrusion/mold

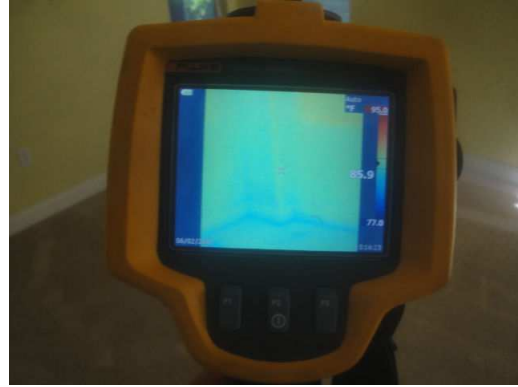
water intrusion at base

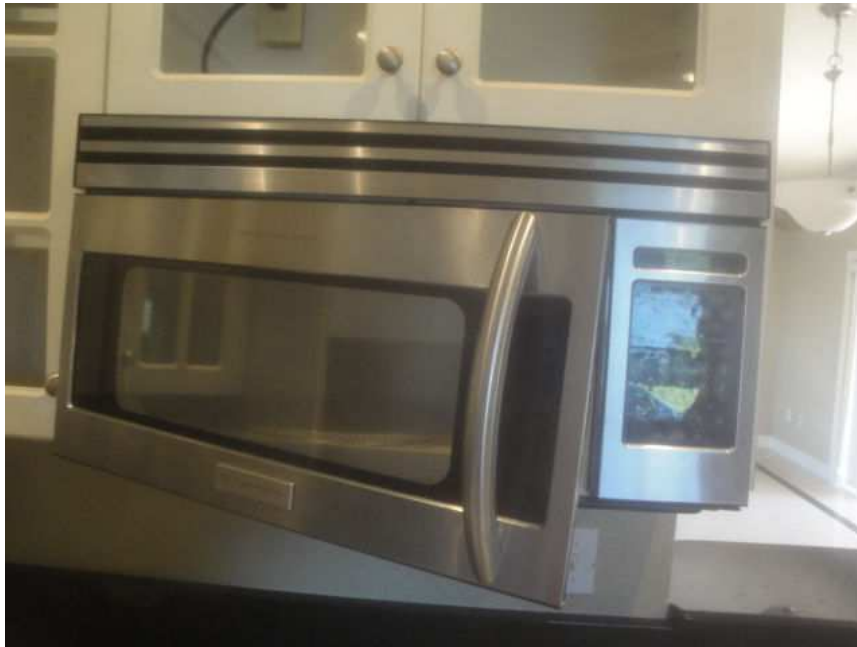
Microwave door is damaged. Requires replacement.

damaged microwave door

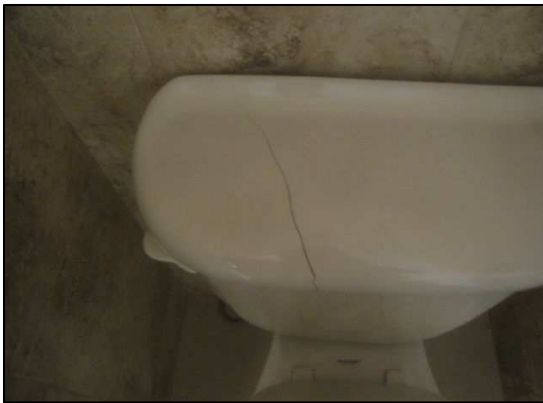
Water closet has broken lid / missing lid. Requires repair.

broken lid

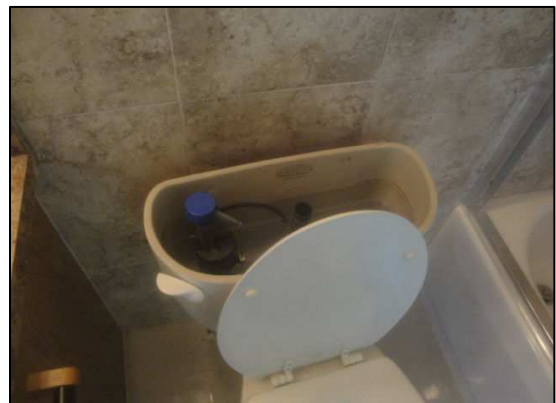
missing lid

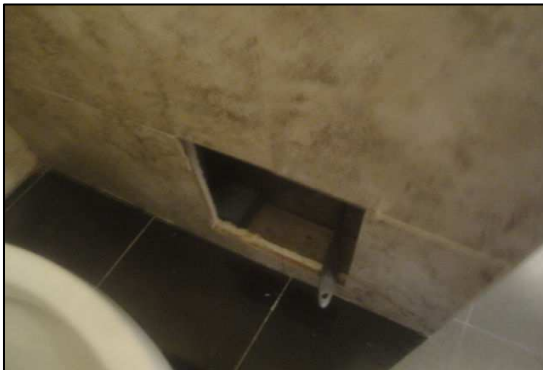
Access door is missing at jecuzzi in master bath. Requires installation.

missing acces cover panel

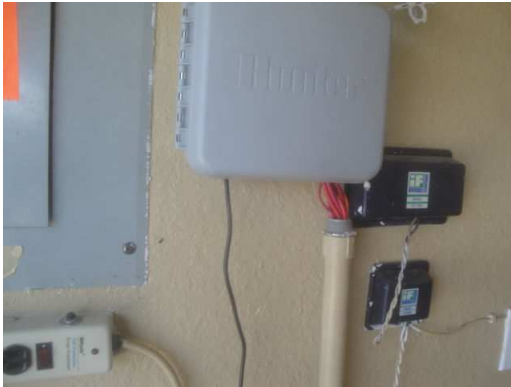
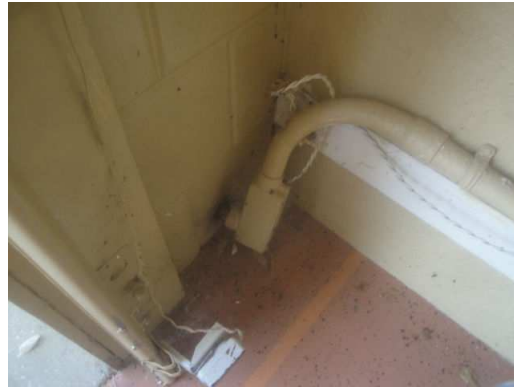
Irrigation system could not be operated due to dead receptacle at control panel.

conduit loose at control panel and wall

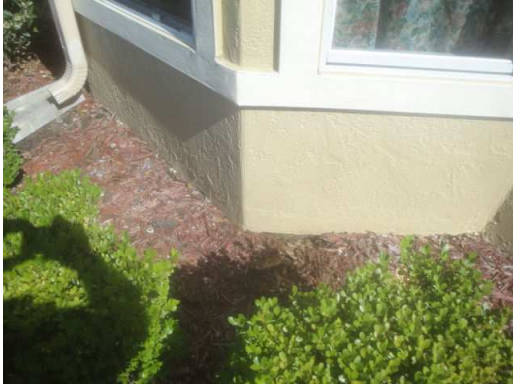
Soil is above grade at right side and rear perimeter. Recommend removal of soil above grade exposing foundation. Soil above grade is a condusive climate subterranean termite intrusion.

soil below grade

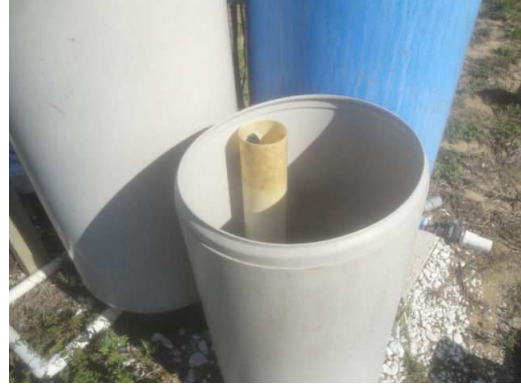
Covers are required at brine tank and chlorinator tank.

missing covers

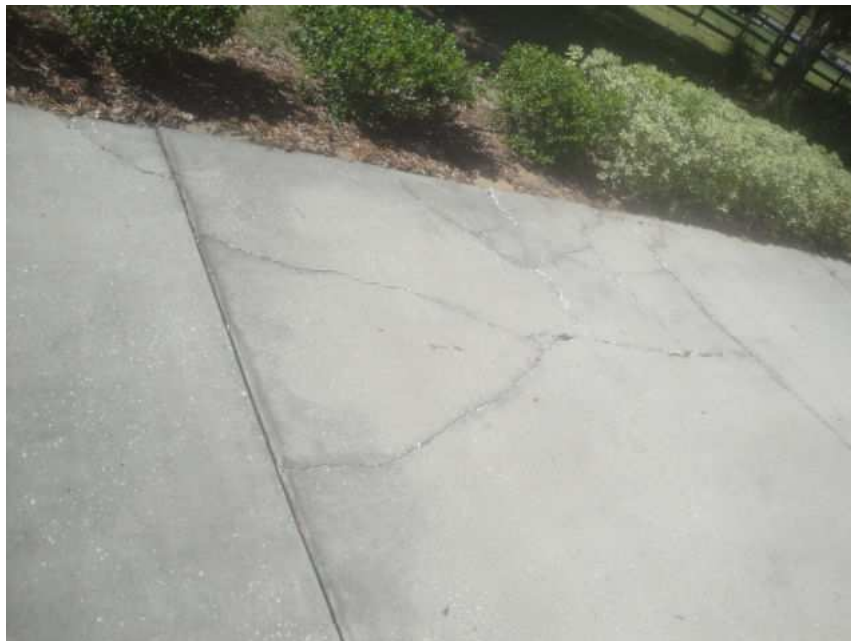
Several areas of driveway requires repouring.

area requiring repouring

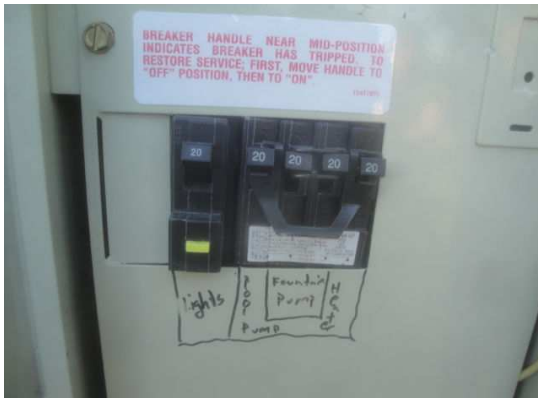
Heater does not have its own breaker. Requires repair.

pool heater not on separate breaker

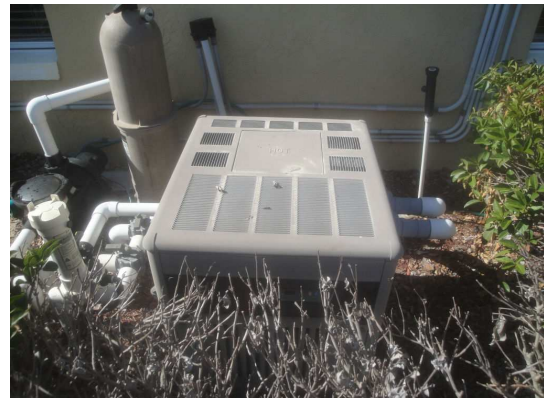
Heater did not operate. Requires further investigation/repair.

pool heater did not operate

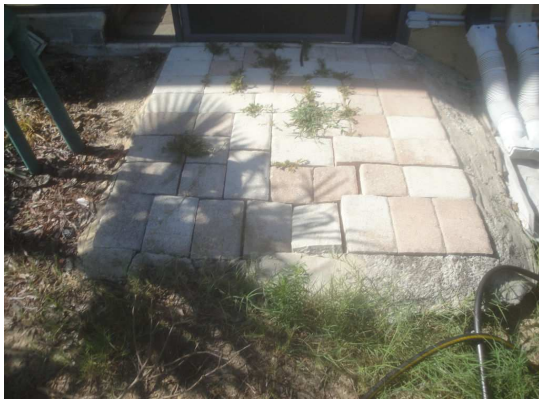
Several areas of brick pavers have settled. Requires repair.

brick pavers settling

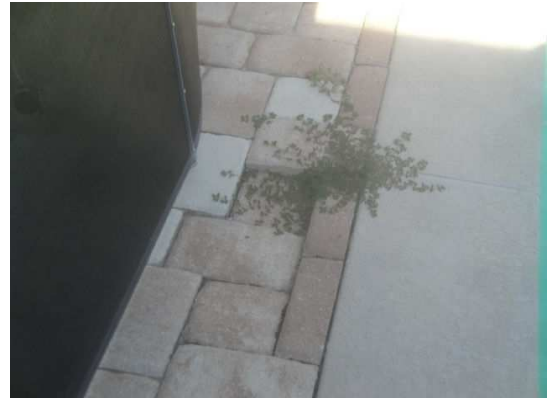
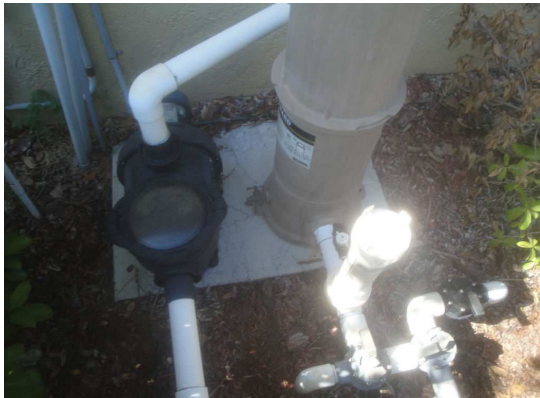
Seal around basket strainer of pump is leaky. Requires new O ring.

leaky seal at pump

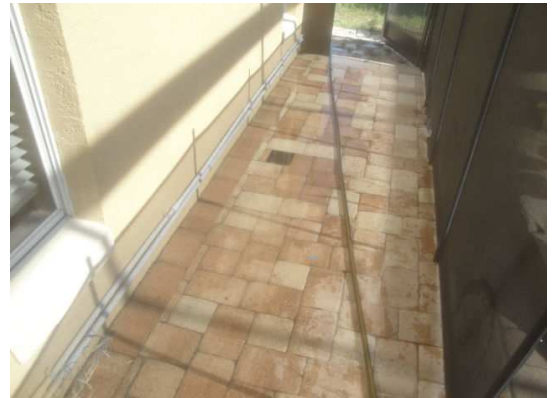
French drain at left front did not perform well. Requires further investigation/repair.

drain does not perform well

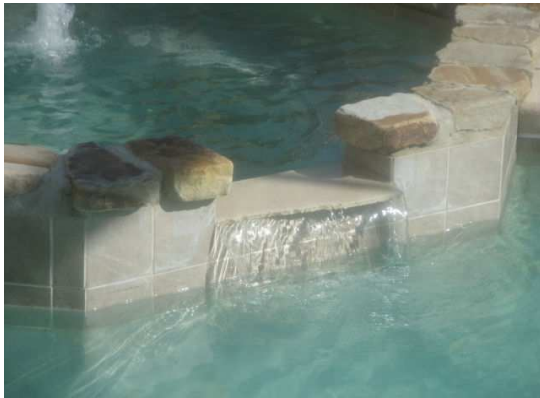
Sill plate on jecuzzi is broken leaving sharp edges. Requires repair.

broken sill plate
