MANDATORY SERVICE BULLETIN

NO. MSB-42-031/1

Inspection and repair of MLG brace rib.

WI-MSB-42-031

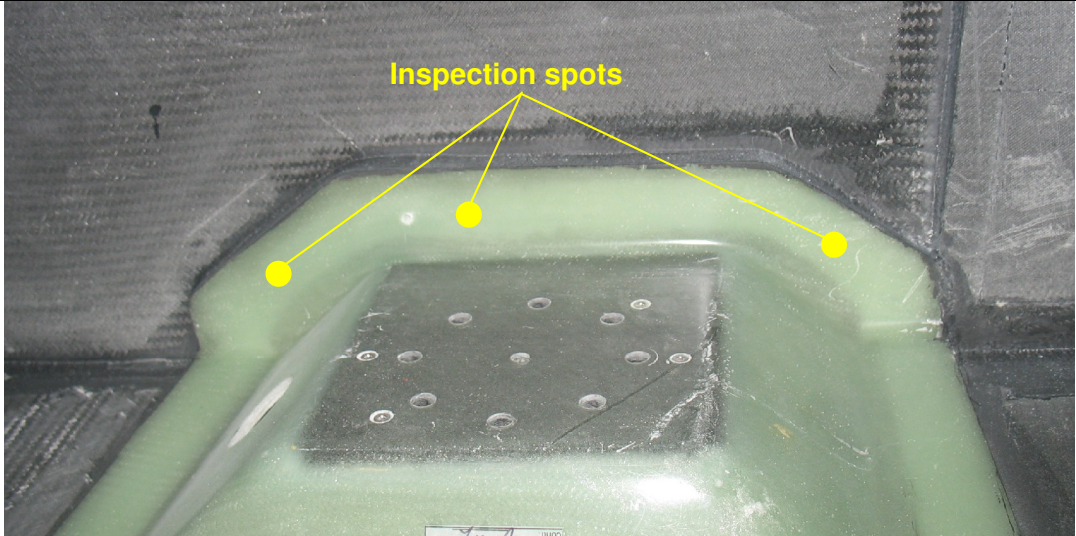
10. At the locations specified in the picture below (3 each side) carefully drill holes with a diameter of 4 mm (0.157", gauge 22 drill bit) and observe the following resistance behavior:

A) The drilling resistance develops as follows:

- a. The resistance is high due to the glass fiber laminate of the drag brace attachment rib.
- b. The resistance decreases due to the bonding paste.
- c. The resistance increases significantly due to the carbon fiber laminate of the upper shell of the center wing section.

B) The drilling resistance develops as follows:

- a. The resistance is high due to the glass fiber laminate of the drag brace attachment rib
- b. The resistance decreases due to the bonding paste
- c. The resistance first decreases significantly and then the drill hits the hard surface of the upper shell of the center wing section.

<p>LH side shown, RH side laterally reversed. (Brace pedestal not shown for clarity)</p>
11.	Remove the drill.
12.	<p>Inspect the hole and note one of the following conditions:</p> <p>A) The bottom of the drilled hole has the same color as the bonding paste</p> <p>B) The bottom of the drilled hole is black and glossy</p>
13.	<p>If in one of the inspection spots of items 10 and 12 the result B is detected proceed with item 14.</p> <p>Otherwise no repair is required. Fill inspection drill holes with bonding paste and proceed with item 21.</p>
14.	<p>Test fit repair ribs into place and mark out bonding area on both sides. Refer to drawing D60-5710-03-00RÄM and the labels on the repair brackets to identify the parts and the matching locations.</p>

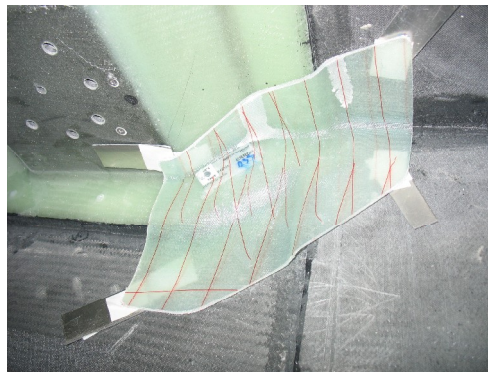
Picture for clarity only; do not extend the spacers too deep into bonding area

16. Drill a 2 mm (0.079", gauge 47) hole in the bonding flange of the faulty rib on both sides. Use the prepared repair ribs as a template. Use the 1.5 mm (0.059") spacers to account for the bonding paste (thickened resin) gap.

CAUTION: Measure thickness of the faulty bonding flange prior drilling of the holes. Do not damage the center wing shell sandwich!
