HARTZELL PROPELLER INC.
ALERT SERVICE BULLETIN
TRANSMITTAL SHEET
HC-ASB-61-313
Propeller - Counterweight Slug Bolt Inspection

July 15, 2009

HC-ASB-61-313

Propeller - Counterweight Slug Bolt Inspection

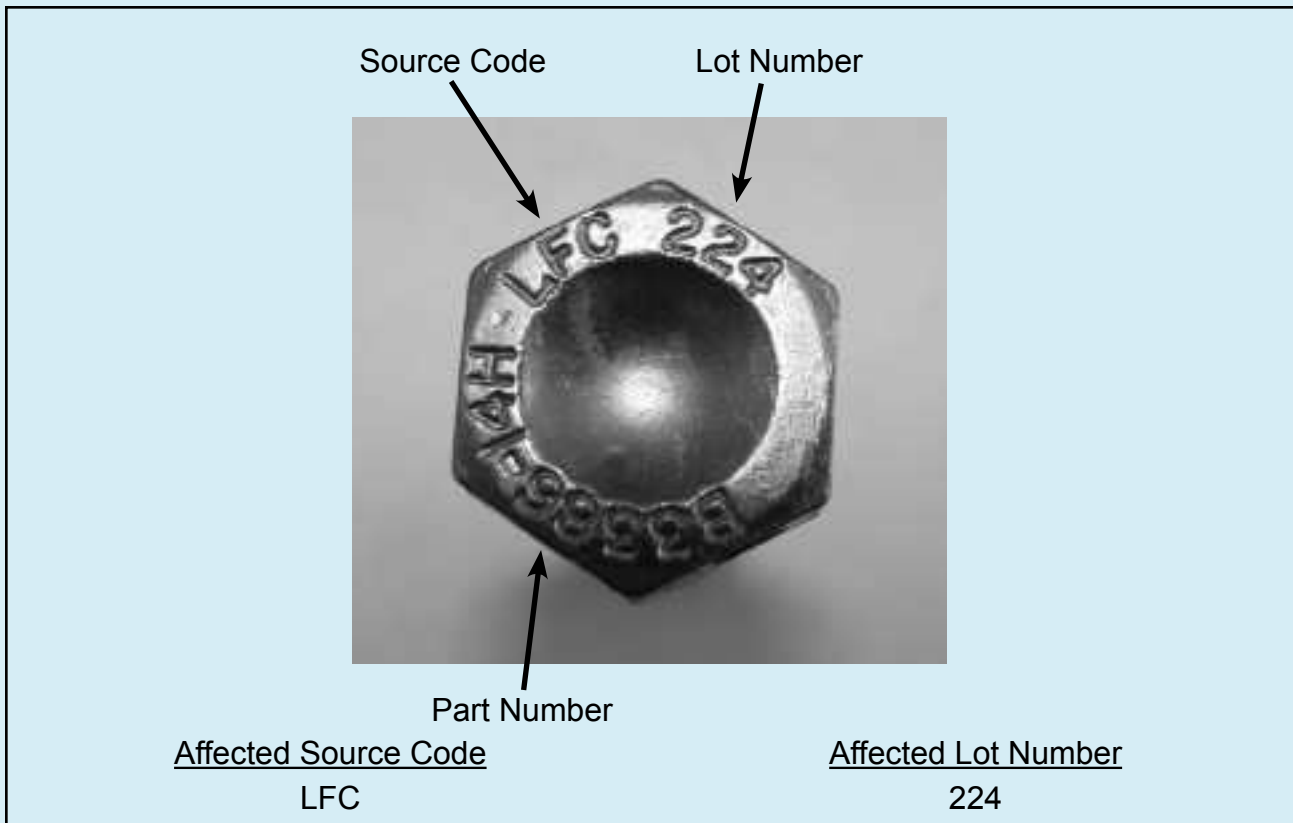
Counterweight Slug Attachment Bolt Identification
Figure 1

- (a) Locate the counterweight slug attachment bolts. Refer to Figure 2.
- (b) Inspect each B-3386-14H counterweight slug attachment bolt on the propeller for the affected LFC manufacturing lot. Refer to Figure 1.
 - 1 Bolts marked from another source code or lot number other than 224 are not affected by this Alert Service Bulletin.
 - 2 If only one counterweight slug attachment bolt on a counterweight slug is from the affected LFC manufacturing lot 224, both bolts may require replacement.
 - 3 Visually inspect all LFC manufacturing lot 224 counterweight slug attachment bolts for the following obvious signs of failure:

- (1) Inspect each B-3386-14H counterweight slug attachment bolt for the affected LFC manufacturing lot number. See Figure 1.
 - (a) Bolts marked from another source code or lot number other than 224 are not affected by this Alert Service Bulletin.
- (2) Immediately quarantine all affected bolts.

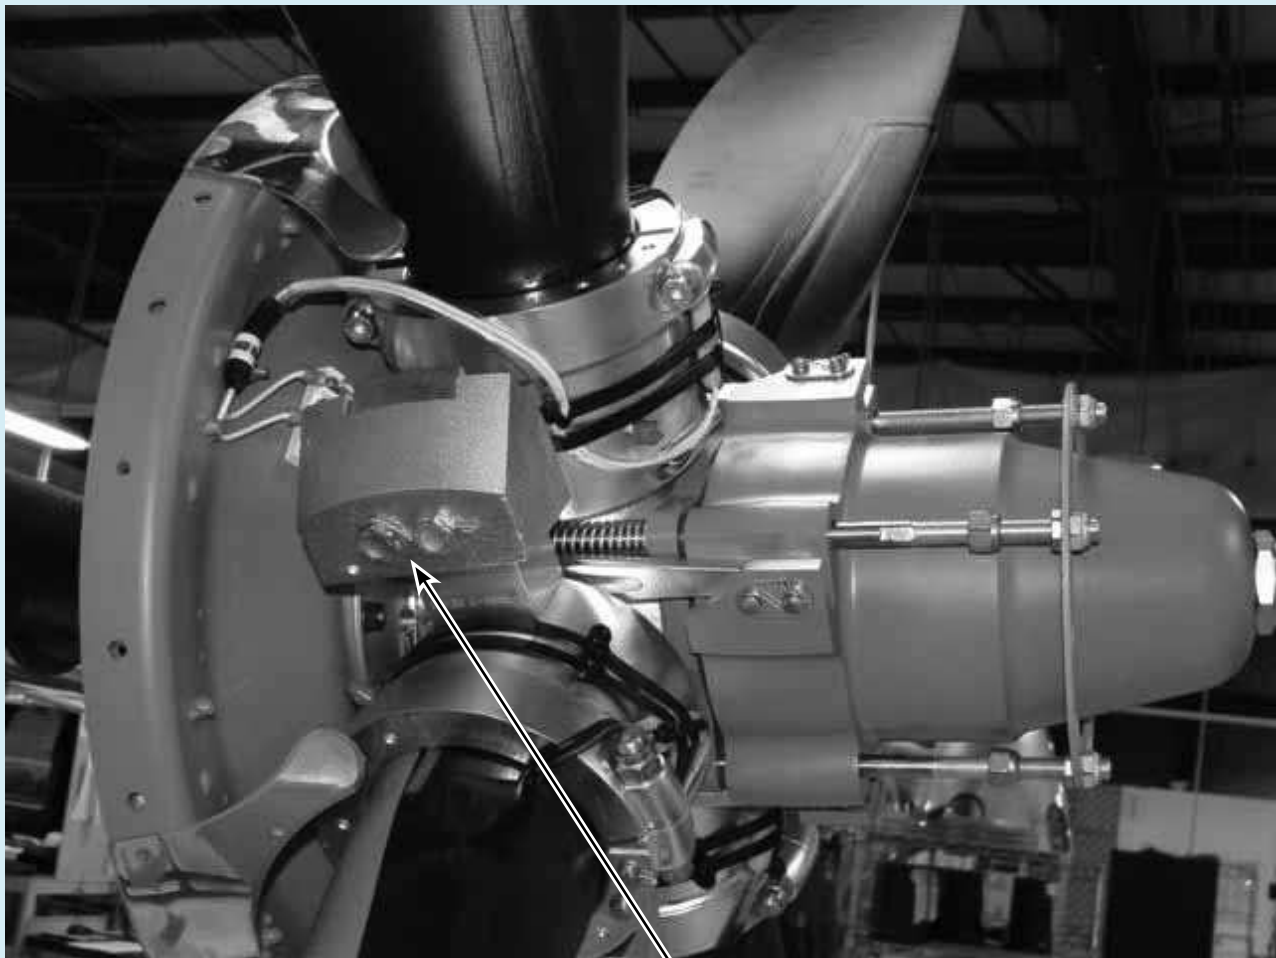
Figure 2

- a An obviously bent shaft.
- b Any obvious cracking.
- c The head of the bolt is separated from the shaft.

Inspect B-3386-14H bolts in this location
on each blade (two bolts per blade)

- a Both counterweight slug attachment bolts on the slug must be replaced as affected bolts in accordance with the Bolt Replacement section in these Accomplishment Instructions.
