CERTIFIED BUILDING INSPECTORS

HOME INSPECTION REPORT

**123 Sample St.
Orlando, FL 32888**

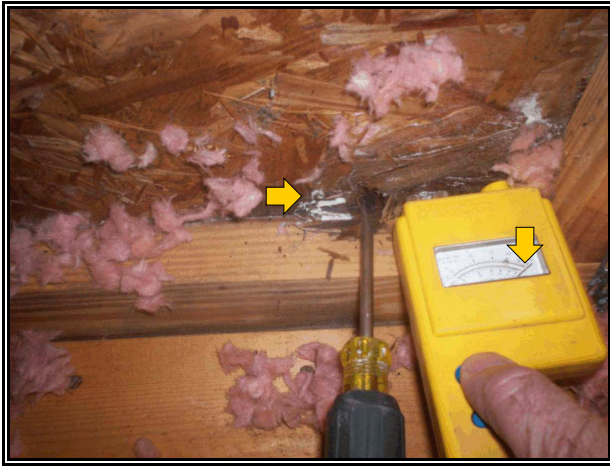
1. The damage by wood decay fungi as follows;
 - * sections at the base of the siding of the right gable end as seen in the attic, (See photos 1 and 2.)

Photo 1- Wood decay and increased moisture at the base of the right gable end siding in the attic.

Wood decay fungi or rot damage to wood members was observed as identified in the Synopsis also. These conditions should be corrected as needed before closing on the home.

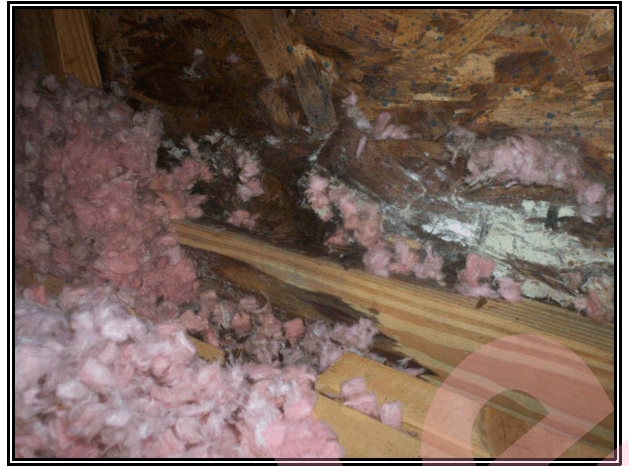
2. Moisture intrusion into the home as evidenced by the moisture staining and increased moisture levels detected with a moisture meter at;
 - * the right side wall toward the rear of the front bedroom and behind the right wall of the hall bath shower where water is entering at the seam at the base of the right side gable end wall, (Again, see photos 1, 2 and 4.)

Photo 2- Another decayed section of the right gable end siding above the hall bath wall below.

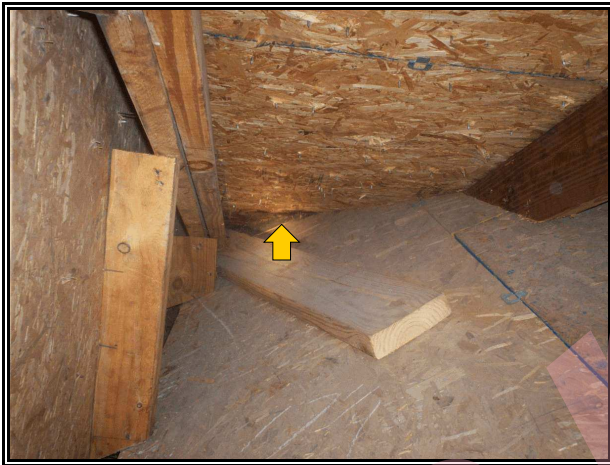
- * a section of the roof sheathing at the base of the valley to the right rear of the garage, (See photo 3.)
 - * the base of the jambs of the front entry door,

Photo 3- Wood decay at a section of roof sheathing below the base of the valley right of the garage.

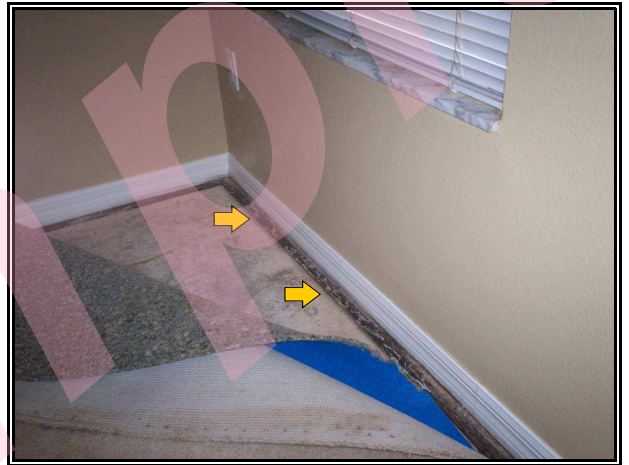
- * sections of the carpet tack strip at;
 - the base of the right wall of the right front bedroom below and to the rear of the window, (See photo 4.)
 - the base of the wall below the right jamb of the window assembly to the front of the living room. (See photo 5.)

Photo 4- Decay damaged section of the moist tack strip in the right front bedroom.

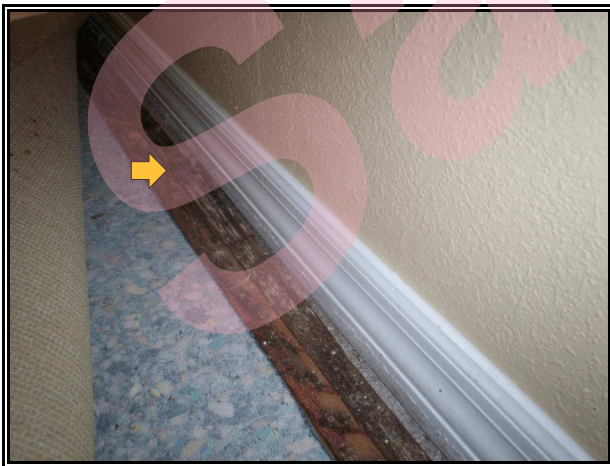
Photo 5- Decay damaged and slightly damp carpet tack strip at the front of the living room.

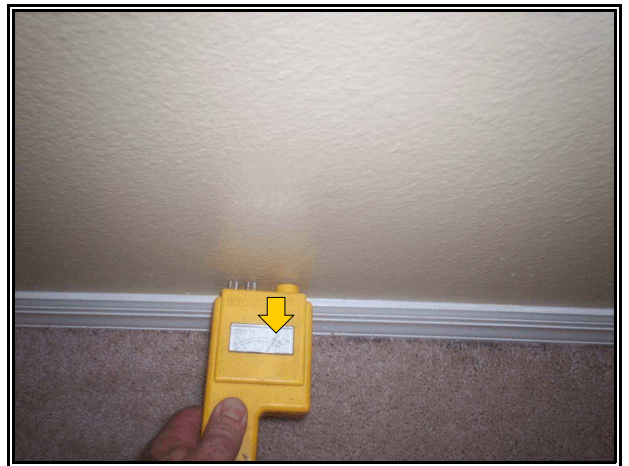
- * below the window at the front of the dining room, (See photo 6.)
 - * below the window at the front of the living room, (Again, see photo 5.)
 - * at the base of the right jamb of the rear sliding glass door assembly.
3. Pests entering the attic space at the displaced soffit segment at the right end of the eave to the right of the front door. (See photo 7.)
4. With the rain gutters;
 - * loose down spout segments at the left front corner of the house (see photo 8) and at the right side of the house,
 - * the right end of the run above the living room windows is disconnected and hanging down, (See photo 9.)

Photo 6- Increased moisture at the wall below the dining room window. The tack strip below is stained as well.

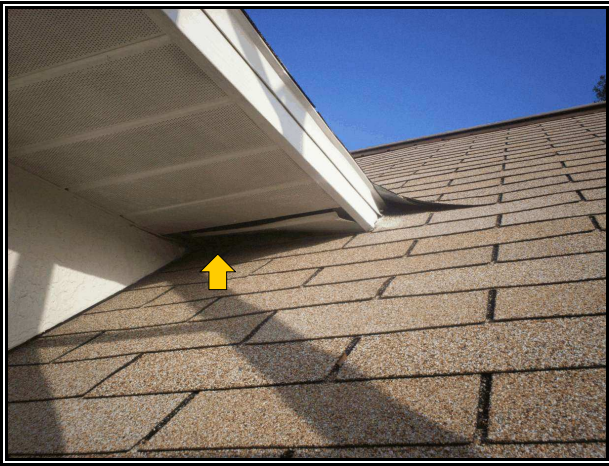
In the attic we did see indication of rodent activity as evidenced by the presence of "trails" in the insulation and "droppings". The pests appear to be entering at the displaced soffit segment identified in the Synopsis. There may be other entry points as well. We recommend that you refer this matter to a pest control company for evaluation and treatment as needed. Also, live ants were seen below the carpet at the base of the right jamb of the rear sliding glass door and below the carpet at the left rear corner of the master bedroom. You may want to have the pest control company assess this issue also.

Photo 7- The displaced soffit cladding allow pest entry to the attic.

We did detect pest entry at the front of the attic at the displaced soffit segment identified in the Synopsis. This opening should be sealed to eliminate this access.

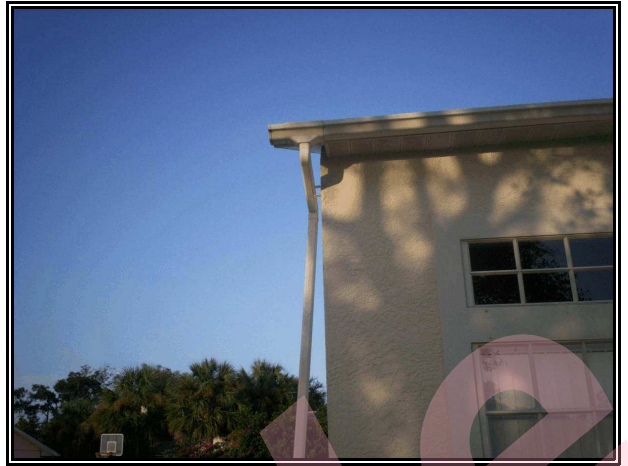
Photo 8- The loose rain gutter down spout at the left front corner of the house.

The valleys, vent stacks, flashings, drip edge and other roof penetrations were also checked. The faults with the rain gutters were detected as noted in the Synopsis. These should be addressed as needed. Otherwise, we detected no abnormal conditions with these features.

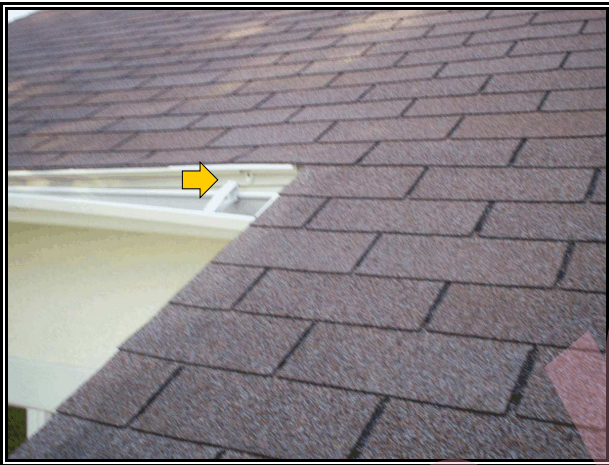
Photo 9- The disconnected run to the front of the living room.

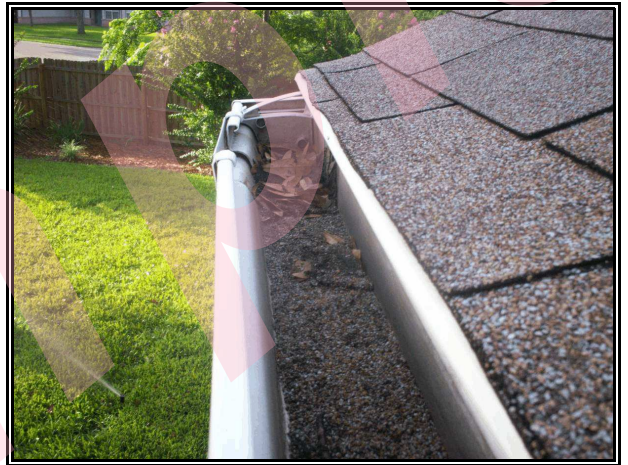
- * the runs are somewhat clogged with plant debris and granules off the shingles preventing them from draining properly. (See photo 10.)
- 5. With the plumbing components;

Photo 10- One of the partially clogged rain gutter runs.

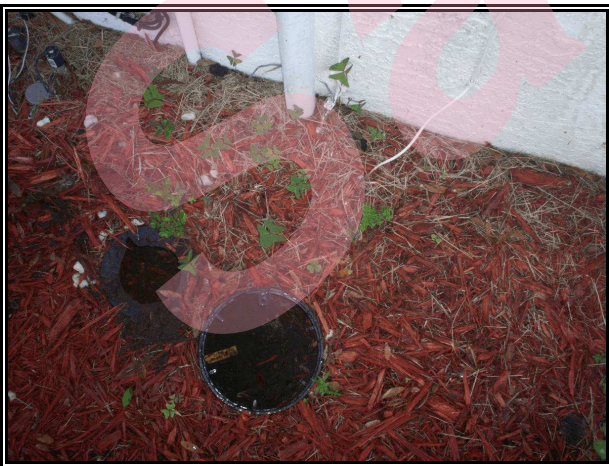
- * the missing drain stopper at the hall bath tub,
 - * the missing caps at the right side in ground wells for the domestic water and lawn sprinkler shut off valves. (See photo 11.)

Photo 11- The missing caps at the domestic and lawn sprinkler shut off valves right of the home.

Most of the fixtures have shut off valves below. The main shut off for the water supply is located at the right exterior of the home. The cover to the well housing it is missing as noted previously however. (Again, see photo 11.) This should be replaced.

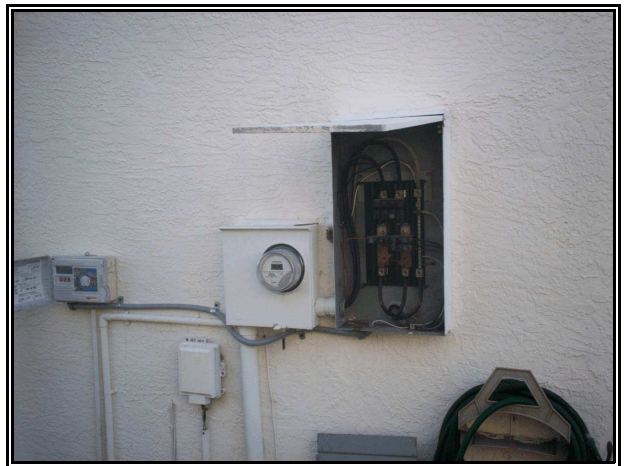
The main service into the home consisted of an underground, 120/240 volt feed, aluminum service entrance cables and a main disconnect rated at 150 amps. The disconnect was located adjacent to the meter on the right exterior wall of the house. (See photo 12.) The service was grounded on the exterior.

Photo 12- The main 150 amp disconnect panel and active lawn sprinkler panel right of the home.

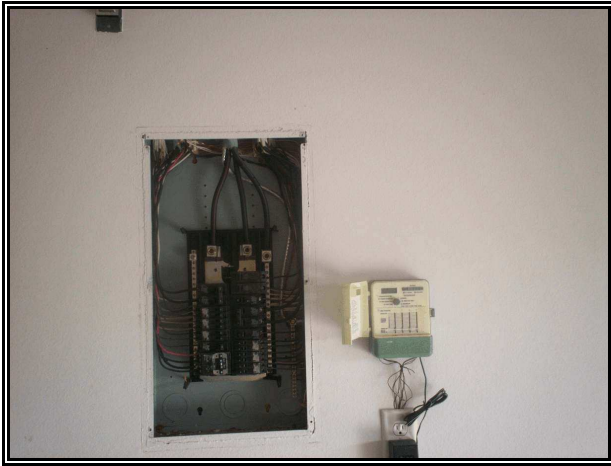
The sub panel breaker box was located in the garage. (See photo 13.) In this panel the breakers and corresponding lines were all properly sized and connected. There was room in the box for additional lines or breakers that may be required in the future.

Photo 13- The electrical sub panel in the garage and inactive lawn sprinkler panel adjacent.

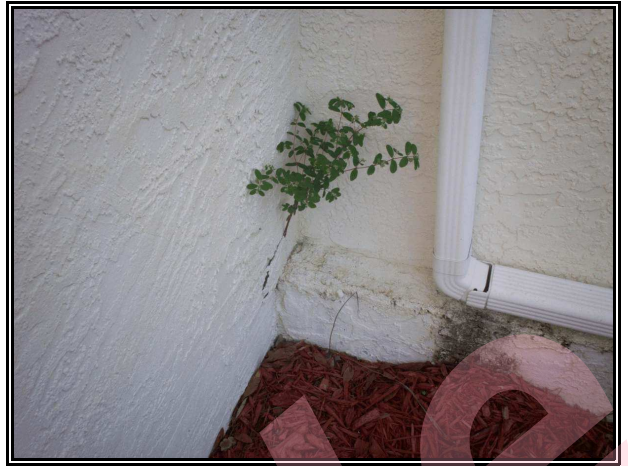
There is a crack at the base of the left wall near the front corner behind the decorative wing wall. The crack is not unusual, but there is a small shrub growing in it. This plant should be removed. There were also plants seen growing from the threshold area of the front door also. These too should be removed.

Miscellaneous photo of the plant growing in the crack at the left side of the home.

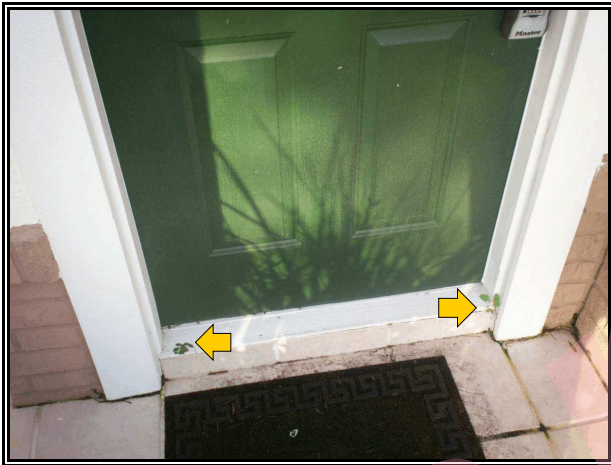
Miscellaneous photo of the live plants at the front entry near the decay damaged wood.

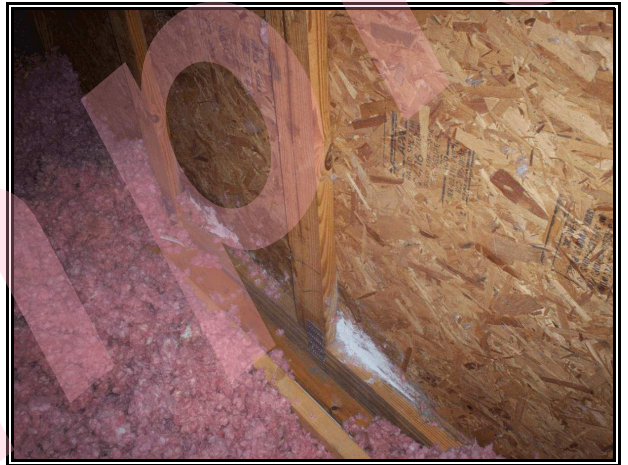
Miscellaneous photo of mold growing at other areas at the base of the right gable end siding.

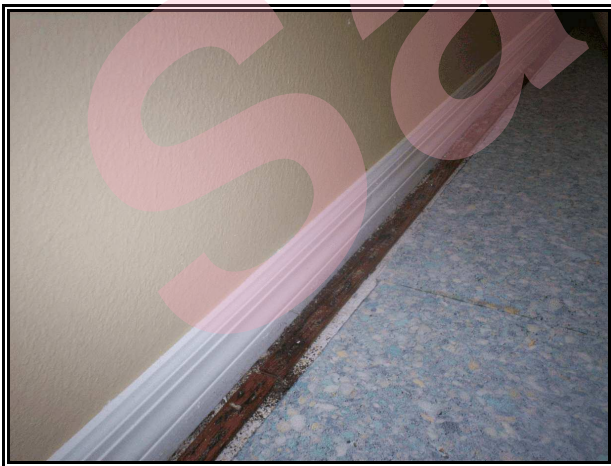
Miscellaneous photo of the water stained carpet tack strip at the front of the dining room.
