MORGAN K. COHEN HOME INSPECTION LLC

Property Inspection Report

Property Address: 20 Elm St. Arlington MA

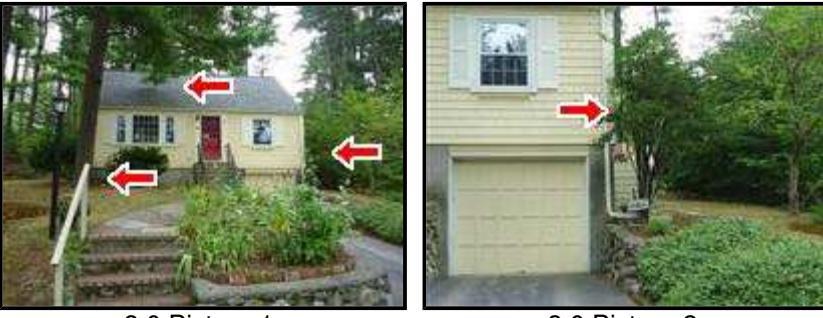
(1) **<u>RR</u>:** Trees and/or shrubs are planted too close or are growing too close to the building. Vegetation can damage the siding, the trim and the roof, and it can clog the gutters. Overhanging tree limbs can allow animals and insects onto the roof or can cause damage to the roof. Roots from trees planted too close to the building can cause damage to the foundation and sewer lines. Areas that are too shady do not allow the siding to dry out and mold, moss, and deterioration can occur. Prune trees and shrubs away from the building. Shrubs should be trimmed at least 18 inches away from the building and trees should be pruned 10 feet from the building. You should seriously consider removal of the large pine tree at the front left corner of the home. Consult a landscape contractor for repair.

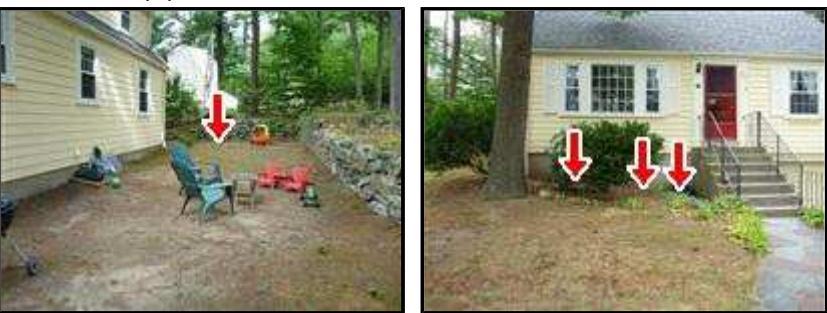
(2) **<u>RR</u>**: There are areas on the left rear corner and nest to the front stairs of the home that are level or do not slope away from the building. Improvements to the grading to slope away from the building are recommended. Add a clay type soil surrounding the structure wherever possible on the perimeter up to 2 ft away from the foundation to help prevent moisture infiltration into the foundation.

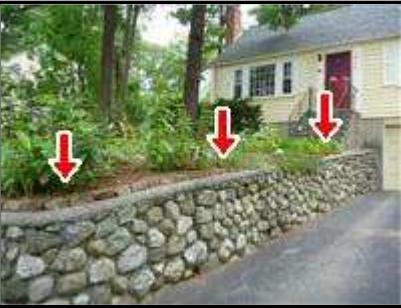
3.0 Picture 5

(4) **<u>RR</u>**: The retaining wall on the side of the driveway has no guardrails in place. This condition is a safety

hazard because someone could fall from this area into the driveway. Installation of guardrails is recommended in these areas.

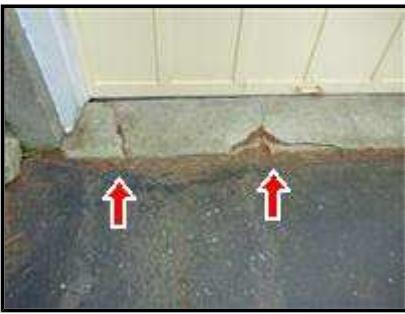
3.0 Picture 6

(5) **<u>RR</u>**: There are cracks in the concrete portion of the driveway near the door. When water penetrates these cracks it can cause them to worsen, and weed growth can cause damage, and moisture accumulation can cause heaving. It is recommended that this section of the driveway be patched (temporary repair) or replaced (preferred repair).

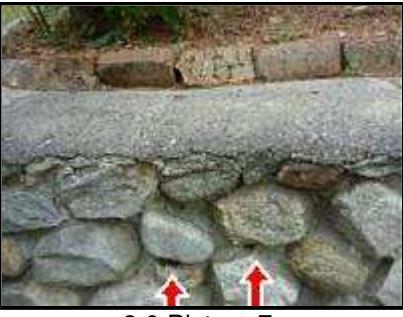
3.0 Picture 7

(6) **FR:** There are minor areas of mortar cracking. Expect to re-point these areas in the near to medium term.

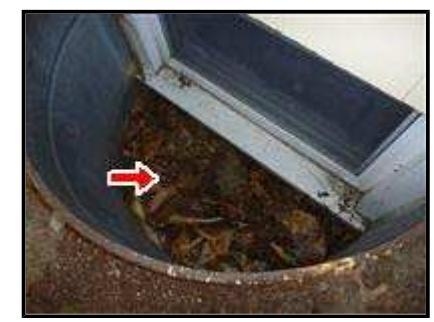
3.2 Picture 1

MR: There is dirt at the bottom of the window wells. This prevents drainage of the wells. Add gravel at the bottoms of the window wells to allow for drainage of the wells. Remove leaf debris and dig down to 6 inches below the bottoms of the sills. Add 2 inches of gravel on soil so that bottom of basement window sill is approx. 4-6 inches above gravel.

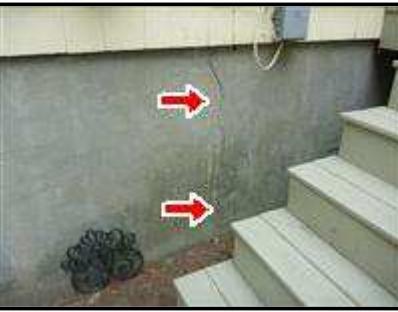
3.3 Picture 1

RR: There is a crack on the exterior of the foundation on the right side of the home. This condition can cause moisture or insect infiltration and may worsen over time. This crack should be sealed on the exterior and interior. Consult a foundation crack repair specialist or mason for repairs.

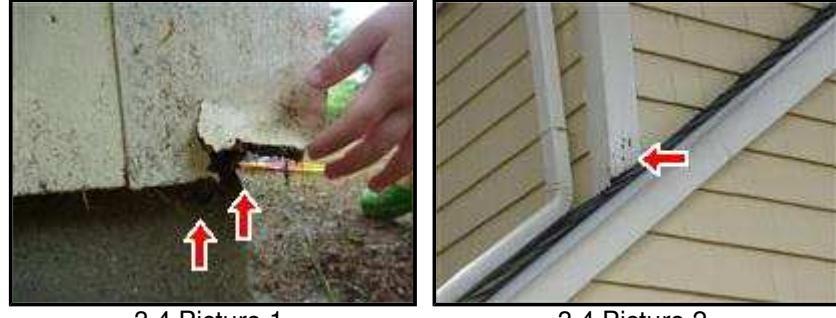
(1) **<u>RR</u>**: There is rot to the corner boards on the left rear of the home. These rotted sections of corner board should be replaced. Consult a contractor for repairs.

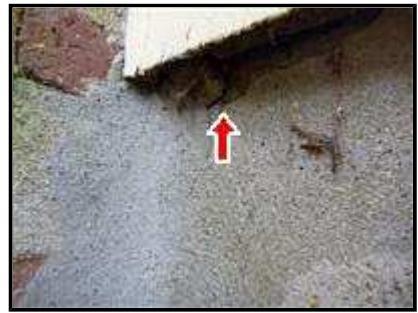
3.4 Picture 3

(2) **<u>RR</u>**: There is a gap in the siding at the bottom edge on the left side of the home next to the chimney. Sealing this hole is recommended.

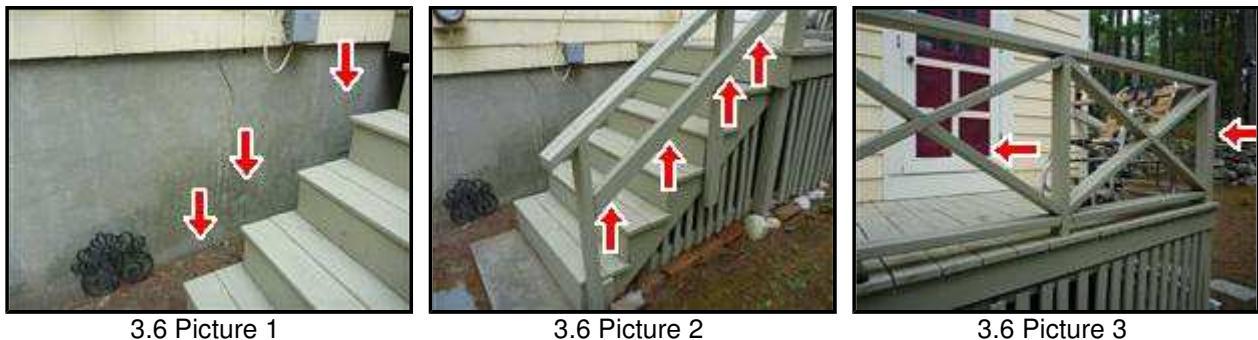
(1) **RR**: The handrail in place on the right side stairs has no baluster system. This condition can allow children to fall through the sides of the stairs. Replacement of the railings on the stairs with railings that have vertical balusters is recommended. Consult a contractor for repairs.

RR: The railings on the right side stair platform/deck do not have proper balusters. The guardrail and railing is constructed of horizontal components. This creates a ladder effect. Children can climb up the railing and fall. It is recommended that the railing be repaired or replaced with proper vertical balusters. The space between each baluster should be such that a sphere 4 inches in diameter cannot fit through.

<u>RR</u>: There is a space between the stairs to the right side entry and the foundation wall/siding on the home. This is a falling hazard. It is recommended that you install a handrail on this side of the stairs or replace stairs with stairs that are built to run up against the home.

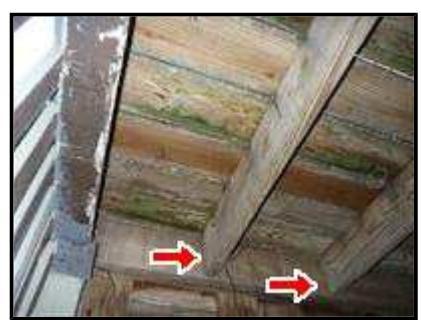
3.6 Picture 4

RR: There are no joist hangers for the joists under the deck. Joist hangers are recommended to provide additional support for the decking. Without these, the joists may become loose and could fail. Installation of hangers is recommended.

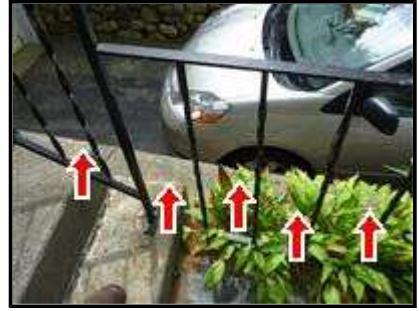
3.6 Picture 5

(2) RR: The spacing of the balusters for the front stair and path guardrail and handrail is too far apart. This may allow a child to climbing or fall through, or get their head stuck in the guardrail. Ideal spacing is such that a sphere 4 inches in diameter cannot fit through any gaps in the railing components. This condition should be corrected. Consult a contractor for repairs.

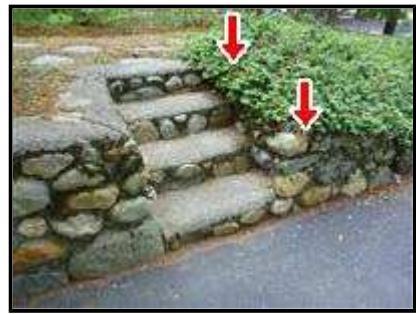
3.6 Picture 6

(4) **<u>RR</u>**: There are no handrails on the right side exterior steps. This condition can be a falling hazard. Installation of handrails is recommended.

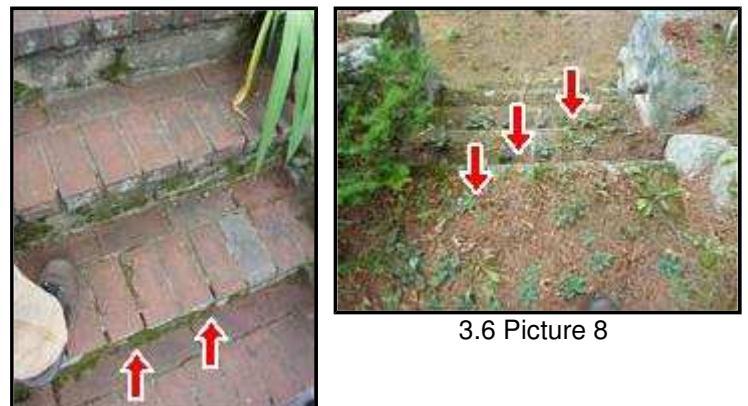
3.6 Picture 7

(5) **<u>RR</u>**: The front steps to the street have some open mortar joints, and the rear yard stairs have open tops to the treads, which are made of masonry block. This condition can lead to further moisture damage, and is also a safety hazard because the stair treads are not smooth and even. Repairs are recommended. Pointing is recommended to the front steps, and addition of treads on the rear steps is recommended. Consult a mason for repairs.

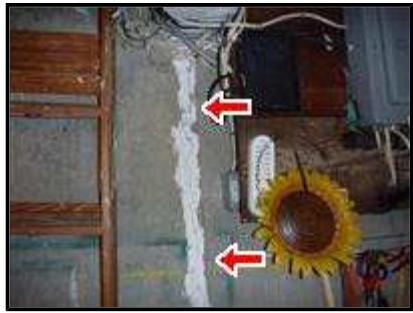
4.0 Picture 1

(1) **<u>RR</u>**: There is a vertical crack in the concrete on the right side of the foundation (in the garage area of the home). This type of crack is typical for a home of this type and age. The crack should be sealed to prevent moisture and insect infiltration. Consult a foundation crack specialist for repairs. Foundation cracks should also be monitored for further movement or opening. If any changes are noted, a licensed engineer should be consulted for further investigation.

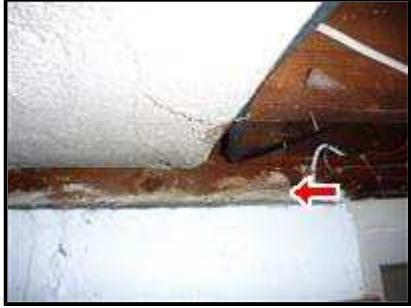
4.3 Picture 1

(1) <u>FI:</u> There is insect damage on the left side of the home in the sill. This damage appears old and the sill is hollow in the area of the damage. There is a concern that there could be additional damage to the sill in the areas to the front of the damage and potentially to the main beam. These areas were not able to be inspected because they were concealed by plaster. It is recommended that the concealed sections of sill and beam be uncovered and the structural components be inspected in these areas.

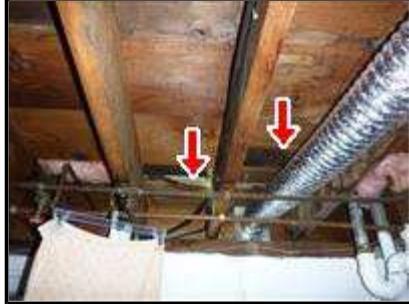
4.3 Picture 2

(2) <u>MR:</u> There are holes around pipes and wires and/or open gaps in the subfloor for the flooring in the first floor. Sealing these holes and patching these gaps is recommended to help prevent air, insect, and rodent infiltration up into the home. Consult a handyman or other qualified person to repair this condition.

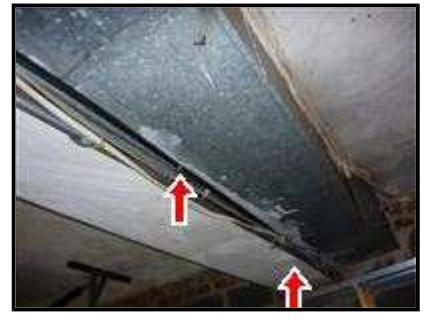
5.3 Picture 1

(2) **Energy Efficiency Upgrade:** There is no insulation on the supply ducting in the basement and the garage. This can make the heating system operate less efficiently than one with insulation on the supply ducting. Adding insulation is recommended.

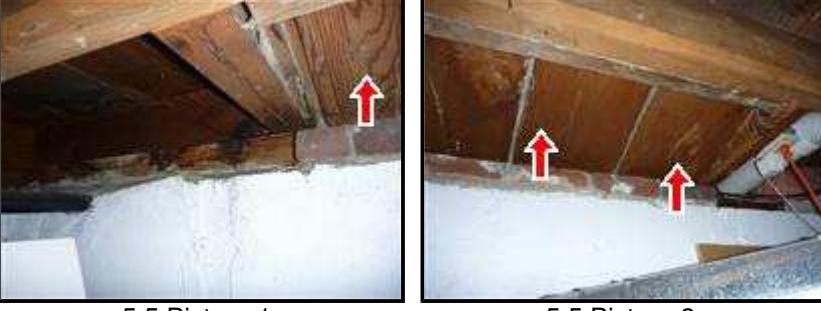
(1) **<u>RR</u>**: The form boards for the hearth extension are still in place under the fireplace chimney hearth extension in the basement. These form boards are meant to be removed after the hearth extension is built because they are a fire hazard in the case that embers fall through any cracks that may form in the hearth or hearth extension. Removal is recommended. Consult a chimney sweep for repairs.

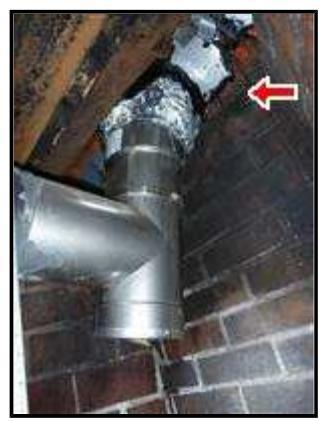
5.6 Picture 1

<u>RR</u>: There is a wood stove currently installed in the fireplace. This stove may or may not be staying. Verify if staying or not. Also, there is a direct connection between the stove and the fireplace flue. The damper has been modified for use with the wood stove. The interior of the flue was not visible for inspection due to this condition, and the damper will require rebuilding or replacement if the stove is removed. Consult a chimney sweep for repairs to be able to burn wood normally in the fireplace if stove is removed.

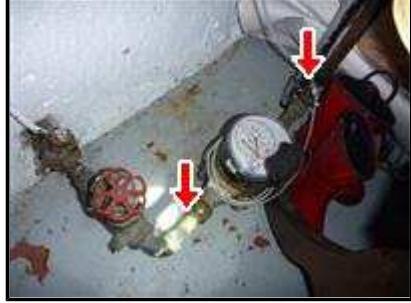
6.1 Picture 1

(1) **<u>RR</u>**: There is no bonding jumper wire over the water meter. This wire connects from the street side to the house side of the meter and connects the grounding system to the house side of the plumbing system. This wire is recommended. Consult licensed electrician for repair.

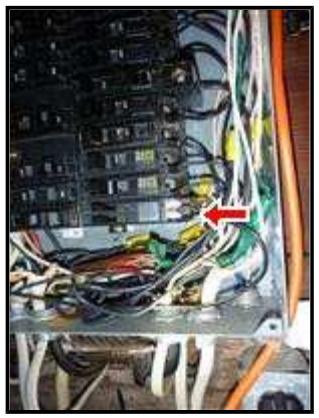
6.1 Picture 2

(2) **<u>FI</u>:** There are mini-breakers in use in the subpanel in the unit. The panel schematic does not indicate that the panel is designed for use with mini-breakers. Further investigation by an electrician is recommended, with correction as necessary.

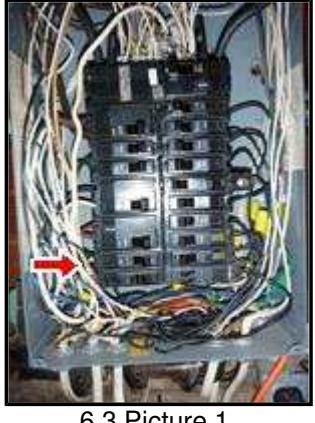
6.3 Picture 1

(1) **RR:** There are three circuits installed on one breaker in the main panel. This is a safety hazard and should be corrected. Circuit breakers may only have a maximum of two wires attached to the lugs if allowed by the manufacturer, and most are only rated for use with one circuit. Consult an electrician for repairs.

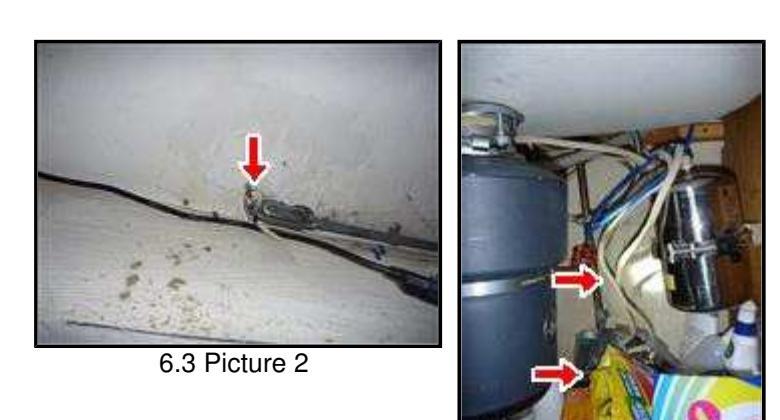
6.3 Picture 3

(2) **RR:** There is some wire sheathing that is taped with electrical tape on the outside of the wire. The extent of any damage to the wire is not known, remove tape in this area and replace feed wire if necessary. Consult an electrician for repairs.

RR: The wiring for the appliances under the sink is unprotected romex wiring, and the junction box is floating loose in the cabinet. This is a safety hazard. Properly mount junction box and replace exposed romex wiring with flexible armored wiring. Consult an electrician for repairs.

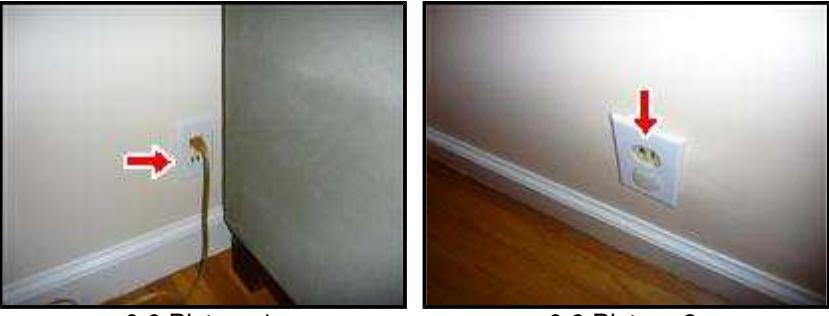
(1) **<u>RR</u>**: There are older two prong ungrounded receptacles in living room, dining room, and bedroom areas. Upgrade is recommended. Replacement with grounded wiring or replacement of aged two prong receptacles with GFCI receptacles is recommended. Upgrade to grounded circuits in rooms or areas where you intend to use appliances that require ground. Consult electrician for repairs.

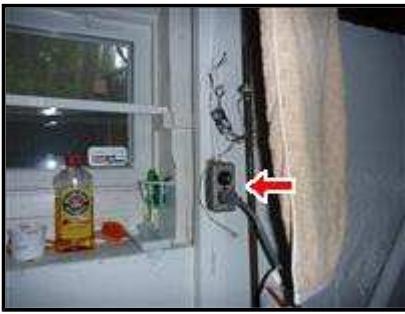
6.6 Picture 3

(3) **<u>RR</u>**: Upgrade unfinished basement and laundry area receptacles to GFCI is recommended. Consult electrician.

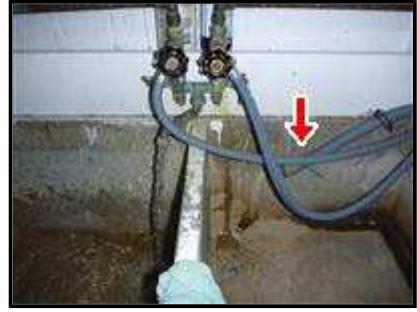
7.0 Picture 1

(2) **<u>RR</u>**: The basement utility area for laundry is set up so that a washer will need to drain into the laundry sink. This is not recommended. It is recommended that a dedicated, properly plumbed standpipe be installed for washer drainage.

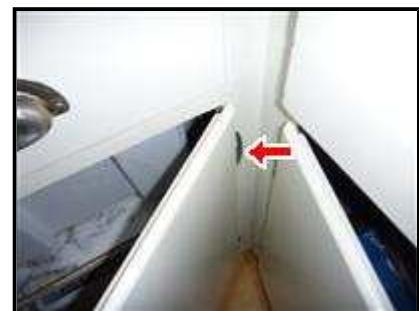
9.3 Picture 1

MR: Fill and seal holes around pipes under sink.

MR: Secure and adjust loose hinges on cabinet doors.

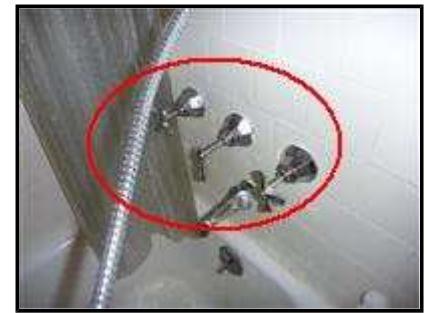
10.0.A Picture 1

(1) **<u>RR</u>**: Replacement of older hot and cold isolated shower/tub control valves with antiscald valve conversion kit is recommended. Consult plumber for repair/upgrade.

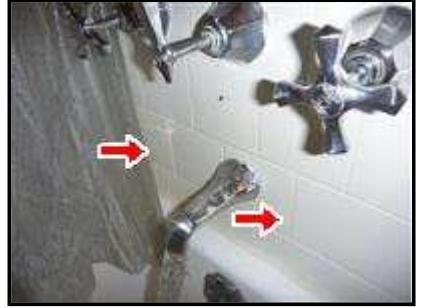
10.1.A Picture 1

<u>RR</u>: There was a hollow sound in places on the wall in the shower and the wall feels soft in places. There may be additional damage, mold, rot or deterioration to the framing and wall board behind the tile in this area. Repair is recommended. Keep in mind that if the damage is too extensive, then retiling the wall may be necessary. This is often the case when there is old deteriorated wallboard or plaster behind tile.

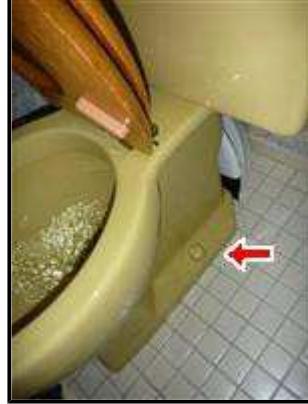
10.0.B Picture 1

(1) **<u>RR</u>**: The toilet is loose in the floor. Repairs may involve re-setting the toilet on a new wax seal or repairs to the flange. Consult a plumber for repairs.

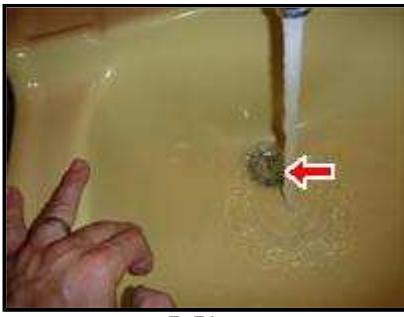
10.0.B Picture 2

- (2) **<u>RR</u>:** The tub stopper valve did not operate. Repair recommended. Consult plumber.
- (3) **<u>RR</u>**: The sink stopper did not operate properly when tested. Repair/adjust.

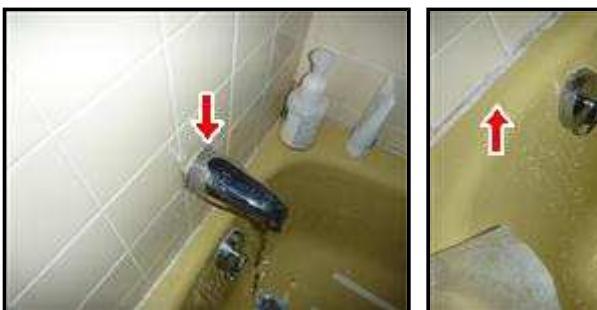
10.1.B Picture 1

<u>RR</u>: Scrape and reseal caulking between tub and walls, and caulk the joint between the tub spigot and the wall.

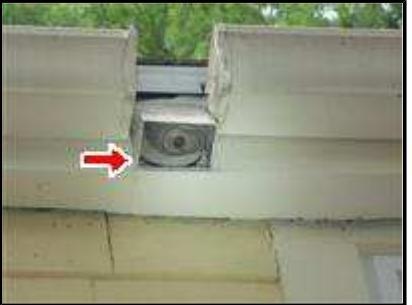
10.3.B Picture 1

<u>RR</u>: The bath exhaust vent fan outflow hood is blocked by a bees nest. This prevents the flap from opening and is a safety hazard. It is recommended that the bees nest be removed. It is not known whether or not this nest is active. No bees were observed in this nest or in the area of the nest (The nest may still be active, though). Consult a pest control operator for removal of the nest.

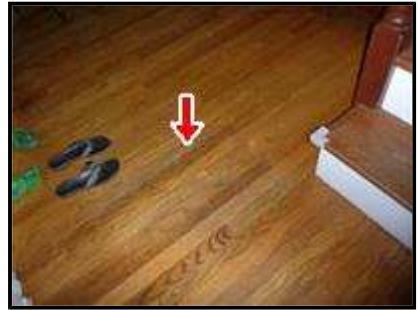
11.2 Picture 1

<u>RR</u>: There is surface damage, wear and cupping to wood floors in the home. Refinishing the floors is recommended.

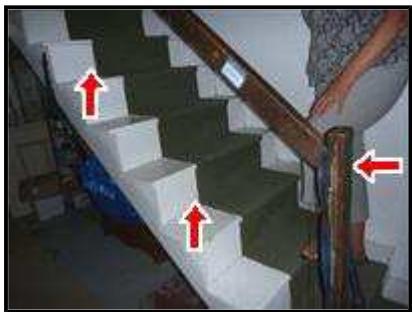
11.3 Picture 1

<u>RR</u>: It is recommended that you add vertical balusters to the stairs to the basement on the open side of the stairs, and secure the basement handrail. Consult a contractor for installation.

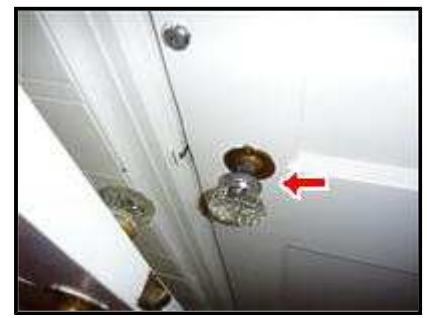
11.4 Picture 1

<u>RR</u>: There are older doors and door hardware throughout the building. Some latches do not line up and require adjustment. Some hardware is loose and requires repair or replacement. Consult a carpenter to repair and adjust doors in the home to operate properly.

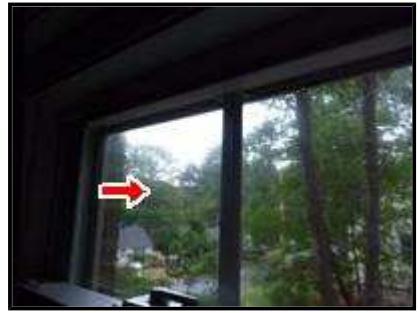
11.5 Picture 1

RR: The top sash on the left side second floor window has a thermal seal failure. This condition is evident due to condensation and staining between the panes of glass. This condition causes the window to become fogged. This sash should be reglazed or replaced.

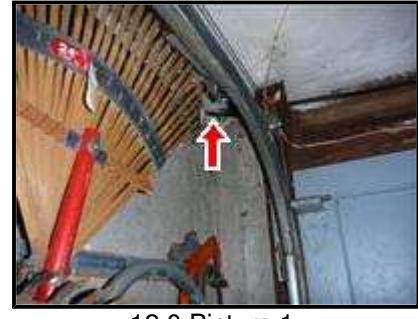
12.0 Picture 1

<u>MR</u>: There is a small hole in the ceiling in the garage above the door on the right side (right front corner). Fill and seal with a fire rated caulking.

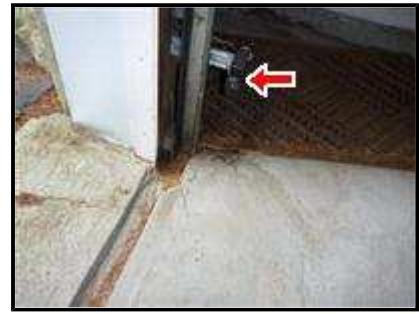
12.4 Picture 1

(1) **<u>RR</u>**: The opener has electronic sensors located higher than six inches off floor which may not be installed according to manufacturers specification. Most door manufacturers state that sensors should be mounted 6 inches or lower from the floor. This is unsafe and needs correcting.
