BLACK LIQUOR RECOVERY BOILER ADVISORY COMMITTEE

MINUTES OF MEETING Crowne Plaza Hotel/Atlanta Airport March-April 30, 31 & 1, 2015

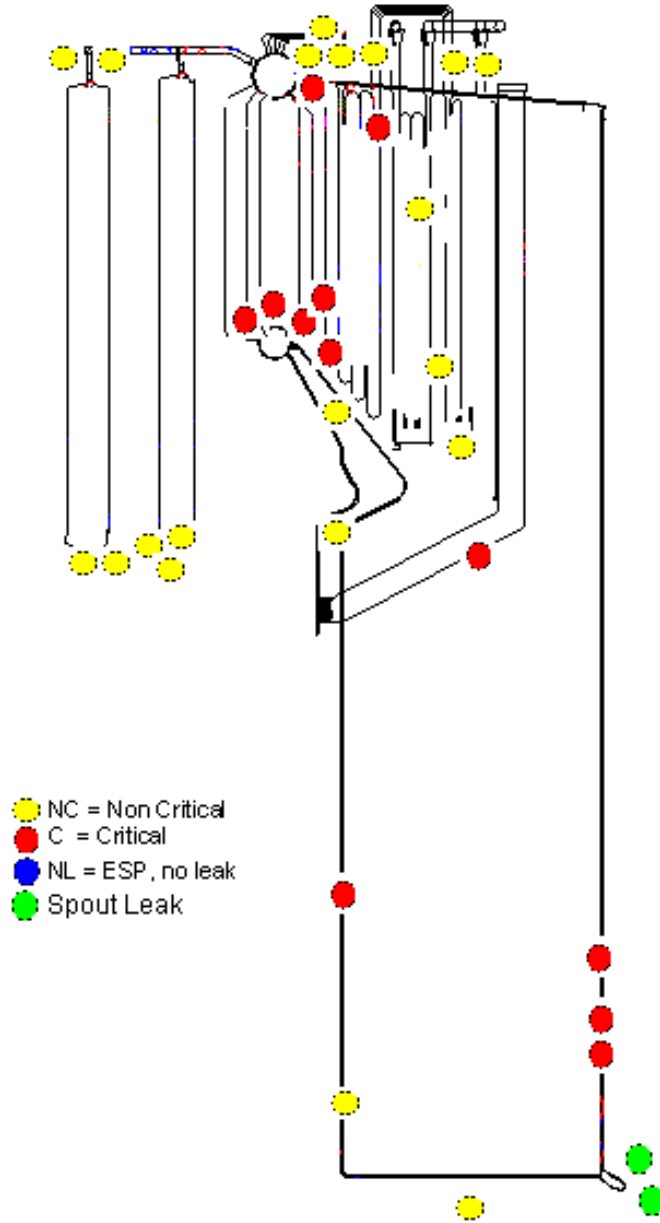
Figure 1

The general locations of the leaks for boilers in North America are shown in Figure 1, which displays a typical boiler, not representing any particular style or model. The yellow circles are the non-critical incidents and the red circles indicate the location of the critical incidents. The two green dots are for the Spout Leaks.

The leaks locations are summarized as follows:

- 7 – Economizer
- 3 – Superheater
- 2 – Screen
- 5 – Upper Furnace
- 4 – Boiler Bank
- 5 – Lower Furnace
- 5 – Penthouse
- 1 – Lower Vestibule
- 2 – Smelt Spout Leaks

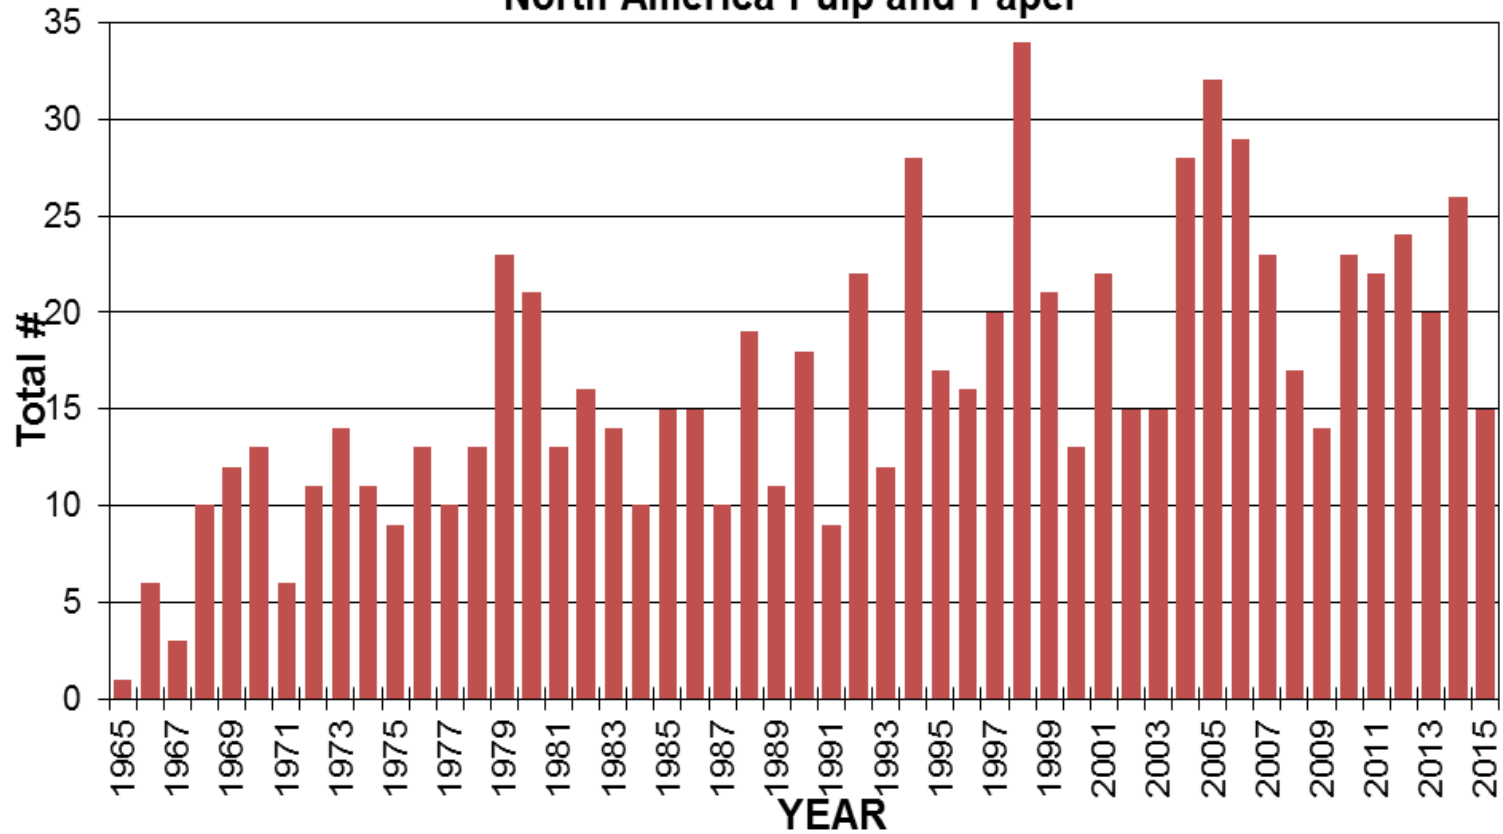
Figure 2 shows the critical incidents reported each year. The bar for 2015 just represents the leaks reported in the Spring Meeting. Figure 3 shows the history of Recovery Boiler Explosions showing the smelt water explosion reported last year and the one from 2012.

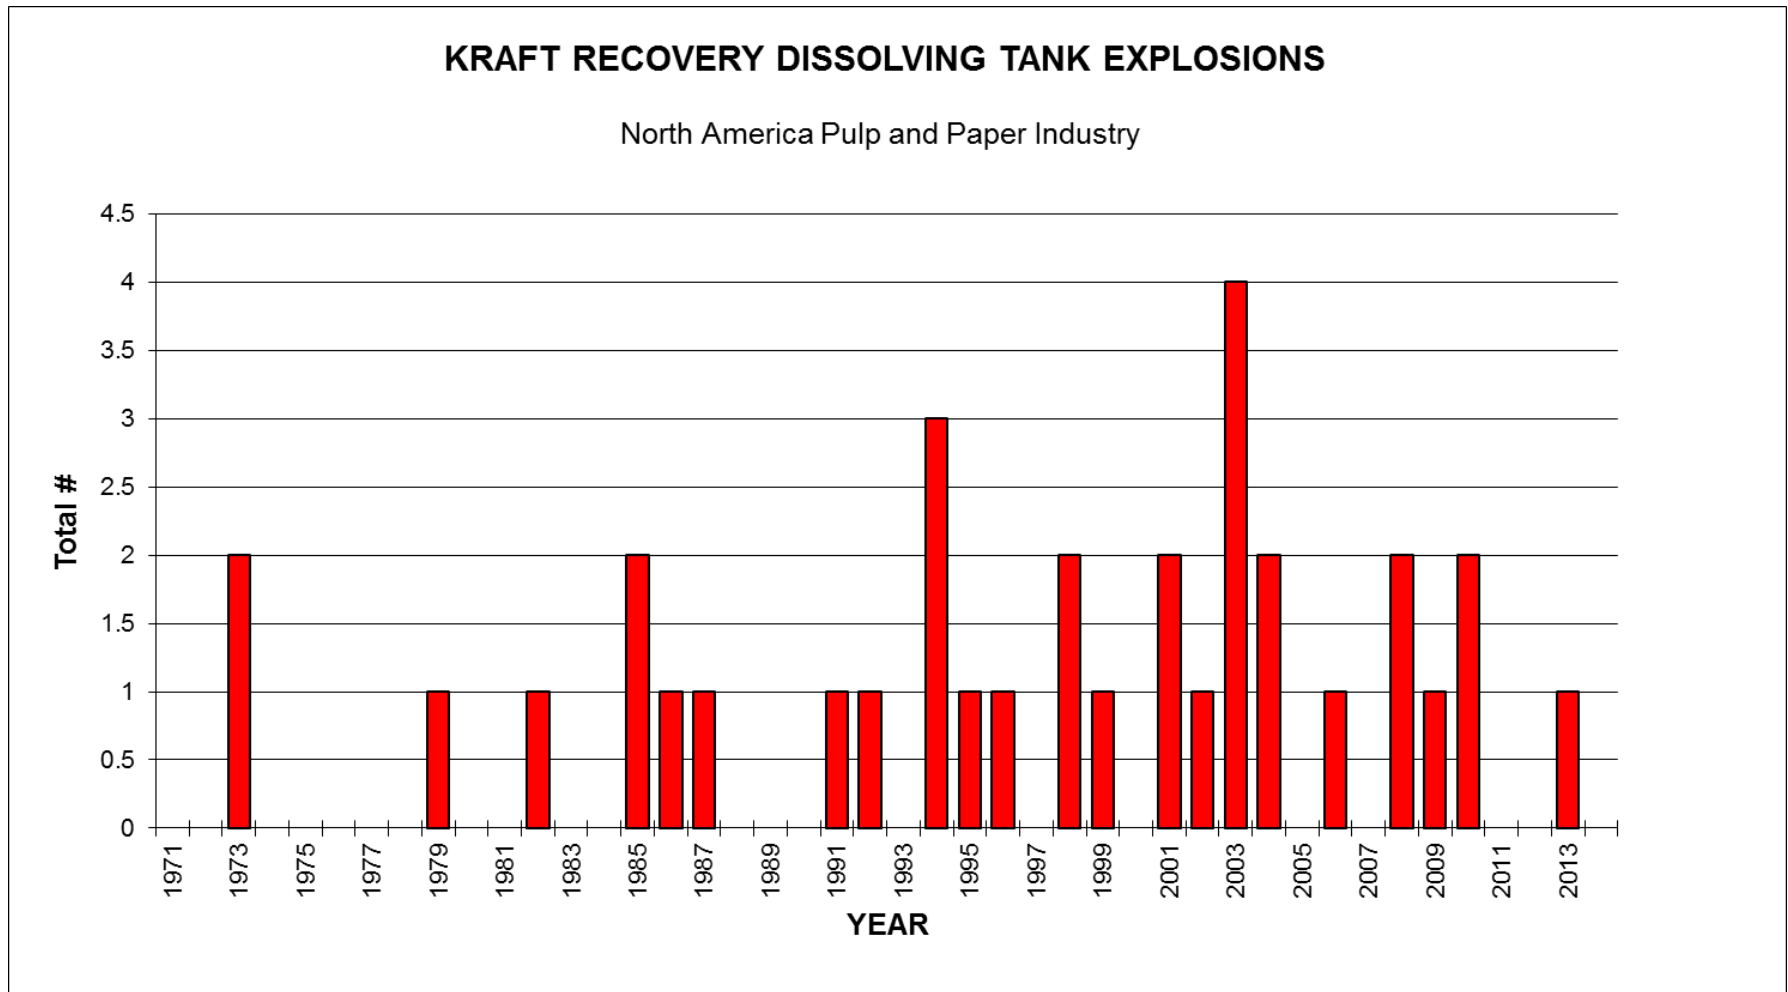
Figure 5 shows the history of reported dissolving tank explosions showing that we may be making some progress in reducing the incidents although it does not include the incident that came in after the cut off for this meeting. It will be included in the report next meeting. Following the recommendations from Section 10 of the Safe Firing of Black Liquor document would prevent many of the reported dissolving tank incidents that have occurred in the past.
