PROPERTY INSPECTION REPORT

Prepared For:	John Doe	
	(Name of Client)	
Concerning:	111 Sample Ave	
	(Address or Other Identification of Inspected Property))
By:	Curtis Carr Lic. # 4026	1-09
•	(Name and License Number of Inspector)	(Date)

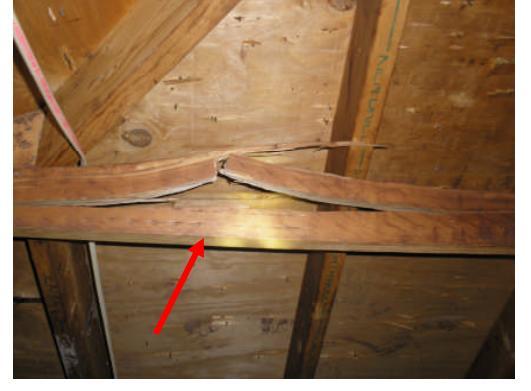
There was a broken purlin in the right side of the attic.

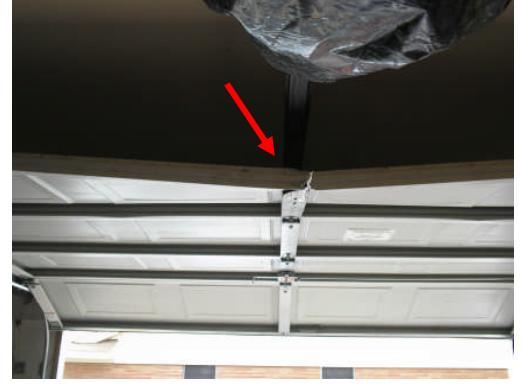
The overhead garage door was damaged at the top.

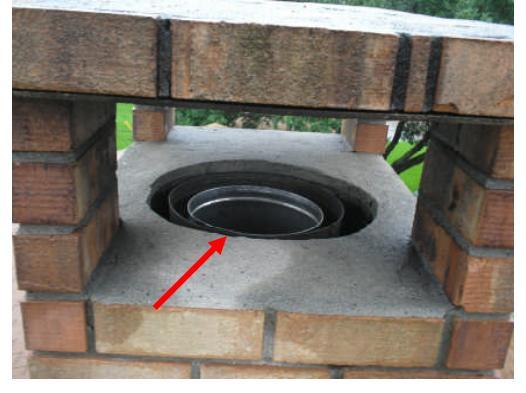
The top of the chimney pipe was not properly capped. It was open back down into the inner walls of the multi-walled pipe.

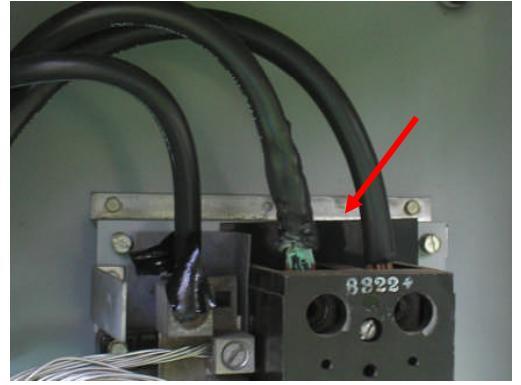
The overhead electrical service entered a Square D panel box located in the garage. There were no AFCIs present (see attachment). There were signs of previous arching at the feeder wires to the box. It is recommended that an electrician be contacted.

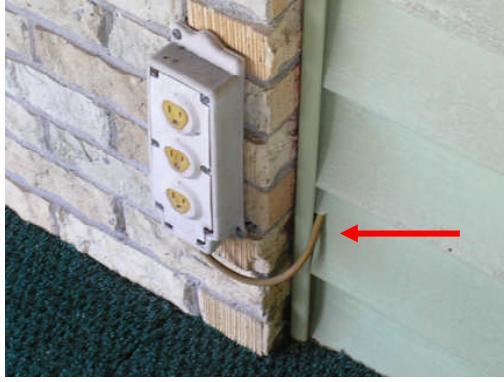
An exterior receptacle on the rear porch was improperly wired.

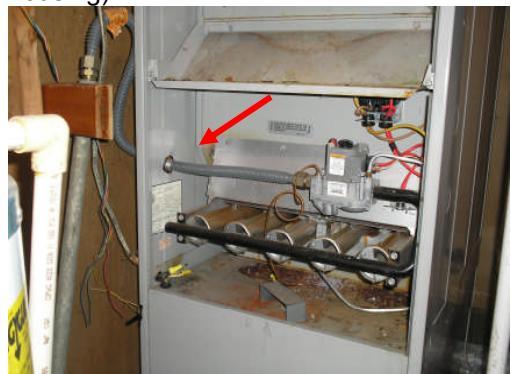
> The Trane heating unit was functioning properly at the time of the inspection. However, the gas line had an improper connection at the unit (flex hose through the housing).

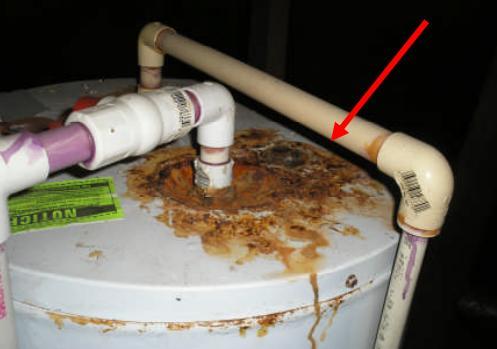
I = Inspected	NI = Not Inspected	NP = Not Present	D = Deficiency
I NI NP D	•	Ins	pection Item
		: electric gal. em water heater located	in the garage had significant rust corrosion to that a plumber be contacted.
