## Interim Report on the Status of the Analysis of Electrical Components Installed in Homes with Chinese Drywall<sup>\*</sup>

Mark Gill Andrew Trotta Division of Electrical Engineering Directorate for Engineering Sciences U.S. Consumer Product Safety Commission

#### November 23, 2009

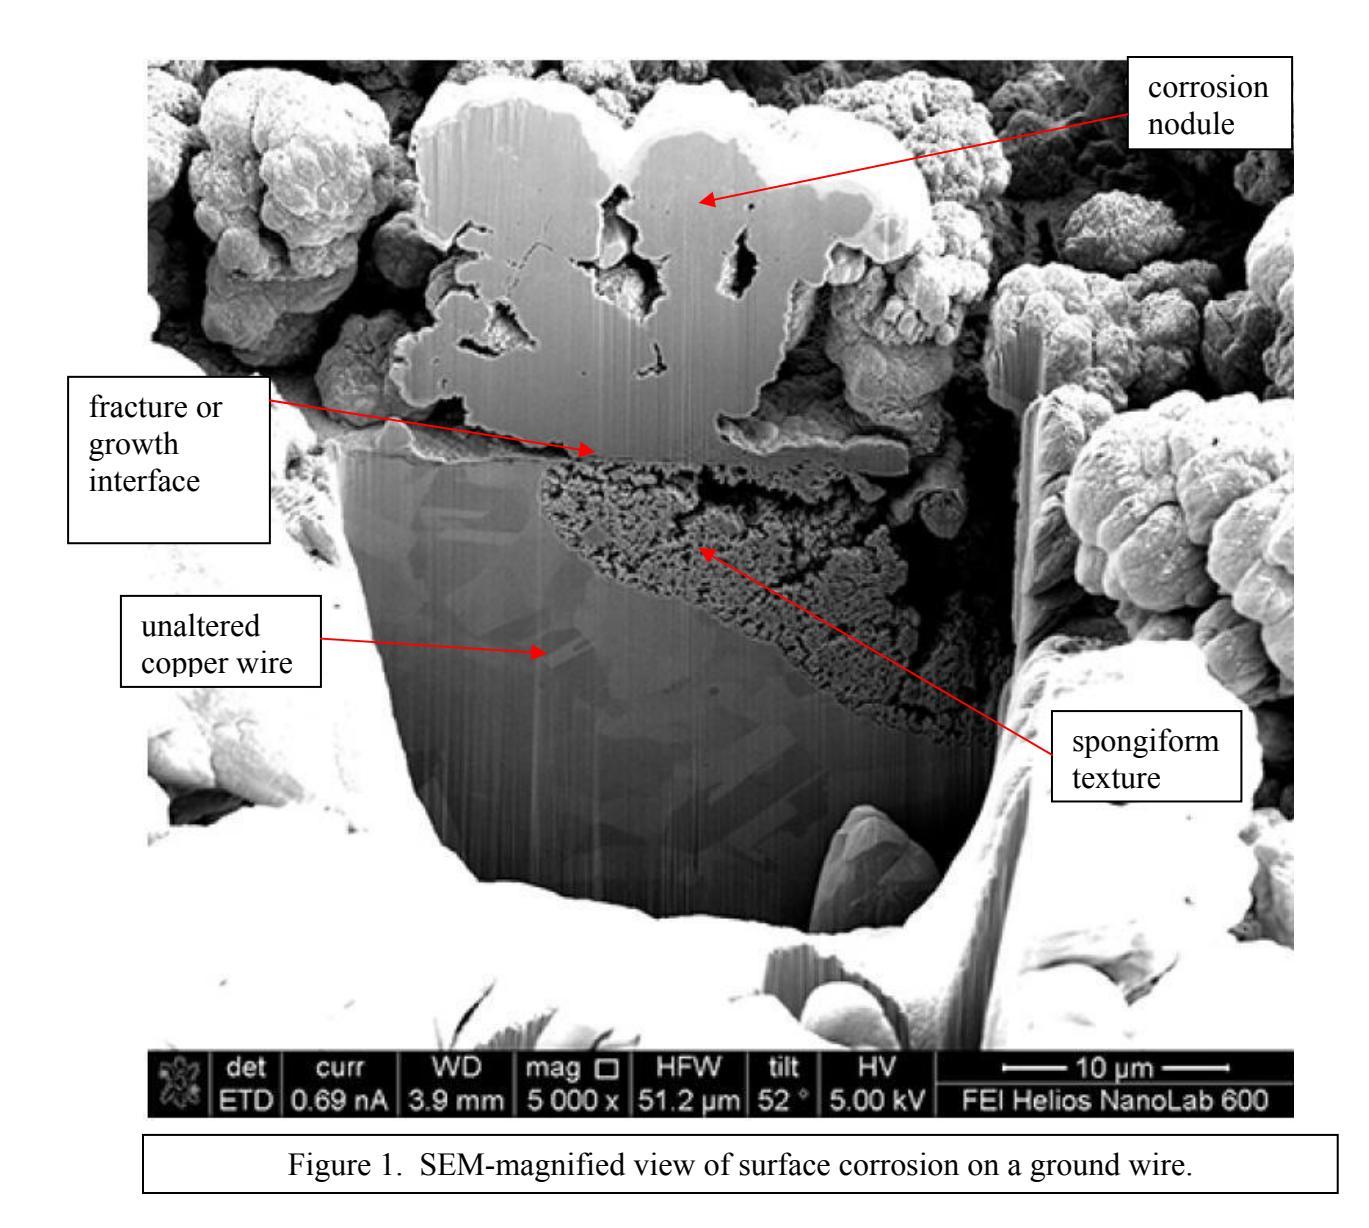
Examination of wires attached to the six receptacles revealed several morphologies, or forms of copper corrosion products, but due to time constraints only two morphologies were able to be analyzed from one wire in time for this interim report: cauliflower-shaped nodules and spongiform (sponge-like) texture. Figure 1 shows a scanning electron microscope (SEM) image of the surface corrosion including a cross-sectional view created by removing a section of the corrosion and wire with a focused ion beam. The corrosion nodules are readily found on the surface of the exposed copper wires, while the spongiform texture appears in micro-cavities that underlie the corrosion nodules. The sequence of events understood at this time suggests that as the corrosion nodules grow, micro-cavities form under the corrosion nodules. After the micro-cavities form, corrosive gases may then penetrate into the cavities, creating the spongiform texture. The overall thickness of the corrosion layer varies from nearly zero to twenty thousandths of a millimeter. The micro-cavities also show depths of a similar magnitude. Analyses of other samples could reveal greater thicknesses of corrosion product and cavity depths.

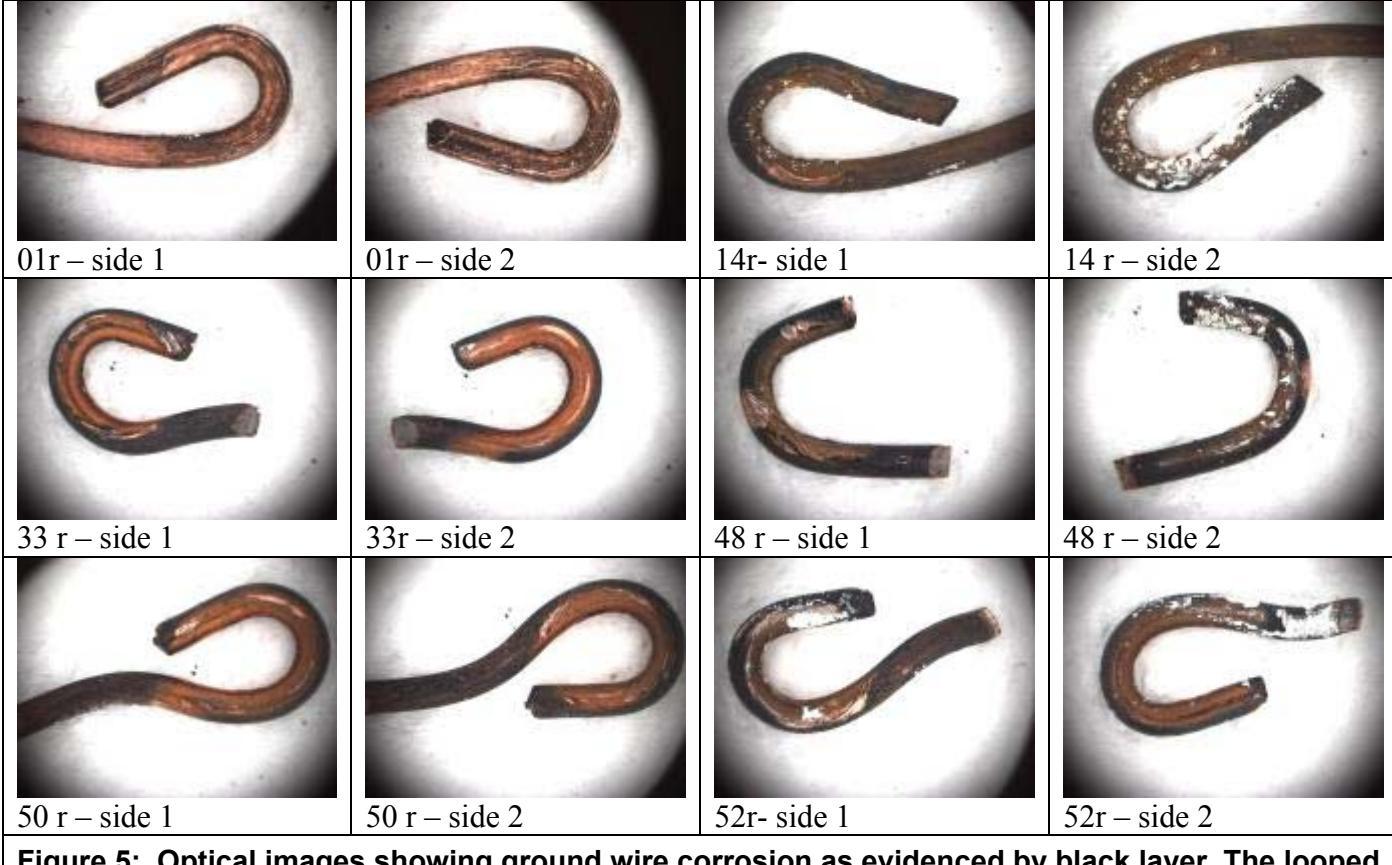
Each of the six 110V rated, screw-type connection receptacles (5 duplex, 1 single pole) had paint or plaster splatter on various surfaces including the wires. There was visible corrosion on the ground, neutral, and hot wire surfaces as well as on the contact plate surfaces for the neutral and hot wire connections. Figure 5 shows the corrosion (blackened regions) that is observed on both sides of ground wires from the six receptacles examined to date. Each of these wires was originally fastened to the receptacle with a screw at the curved section of the wire. The areas where the wire made contact with its screw or contact plate show less blackening or no blackening compared to other regions of the wire where it was not in contact with another material. The lack of corrosion in these areas is likely due to this region being somewhat shielded from any corrosive gasses that are present. Some of the wires also show a white material (likely paint, texturing material, or drywall debris). Some of this appears to have been introduced prior to it being fastened to the receptacle as it is located in a region that was under the screw when it was fastened to the receptacle. Blackening was observed on neutral and hot wires as shown in the examples in Figure 6.

Figure 5: Optical images showing ground wire corrosion as evidenced by black layer. The looped section of the wire, which had been in contact with the screw or contact plate, has little or no blackening in some cases (for example, see 33r – side 2).

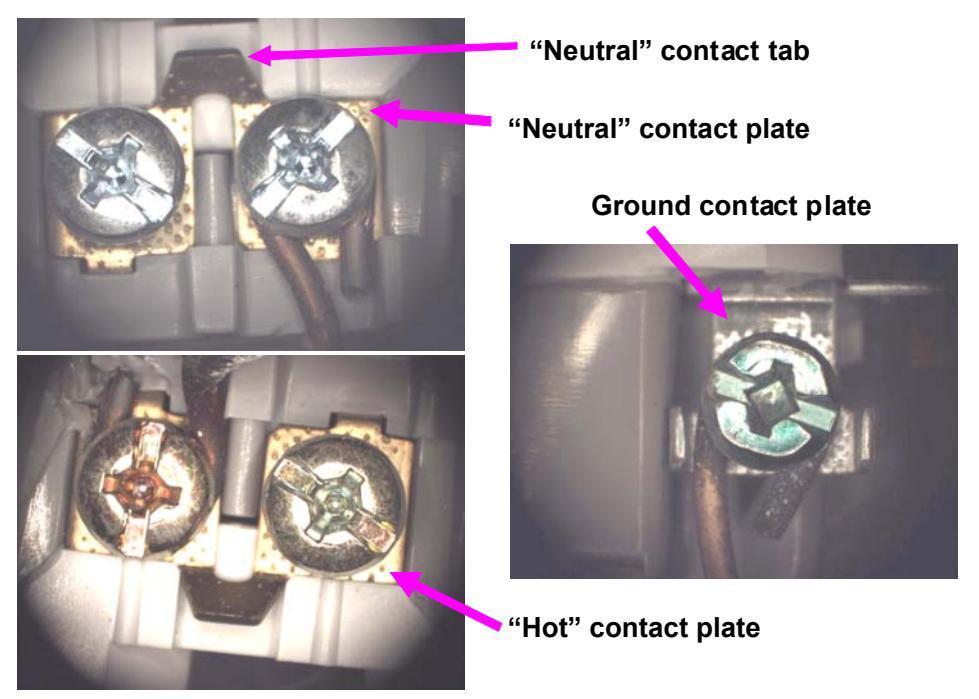
For the group of six examined receptacles some tarnishing and/or corrosion products was observed on the (1) ground screws, (2) neutral screws, and (4) hot screws as shown in Figure 7. Hot and neutral screws have a yellow and silver appearance respectively to distinguish them from each other, and the ground screws are green in appearance. The extent of corrosion of the screws examined to date was significantly less than that observed on the various wires examined to date.

Figure 7: Optical photographs of connection terminals including the contact plate, screws, and wires before disassembly. Ground screws have a green appearance, hot screws appear yellow, and neutral screws appear silver.

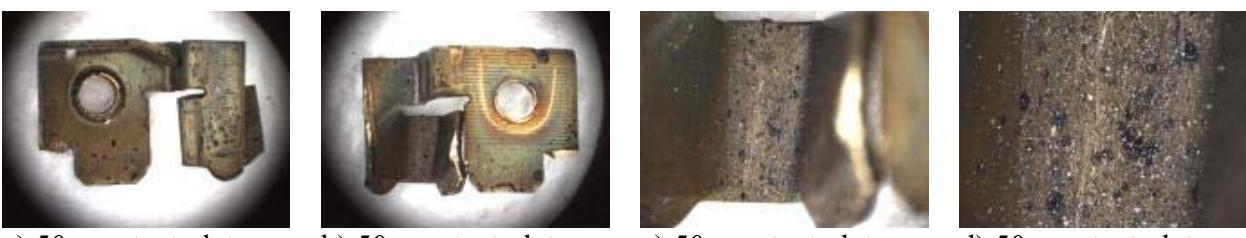
a) 50r contact plate – back view

The appearance of a tarnished contact plate from receptacle number 50 is shown in Figure 9. The top and bottom surfaces of the contact plate and a close-up of the plug contact surface are all shown to demonstrate how corrosion has changed the appearance of the surface. Black specks (mounds of corrosion products) can be seen on the surface of the contact plate especially in the region shown in Figure 9d) at higher magnification. It is important to note that these surfaces are interior to the receptacle, and suggest that the corrosive gasses penetrated the receptacle in this case.

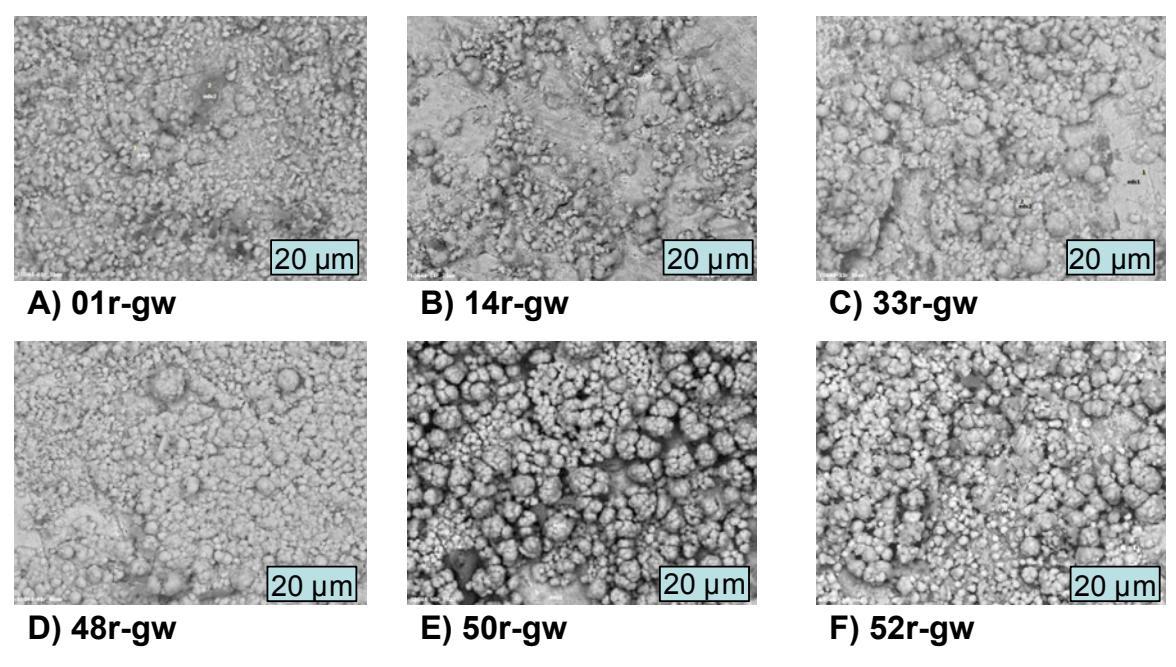
Figure 10 shows the plan view Scanning Electron Microscope (SEM) images of the corroded copper ground wires from six receptacles. The corrosion product layers are similar for the six receptacles. The layers have a nodular appearance with varying degrees of coverage of the Cu wire, and differences in the apparent corrosion product thickness. In some regions small cracks are observed in the layer. Further analysis of each wire and analysis of additional wires would be needed to determine whether there are real differences in the corrosion product coverage on wires from different locations, or between locations within a home. The residence time of the receptacle in a home would also need to be considered to be able to determine that the corrosive environment in one home was more severe than in another.

Figure 10: SEM plan view images of six corroded ground wires. All samples show the growth of a layer on the copper wire. The morphology in these images shows what appear to be individual particles or clusters of particles.

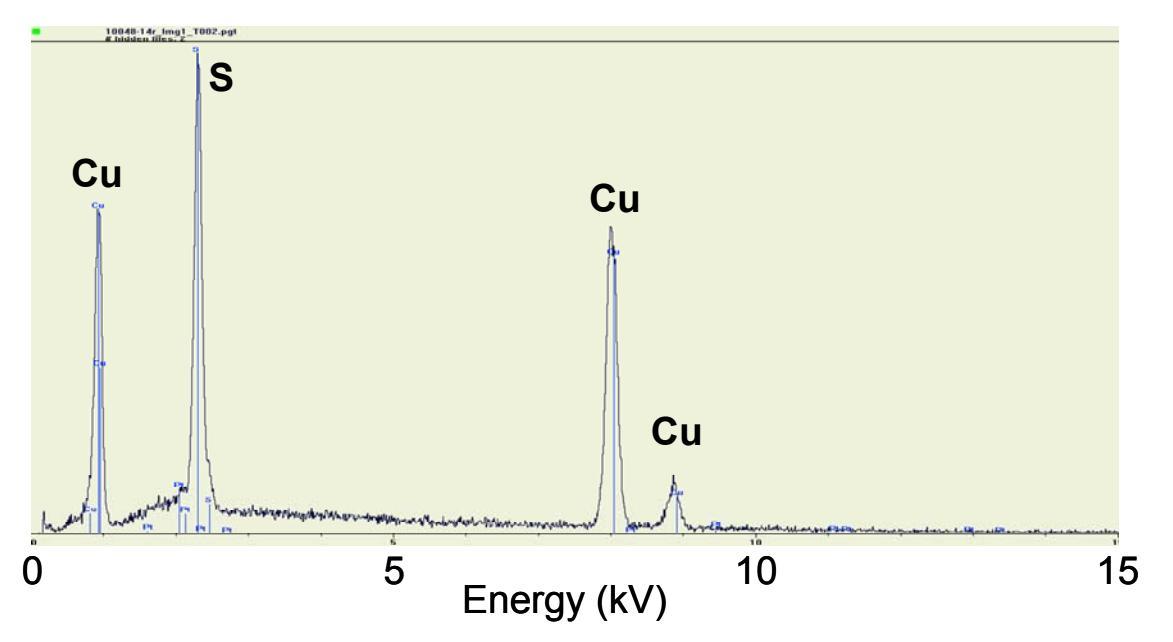
The elemental composition of the corrosion product layer on ground wires observed to date is primarily copper and sulfur (indicating a copper sulfide rather than a copper sulfate) as shown in the Energy Dispersive Spectrum in Figure 11. The presence of Cu and S was confirmed with both X-ray Photoelectron Spectroscopy (XPS) and Auger Electron Spectroscopy (AES) analyses.

Figure 11: EDS spectrum showing elemental composition of the ground wire corrosion product shown in Figure 10. (From component 14)

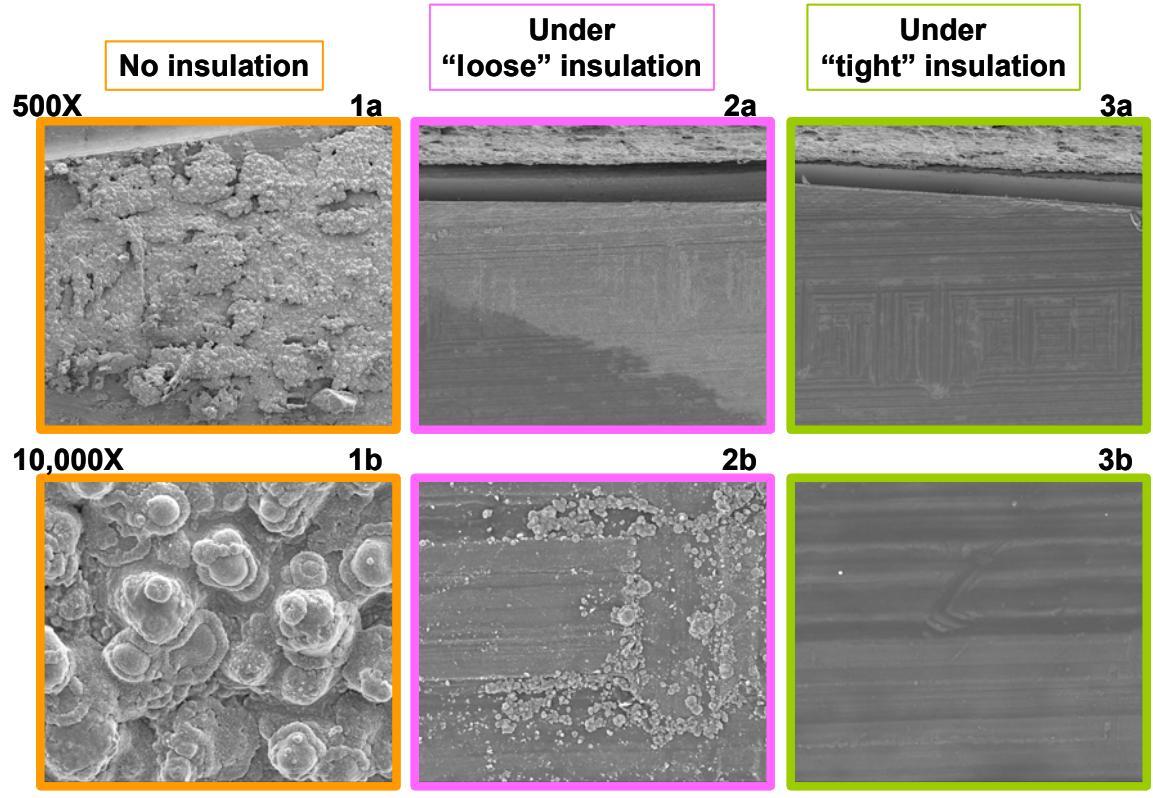
To assess the ability of the wire insulation to prevent corrosion of the copper wire, the insulator was carefully cut from one sample and the wire surface was analyzed. Figure 12 shows a comparison of three regions of a single hot wire near the edge of the electrical insulation. Location 1 is the boldly exposed copper surface near the edge of the insulation. Location 2 was originally under the insulation (after a strip of insulation was removed) at a distance of approximately 0.2 cm from the edge. Location 3 was originally under the insulation at a distance of approximately 0.7 cm from the edge. There is a clear difference in the extent of the surface corrosion with the boldly exposed region showing a substantial layer, the middle region showing the start of a surface layer (which seems to begin along surface features on the underlying copper), and the region under the tight insulation showing no corrosion, only bare copper. There is no corrosion product on the wire at a distance of approximately 0.3 cm away from the interface between the originally bare and covered regions of the wire. The act of stripping the insulation from the wire may produce a separation between the wire and the insulation, allowing access to the copper by the atmosphere. These observations indicate that the electrical insulation acts as a barrier to the corrosive gasses and protects the underlying copper.

Figure 12: Comparison of SEM images at 500X and 10,000X magnification showing a hot wire in (1) an area that was not covered by electrical insulation (2) an area originally covered by "loose" electrical insulation prior to Sandia's analysis (3) and an area tightly covered by the electrical insulation prior to Sandia's analysis. The copper in this area exhibits no corrosion.

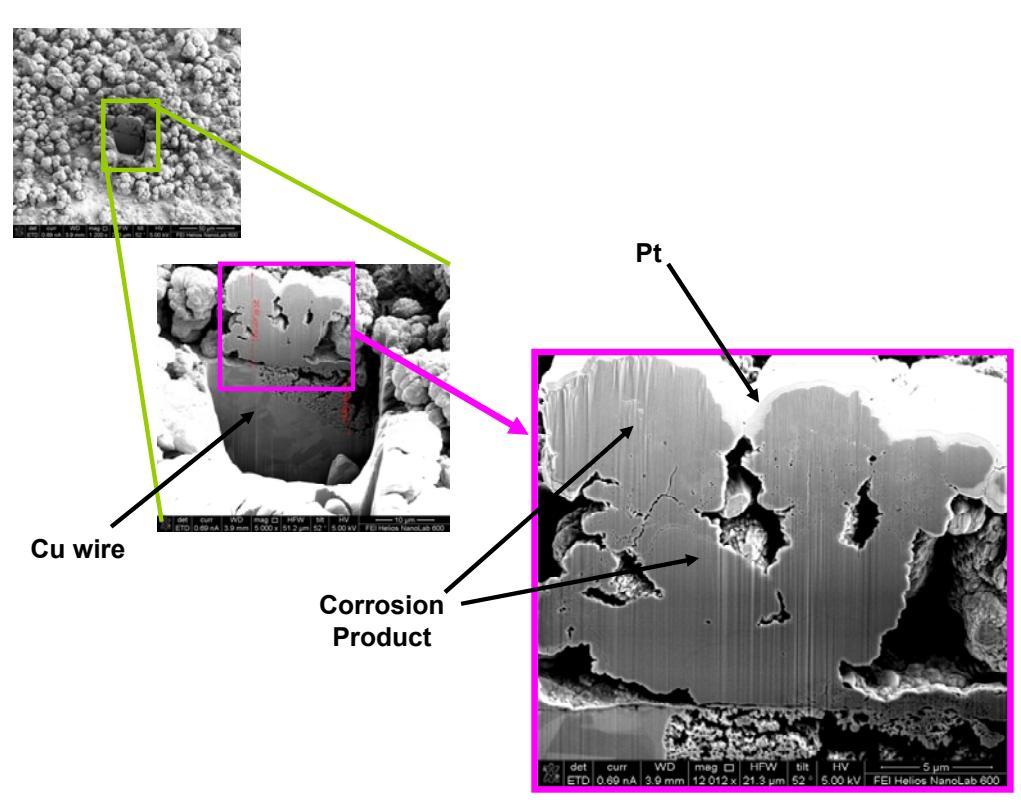
Figure 13: SEM images at increasing magnification of FIB cut into a corroded ground wire showing "cauliflower" morphology of corrosion product and porous region in the base copper. The cauliflower feature is approximately 20 microns in height. The very bright region seen on top of the cauliflower feature is platinum used to coat and protect the sample during the FIB cutting process.

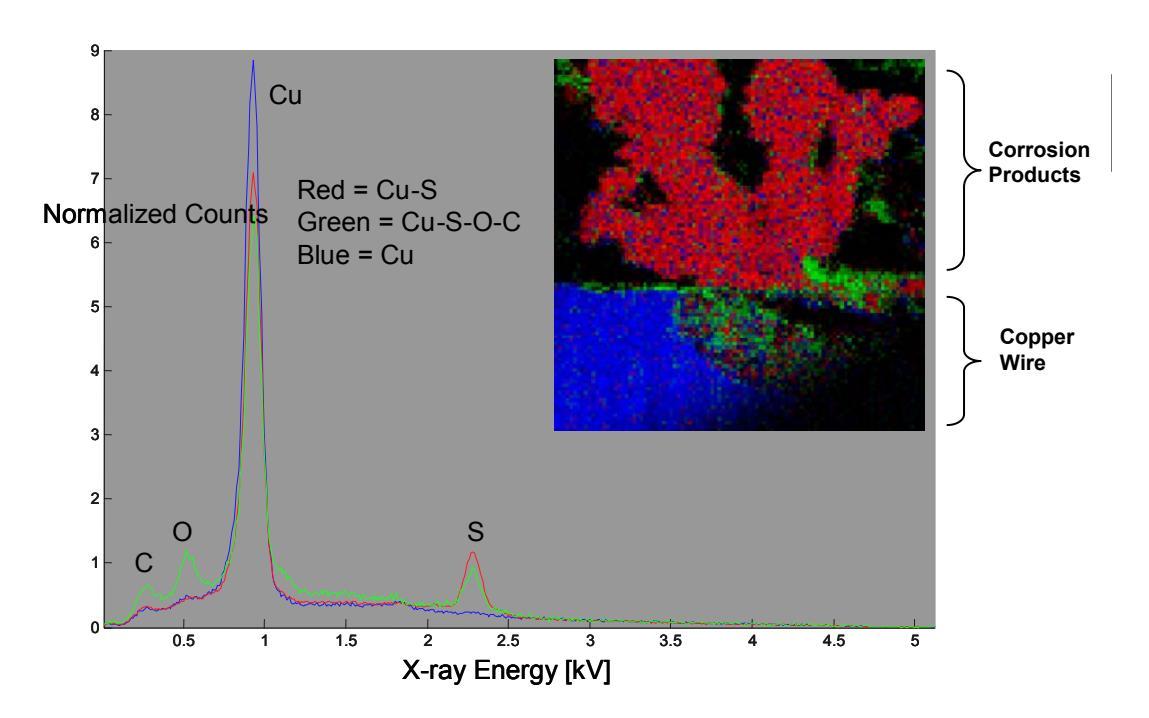
Spectral imaging was performed on the FIB cross section shown in Figure 13. In essence, spectral imaging uses EDS techniques to identify "phases" or "components" present in a sample. Figure 14 shows the hyperspectral image and spectrum for the FIB cross section of the corroded ground wire shown in Figure 13. For this region three components were identified: a Cu-S component, a Cu-S-O-C component, and Cu. Colors are used in the figure to identify the location of the components. Individual representative spectra for the components are also shown. Note that the tree-like nodule (red) is basically a copper sulfide. The copper substrate shows up as the blue area. The spongy material below the copper sulfide appears to be a mixture of copper sulfide and something containing Cu, S, O, and C. While these results represent only a single sample and cannot therefore be used to arrive at a general conclusion, they do provide insight into the nature of the corrosion product and possible corrosion mechanism.

Figure 14: Hyperspectral image and spectrum showing the elemental make-up of various regions of the FIB cross-section of the corroded ground wire shown in Figure 13.

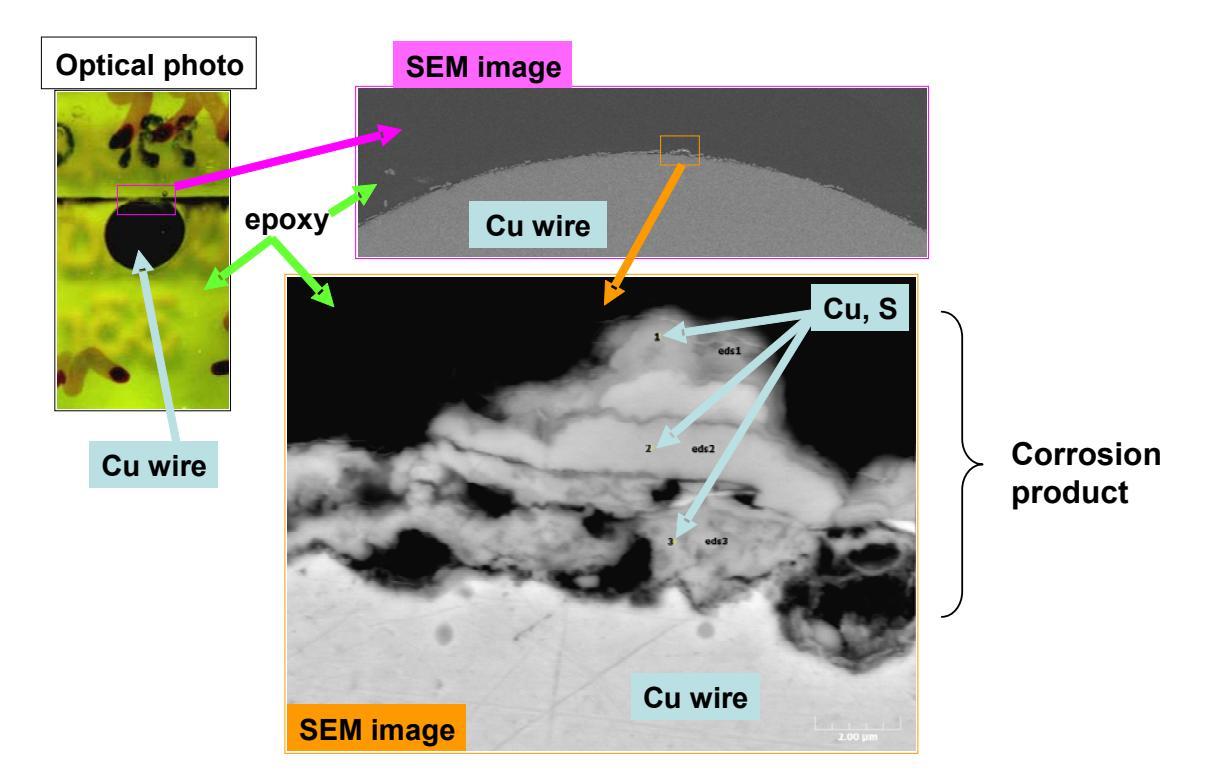
Figure 17 shows an optical micrograph and two SEM images of a cross sectioned ground wire used to identify the thickness and elemental composition of the corrosion layer or layers. Consistent with previous images, this sample exhibits a layered structure. The difference in contrast seen in the highest magnification SEM image could be due to changes in density or elemental composition. These differences suggest that there may have been periods of growth of the corrosion product during which conditions varied. The corrosion product layer was not of a consistent thickness over the circumference of the wire. The range of corrosion layer thicknesses observed on cross sectioned ground wires from six homes are shown in Table 4. The values range from 0-18 microns, the highest values being consistent with the observations made on FIB slices. The purpose of the layer thickness measurement was only to obtain an estimate of the corrosion product layer – it is not a statistically valid measurement from which inferences can be made about the entire population.

Figure 17: Optical (left) and SEM images (right) of the cross section of receptacle ground wire at increasing magnification used to estimate corrosion layer thickness and determine elemental composition. EDS was used to identify the primary elements (Cu, S) in the regions shown in the highest magnification image (bottom right).

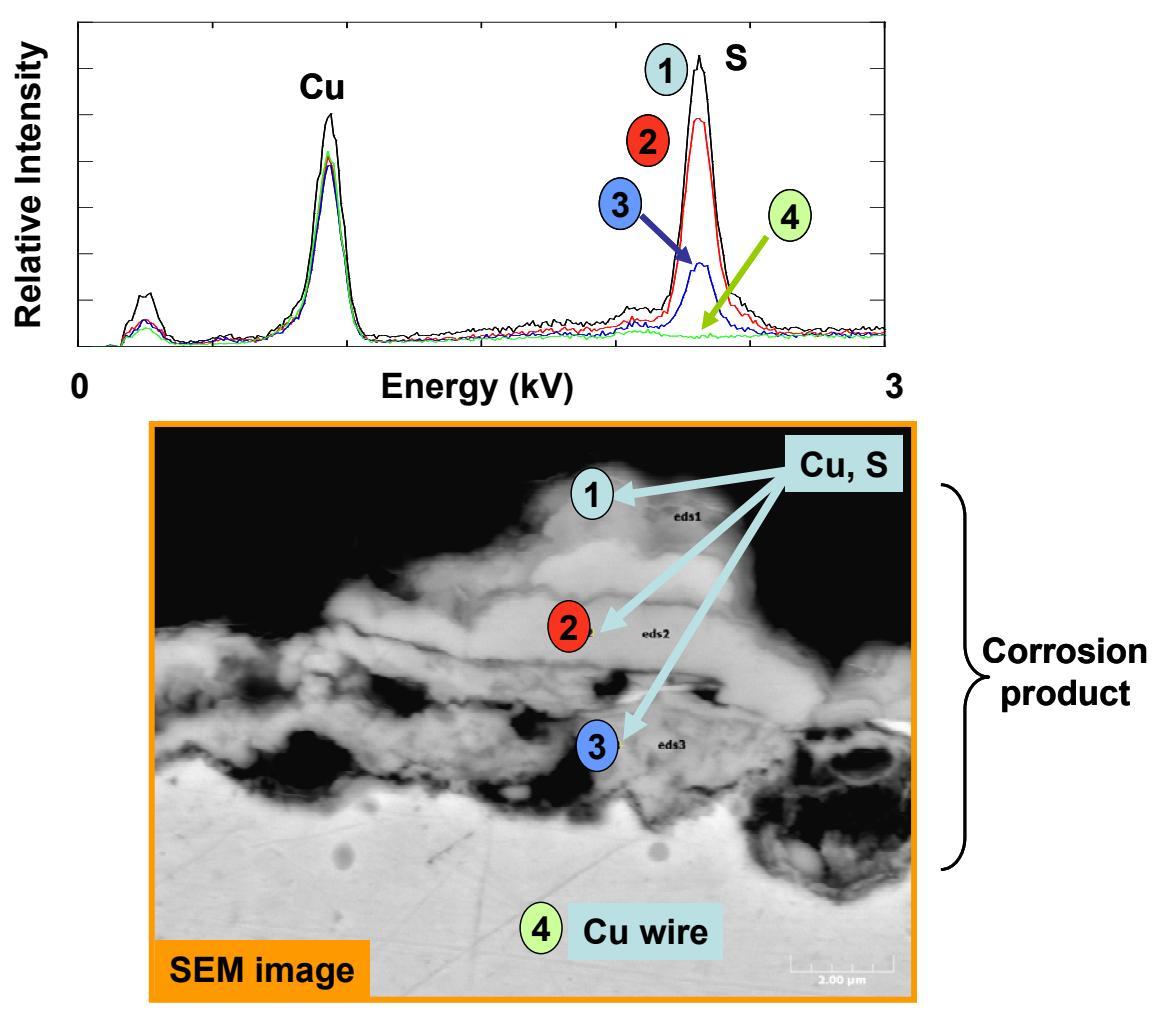
Individual spectra were obtained for several of the layers shown in Figure 17. The spectra were normalized to the Cu peak and are plotted in Figure 18. Only sulfur and copper were identified by EDS, indicating that the corrosion product is a form of copper sulfide. The difference in Cu/S ratio for the various layers suggests that the corrosion products are not a single sulfide (for example  $Cu_9S_5$ ), but are likely a mixture of sulfides.

Figure 18: Qualitative comparison of changes in the sulfur content relative to the copper across the corrosion layer thickness as measured by EDS (normalized to Cu peak at 8 kV) for a corroded ground wire.

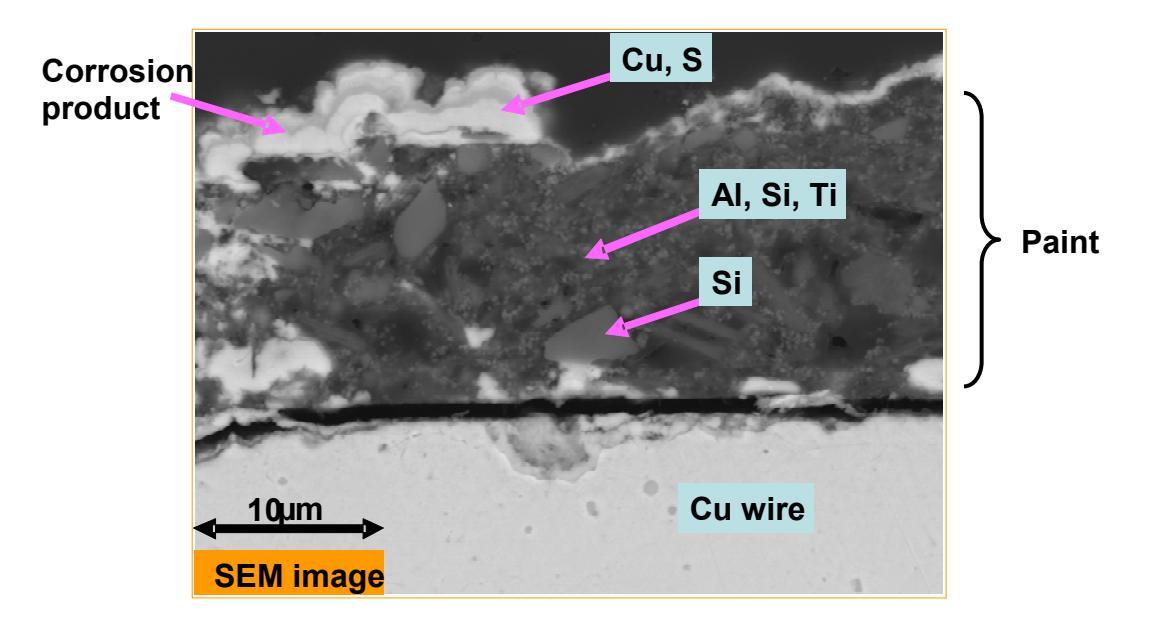
Ground wires and other subcomponents from the set of analyzed receptacles often showed white particles or paint on their surfaces during optical examination. Cross sections of the ground wires often cut through these particles on the surfaces of wires. EDS analyses were used to identify the elemental composition of these materials and to distinguish them from areas of corrosion product. Figure 19 shows the SEM image of a cross section that cut through a region of the wire that appears to be covered by paint. The EDS spectra in Figure 20 show the differences in composition between the darker and lighter regions that are located above (on top of) the copper wire in Figure 19. The spectrum in Figure 20 **a**) shows that the elemental composition of the darker contrast region consists of aluminum (Al), silicon (Si) and titanium (Ti), typical constituents of pigments or pigment extenders in paint. Figure 20 **b**) shows the spectrum for the light region, which consists of Cu and S, on top of the paint layer. This observation of corrosion product on top of paint indicates that the corrosion product formed after the paint was spattered on the wire surface and that it occurred after installation of the receptacle. In addition, the observation of creep corrosion supports the claim that the actual corrosion conditions were more aggressive than Battelle Class II, and likely Class III, IV or higher.

Figure 19: SEM cross sectional image of corroded copper ground wire, showing corrosion product growth on top of paint layer. Elements detected by EDS are shown at particular spots.

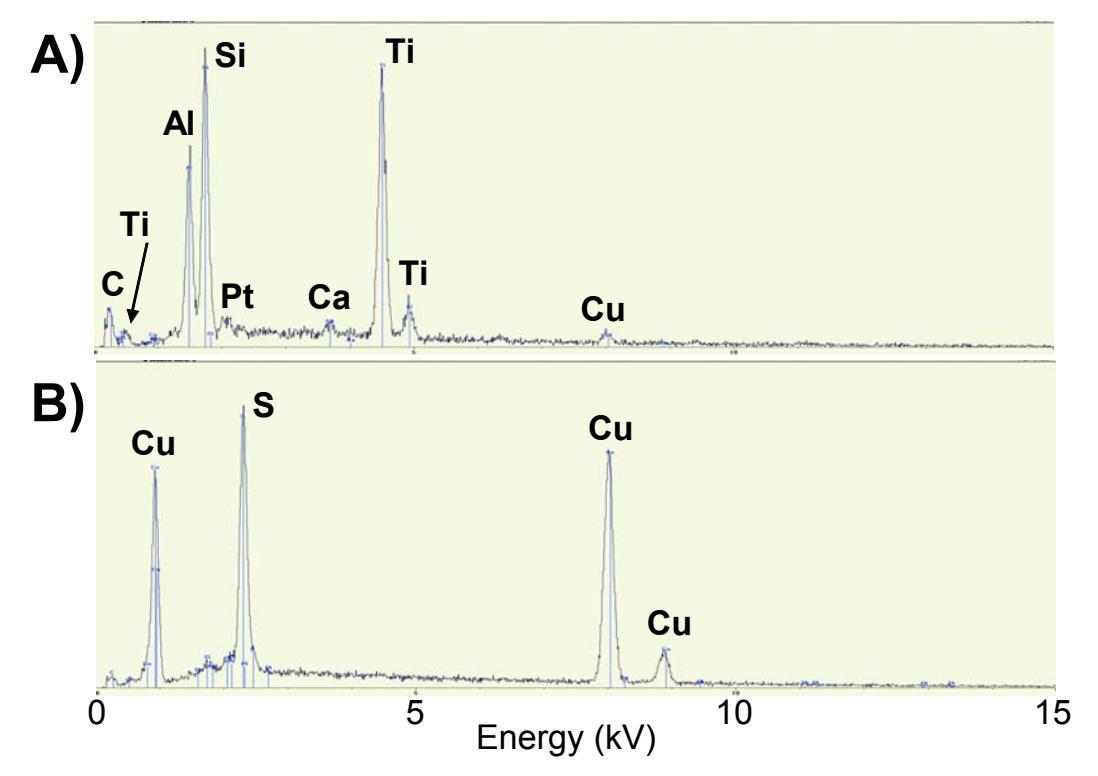
Figure 20: EDS spectrum (signal intensity versus energy in kV) showing major elements detected in areas attributed as A) paint and B) corrosion product shown in Figure 19.

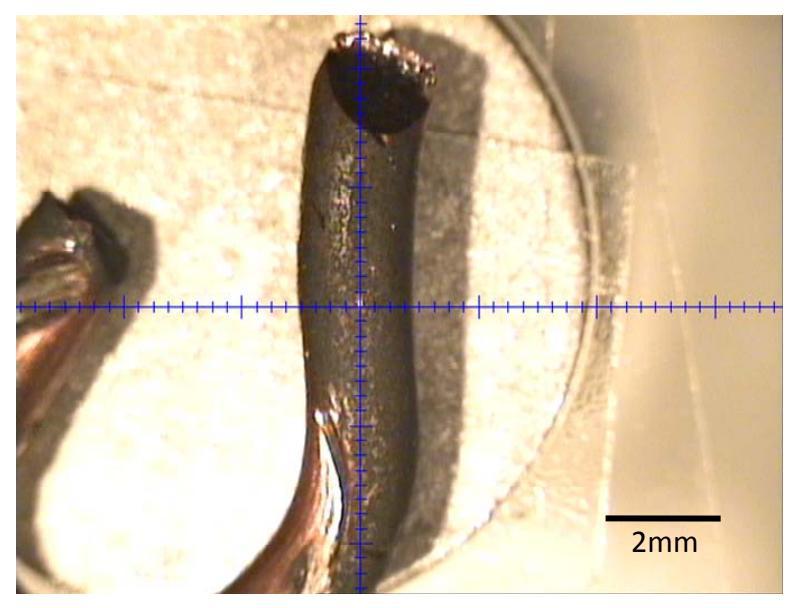
X-ray diffraction (XRD) analysis was conducted on two spots on a single corroded ground wire to gain an initial understanding of the chemical compound (or compounds) present in the corrosion layer. The analysis used a spot on the sample that was approximately 300 microns (0.3 mm) in size and was located on a region of interest as shown by the cross hairs in Figure 21. The XRD spectrum (Figure 22) showed peaks identified as Cu, Cu<sub>2</sub>O (cuprite), and Cu<sub>9</sub>S<sub>5</sub> (digenite). Other elements or compounds may be present, but at small concentrations relative to the species identified above. A 300 micron diameter X-ray spot provides information about an area that is large relative to the size of the particles (or clusters of particles) in the corrosion product layers shown in the SEM images in Figure 10. The XRD analysis cannot be used to identify the chemical identity of individual particles, but provides information averaged over the entire spot. The analysis provides chemical information from a 10-20 micron depth, but most of the X-ray signal comes from the top 5 microns. The large Cu peak in the spectrum suggests that there is incomplete coverage of the surface or that the corrosion product depth is not large on this sample. To enhance the identification of other minor phases and to increase the relative peak heights of the cuprite and digenite additional XRD analyses will be performed on material scraped from the surface of the wire and collected for analyses.

Figure 21: Optical photographs of corroded ground wire used for XRD analysis. The intersection of the blue cross hairs indicates the region of the wire that was analyzed.

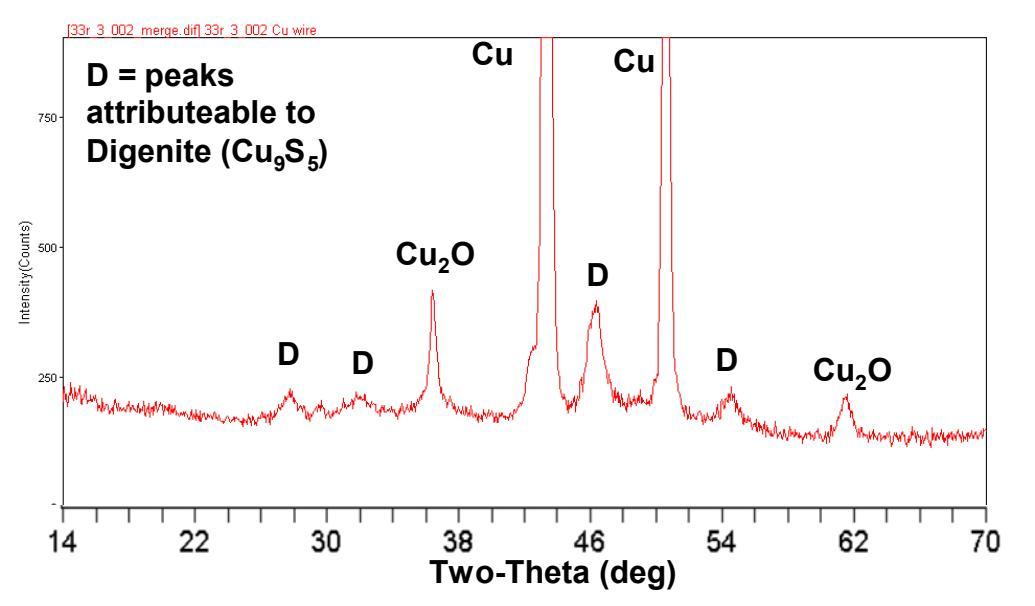
Figure 22: XRD data (signal intensity versus diffraction angle) showing peaks attributable to copper (Cu), cuprite (Cu<sub>2</sub>O) and digenite (Cu<sub>9</sub>S<sub>5</sub>).

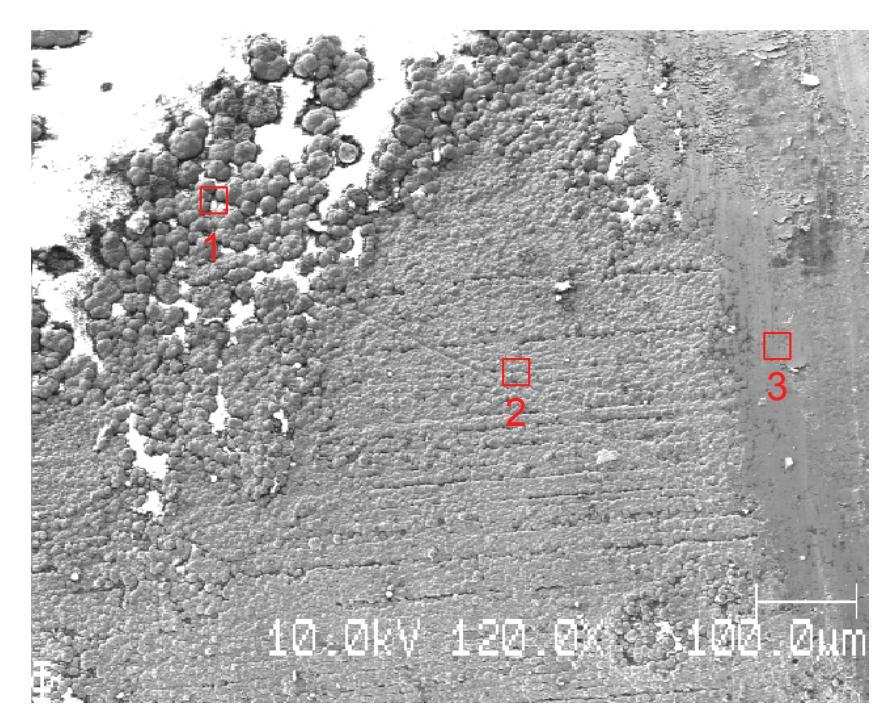
analyzed are indicated in Figure 23. These three spots illustrate the three different surface morphologies observed: "nodular", "smooth", and "smeared". The smeared area was likely generated in prior handling of the component as extra care was taken during disassembly to leave corrosion undisturbed.

Figure 23: SEM image of ground wire showing three different morphologies and three spots indicating where Auger sputtering was performed.

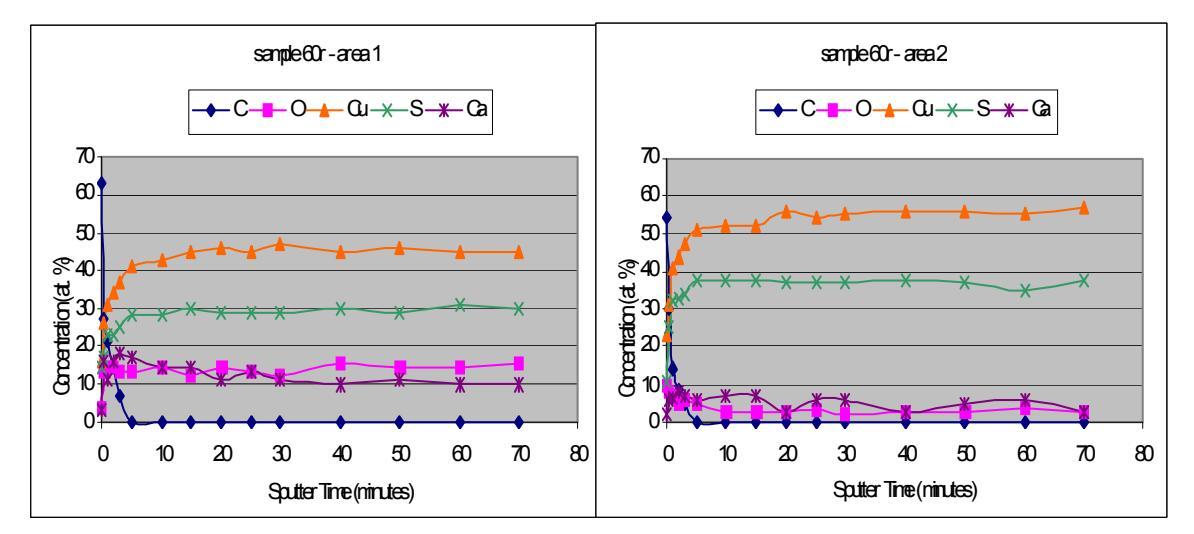
Auger depth profiles were performed in each of the three spots shown in Figure 23 to obtain a preliminary indication of whether there are differences in the elemental make-up of corrosion product for corroded regions of the same wire, with different morphologies. The depth profiles for spots 1 and 2 are shown in Figure 24. Carbon, which is detected at high levels at the surface but rapidly decreases with depth, is believed to be surface contamination from transport, handling, etc. Both spots show high levels of Cu and S, and lower levels of Ca and O. Spot 1 shows higher levels of Ca and O than Spot 2, not surprising since this spot clearly include a non-conductive substance (white in the image), possibly gypsum (CaSO<sub>4</sub> <sup>•</sup> 2H<sub>2</sub>O) dust. These results demonstrate that on this particular wire, despite clear morphological differences, the corrosion product is similar in elemental composition.

Figure 24: Comparison of Auger elemental analysis results versus sputter time for spot locations 1 and 2 shown in Figure 23.

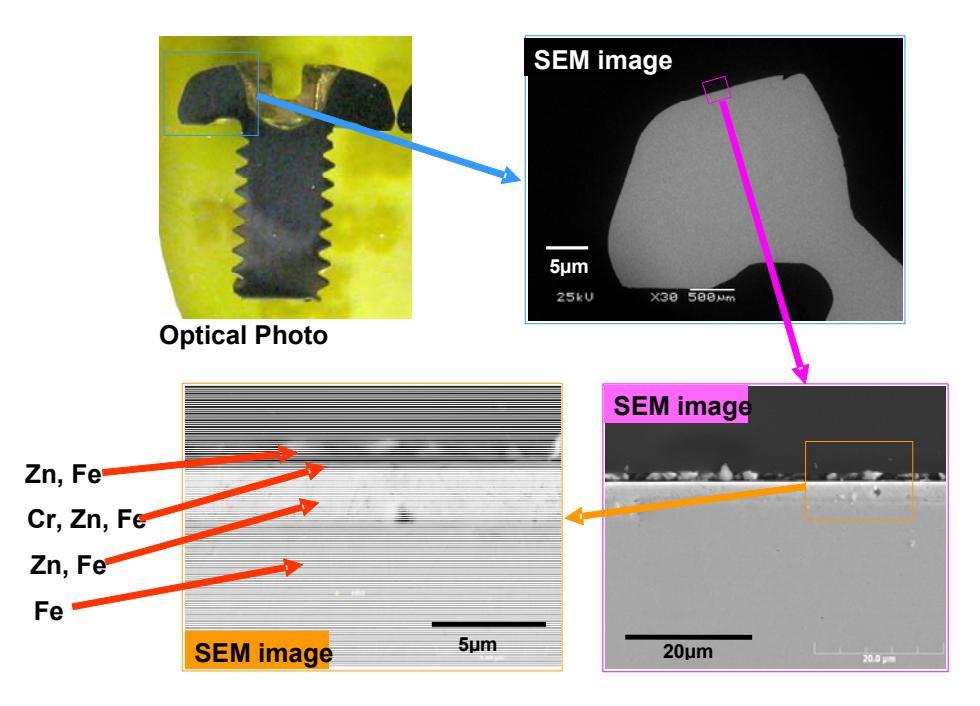
Table 5 shows the major elemental constituents of the hot, neutral and ground screws (note that these analyses are not complete and will be filled in as data become available). The bulk composition of receptacle hot screws is Fe. All of the hot screws are plated (to prevent rusting) with other metals or combinations of metals including Zn, Cr, Fe and Ni. The plating composition for the analyzed screws depends on the component that each originated from.

Figure 25: Optical and SEM images of a cross sectioned hot screw. Elemental analyses results are shown in the bottom left image for the bulk metal (Fe) and the plating layer (Zn, Fe, and Cr).
