# Power Steering Cold Start Squawk/Squeal Type Noise When Outside Temperature Below -24C (-12F) (Replace Power Steering Fluid) #04-02-32-002 - (Mar 1, 2004)

2004 Cadillac CTS, CTS-V

with 3.6L or 5.7L Engine (VINS 7, S -- RPOs LY7, LS6)

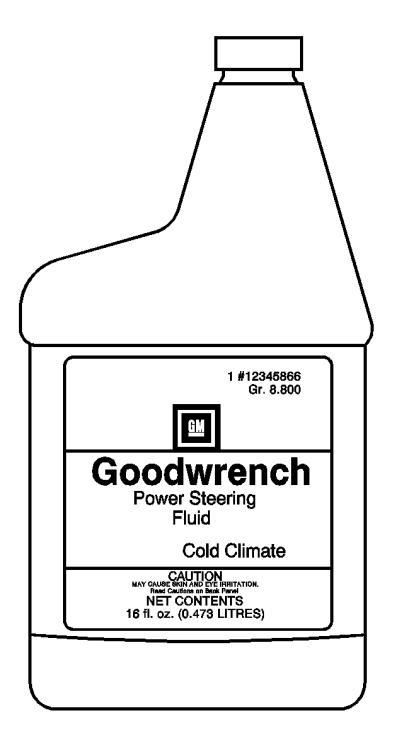
Some customers may comment on hearing a squawk/squeal type noise coming from the engine compartment and occurring when the outside ambient temperatures are very low (approximately -24°C (-12°F) and lower).

This condition may be due to the low ambient temperatures causing the power steering fluid to thicken in the same manner as any other petroleum-based oil or fluid. Upon cold starting, the fluid resists movement and does not circulate through the power steering pump as easily as it does after warming and thinning to its normal operating viscosity.

1. Flush the old fluid from the power steering system. Refer to Flushing the Power Steering System in the Power Steering sub-section of the Service Manual or SI document #662938.

- 2. Fill the power steering system with new Cold Climate Power Steering Fluid.
- 3. Bleed the power steering system to remove any trapped air. Refer to Bleeding the Power Steering System in the Power Steering sub-section of the Service Manual or SI document #487449.
