Nuclear Ship SAVANNAH

Radiological and Non-Radiological Spaces Characterization Survey Report

CONTRACT No.: DTMA1C05013

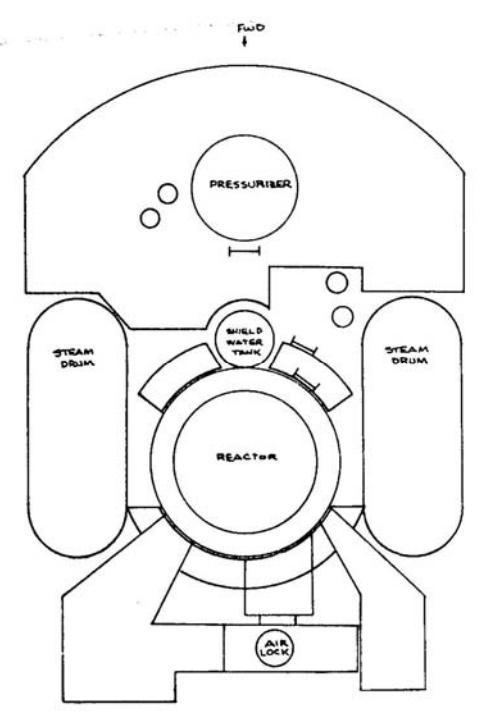
Figure 5A.6-2 Primary Containment Level 1 (Top)

The aft area of 1st level general area dose rate is 0.1–0.5 mR/hour. Next to and forward of the reactor, dose rates vary, with the highest being on the starboard side of the pressurizer at 0.7 mR/hour. Radiological contamination found in several locations <1000 dpm/100cm². One location to right of pressurizer has radiological contamination at 1200 dpm/100cm². See survey numbers NSS-0087, NSS-0079, and NSS-0083.

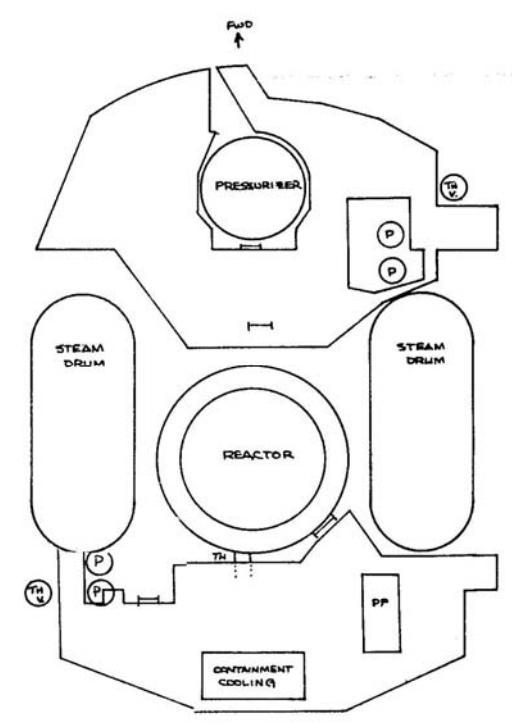
Figure 5A.6-3 Primary Containment Level 2

Dose rates on Level 2 vary 0.1–3 mR/hour. Highest reading is forward starboard near steam drum. No radiological contamination was found. See survey number NSS-0084.
