# **VAUSE CONSTRUCTION Ltd**

# CONSTRUCTION PHASE HEALTH & SAFETY PLAN

# Kingswood Rd Prestwich Manchester M45 0AR

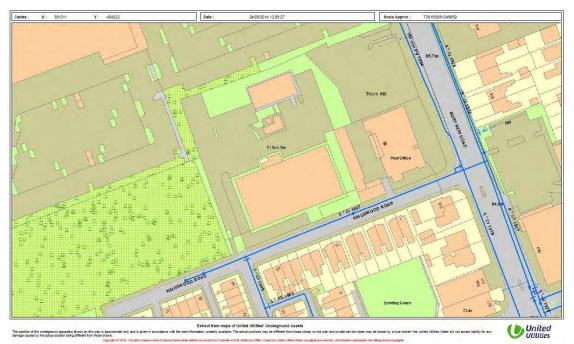
Figure 4.1 United Utilities Water Asset Plan

No diversion costs are anticipated as the water main within Kingswood Road is located in carriageway.

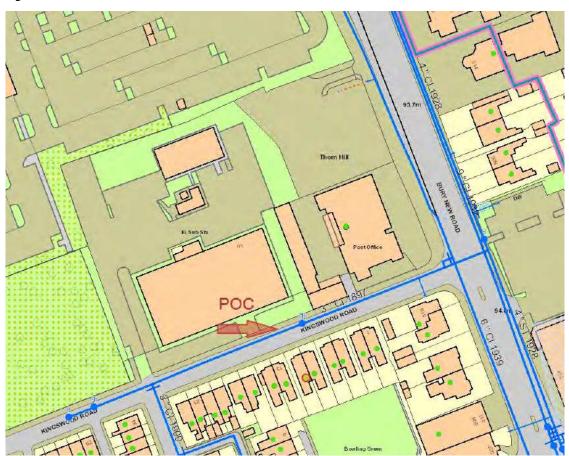
Figure 4.2 United Utilities Point of Connection

An estimated cost for the new connections (24 units) and infrastructure charges associated to the units is £26,400.

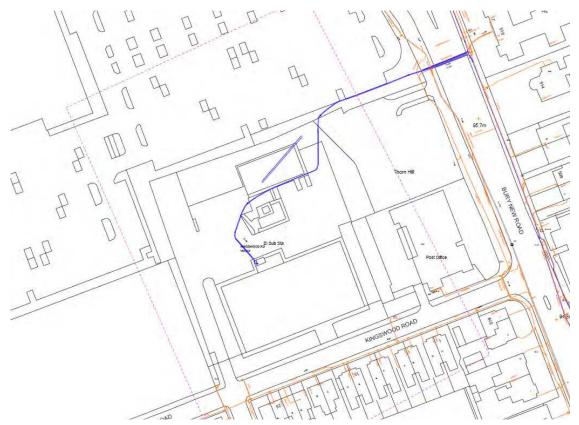
Figure 5.1 ENWL Asset Plan

No diversionary works are anticipated to the existing low voltage network.

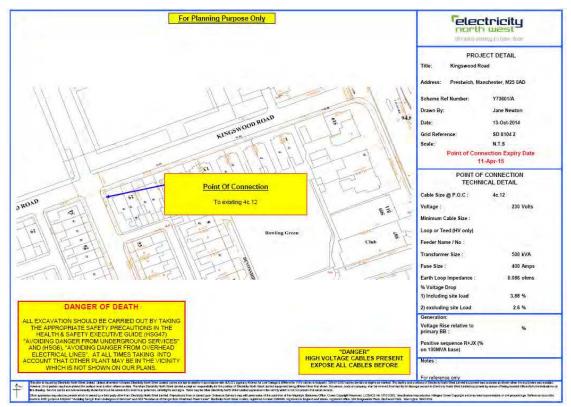
Figure 5.2 ENWL Low Voltage Point of Connection

Figure 5.2 shows the existing low voltage network that the point of connection (POC) will be taken from.

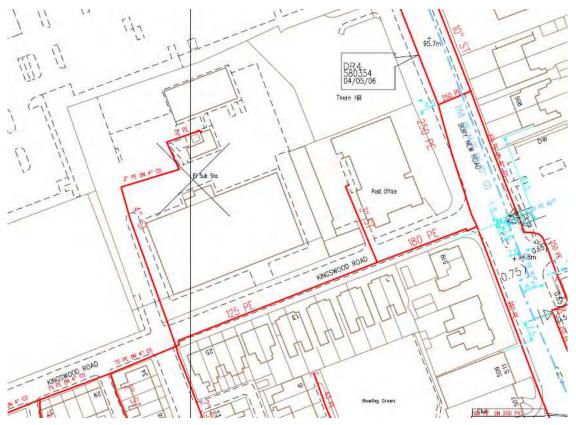
Figure 6.1 National Grid Gas Network Asset Plan

No diversion costs are anticipated.

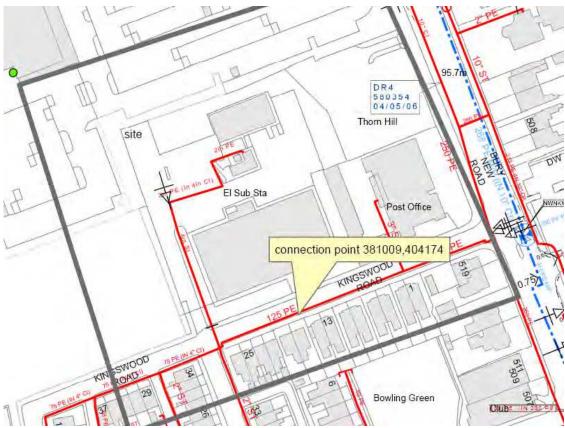
An estimated budget cost for the new low pressure main to be installed from Kingswood Road and 24 plot connections is £12,000.

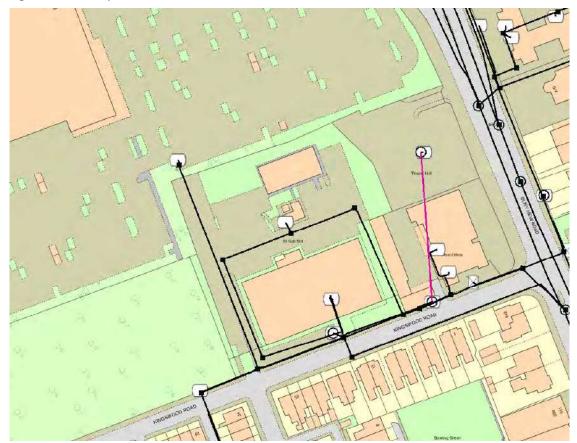
Figure 7.1 B.T Openreach Asset Plan

Please note that the above estimate is based on a copper network, if optical fibre is presents costs could significantly increase.

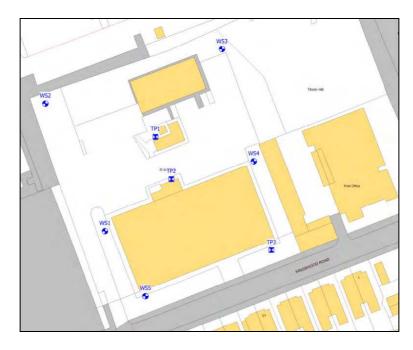
Full copies of the Geo Assist reports have been included within Appendix E The sketch below shows the exploratory hole locations of the Geo Assist investigations.

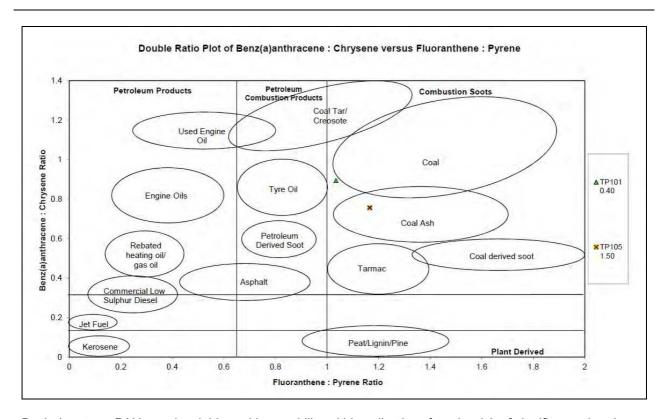
Double ratio plots determine TP105 as coal ash and TP101 as coal and combustion soots. This is shown below:

By their nature, PAHs are insoluble and low mobility within soils, therefore the risk of significant migration to the underlying aquifer or off-site receptors is deemed low. Residual human health risk will require mitigation via remediation options. See Section 14 for remediation details.
