# Fistula Salvage Utilizing the HeRO Vascular Access Graft

in Dialysis Patients

James Lin, MD, Aaxess Partners, Vascular Access Center, Tampa, FL Victor D. Bowers, MD, Surgery, LifeLink HealthCare Institute, Tampa, FL James T. Huang, MD, Surgery, LifeLink HealthCare Institute, Tampa, FL

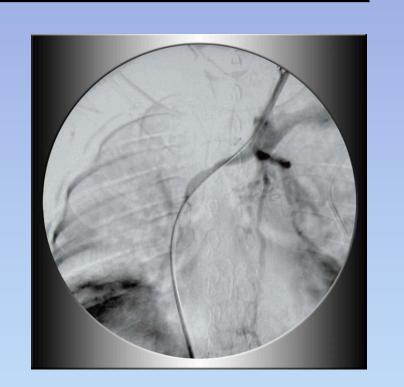
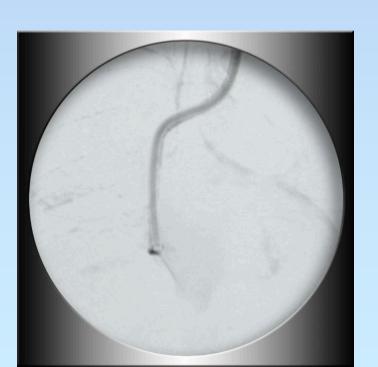
Images above reflect a typical HeRO access placement. No images from the referenced patient procedures were available. In the referenced procedures, the arterial anastamosis was connected to existing fistula rather than brachial artery. A bridging catheter was avoided and fistula was used for immediate cannulation.
