## COLORADO CULTURAL RESOURCE SURVEY

**Architectural Inventory Form**

1. Resource number: **5SM.1749**  
 2. Temporary resource number: **N/A**  
 3. County: **San Miguel**  
 4. City: **Telluride**  
 5. Historic Building Name: **Miners' Hospital; Dr. Hall's Hospital; Hadley Hospital;  
American Legion Hospital; Community Hospital; San Miguel  
County Historical Museum**  
 6. Current Building Name: **Telluride Historical Museum**  
 7. Building Address: **201 W. Gregory Avenue**  
 8. Owner Name and Address: **Town of Telluride  
P. O. Box 397  
Telluride, CO 814350397**

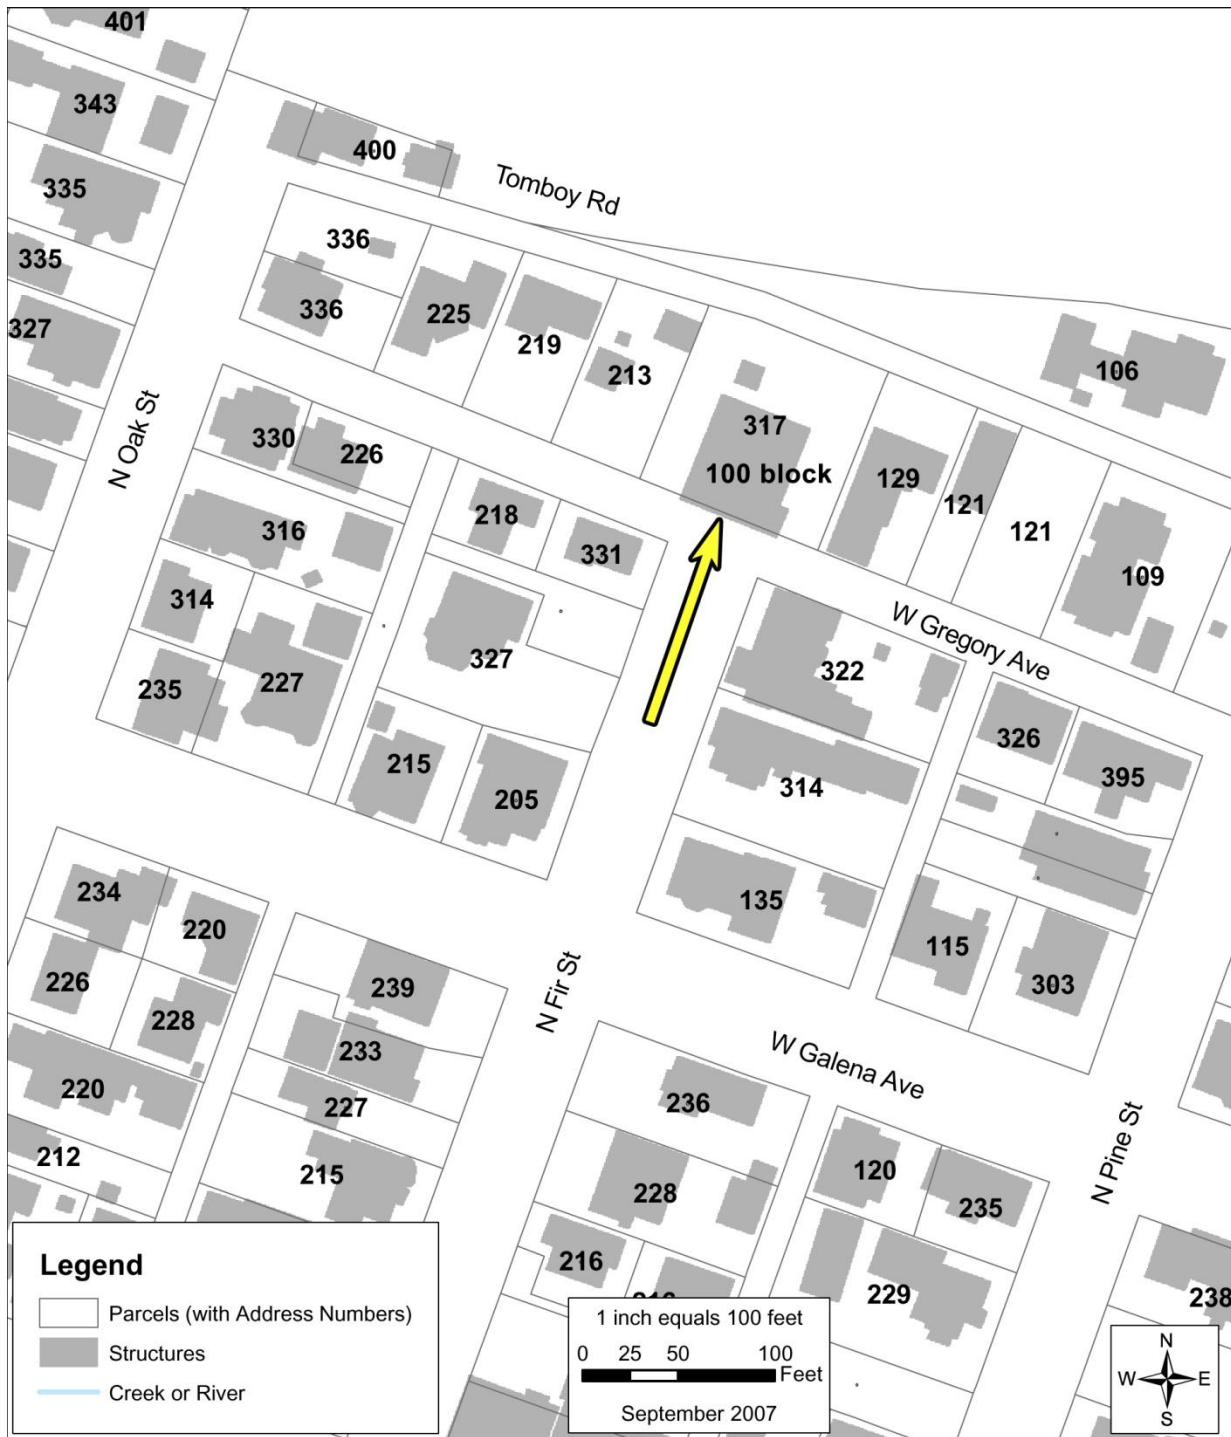
## Sketch Map

**The Telluride Historical Museum is located on the north side of Gregory Avenue at the north (top) end of Fir Street. Tomboy Road ascends the mountain behind the building to the north.**

| A shed (THAS #88) is located directly behind the museum. This single-story building measures 12' by 10', and has uncoursed sandstone walls with concrete mortar. It is covered by a shed roof with metal roofing material and closed eaves. An unpainted vertical wood plank door, side-hinged with metal strap hinges, enters the south elevation. |
| Another shed (THAS 64) is located northwest of the museum just below Tomboy Road. This structure was previously located at 317 N. Oak Street (5SM.1688) before it was moved to its present location. It appears either to be associated with the Museum property here at 201 W. Gregory or with the adjacent property to the west at 213 W. Gregory. This single-story wood frame structure measures approximately 12' by 16'. Its north and east elevation walls are clad with corrugated metal. Its south elevation wall is clad with painted red board and batten. Its west elevation wall (facade) is clad with painted cream white vertical wood siding. The roof is a moderately-pitched front gable, with corrugated metal laid over 1x wood decking and 2x wood rafters. A stained brown wood-paneled door enters the south end of the west elevation. Windows penetrate the north and south elevations. |
