Discretionary Five-Year Review Report

Jibboom Junkyard

Sacramento

September 2007

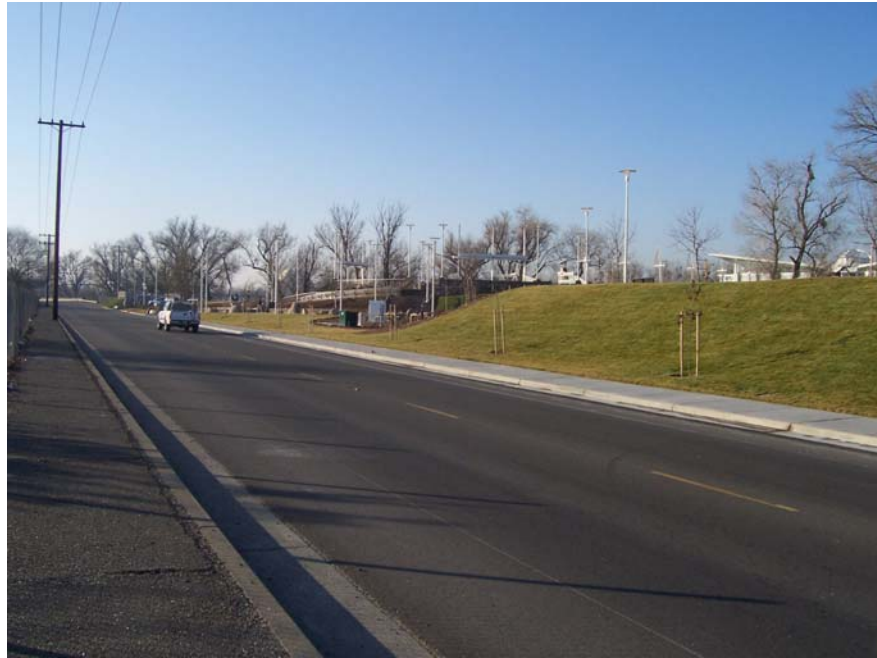
Jibboom Street and Jibboom Park, Sacramento. Park surface elevated by ten feet from original grade. View looking south, January 2007.

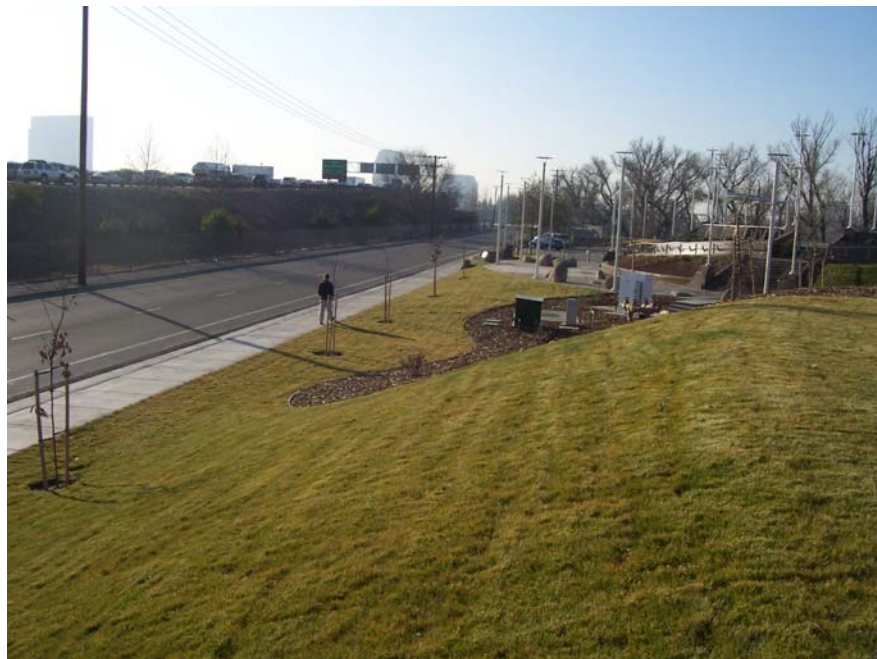
Jibboom Park, Jibboom Street and Elevated Interstate 5 Freeway Right-of-way . View to the south toward downtown Sacramento skyscrapers.

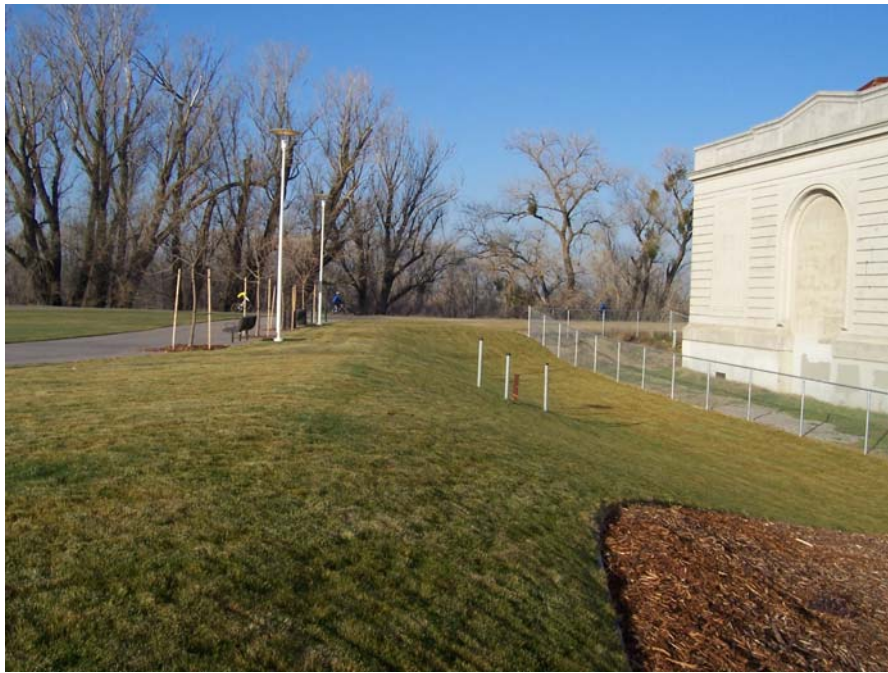
Northern boundary of Jibboom Street Park with former PG&E building, looking west toward Sacramento River with bicycle trail along top of the levee.

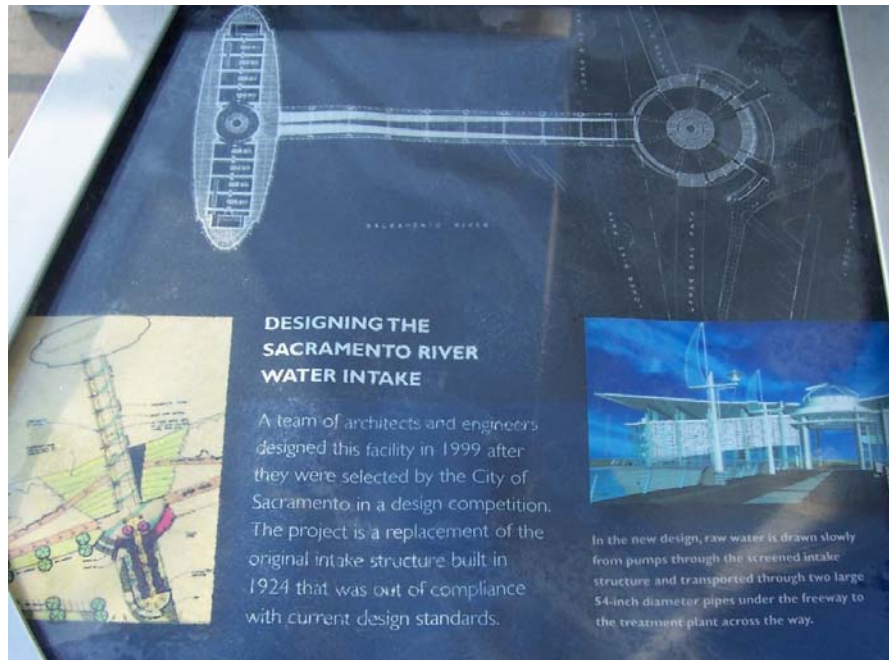
Interpretive sign on bridge to Water Supply Intake Structure from Jibboom Park. The structure was completed in 2004, including two 54-inch diameter pipes under the freeway

Kevin asked about the construction of the two 54-inch water pipelines for the new water intake structure. Mr. Day did not know if any soil was excavated or disposed or if any of the subsurface was tested for contamination during the project. He suggested that EPA contact the City Utilities Department. Kevin asked about the curb construction project we had observed in August 2006. Mr. Day pointed out that there were no storm drains along Jibboom Street. He mentioned that the City was working on major redevelopment projects for the Union Pacific Railyards just east of the freeway and a bit to the south of Jibboom Park. He thought that these projects could involve construction of storm drains along Jibboom Street and possibly other utility lines along Jibboom Street and I-5. We discussed whether such excavations would affect contaminated soil below the roadways and how ICs could help.

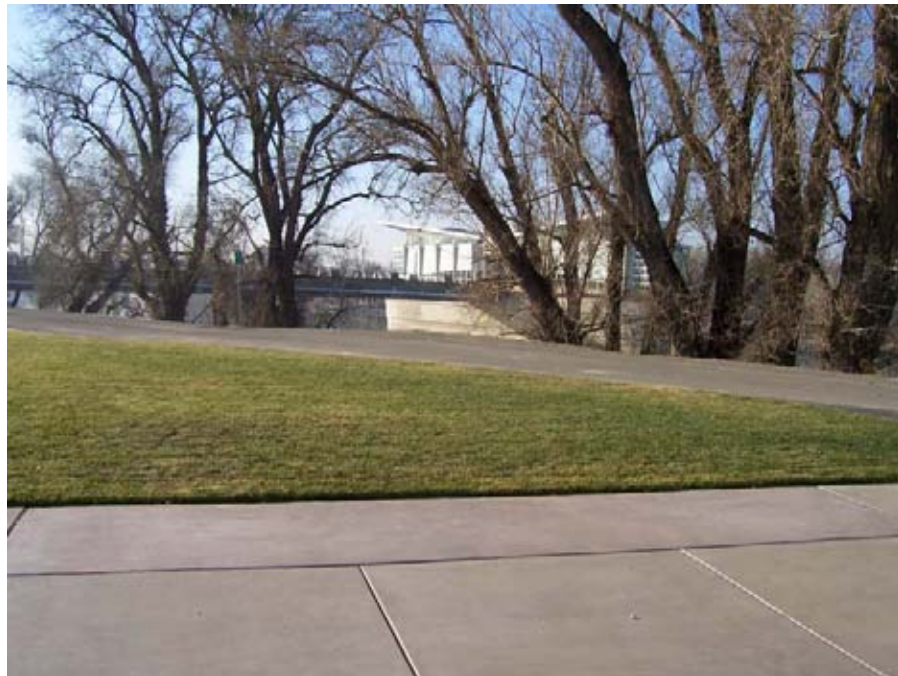
Water Supply intake structure in Sacramento River directly west of Jibboom Park.

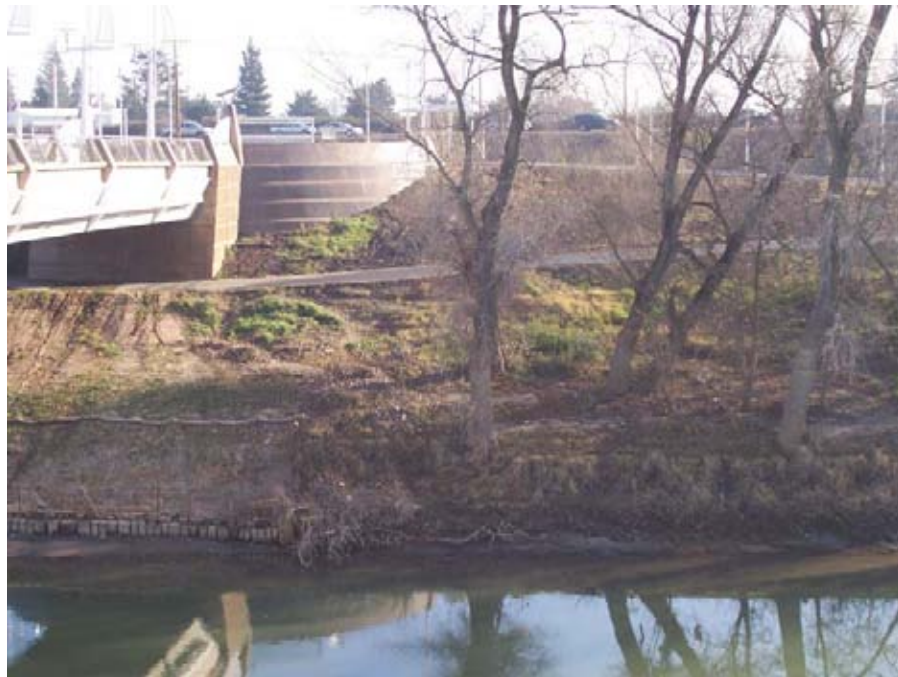
Sacramento River levee and Jibboom Park from water supply intake structure. View to the east, with elevated I-5 freeway in the background. Bicycle trail allows cyclists to ride under the bridge or to ride to fountain area of the park.
