**Frazil Ice Jam Survey and Report
Cannon River at Northfield, Minnesota.
December 3, 1991 and January 3, 1992.**

CEMVP-ED-GH (1110-2-1403)

SUBJECT: Ice Jam Survey, Cannon River at Northfield, Minnesota, December 3, 1991 and January 3, 1992.

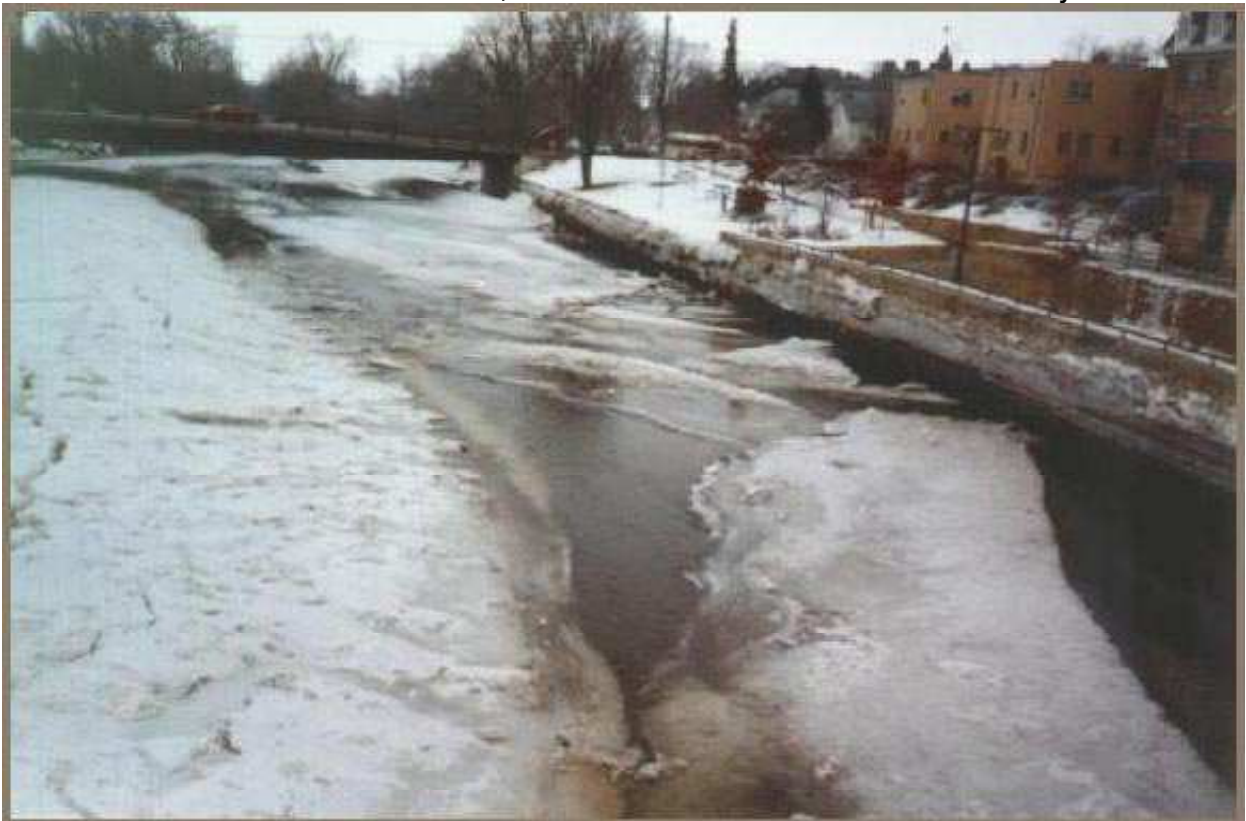
Frazil Ice Jam at Northfield, Minnesota: December 1991–January 1992

4. We inspected the area in town where the jam was occurring. I took still 35mm photos and Matt Bray shot some VHS video. It was quite evident from the Water Street bridge, just downstream of the dam, that frazil mounds were being formed. The surface of the ice completely covered the width of the river and looked not unlike a farmer's field after plowing, with the furrows normal to the flow of the river. The plunge pool below the dam was submerging the frazil and transporting it under the ice cover.

proceeded to the area just downstream of the dam. The ice cover had dropped about 4 to 5 feet from its maximum elevation according to marks along the channel wall. Photos of the river were taken. Below the dam, the water was flowing on top of the ice. Portions of the ice cover had been eroded quite extensively since the flood event. The flow over the ice had developed a meander pattern. In some locations the flow was completely under the ice. In other locations, flow was on top as well as under the ice. A good deal of vertical relief was evident in the ice cover.

- a. The City should be aware that the conveyance of the river downstream of the dam has been seriously compromised by the frazil accumulations. These deposits are now grounded and are not likely to be transported downstream intact.
- b. The pool ice cover above the dam is in very poor condition. It is very thin and
