Cultural Landscape Report for Drakesbad Guest Ranch

CULTURAL LANDSCAPE REPORT FOR DRAKESBAD GUEST RANCH LASSEN VOLCANIC NATIONAL PARK

March 2005

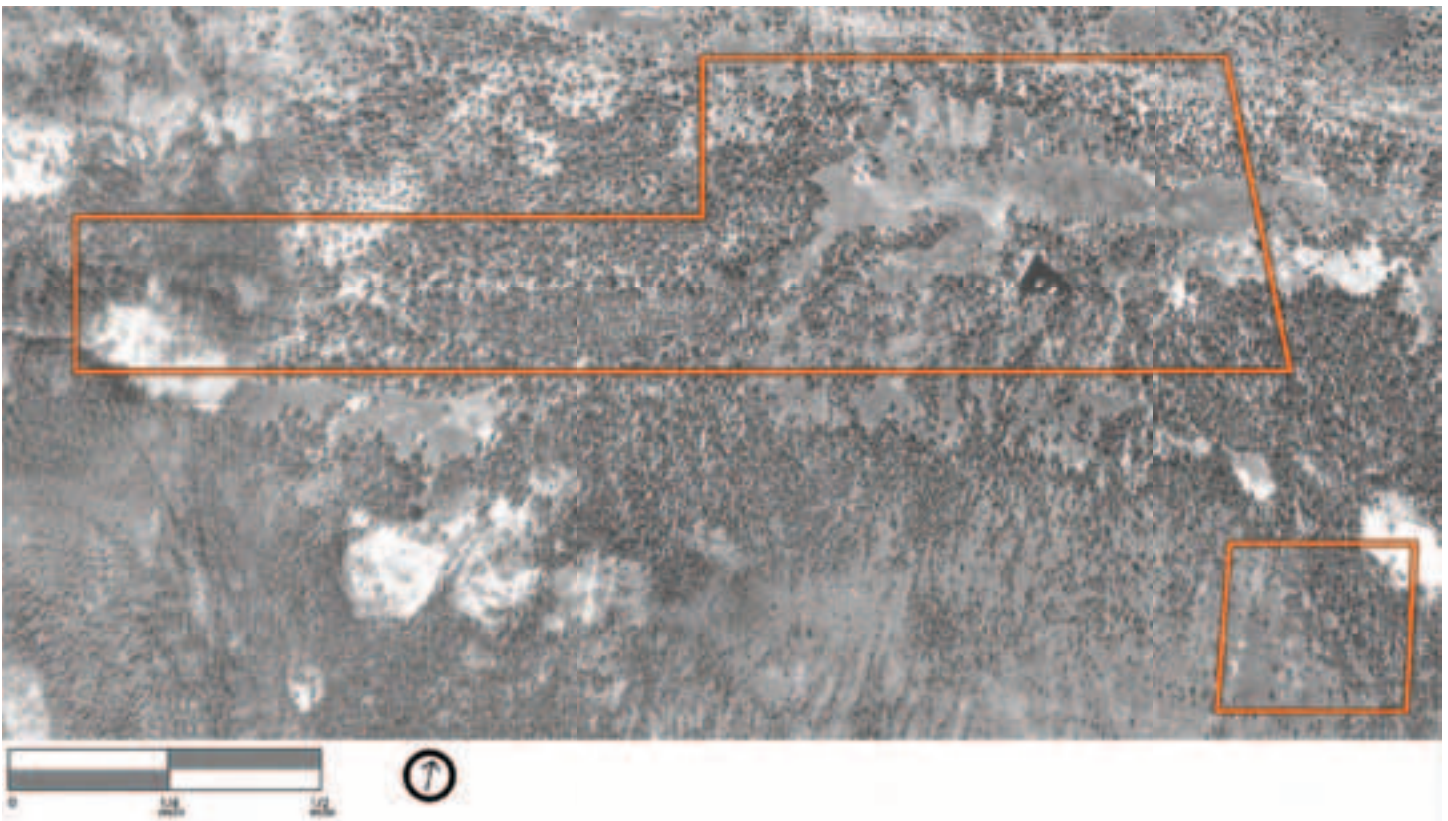
The project boundary, as defined by the National Register Nomination, reveals two discontinuous parcels which make up Drake's original claim and Sifford's later purchase.

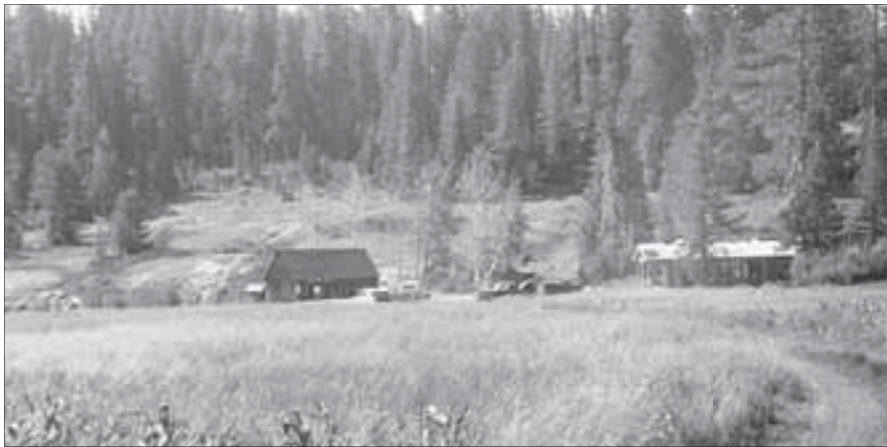
For a short time the swimming pool was flanked by two bath houses, east and west of the pool. This photograph shows the new bath house (on the right) under construction. Photo, 1962. (LAVO Collection, newbath)

The new swimming pool, like the previous pool structures, combined hot water piped from a spring south of the creek with cold water, to regulate the temperature of the pool water. The NPS also constructed a new bathhouse, which was sited at the west end of the pool (the earlier bathhouse was located at the east end of the earlier rock and cement pool). A small wood frame chlorinator building treated the

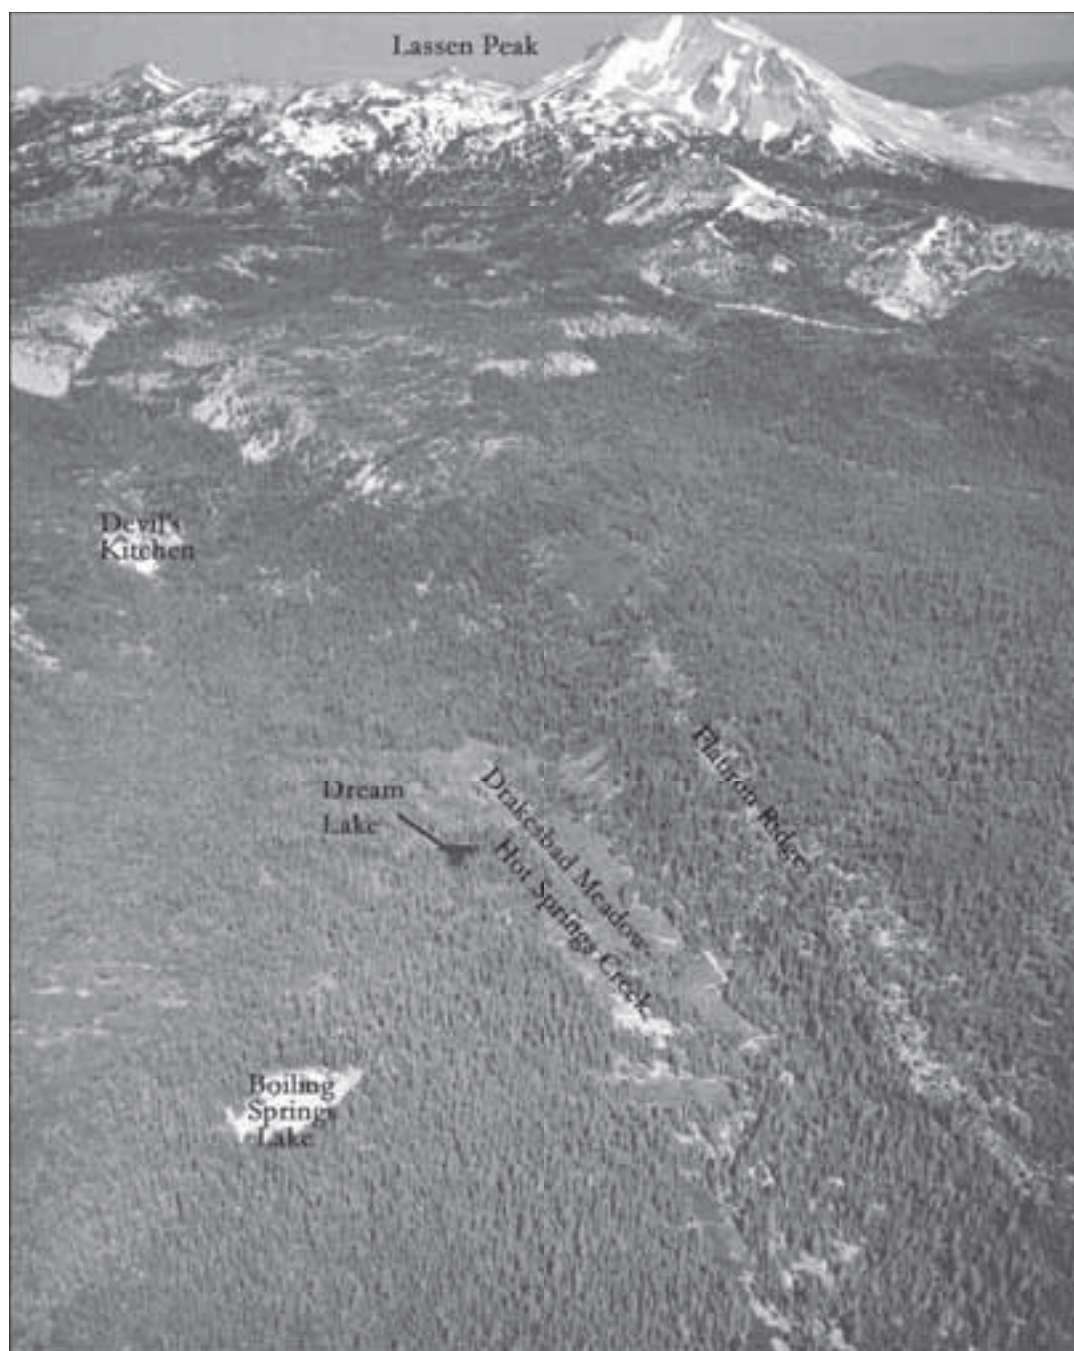
1967 aerial photograph showing key natural systems associated with the historic district including the relatively level, open area of Drakesbad Meadow, surrounding forests, Boiling Springs Lake and Devil's Kitchen . Photo July, 1967 by Clay E. Peters. (LAVO Collection)

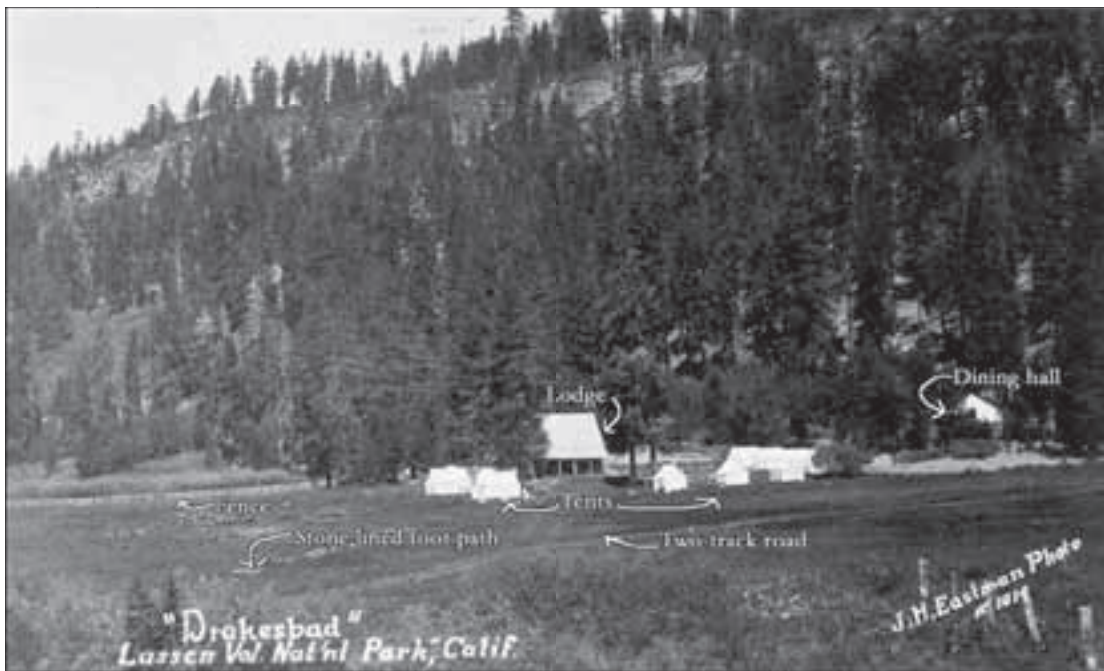
Early core development, including the lodge and the dining hall, was located north of the meadow. A fence system, stone lined foot-path, and two-track road are visible within the meadow. Photo, circa 1926. (LAVO Collection, Eastman photo #1014.)

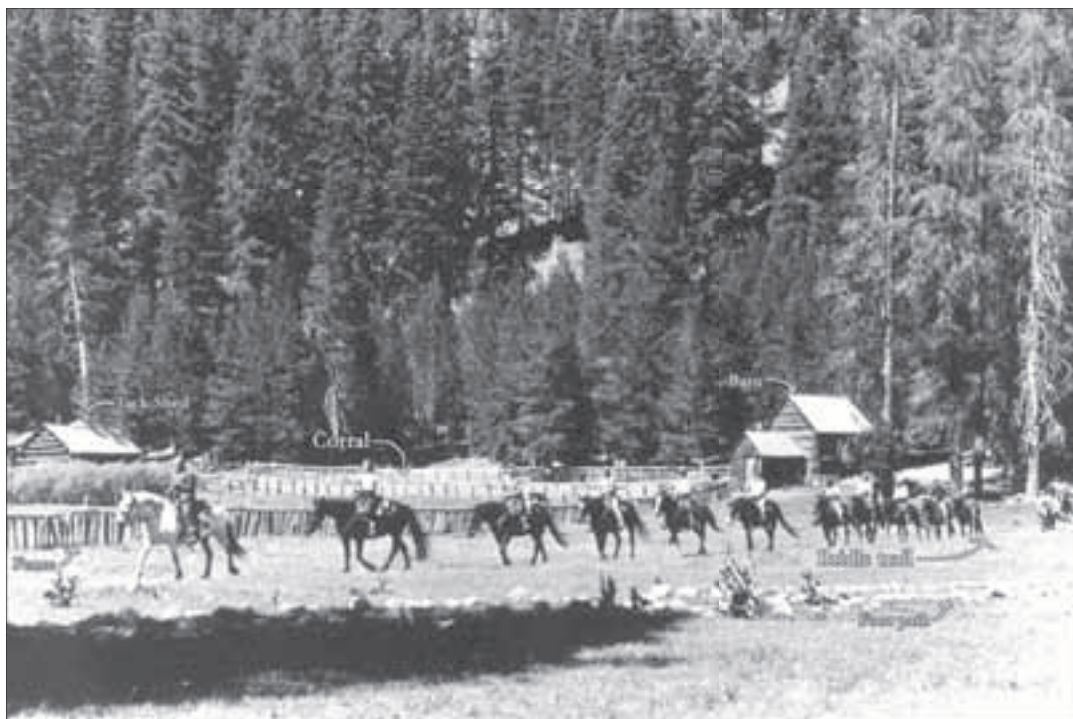
A view from the south reveals the length of the corral, which extended from the tack shed on the left (west) to the barn on the right (east). Photo, circa 1942. (LAVO Collection, DB22.)

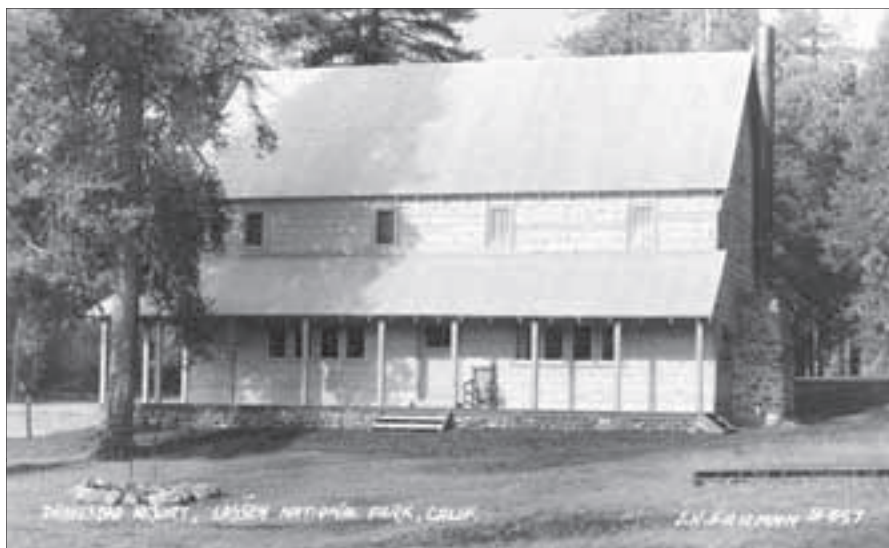
View looking south toward the kitchen and dining room. Photo, circa 1941. (LAVO Collection, DB79)

at Drakesbad consisted of a wood-frame, gable roof kitchen, and a relatively large wood-frame and canvas covered dining room. Both structures were built as early as 1914 on the slope of the hill above the lodge. The canvas dining room was oriented on a north-south axis with a stone foundation absorbing the change in grade as the structure extended down slope from the north. Remarkably, this structure served as the dining hall until it was replaced, once by 1941, and again in 1952 after collapsing in the winter of 1951-52. The two-story kitchen on the north side of the building was also rebuilt in the 1940s, and again in the early 1950s. Over the years, small one-story additions to the northwest and northeast corners of the kitchen structure have modified the simple rectangular plan of the building. Today, the gabled roof is covered with standing-seam metal and the exterior walls are lapped boards. Primary entrance to the dining hall is along the southwest elevation.

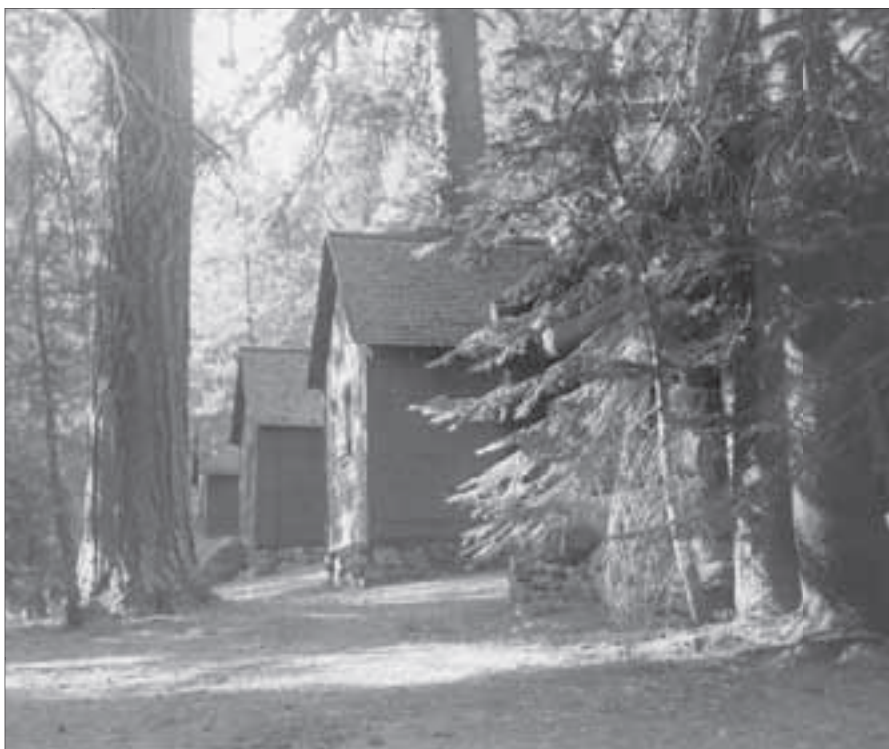
Looking west along the back edge of single room cabins (272, 273, 274 and 275). Only three of the four cabins are visible in this view. The cook's cabin (since removed) is obscured by the trees in the right hand corner. Photo, 1952. (LAVO Collection, NEG 1612)

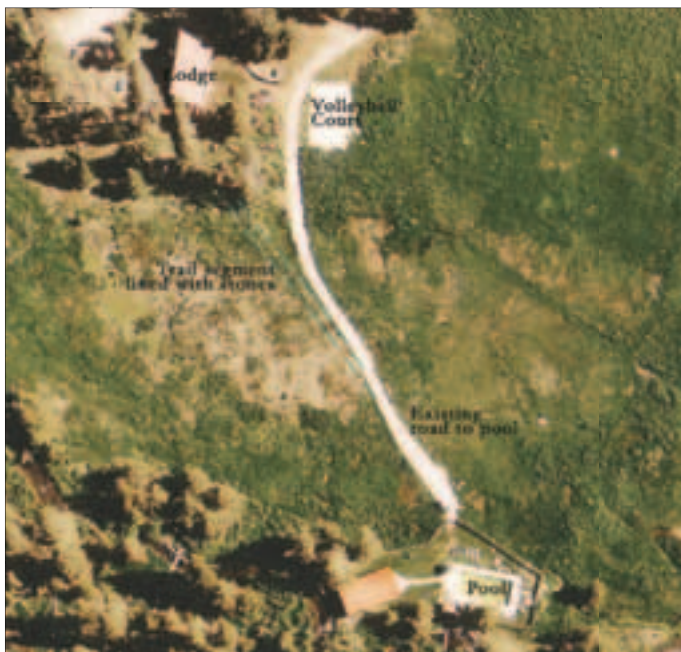
Historic trail segment located between the southeast lawn of the Lodge and the existing road to the pool.

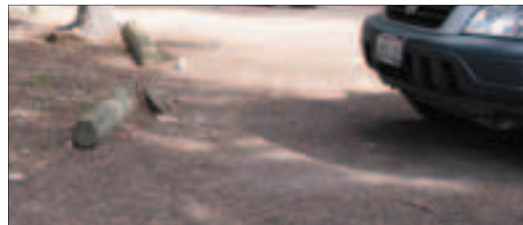
Existing wood bumper stops are undersized and ineffective.

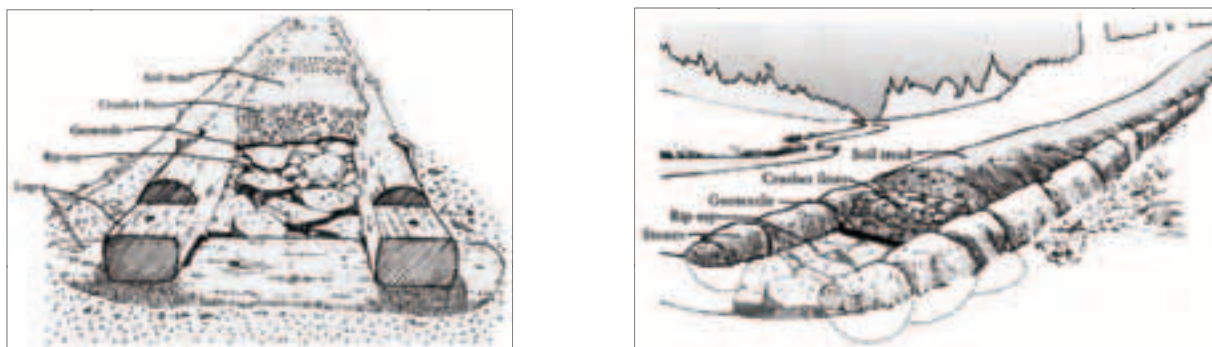
As a second option, a low-profile boardwalk is an acceptable for replacement of portions of the trail tread. A soil survey is required to establish suitable hardware to support the structures. (One product option is the Pin Foundation Diamond Pier™; other structures suitable for saturated soils are available.) Trail treads should be located to provide minimal clearance for water flow. Decking should be constructed from rough-hewn timbers and laid side by side. Decking should be constructed from rough-hewn timbers and laid by side by side. Walkways may have wooden curbs (bull rails) of peeled logs no more than twelve inches in diameter. Boardwalks should be constructed to mimic the alignment of the original trail whenever possible and to follow a curvilinear route, avoiding rectilinear angles.

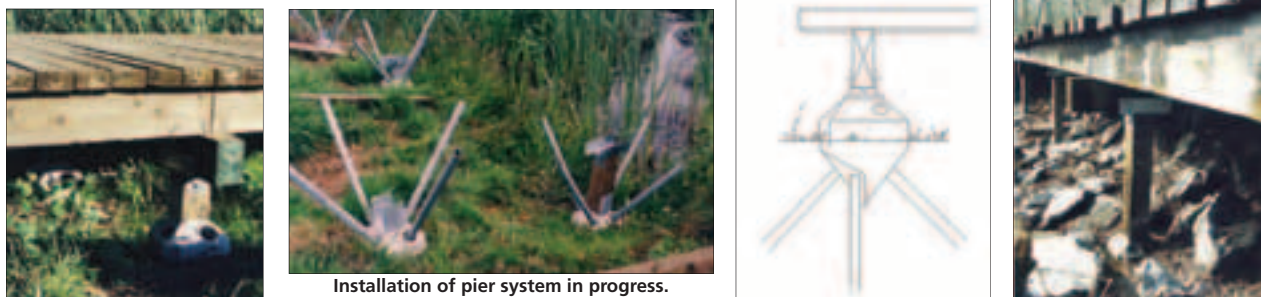
Installation of pier system in progress.

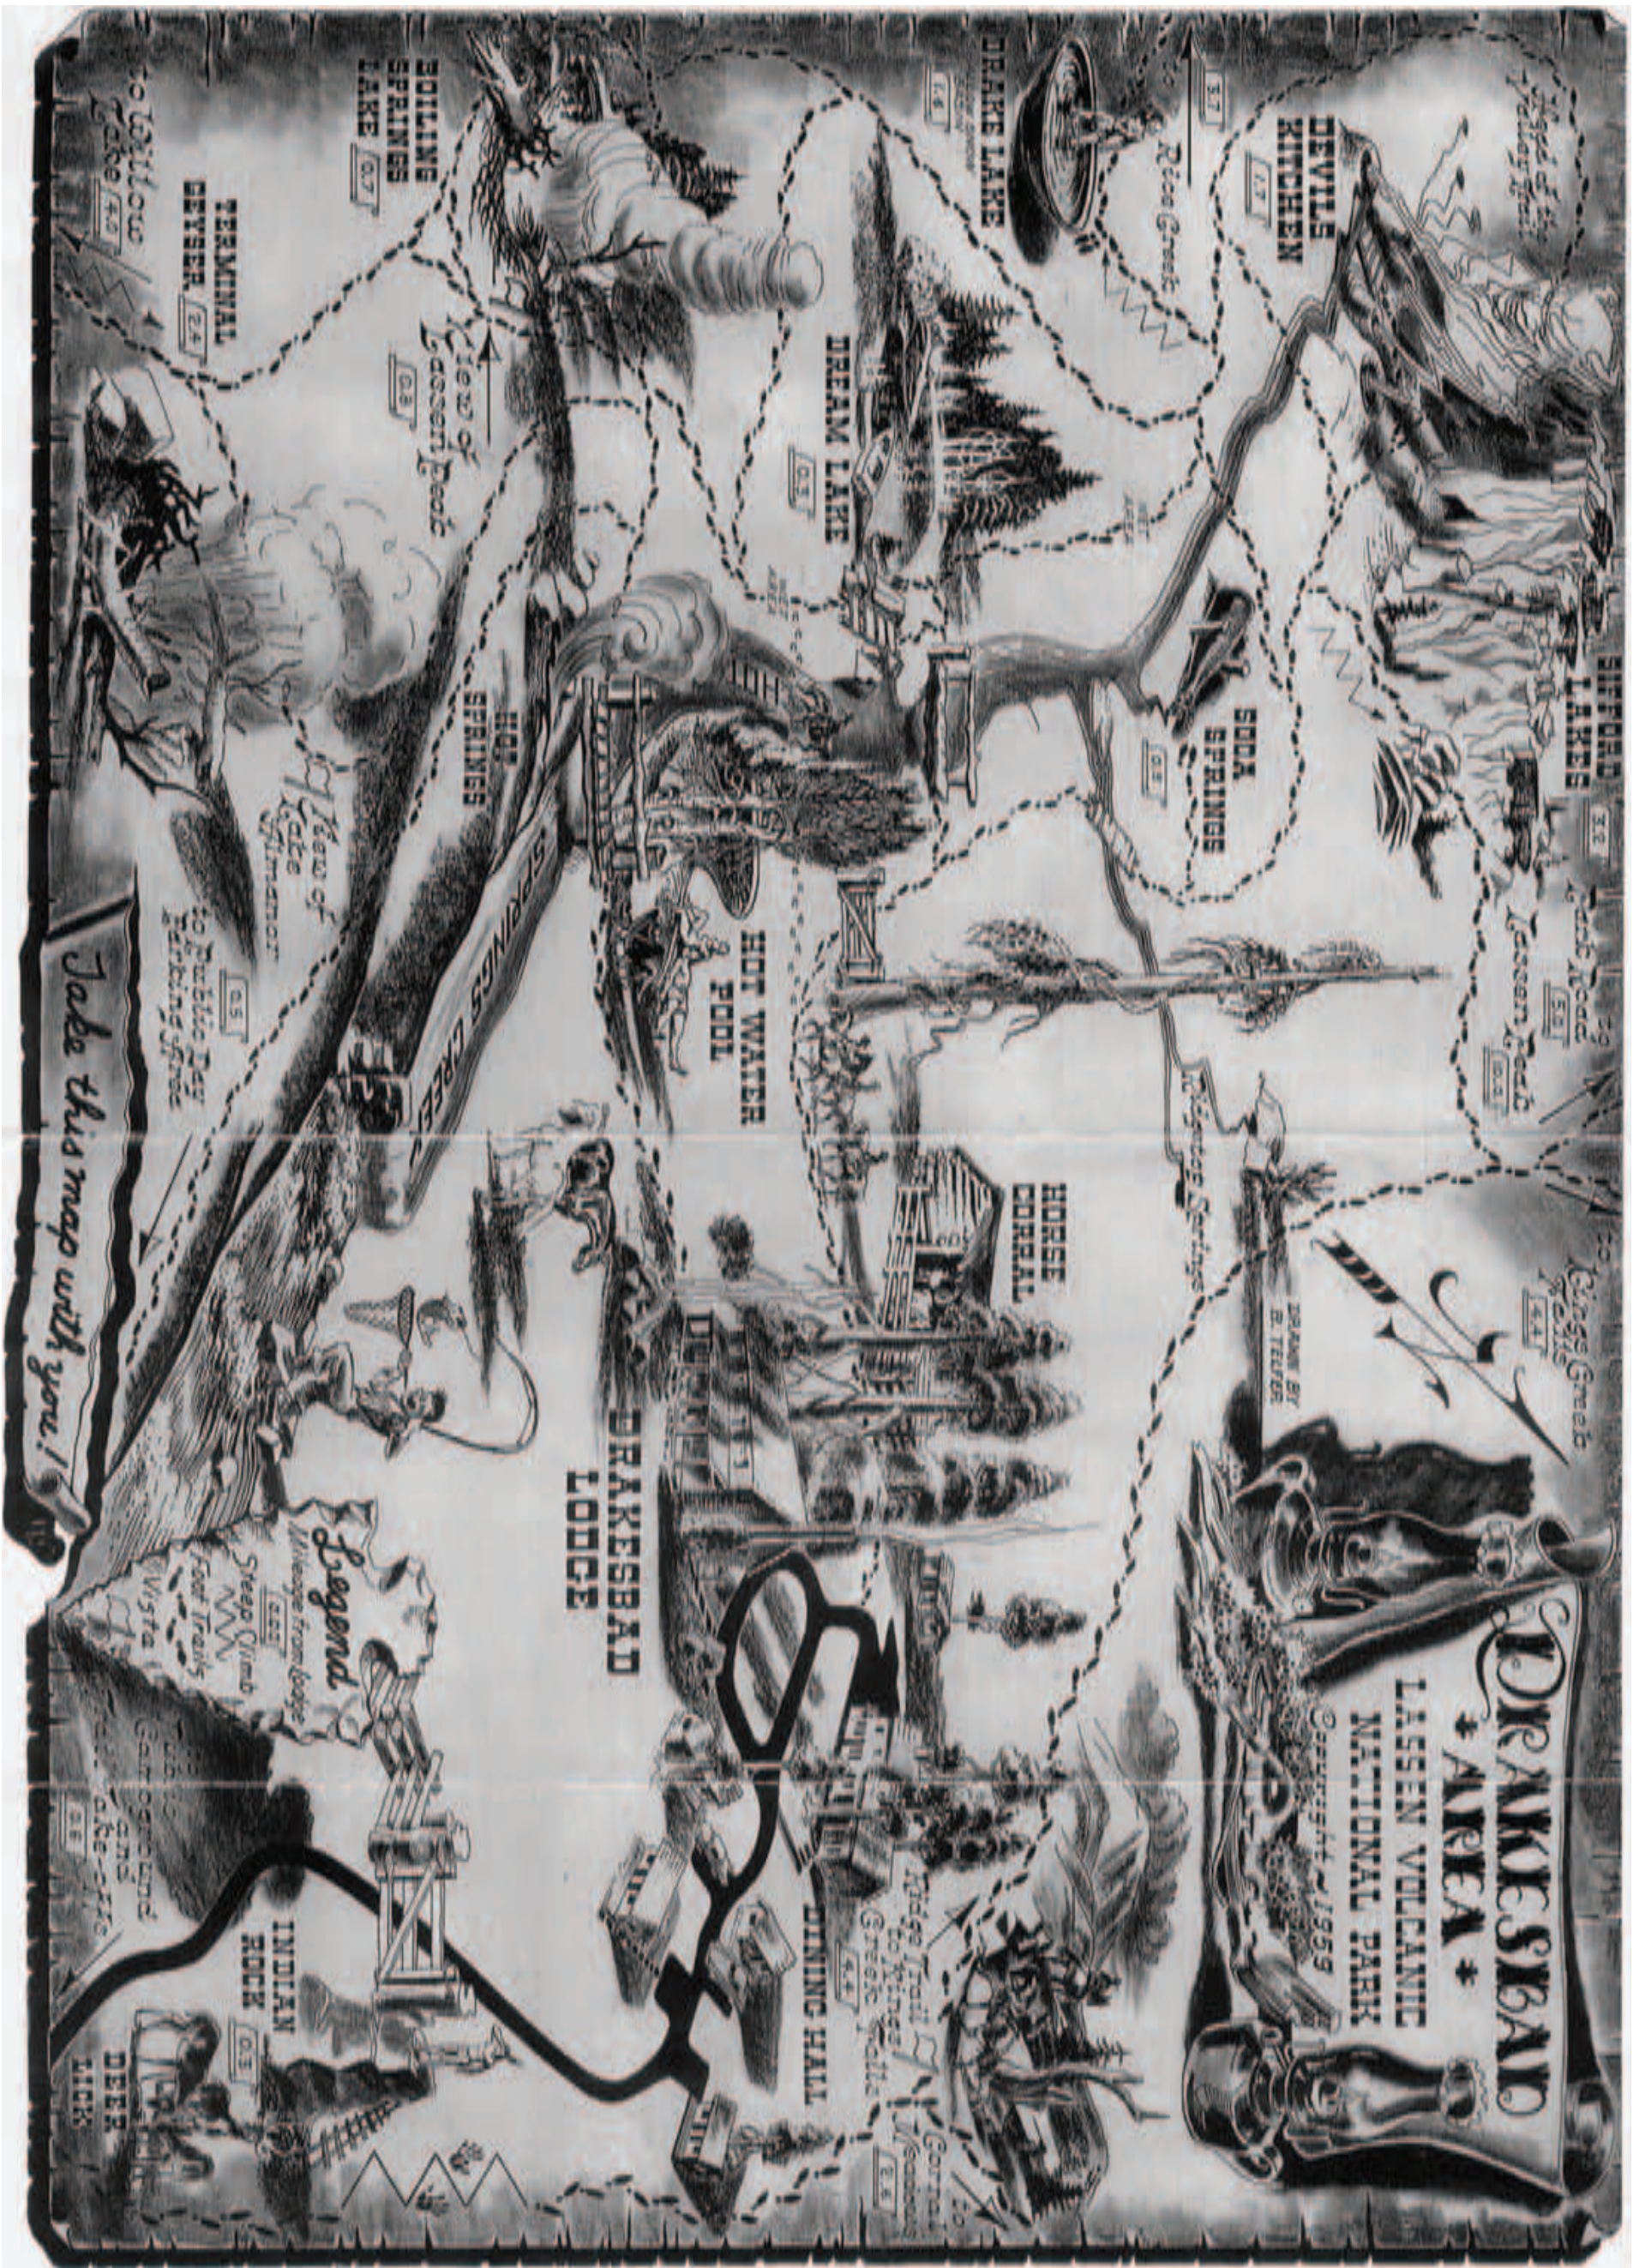
This artistic map, published just after the historic period in 1959, illustrates the expansive network of historic trails in the Drakesbad area.

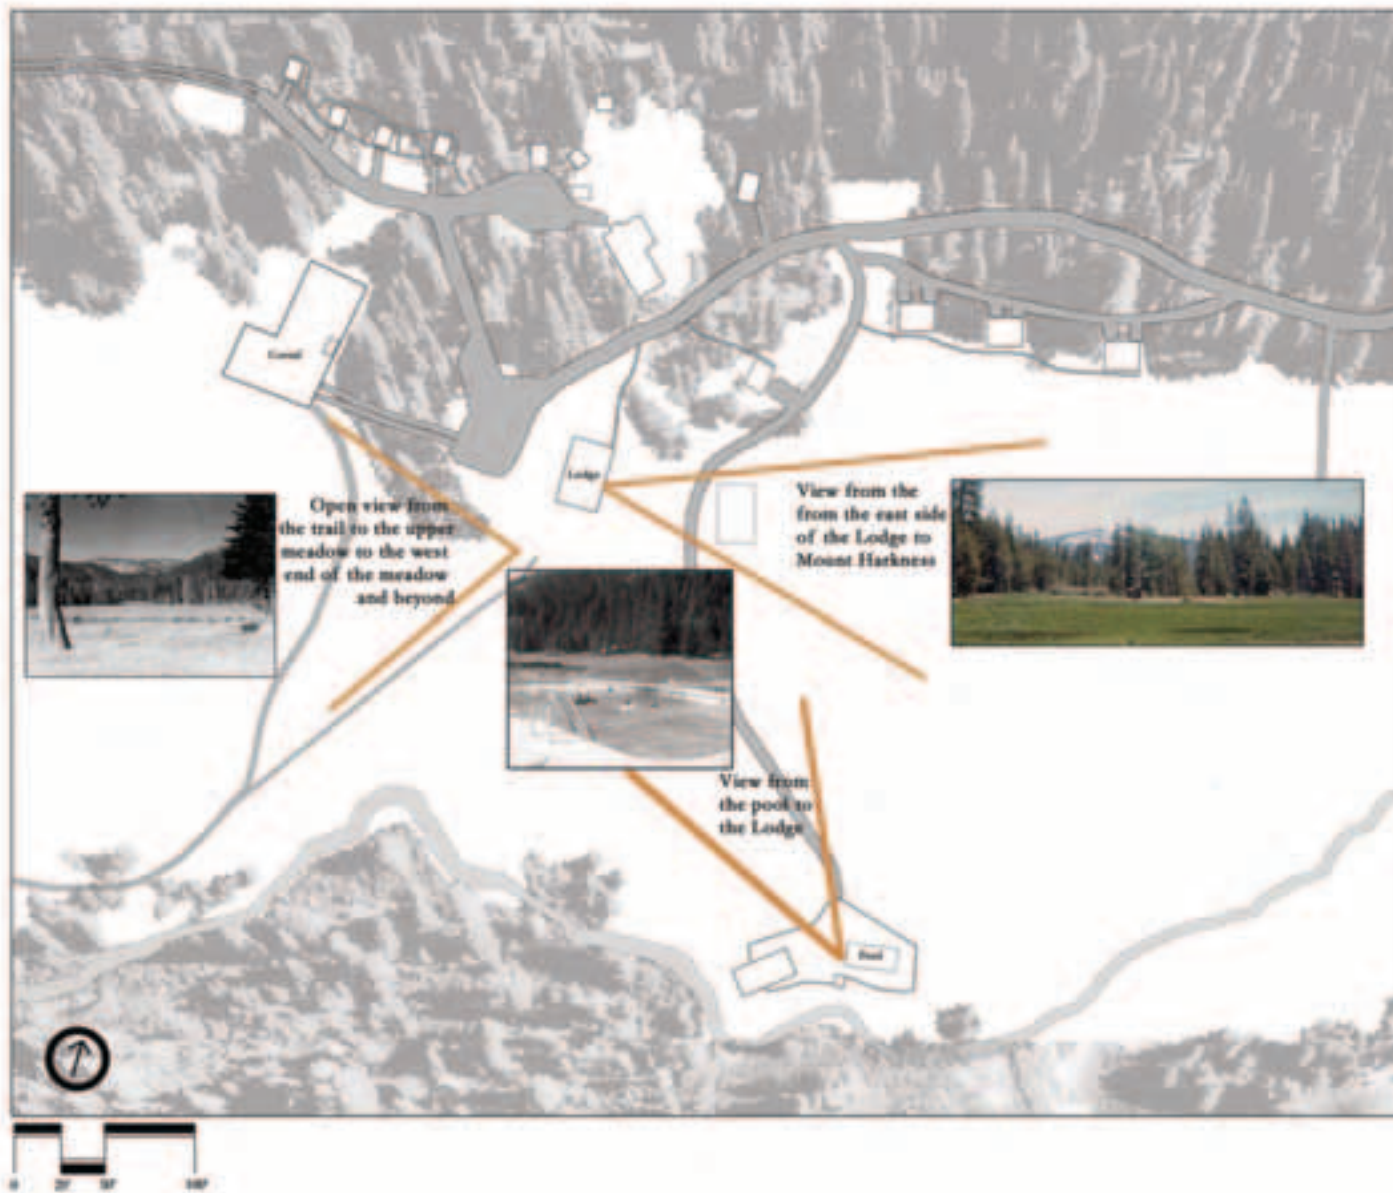
Location of ditches and creek based on field work conducted by Lindsay Paterson, advised by David Cooper, Colorado State University

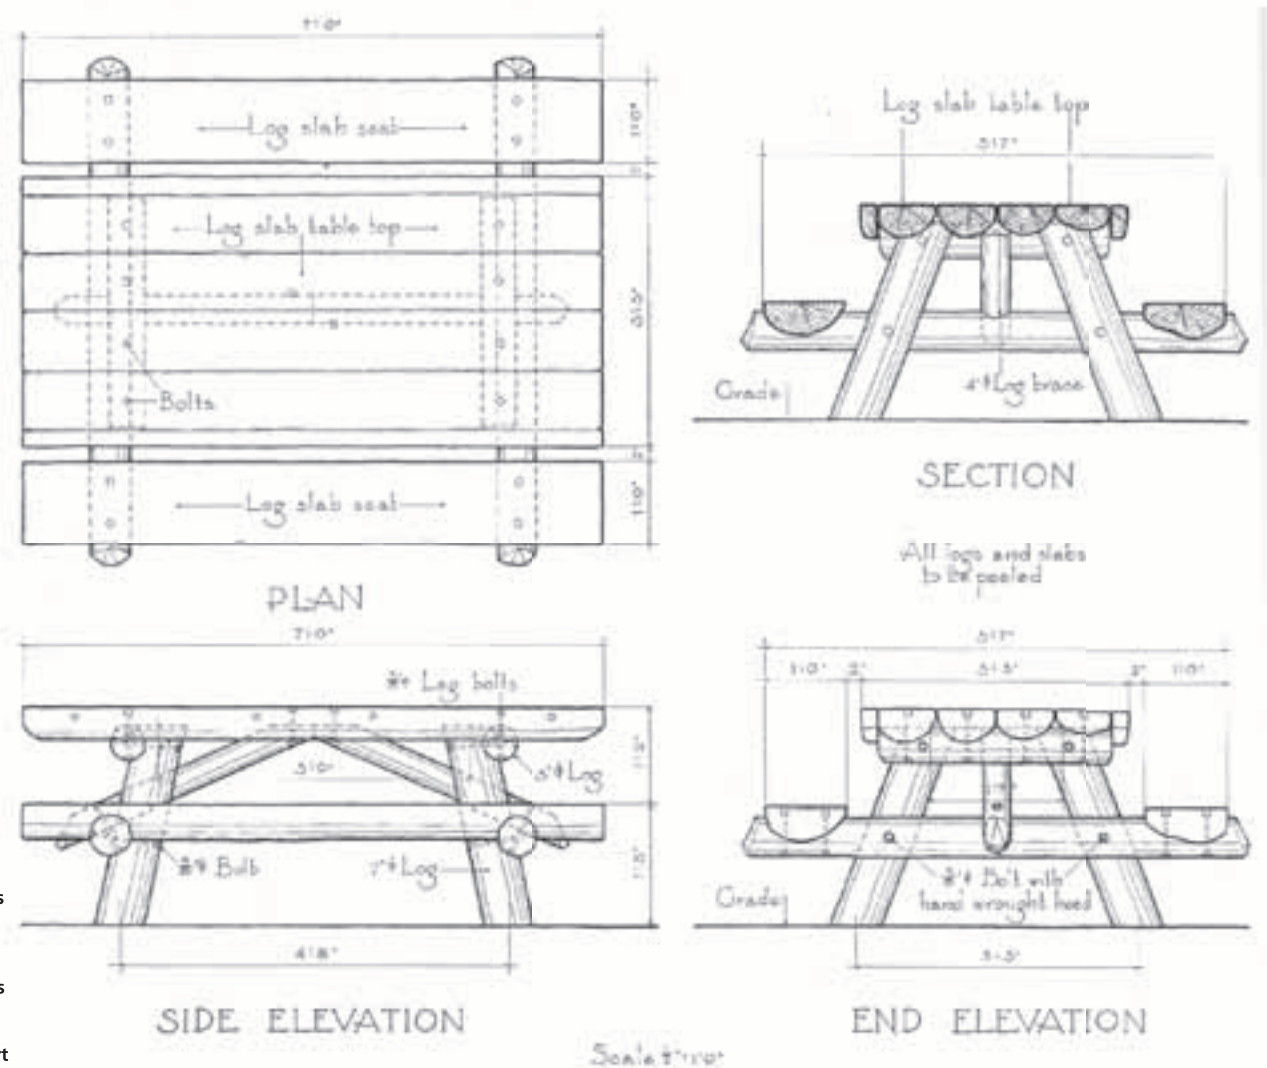
Compatible designs for picnic tables with substructure members in the round. (Illustrations from *Park and Recreation Structures* by Albert H. Good)
