# Inspection Report

**Property Address:**  
1234 Main St  
Anytown OR 99999

**Thompson Home Inspection, LLC**

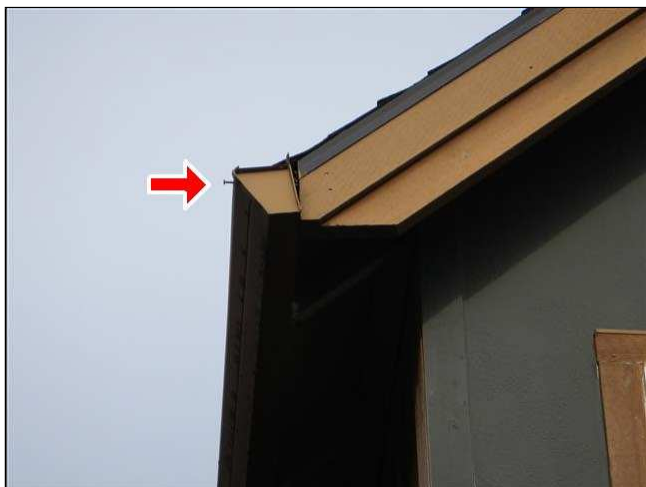
The gutter spikes need to be tightened to keep the gutters tight against the roof.

1.8 Picture 1 Spike protruding out needs to be tightened in order to keep gutter against fascia and water away from house.

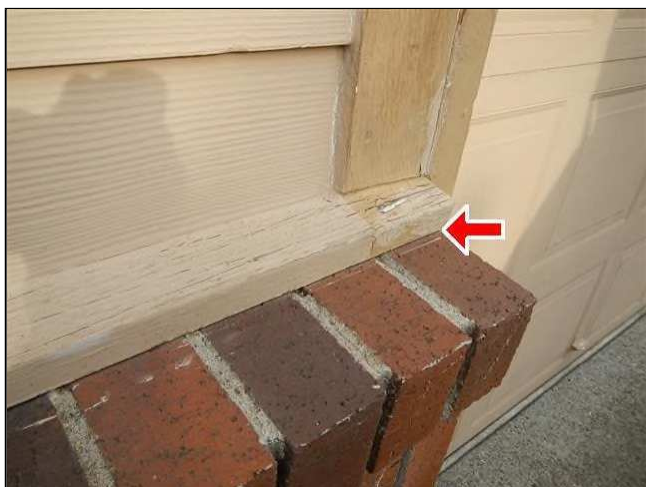
2.7 Picture 1 Paint needed on exterior of house to prevent water damage.

Paint touch-ups needed. Some areas of the siding or trim need to have prep work (scraping, sanding, caulking, and priming as needed) and paint touch-ups. I recommend these areas be repaired by a qualified contractor as weather permits.

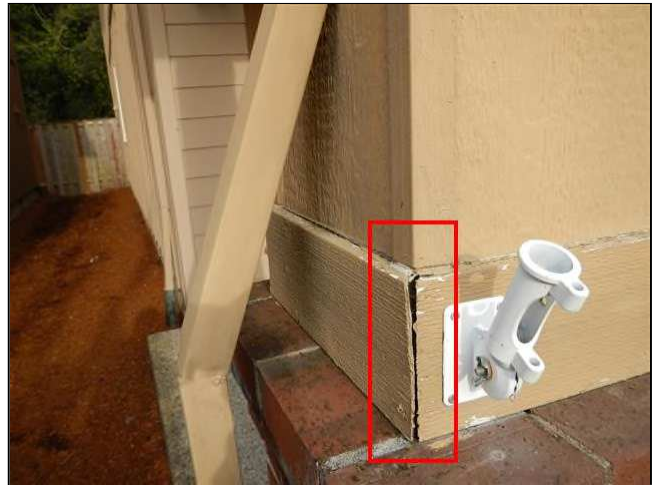
Item 2(Picture) Cracks around trim or siding butt joints or wall penetrations should be sealed with caulking. This is an ongoing maintenance job for nearly all homes.

2.8 Picture 2 Cracks around trim or siding butt joints or wall penetrations should be sealed with caulking.

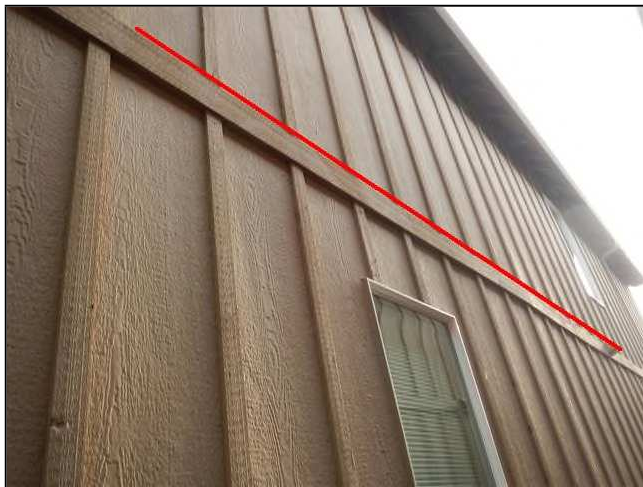
Item 3(Picture) When repainting make sure to reapply caulking to prevent water from getting held up on top edge and getting in between board and siding, creating water damage.

2.8 Picture 3 When repainting make sure to reapply caulking to prevent water from getting held up on top edge and getting in between board and creating water damage.

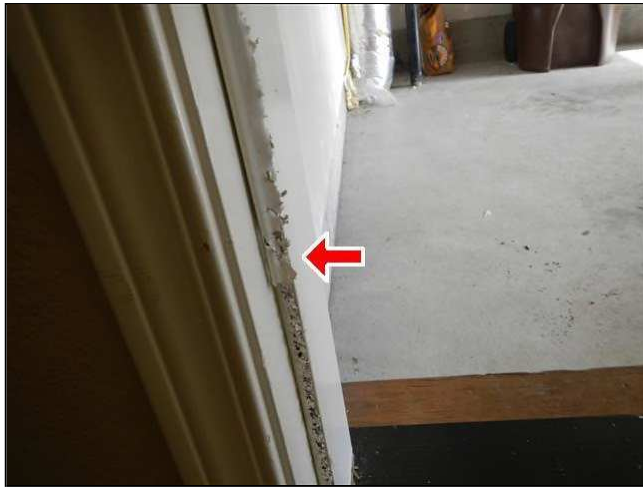
Weather strip, on garage door needs repair. Bottom hinge needs to be secured better to jamb. Recommend longer screws to pull it to door. Some screws were stripped and, as a result, are causing the door to not have a weather tight seal when closed.

3.7 Picture 1 Weather strip, on garage door needs repair.

Repair is recommended.

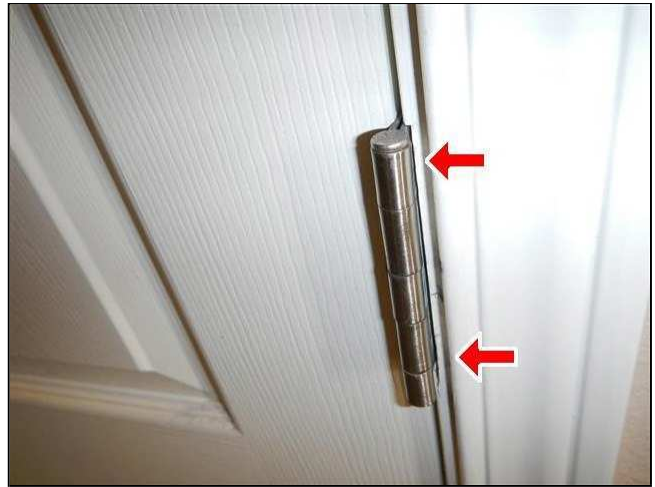
3.7 Picture 2 Bottom hinge needs repair. Screw is loose and needs a longer bigger screw in place.

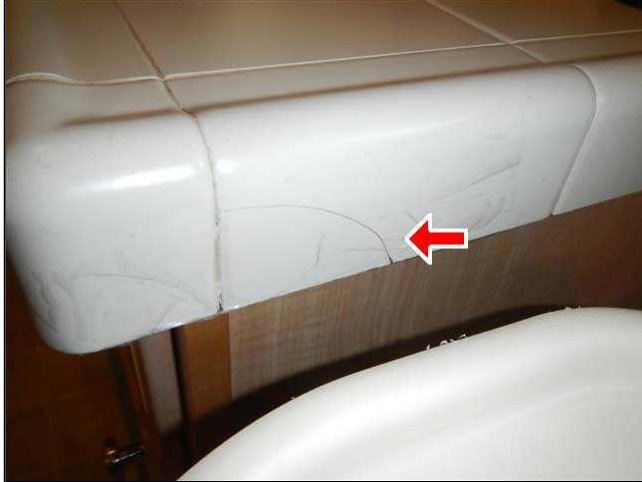
4.5 Picture 1 Small hairline crack in kitchen countertop.

Repair is recommended.

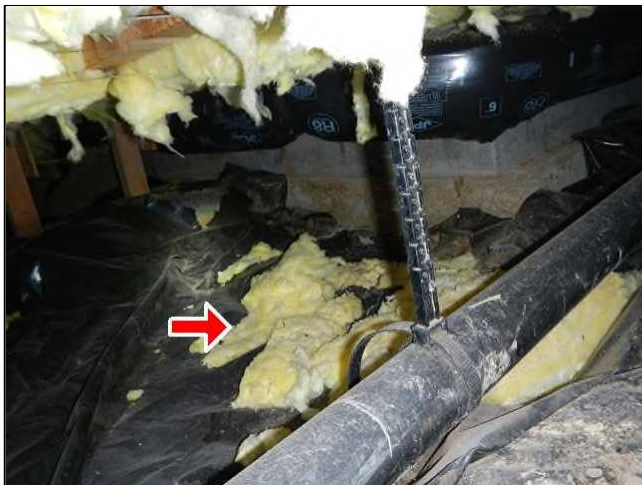
5.1 Picture 1 Some insulation has fallen, needs to be removed in order to prevent habitable locations for pests.

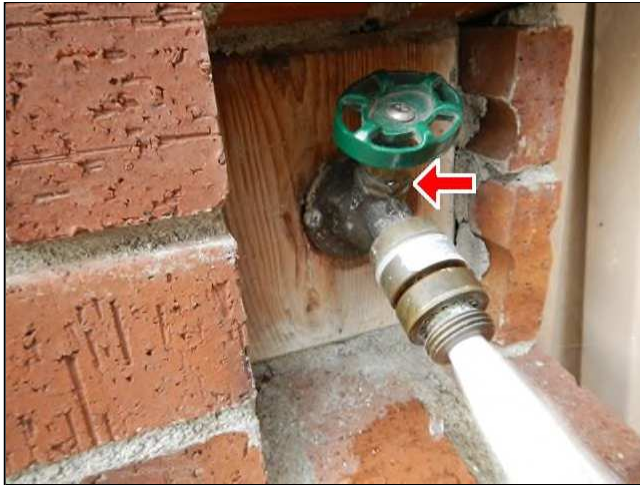
6.1 Picture 1 Both outside hose bibs leak at the stem, when turned on, and need to be repaired. This is usually an easy fix and can be repaired by replacing the internal string in the faucet.

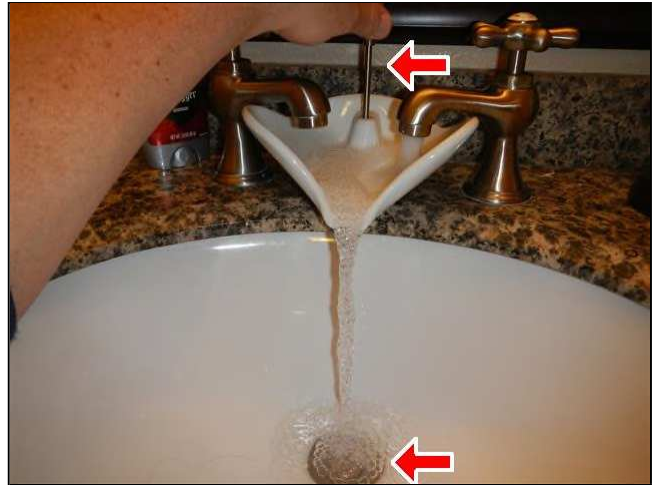
6.1 Picture 2 One pop up stopper is in need of repair. Upstairs bathroom in hallway.

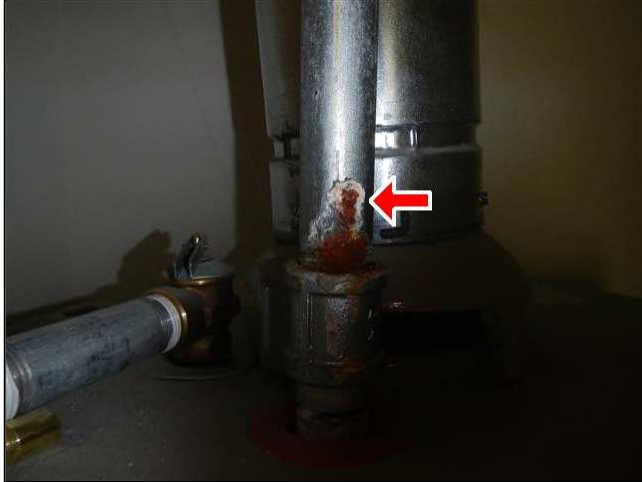
6.3 Picture 1 Small pin hole leak needs repair.

Evaluation and repair by a licensed plumbing contractor is recommended.

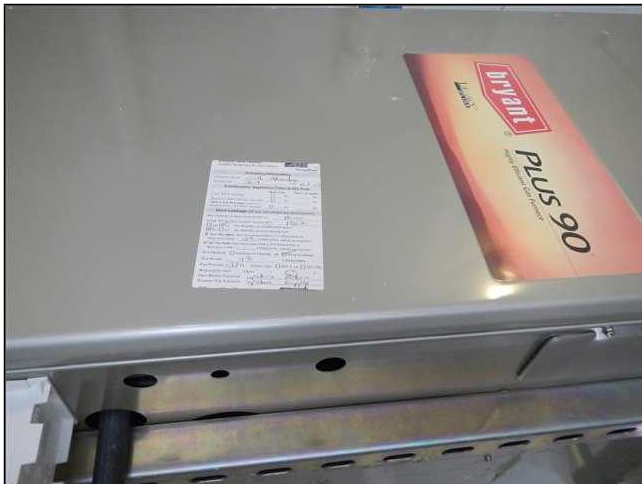
8.0 Picture 1 There are no maintenance documents on the furnace. If it has not been serviced within the last two years, servicing by a n HVAC company is recommended. In particular, the heat exchanger should be checked for possible cracks.

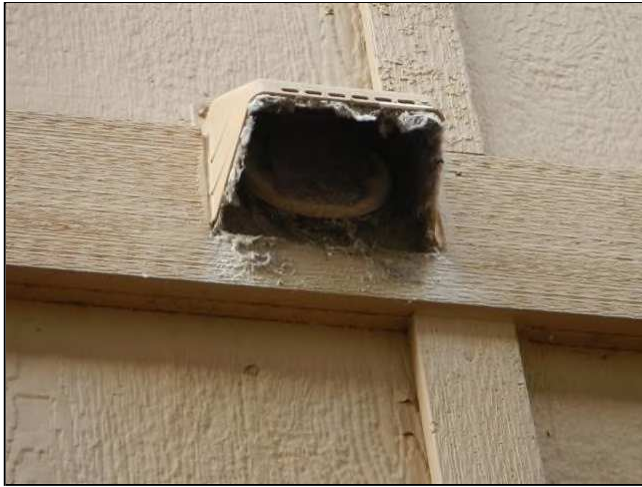
9.6 Picture 1 The dryer vent needs to be cleaned of lint. As a result, the flap is not closing properly and is a potential pest entrance to the home. Repair is recommended.

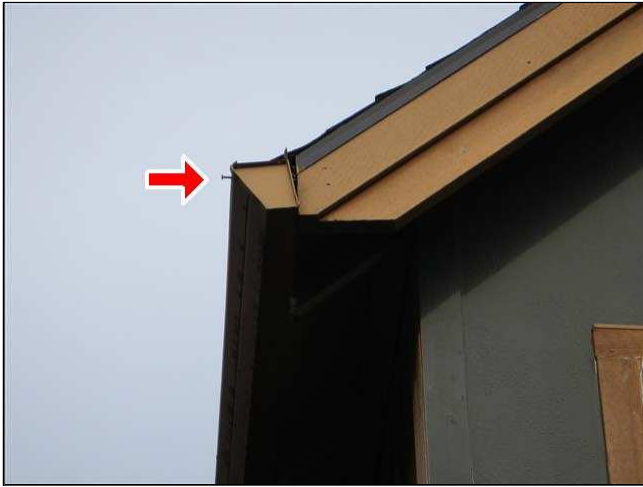
The gutter spikes need to be tightened to keep the gutters tight against the roof.

1.8 Picture 1 Spike protruding out needs to be tightened in order to keep gutter against fascia and water away from house.

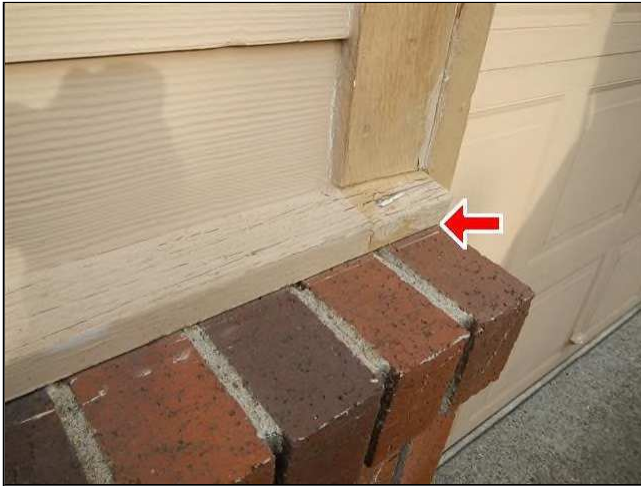
2.7 Picture 1 Paint needed on exterior of house to prevent water damage.

Paint touch-ups needed. Some areas of the siding or trim need to have prep work (scraping, sanding, caulking, and priming as needed) and paint touch-ups. I recommend these areas be repaired by a qualified contractor as weather permits.

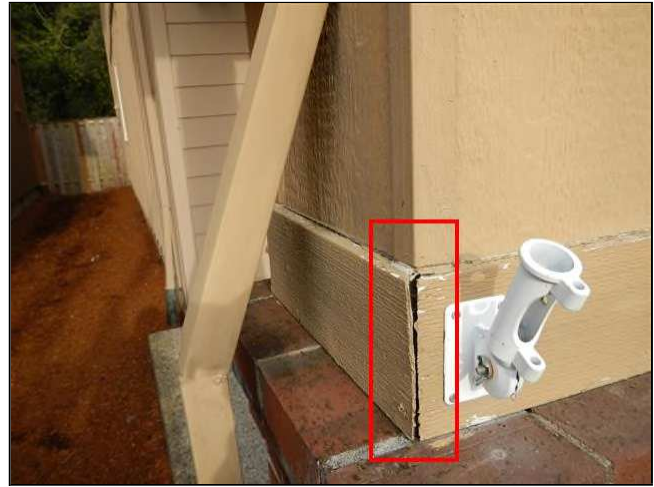
Item 2(Picture) Cracks around trim or siding butt joints or wall penetrations should be sealed with caulking. This is an ongoing maintenance job for nearly all homes.

2.8 Picture 2 Cracks around trim or siding butt joints or wall penetrations should be sealed with caulking.

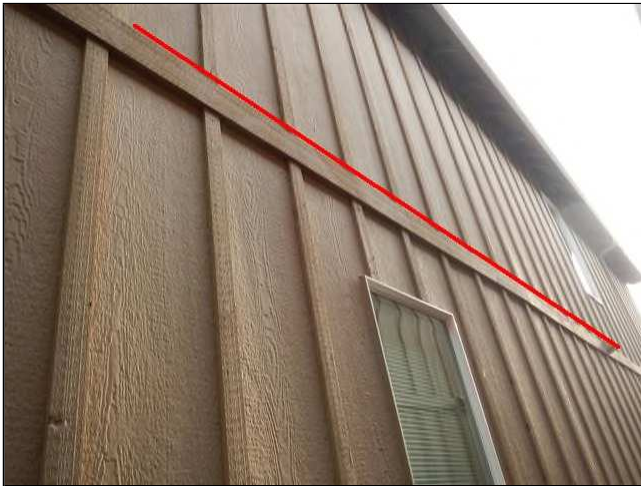
Item 3(Picture) When repainting make sure to reapply caulking to prevent water from getting held up on top edge and getting in between board and siding, creating water damage.

2.8 Picture 3 When repainting make sure to reapply caulking to prevent water from getting held up on top edge and getting in between board and creating water damage.

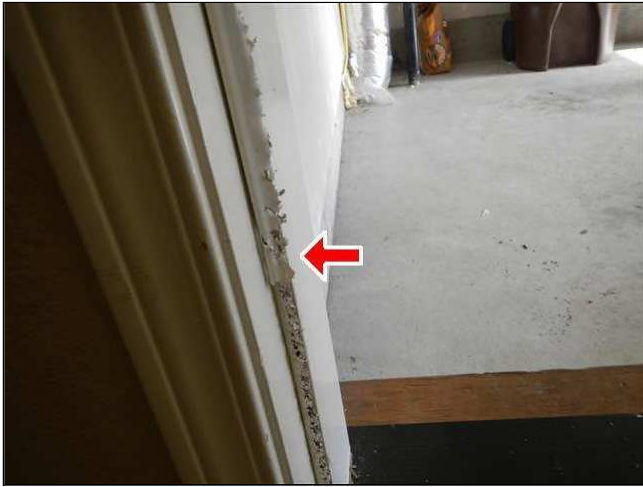
Weather strip, on garage door needs repair. Bottom hinge needs to be secured better to jamb. Recommend longer screws to pull it to door. Some screws were stripped and, as a result, are causing the door to not have a weather tight seal when closed.

3.7 Picture 1 Weather strip, on garage door needs repair.

Repair is recommended.

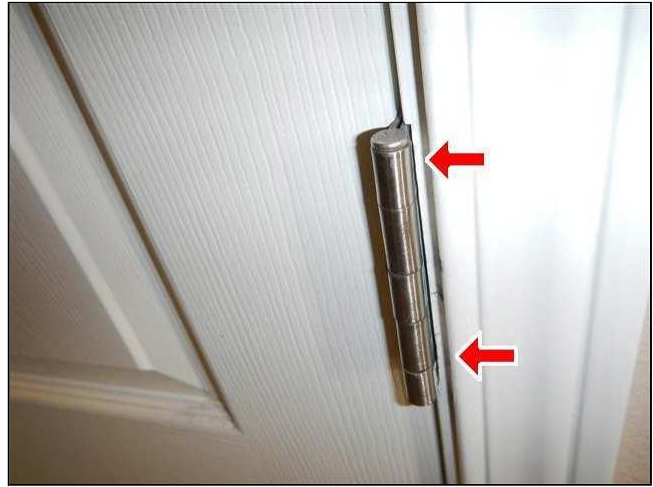
3.7 Picture 2 Bottom hinge needs repair. Screw is loose and needs a longer bigger screw in place.

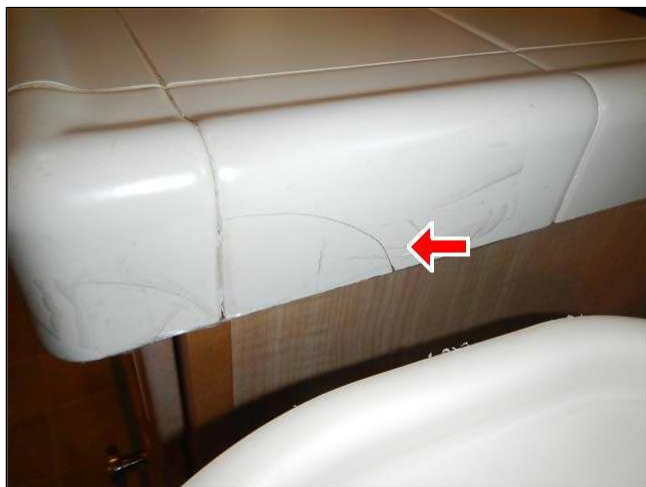
4.5 Picture 1 Small hairline crack in kitchen countertop.

Repair is recommended.

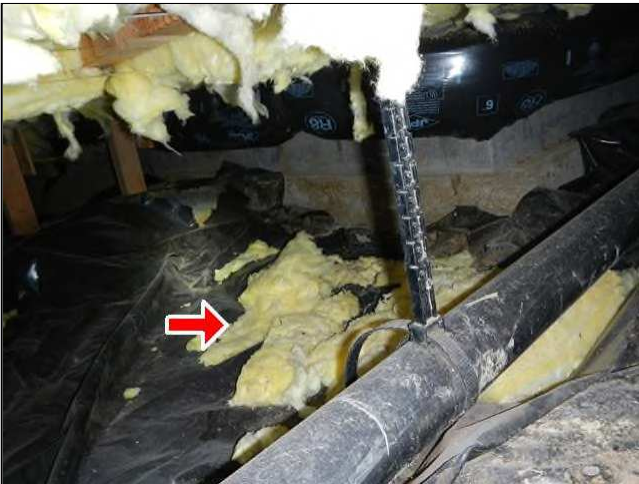
5.1 Picture 1 Some insulation has fallen, needs to be removed in order to prevent habitable locations for pests.

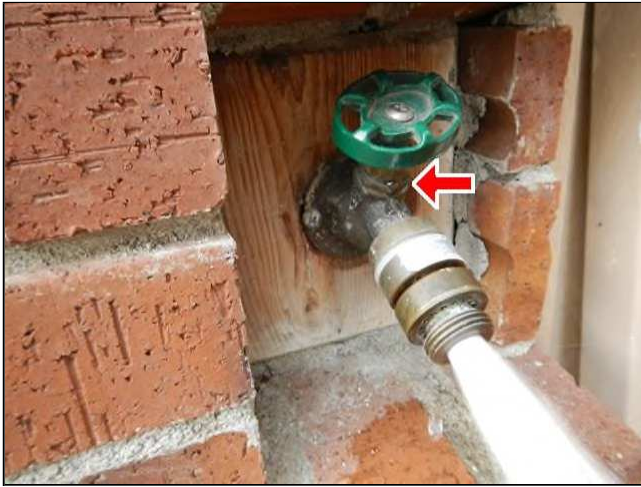
6.1 Picture 1 Both outside hose bibs leak at the stem, when turned on, and need to be repaired. This is usually an easy fix and can be repaired by replacing the internal string in the faucet.

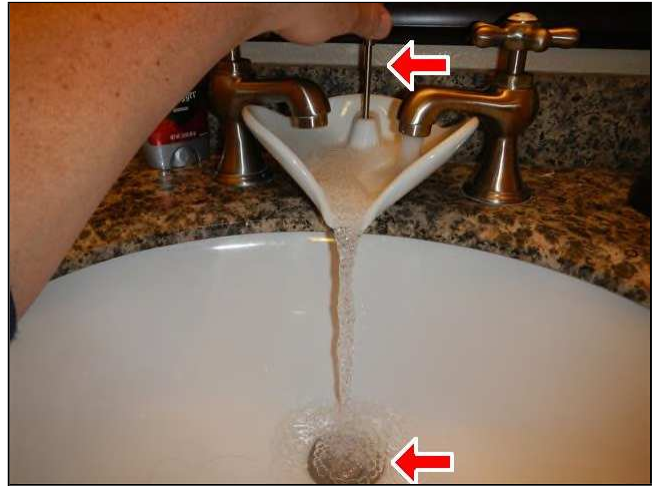
6.1 Picture 2 One pop up stopper is in need of repair. Upstair bathroom in hallway.

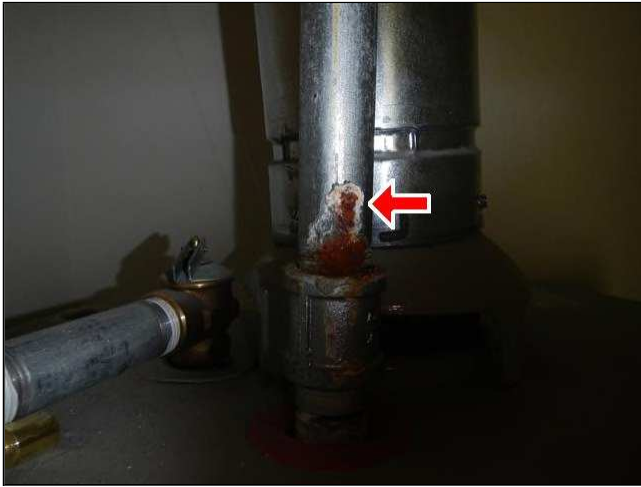
6.3 Picture 1 Small pin hole leak needs repair.

Evaluation and repair by a licensed plumbing contractor is recommended.

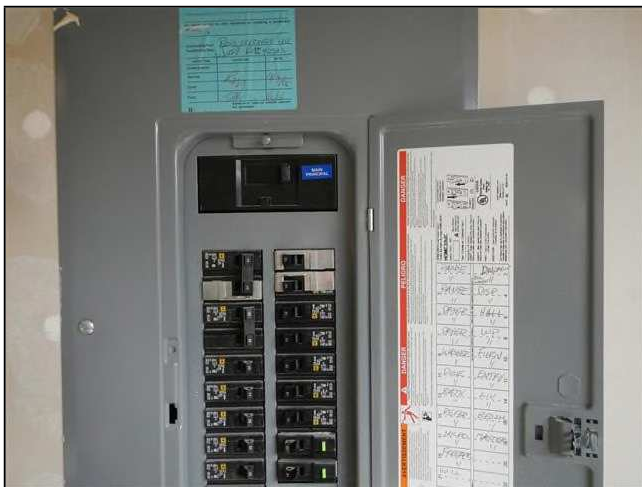
7.1 Picture 1 Properly labeled 200 amp Main Panel

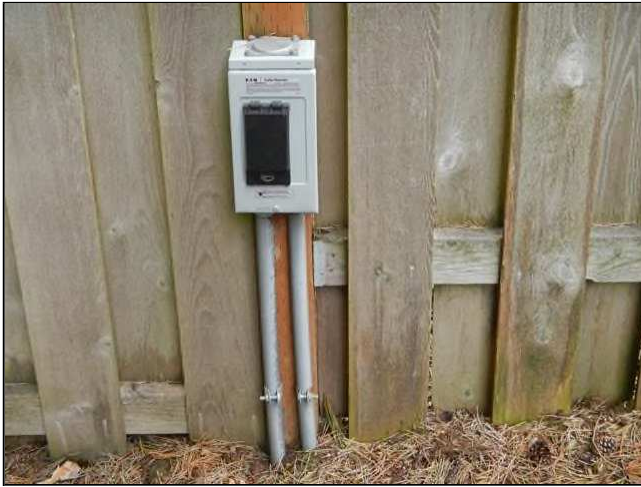
7.3 Picture 1 Outdoor 50 amp breaker for Hot tub.

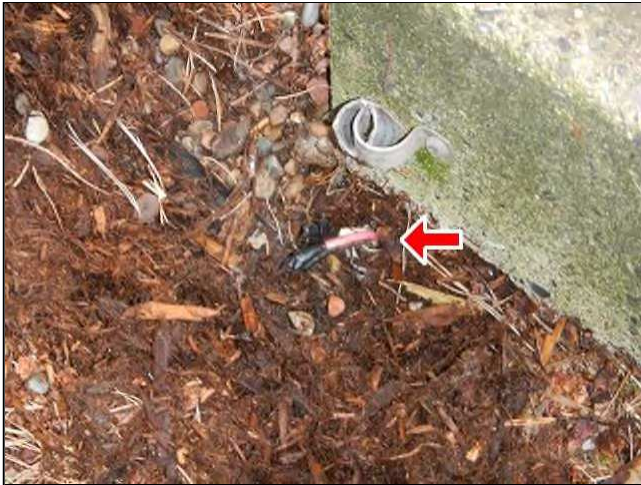
7.3 Picture 3 Dead wires coming out of ground in backyard for previous hot tub.

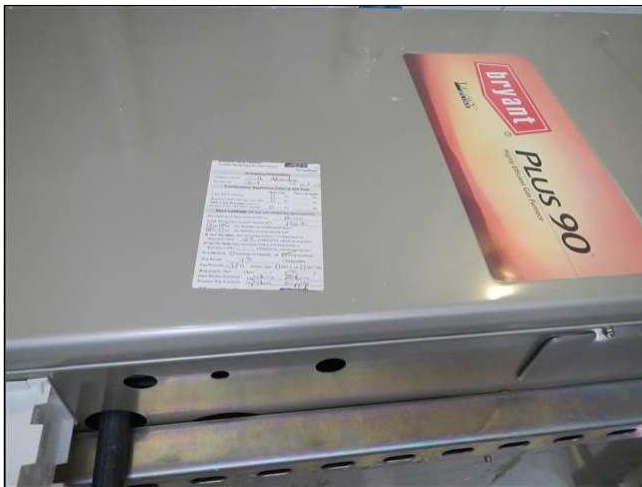
8.0 Picture 1 There are no maintenance documents on the furnace. If it has not been serviced within the last two years, servicing by a n HVAC company is recommended. In particular, the heat exchanger should be checked for possible cracks.

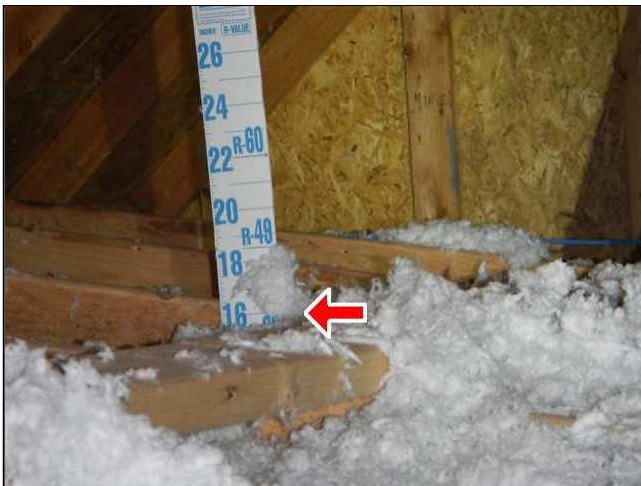
Item 1(Picture) Good insulation in attic. Recommended 14in minimum. Attic has 16in.

9.2 Picture 1 Good insulation in attic

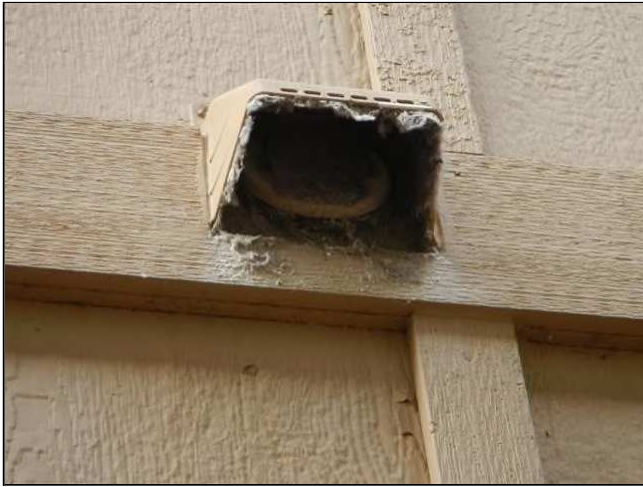
9.6 Picture 1 The dryer vent needs to be cleaned of lint. As a result, the flap is not closing properly and is a potential pest entrance to the home. Repair is recommended.
