United States Department of the Interior
National Park Service
National Register of Historic Places
Registration Form

historic name Tigiwon Community House

other names/site number Tigiwon Lodge; 5EA795

Tigiwon Community House  
Eagle County, Colorado

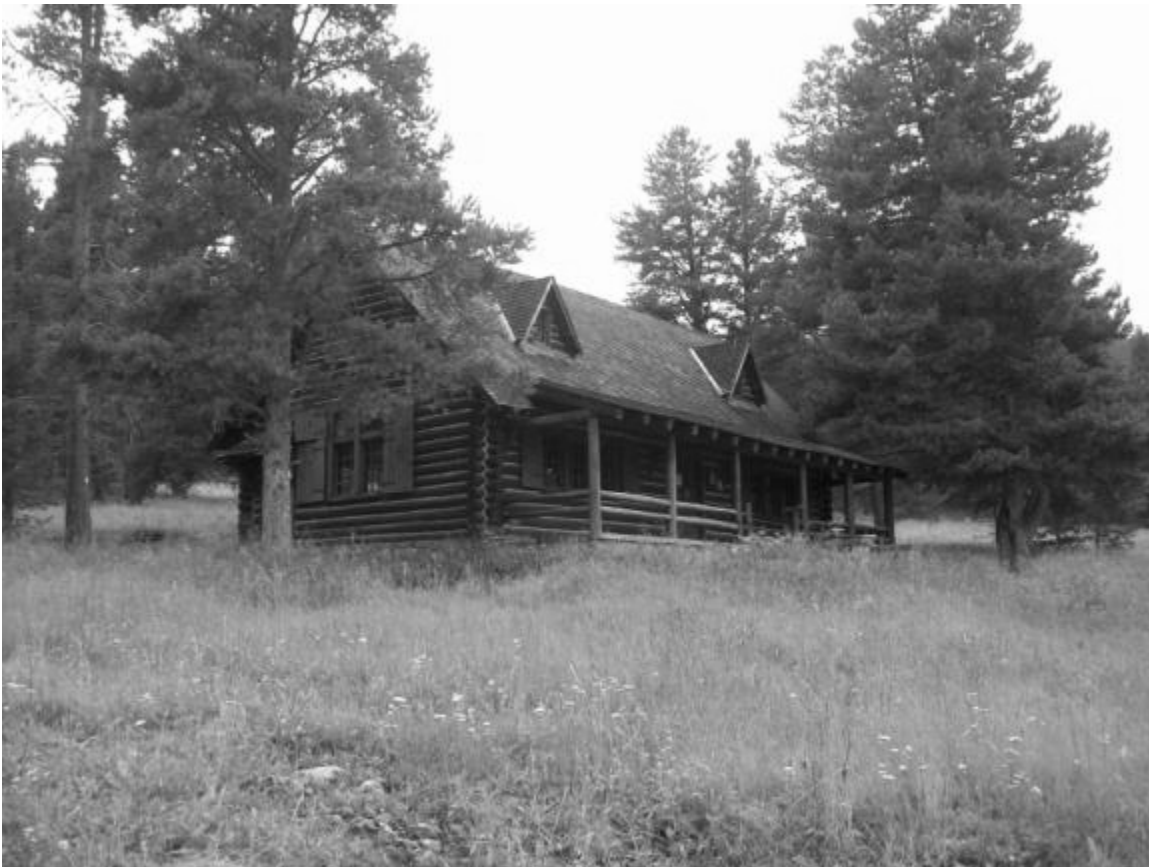
Photo 1. View of the north and east sides of the building.

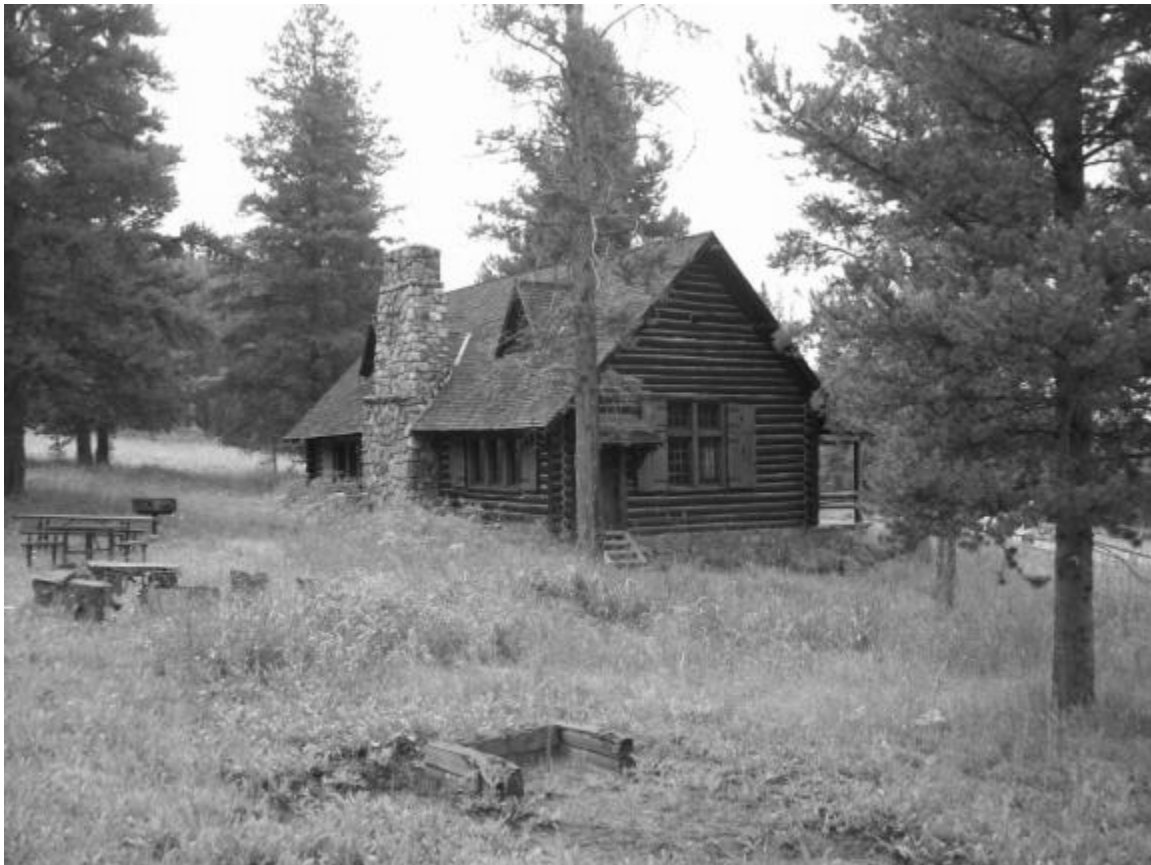
Photo 2. View of the east and south sides of the building.

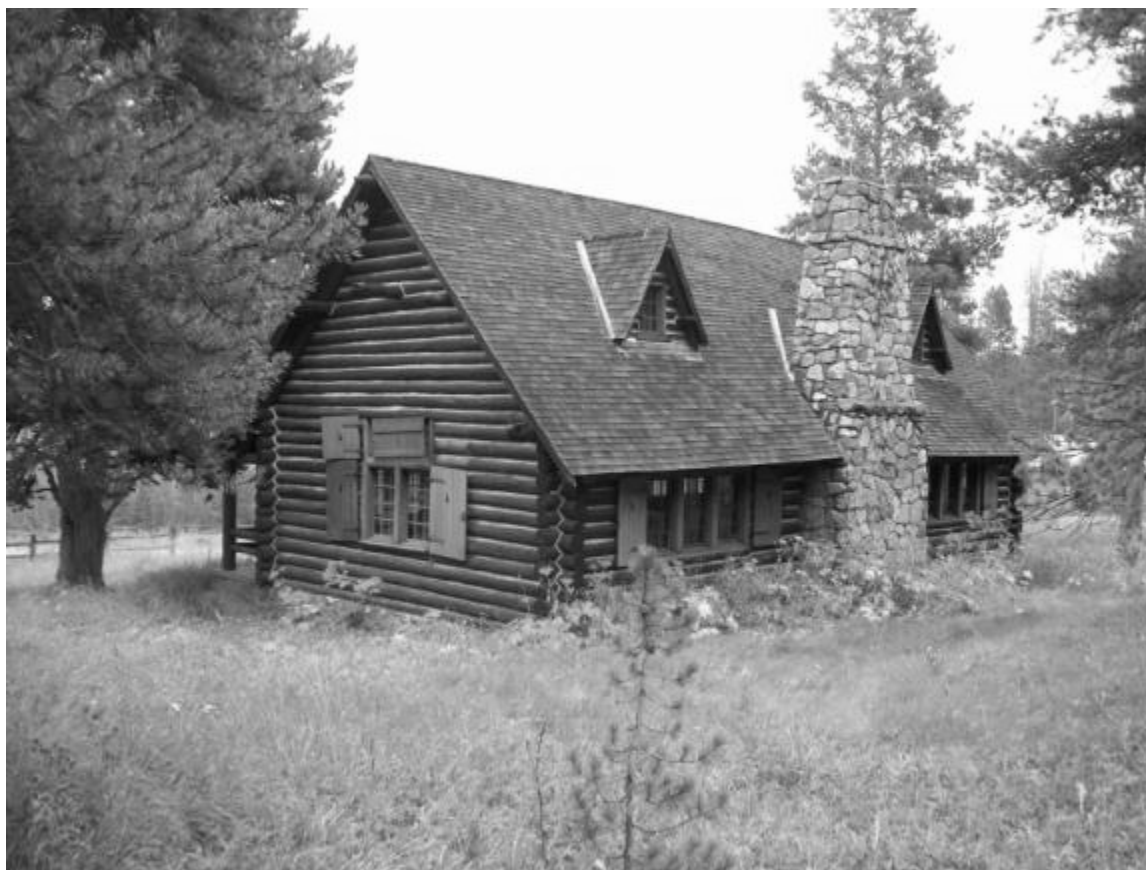
Photo 3. View of the south and west sides of the building.

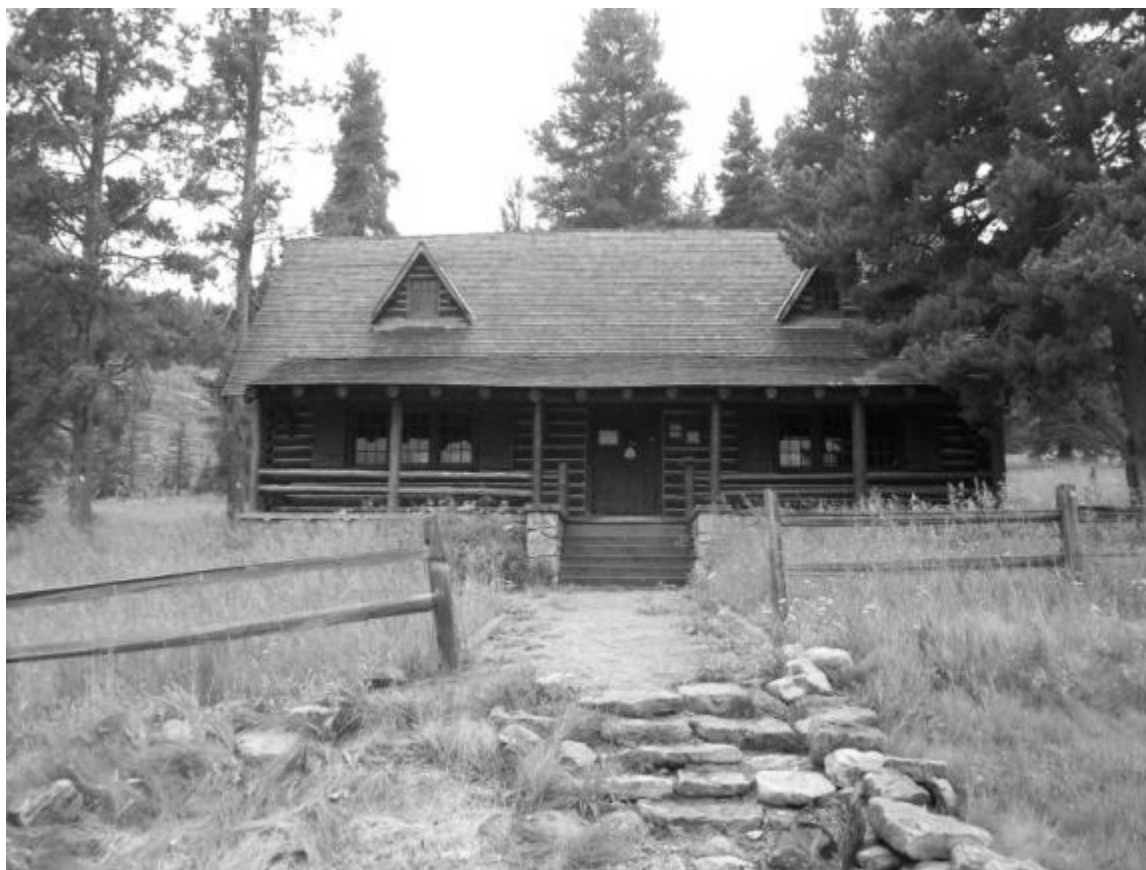
Photo 4. View of the north side of the building.

There is a 44'-wide shed roofed porch with 9" caliper log rafters, bracing, and columns at the north (entry) elevation. The roof consists of sawn cedar shingles. Log poles are notched into the log columns resulting in a railing surround the porch. Eight concrete steps lead up to the concrete slab porch. Concrete capped, rough stone cheek walls flank the steps. Short log columns also flank the entry at the top of the concrete stairs. The east façade includes a simple shed roof canopy over the entrance supported by log brackets and rafters. Split log siding covers the triangular openings between the brackets and shed roof pitch. Three split log steps lead up to the door.

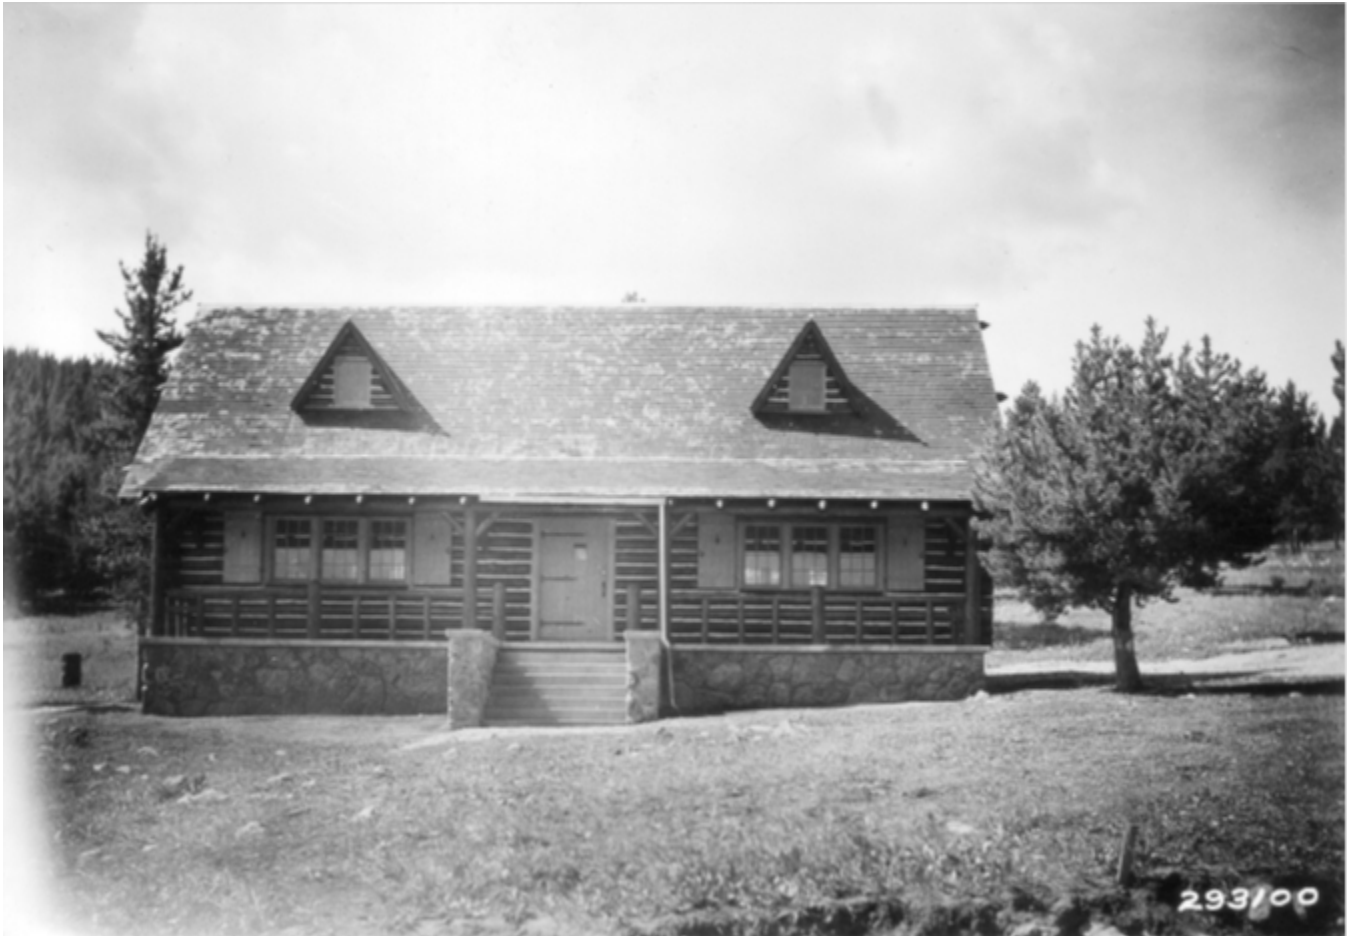
Photo H1. North side of Tigiwon Community House, dated 9/20/1934 Source: White River National Forest

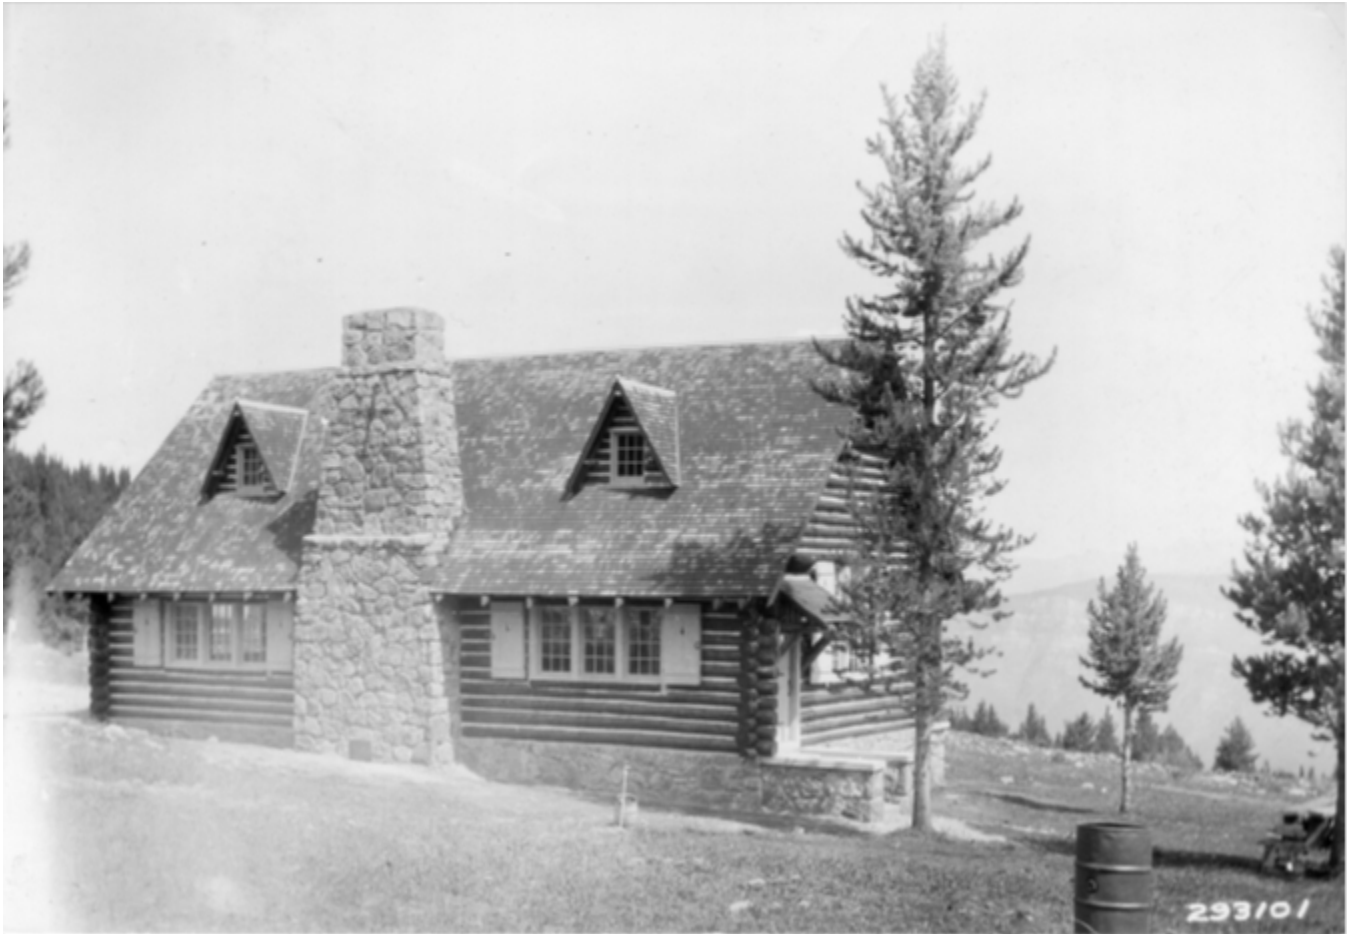
Photo H2. South side of Tigiwon Community House, dated 9/20/1934 Source: White River National Forest

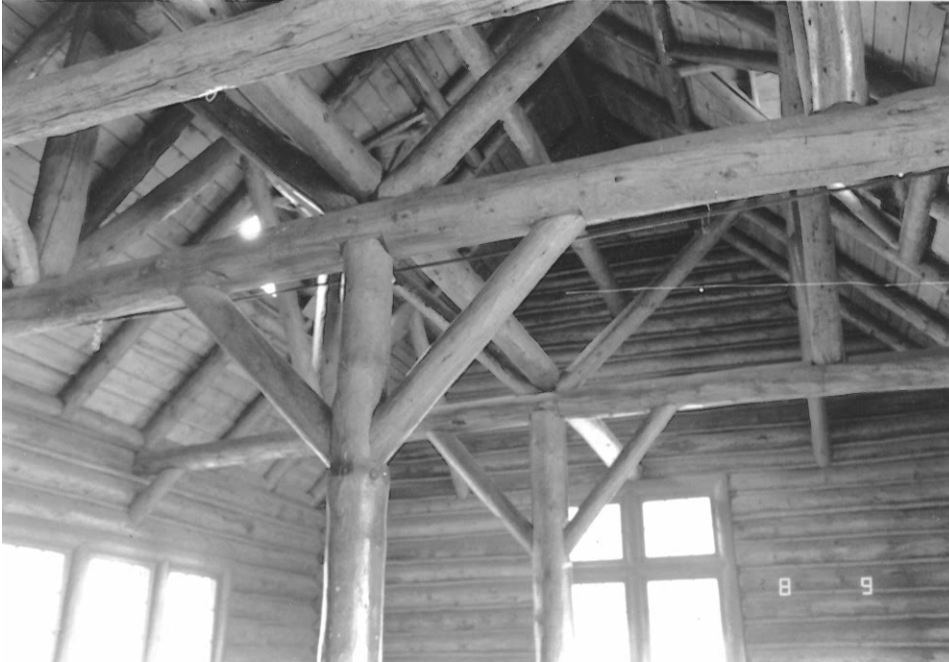
Photo H3. Interior view of roof trusses, dated 8/9/1993. On file with the Office of Archaeology and Historic Preservation, History Colorado

The side-gabled roof is of moderate pitch with both end-gables overhung on log purlins. The roof is a log frame structure with 1' x 1' skip sheathing topped with sawn cedar shingles. The design uses an angled log bracing to create a load path with truss/space frame-like elements in the north/south direction, in line with log rafters in the east/west direction. In the north/south direction, two of the four truss elements are incomplete due to non-continuous top cords /rafters that are interrupted at the two small gabled dormers on both sides. In the east/west direction, a log beam line supports the log rafters at their mid-point. These beams are supported on 8" caliper king posts sitting on north/south beams below and with angle bracing from these posts up to the beam line forming a truss-like structure. The north/south beam lines are supported by log columns at the mid-point.

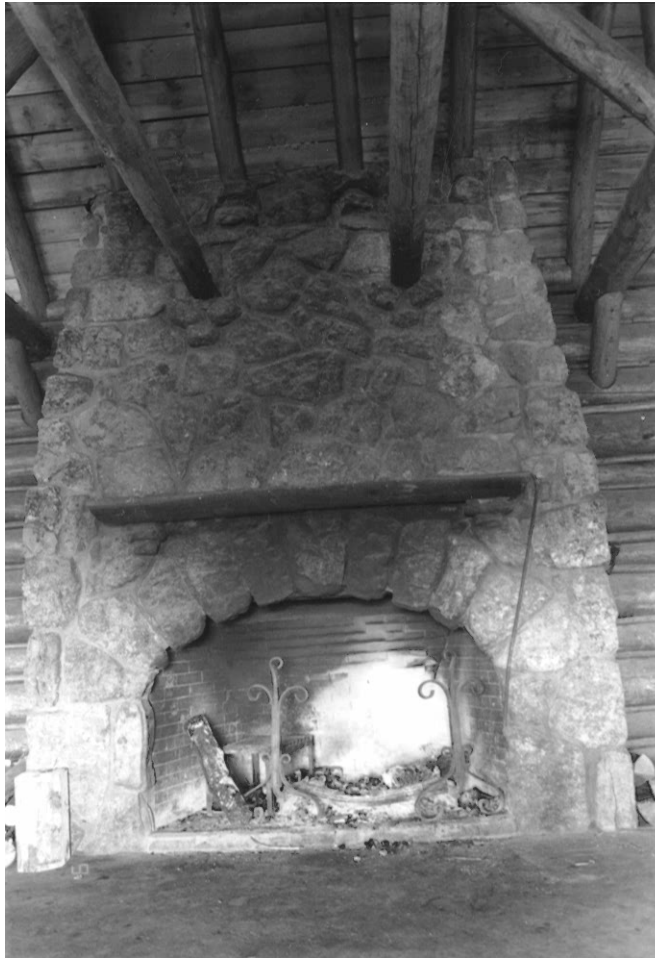
Photo H4. Fireplace, dated 8/9/1993. On file with the Office of Archaeology and Historic Preservation, History Colorado

The building incorporates an iconic stone fireplace and chimney centered in the south log wall on axis with the entry door. The massive eave wall chimney, 10' wide, is constructed of natural uncoursed local stone stepped back to its top with a segmental stone arch over the fire-bricked inner hearth. There is a log mantle over the interior fireplace. A decorative wrought iron "T" or stylized cross is mounted on the exterior south face of the chimney. Outside, two wrought iron chimney braces in a decorative "S" shape support the chimney. As well, two belt courses appear on the exterior, with one just above the roofline and the other near the top.
