Disaster-Resistant University Hazard Mitigation Plan  
Section 7 Risk Assessment

## Section 7 Risk Assessment

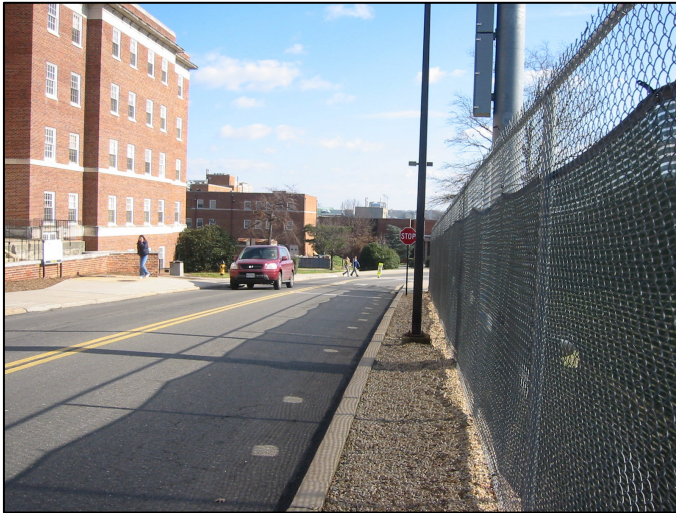
**Figure 7-5**

View east down Stadium Drive, near UM's athletic practice fields. Sheet flows down Stadium Drive toward Paint Branch contribute to flood risk at and near the A.V. Williams Building and various other facilities east of this location.

There are very few flood-related road closures or interruptions on the campus, although the intersection of Campus Drive and Stadium drive does occasionally flood because of its low elevation and the previously noted overland flow from higher points on Stadium Drive. The road closures are generally short and constitute more of a nuisance than a significant risk. UM has not calculated the amount of rainfall that results in road inundation in this area, but this situation occurs on average once or twice a year.

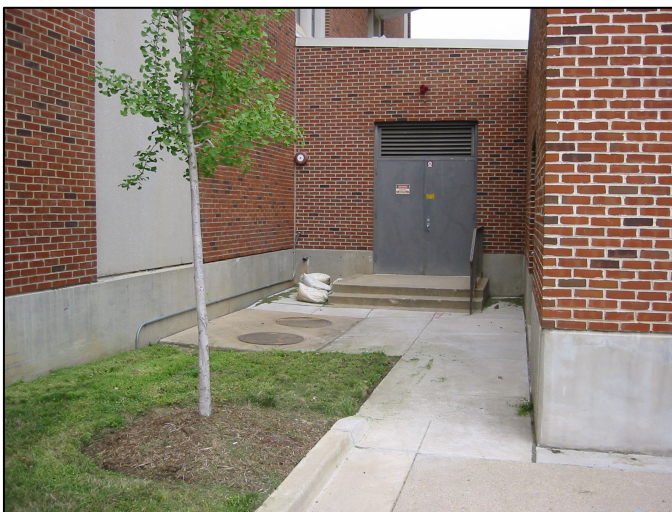
**Figure 7-6**

The door to the mechanical room at A.V. Williams. The mechanical room is vulnerable to flooding (note the sandbags), and equipment housed in this area of the building is essential to the continuous operation of UM's computer systems.

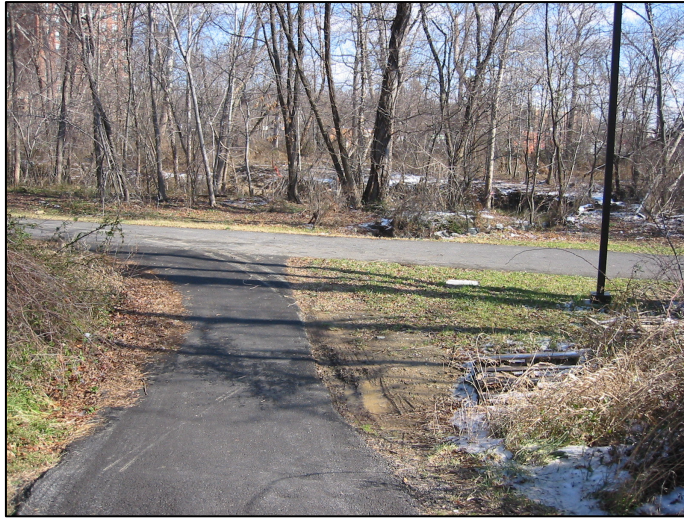
**Figure 7-7**

View of the Paint Branch from behind the A.V. Williams building. Overbank flooding from this source is a relatively low probability event, but the potential impacts of a significant flood would be severe if the Williams building were flooded.

In some larger rainfall events, campus staff have observed minor stream bank erosion and debris in the Paint Branch, although none of these effects has been significant enough to warrant any action.

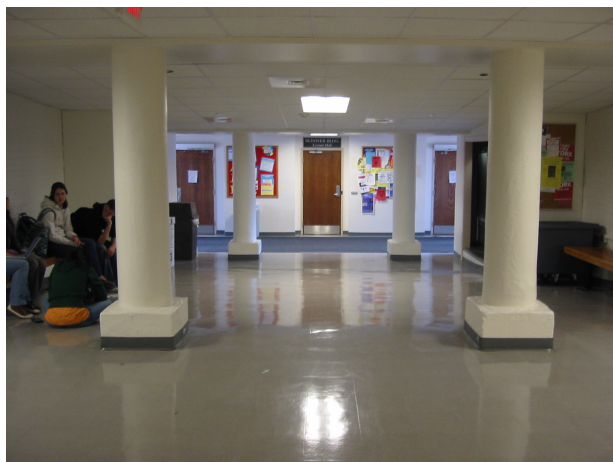
**Figure 7-9**  
Lecture halls, classrooms and administrative offices in buildings in the South Mall area flood several times a year from overland flows due to aging and inadequate storm sewer systems.

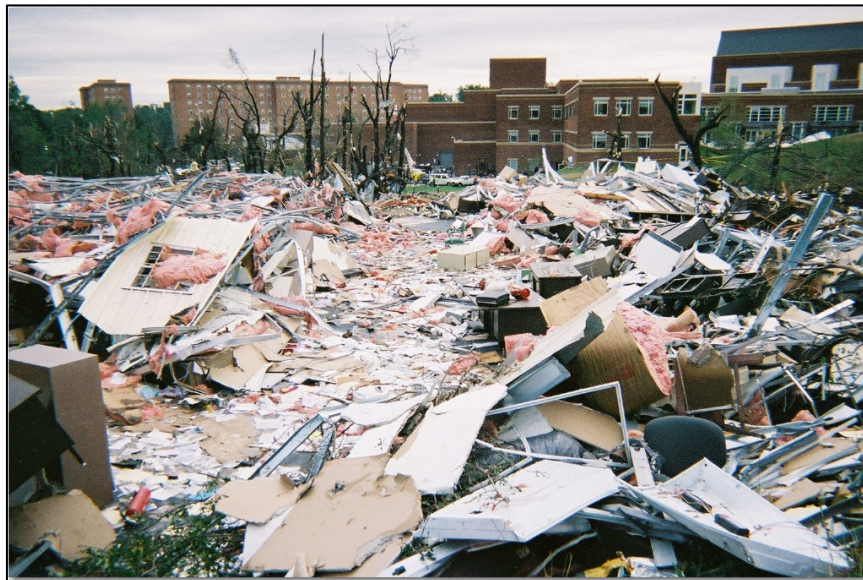
**Figure 7-11**  
**Damage on the UM campus from the September, 2001 tornado**  
(photo: astro.umd.edu)

As noted in the hazard profile section of this plan, Maryland has a relatively low probability of tornadoes compared to many areas in the south and central U.S. According to NOAA's National Climatic Data Center (NCDC) database (query April 2007), the State has experienced 269 tornadoes since 1950, with the large majority of them F0 and F1 class. The County level is the smallest reporting area for NCDC, and Prince George's County has experienced 14 tornadoes in the same reporting period, most of which were Fujita class F1, although there have been two F2s and one F3 in the same period. In September, 2001, an F3 tornado struck the UM campus, killing two students and causing millions in structural damages.
