# PAVEMENT REHABILITATION WITH CONCRETE PAVERS

Herrera, C.<sup>1</sup>, Hernández, M.<sup>1</sup> and Iraola, F.P.<sup>2</sup>

This paper presents details of two projects where existing pavements were badly distressed. Concrete pavers overlay was chosen rather than asphalt or concrete paving. The works were done in the Patagonian region of, Argentina, specifically bellow the 42<sup>nd</sup> Parallel, where the extremely cold winters reduce the number of productive working days.

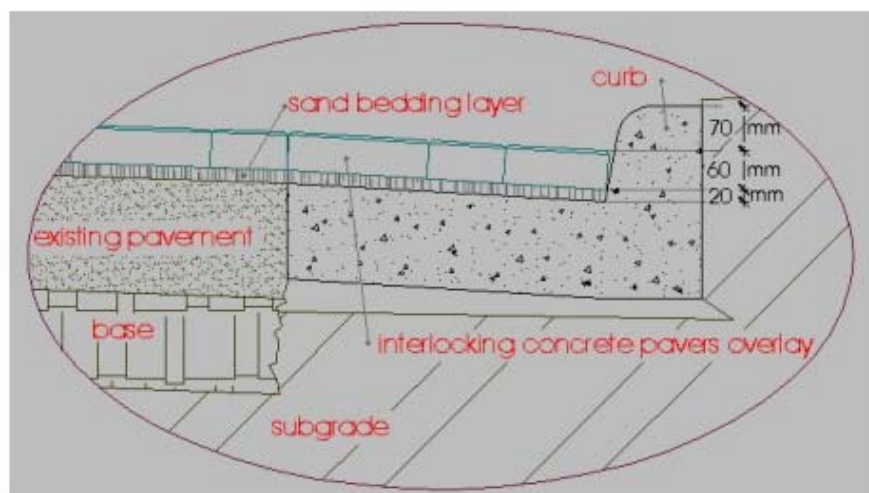
**Figure 1. Cross sections. Overlay with concrete pavers.**

The thickness of the bedding sand layer was reduced from 40 or 30 mm (loose condition) to 20 mm after consolidation because of the presence of impermeable bases, insufficient slopes and the limits imposed on the final thickness of the overlay.

The 60 mm thick concrete pavers were laid in a herringbone pattern. This pattern is considered the most suitable for city streets and industrial pavements because it resists relative displacements in both the longitudinal and transversal directions. The 60 mm thick concrete pavers were selected in order to achieve a 70 mm height curb. (see Figure 1).

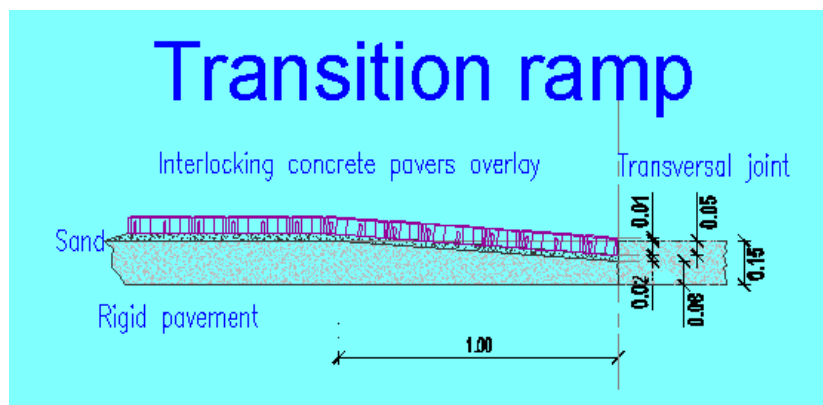
**Figure 2. Rehabilitated pavement – existing pavement transition.**

- a 1 meter width of scarification and trimming using jackhammers, with a variable thickness from 0 to 70 mm, in order to produce a soft joint between the end of the ramp and the existing pavement.
- Levelling of the transverse slope and restoration using soil-cement.
- Overlay with concrete pavers.

Figure 2 shows a typical transition ramp constructed at Puerto Santa Cruz. Only few ramps were generated at El Calafate. The problems there were solved using an anchored steel beam fixed to the existing pavement to confine the pavers, and bonded asphalt material used to compensate for the difference in levels.

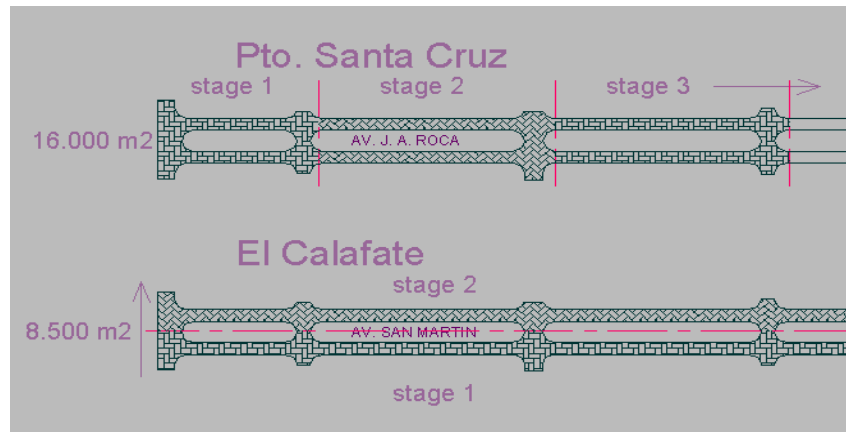
**Figure 3. Construction stages.**

- El Calafate: the overlay was first constructed in one direction, after which it was re-opened to traffic while work proceeded in the other direction. In areas between boulevards, metallic profiles were placed as confining beams to allow traffic in and out of the rehabilitated zone.
- Puerto Santa Cruz: construction was carried out in both directions at the same time, including intersections; a similar procedure continued for the next block and so on.

Figure 3 shows the construction stages.

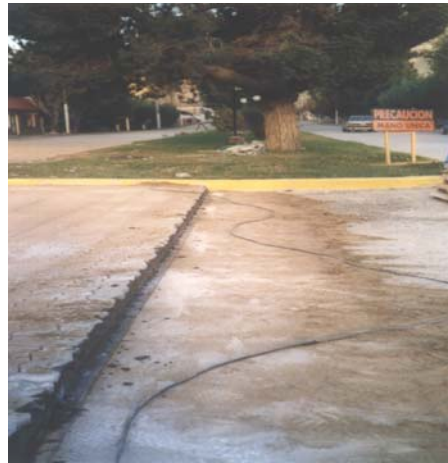
**Figure 4. Metallic confining beam: steel angle fixed to the pavement.**

The edge restraint mainly consisted of the existing curb, but more than 1,000 lineal meters of deteriorated curb had to be replaced before the pavers could be placed. A metallic edge restraint was also used; it consisted of a 3"x 3" (75 mm x 75 mm) wing steel angles 4-mm thick, and fixed to the existing pavement by nails.

In some cases temporary ramps were materialized confining them with steel beams and soil cement was used to compensate difference of levels accessing in and out the rehabilitated zones, without touching the existing pavement (see Figure 4).

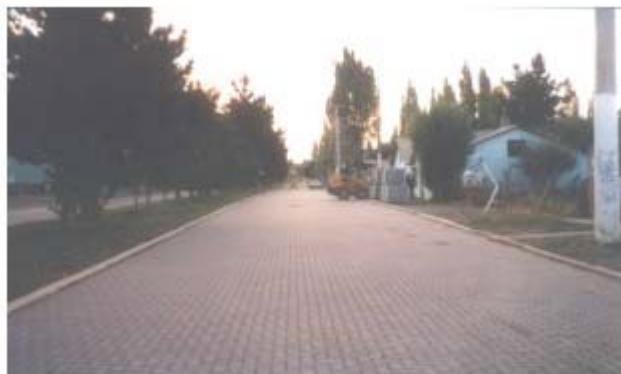
**Figure 5. General view of a completed segment of pavement.**

Architectural value of this pavement was obtained from the patterns and colour arranges used to materialise footpaths and rumble areas.

Figure 5 shows a typical view of a completed segment of pavement.

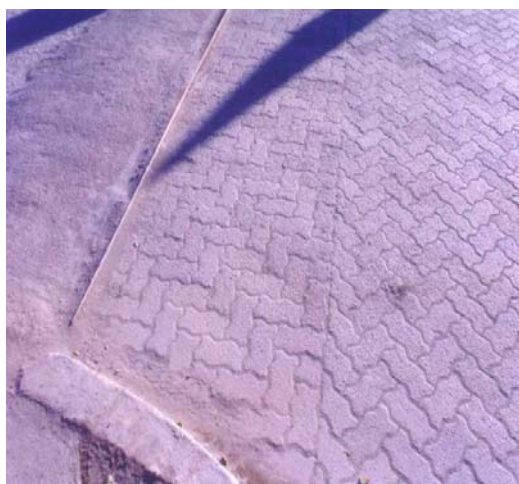
**Figure 6. Eroded transition zone.**

The condition of the rehabilitated pavement at El Calafate is still satisfactory after 3 years. There is some surface erosion at transition zones between the overlay and soil streets, due to stones being carried by vehicles entering the overlay (Figure 6). Possible solutions for this early erosion could be:

- Use of higher strength pavers (> 45 MPa).
- Production of double-layer pavers, with harder sands on the upper layer. This alternative depends on the availability of harder sands near the plant.
