RE: City Landmark nomination  
Riggs House

State of California – The Resources Agency  
 DEPARTMENT OF PARKS AND RECREATION  
**PRIMARY RECORD**

Page 1 of 14                      \*Resource Name or #: (Assigned by recorder)                      Riggs House

c. Address                      577 South Twelfth St.                      City                      San Jose                      Zip                      95112

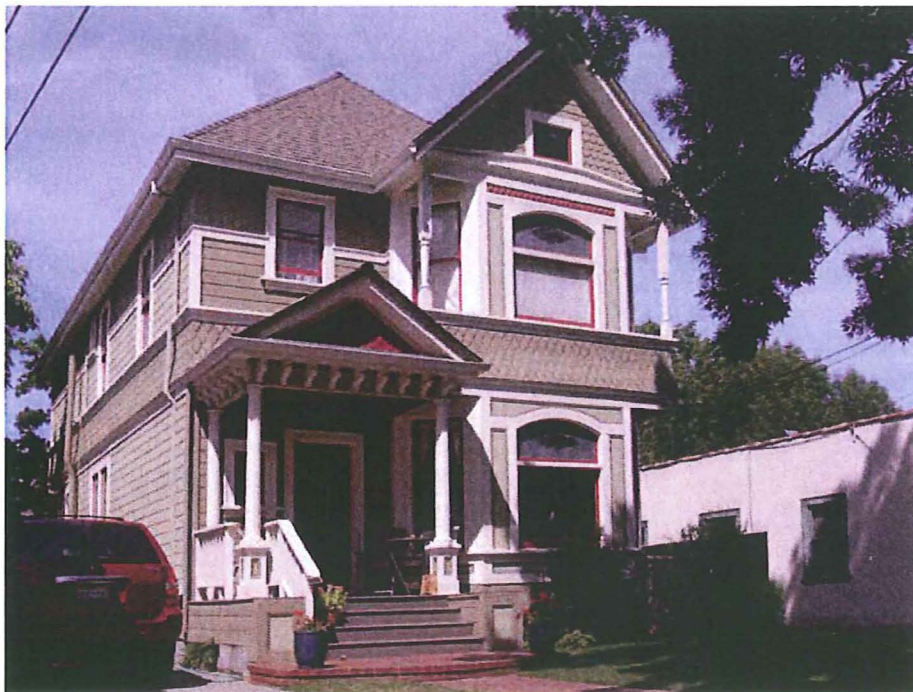
**P5b. Description of Photo:** (View, date, accession #)

View facing west, June 2009.

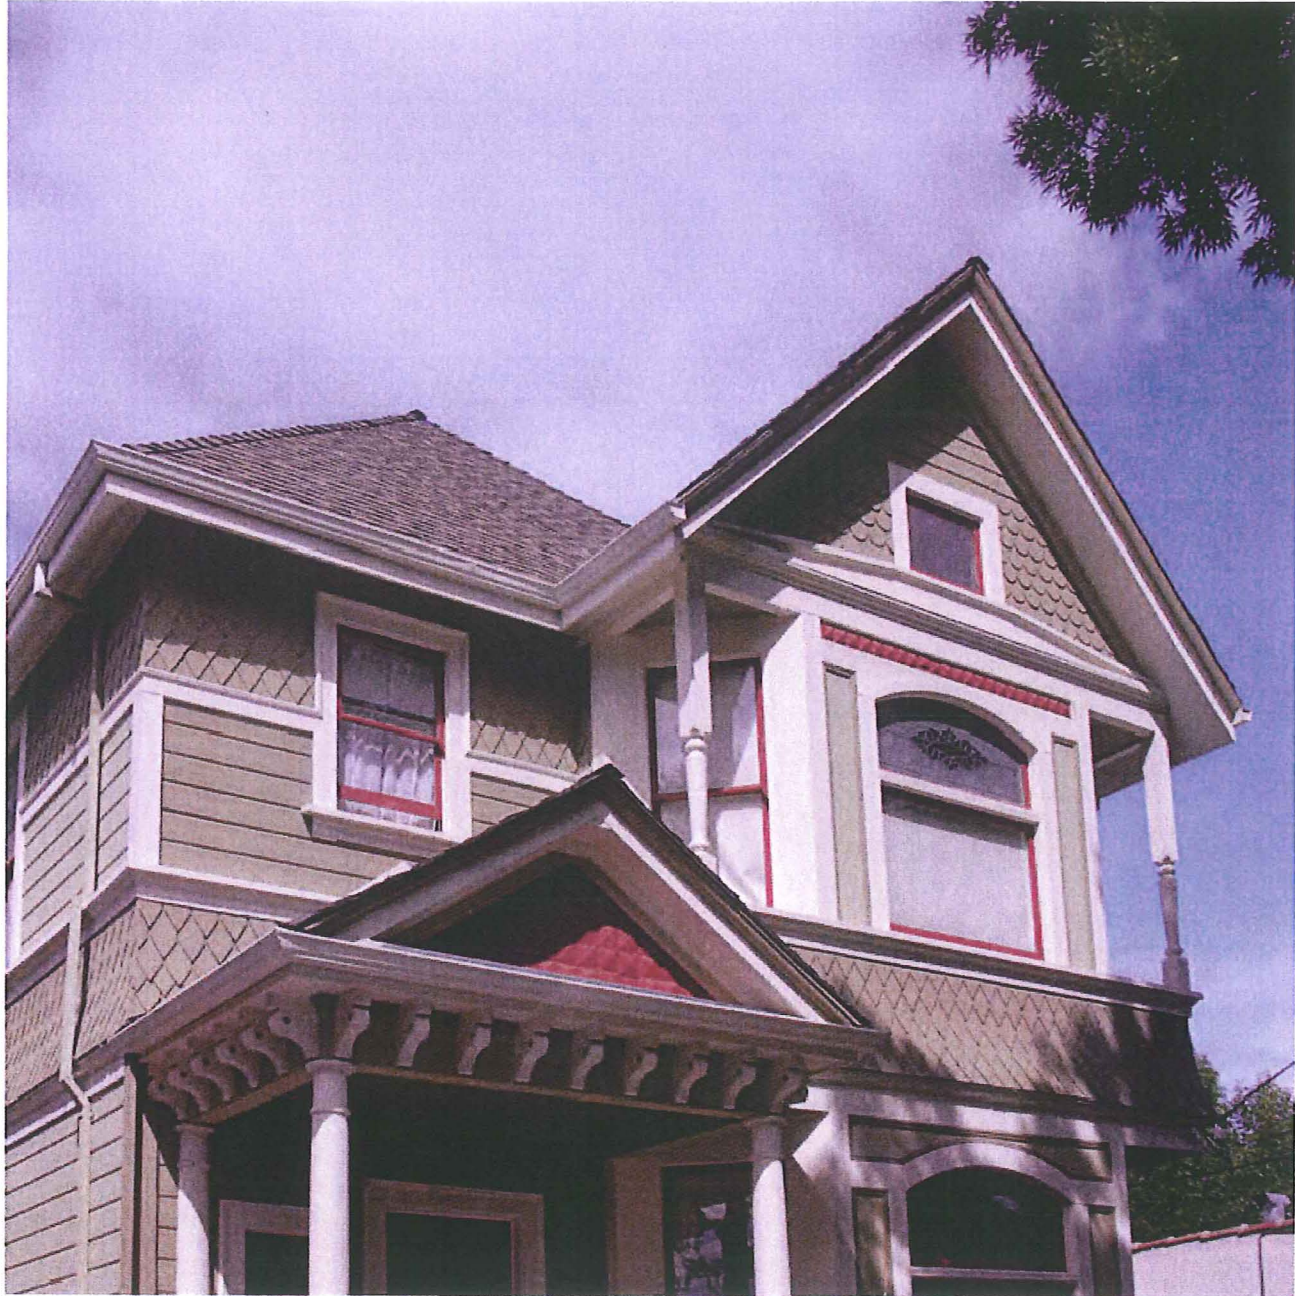
The front elevation is asymmetrical; it features extensive Victorian-era forms and detailing. Entry is through a distinctive projecting porch that features a front-gabled roof with its paneled pediment of pyramidal blocks. The porch has classical columns that are not typical of the Victorian era—they commonly are representative of residential design after the turn of the twentieth century—but do appear on a 1976 photo. The porch columns rest on paneled pedestals and are connected by a modern handrail with 2x framing. The porch eaves feature a series of Stick-style fluted corbels with a drilled-hole pattern. The front entry consists of a front door and high accent window. Centered above the roof gable is a small 1/1 double-hung window. The full-height front bay window is distinctive in its ornamentation. Separating the upper and lower halves of the angled bay window is the wide house bellyband; the flared band is square in plan with the angled windows recessed above and below it. The upper gable is unusually supported on a pair of turned posts at the outer corners of the bellyband. The bellyband is currently cantilevered at the outer corners; scarring of the paint indicates that original corbels have been removed at this bay window. Original corbels are extant on the side bay window and so the front ones could be reproduced. The front-facing focal windows have segmental-arch transoms; these feature stained glass that appears original. These windows are flanked by 1/1 side windows. A single-lite attic ventilation window is centered in the gable end. Trim includes a tapered trim band at the base of the gable. Beneath this band, the windows are outlined in flat-board trim without siding. The upper window is topped by a row of pyramidal blocks; the sides of the focal window are flanked by paneled casings. The first floor has similar side panels, but with a simplified header panel without the row of blocks. The first-floor windows rest on a sill band above three wide recessed panels that wrap the base of the bay window.

Detail view of front façade, viewed facing northwest.

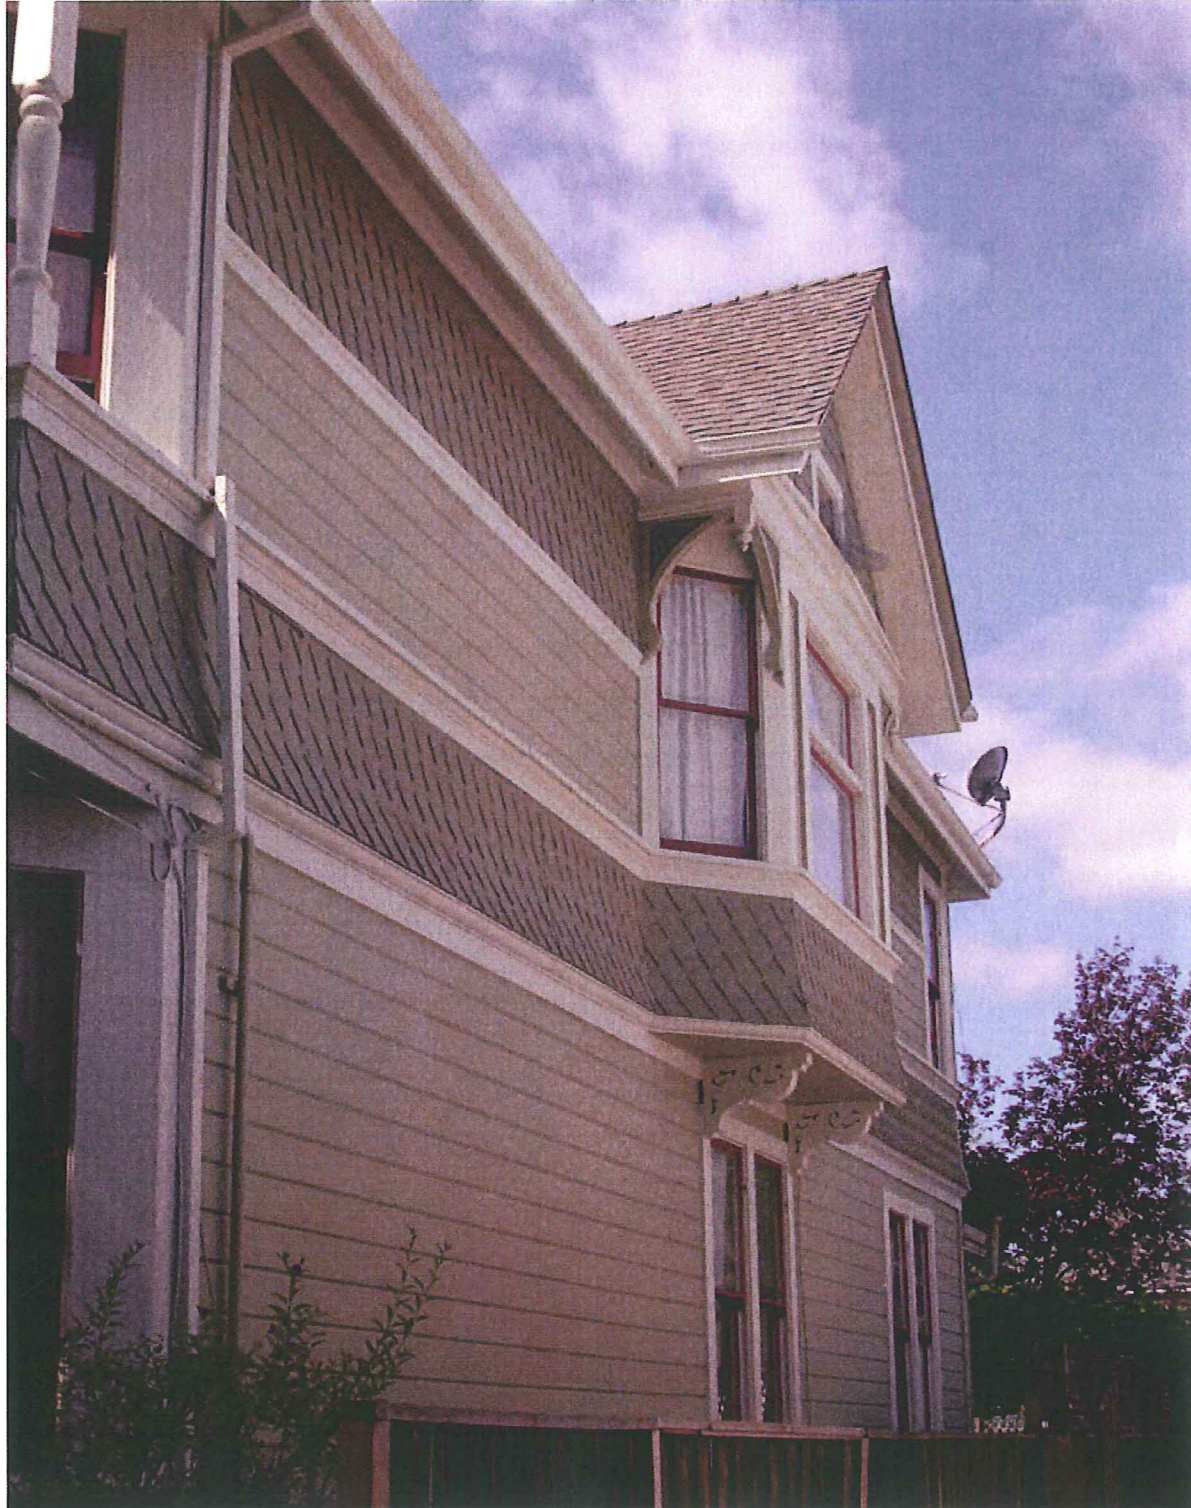
The north side elevation features a roughly centered, cantilevered bay window over a paired focal window. The bay window is topped by a gable with shingled siding and a single attic window. The outer corners of the gable are supported on elongated curved corbels carved with a fan pattern and accented by drop pendants. A pair of large corbels supports the bay window; these are carved with Eastlake patterns. The soffit of the bay window is clad in beaded-board paneling. An individual 1/1 double-hung window is located near the second-story rear corner. There are no additional windows to the front of the bay window at the first or second floors. At the first floor, centered below the bay window, is a paired focal window with narrow 1/1 double-hung windows. A similar paired unit is located to the rear of the first floor; it is not aligned with the upper windows.

North elevation, viewed facing southwest.

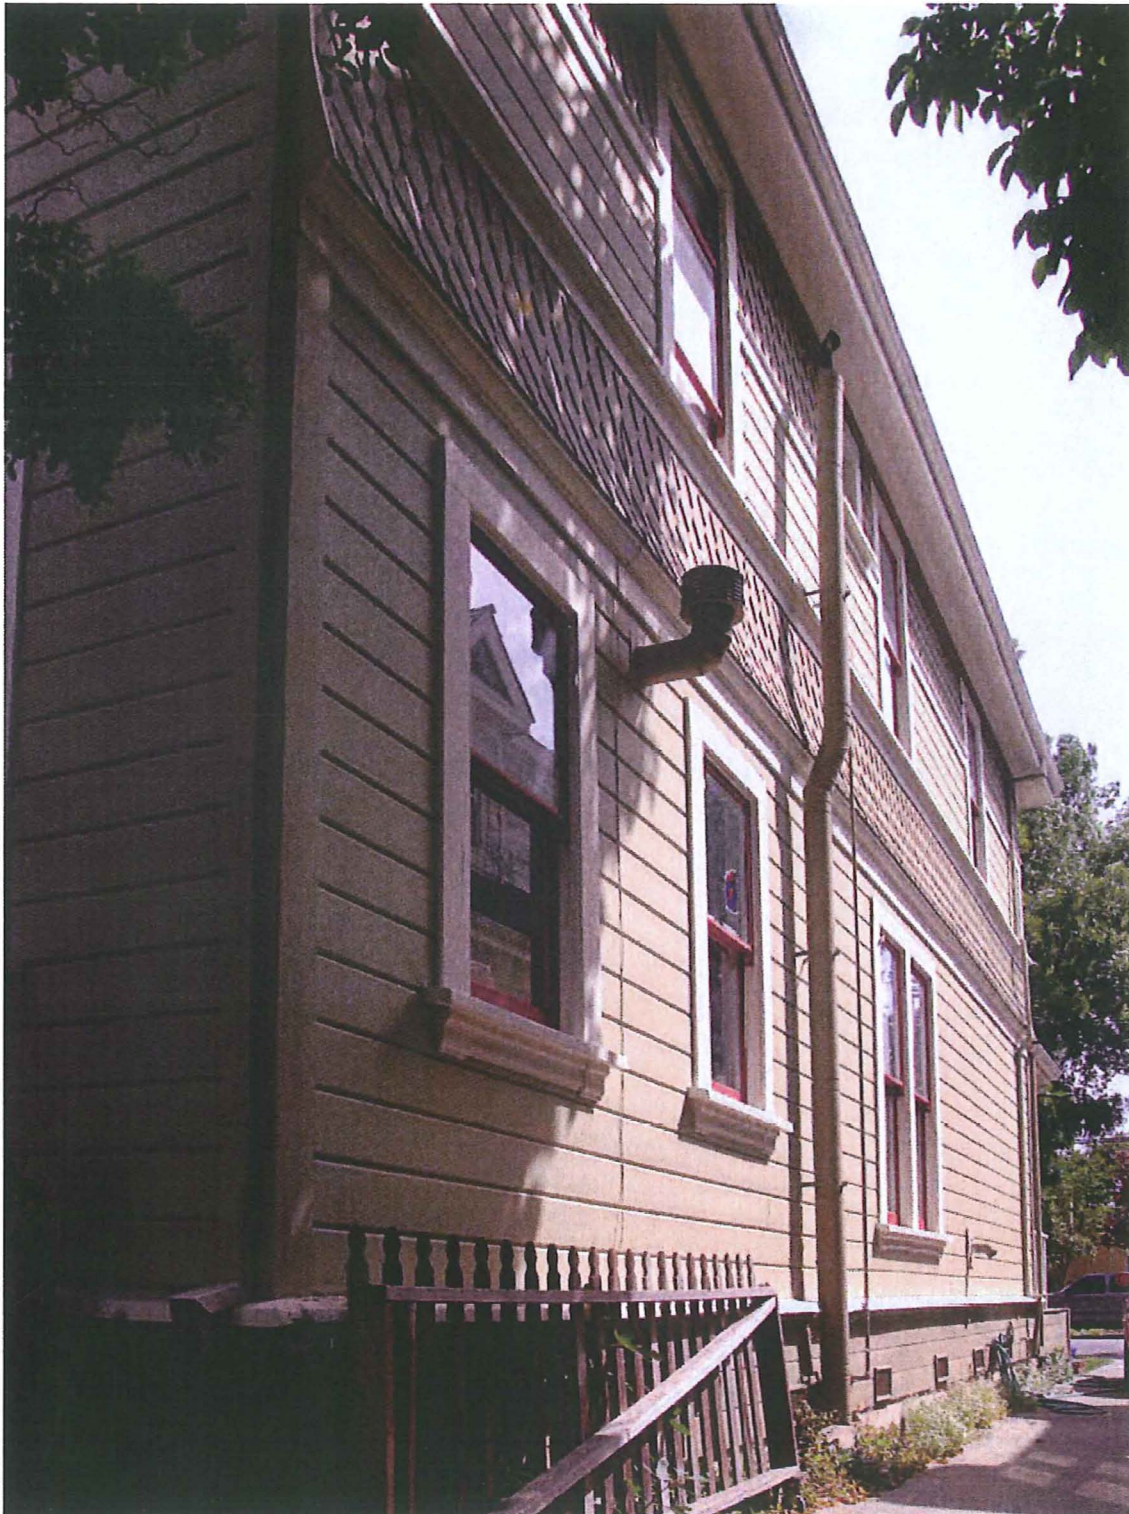
The south façade includes three individually placed 1/1 double-hung wood windows at the second floor, spaced approximately equally apart. The front-most window features leaded glass sash, possibly a modification. A tiny closet accent window sits on the upper trim band between the two rear-most windows. At the first floor, unaligned with the upper fenestration, is a pair of roughly centered, tall, narrow 1/1 double-hung windows. Two slightly smaller, individually placed 1/1 windows are located to the rear of the focal unit.

South elevation, viewed facing northeast.

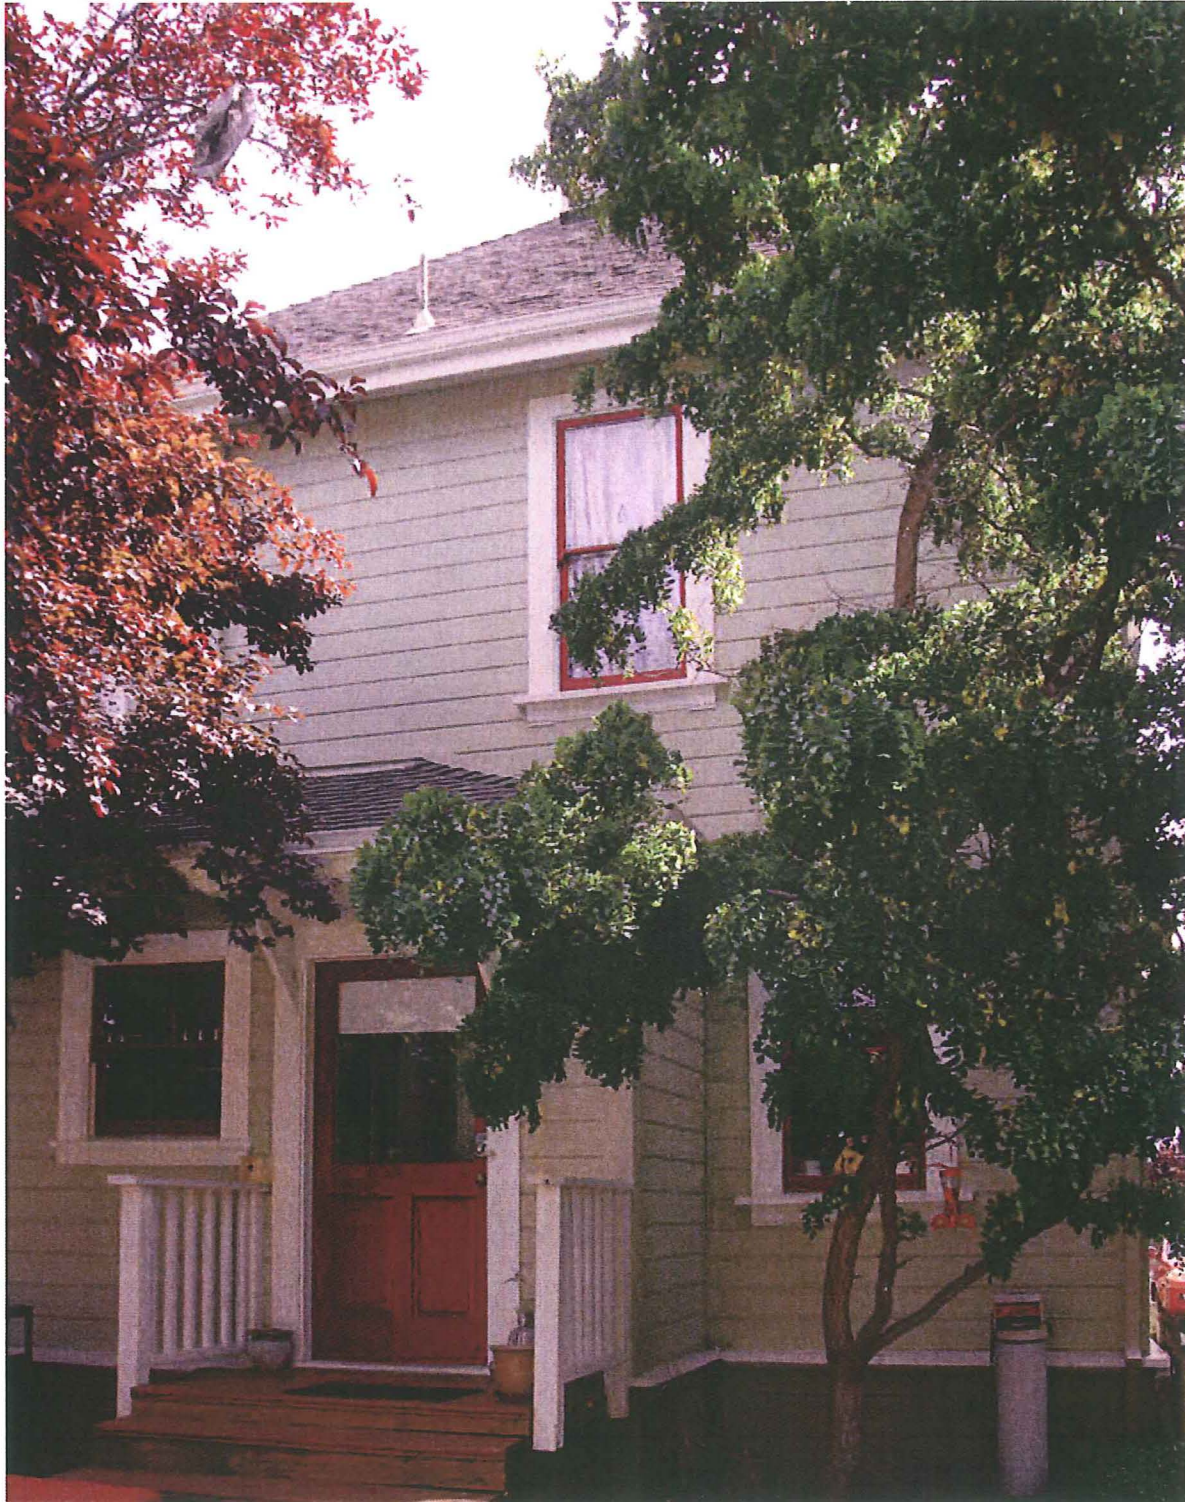
In the upper level of the rear façade are two, asymmetrically placed individual 1/1 double-hung windows. At the ground floor, the northwest corner wing includes a back door and a small 1/1 double-hung window. To the south side of the projecting wing is a single 1/1 double-hung window.

Rear elevation, viewed facing northeast.

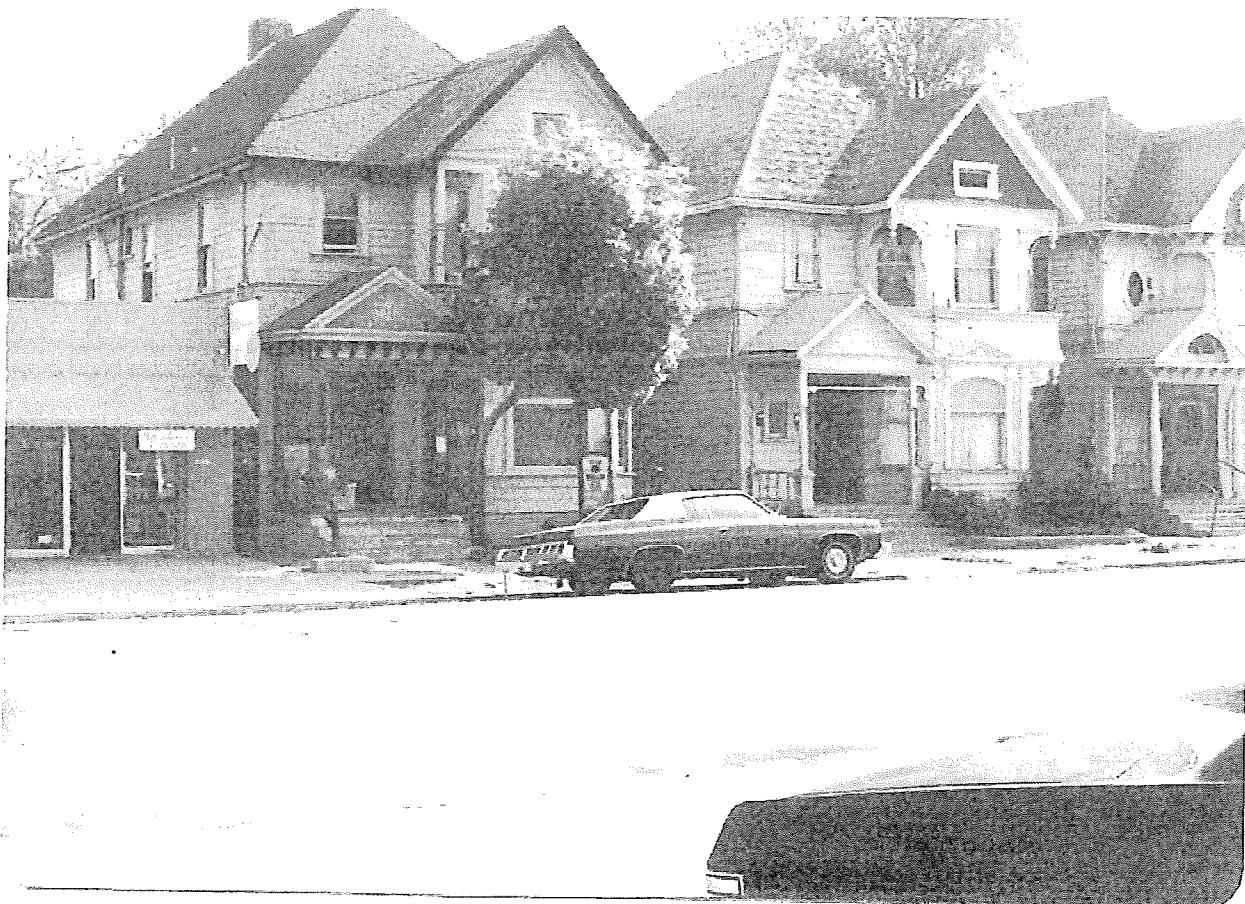
Historic view of house when located at 486 South Tenth St., viewed facing east. This photo was believed to have been taken by one of the authors of this recording in November of 1976, 12 years prior to the relocation of the building to South Twelfth Street. The subject building is the left one of the three residential buildings shown.

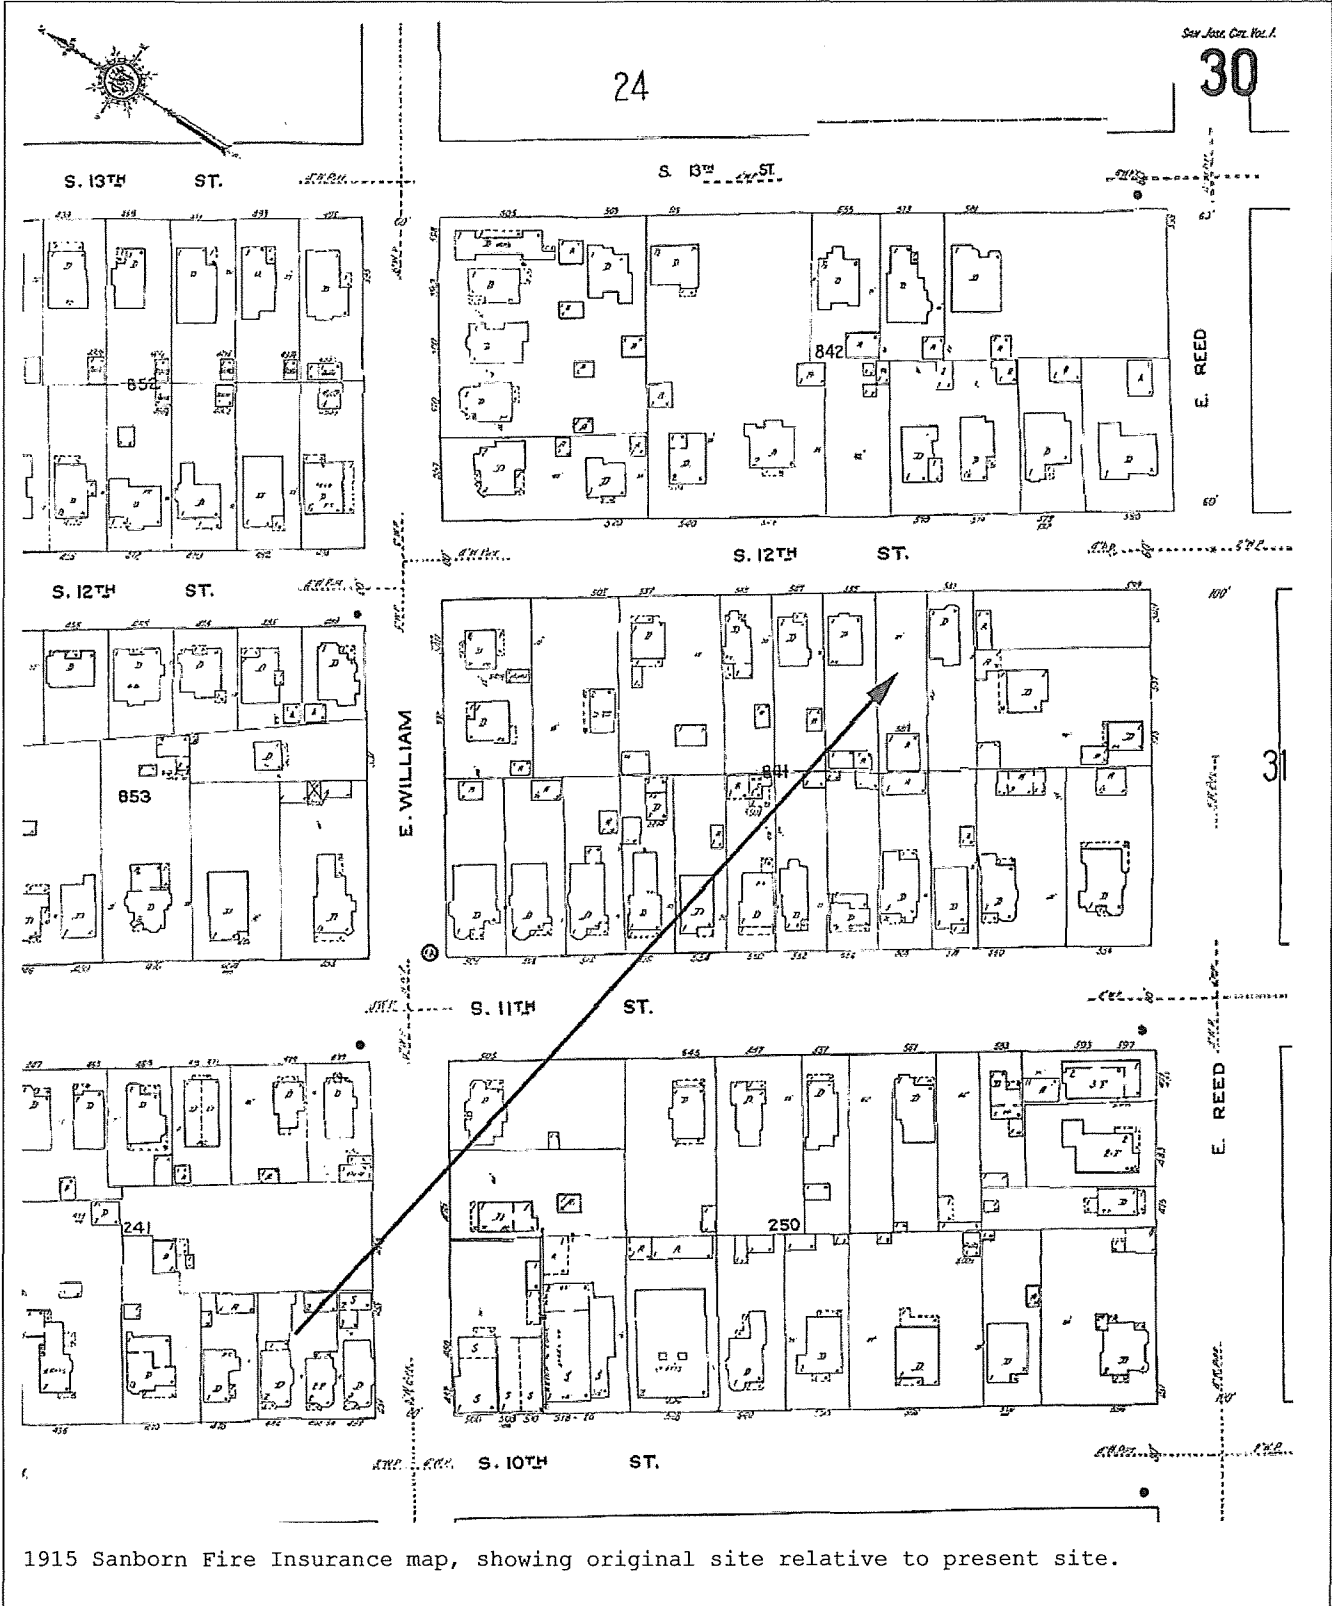
Site Plan

The immediate setting of the nominally east-facing Riggs House includes a modest front yard that is landscaped primarily as lawn with a new brick pathway. Moderately large street trees are found in the parking strip. A concrete driveway fills the south side yard, leading to a detached garage at the rear of the parcel. A very narrow north side setback is not landscaped. The rear yard includes a 2-car modern garage at the southwest corner of the parcel; also within the rear yard are recent plantings, arbors, decks, and walkways.
