Stress-Absorbing Membrane Interlayers for Asphalt Pavement Distress

Prepared for
Northeast Region Technical Services Section
Division of Transportation System Development

Prepared by
CTC & Associates LLC
WisDOT Research & Library Unit
February 14, 2008

**FIELD EVALUATION OF EXPERIMENTAL FABRICS
TO PREVENT REFLECTIVE CRACKING
IN BITUMINOUS RESURFACING
Final Report**

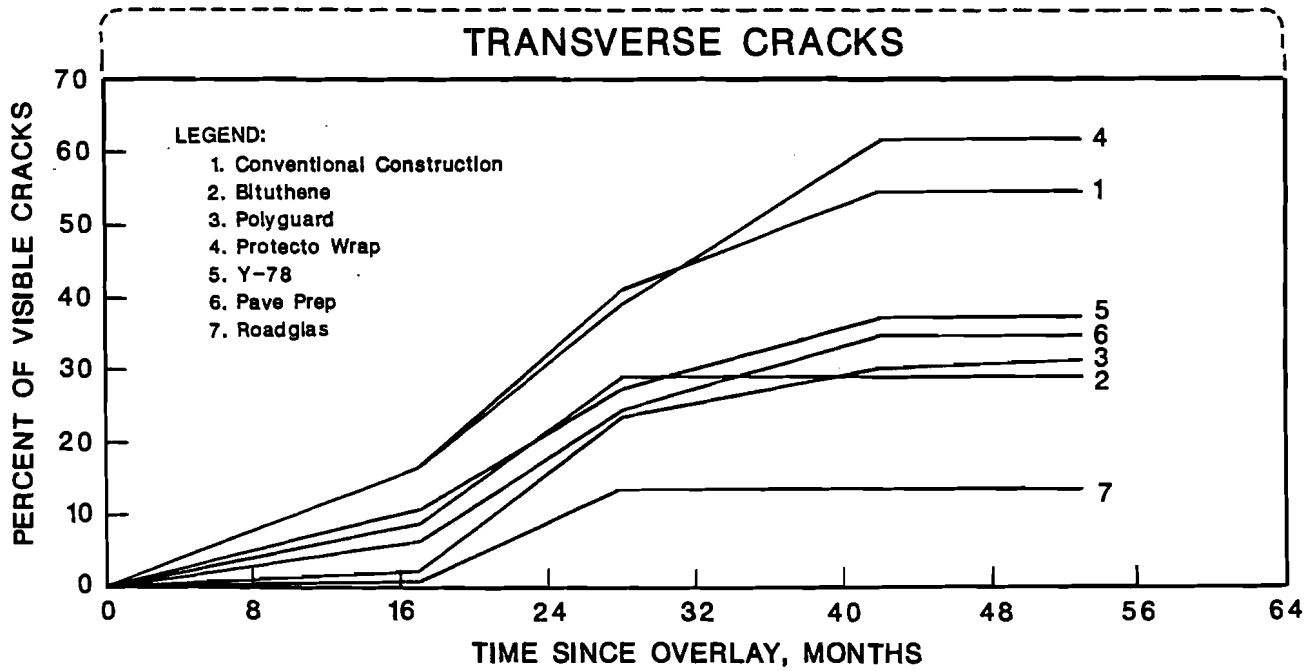
Figure 1. Increase in visible transverse and longitudinal cracks through asphaltic concrete resurfacing after the 1983-1986 winters (Research Projects 71 NM-286, 74 NM-414, 78 NM-552, 78 NM-566, 80 NM-617). Experimental Fabrics on I 94 BL, City of Kalamazoo.

The final crack survey for the project was conducted in March 1986. Figure 1 and Table 3 summarize the results of the March 1983, February 1984, April 1985, and March 1986 crack surveys. There was little or no increase in the longitudinal and transverse crack growth curves for reflective cracking in the bituminous overlay from the curves presented

From Figure 1, it would appear that the Roadglas fabric is slightly more effective in reducing the reflective transverse cracking than the other fabrics. The Roadglas, however, was only placed on part I and the rest of the fabrics were placed on both parts. This may account for the difference in performance between the Roadglas and the other fabrics as the percentages shown in Figure 1 are for the total amount of cracking for parts I and II. The cost of the Roadglas fabric treatment is three to four times the cost of any of the other fabric treatments, however, and thus may not be practical.

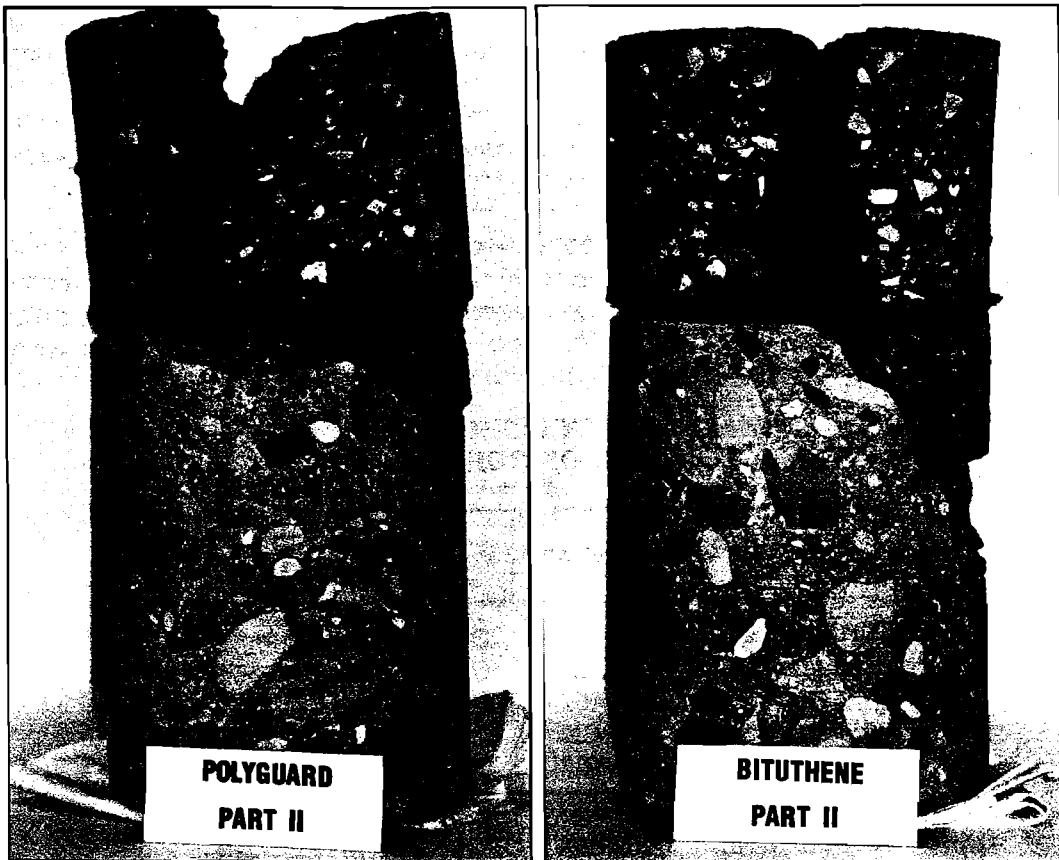
Figure 4. Reflective cracking in the asphalt concrete resurfacing at the edge of the bituminous joint/crack repair placed prior to the resurfacing on I 94 BL.
