ROVER for End-to-End Seismic Risk Management

FEMA 4th Annual HAZUS Conference
Indianapolis, 23-25 August 2010
Keith Porter *SPA Risk LLC*

Problem: Efficient Earthquake Safety Inspection

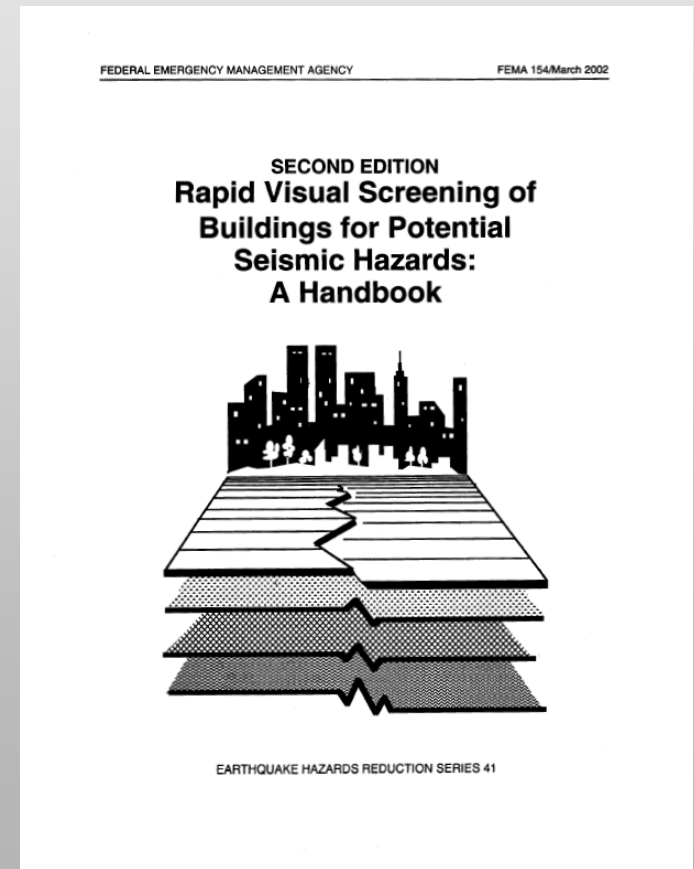
Figure 5-11 Completed Data Collection Form for Example 2, 3711 Roxbury Street.

- The FEMA 154 form
- Location, name, use
- Sketch
- Photo
- Occupancy
- Soil
- Falling hazard
- Scoring section
- Comments
- Detailed eval required?

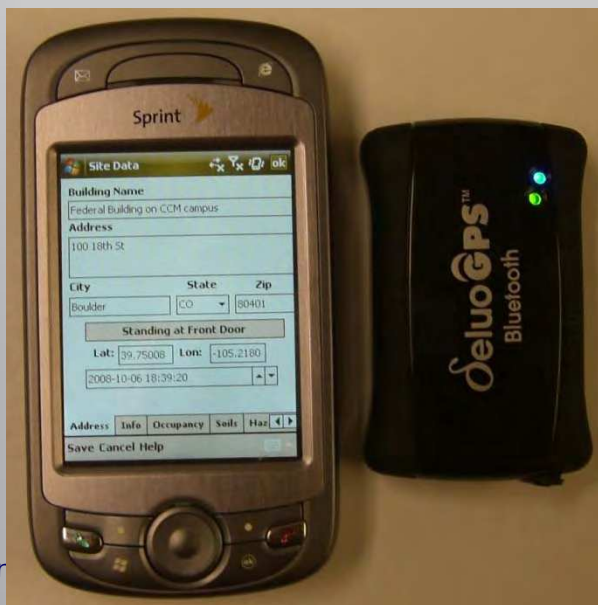
Client Address tab

- Building name, address
- Remembers last city/state/zip
- Lat/Lon from Bluetooth GPS
 - ◆ Better than geocoding address
 - ◆ Server can look up soil & site hazard from internal databases

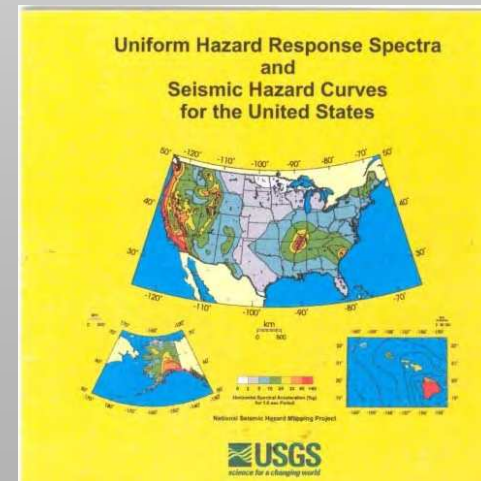
Server's built-in soil and hazard maps from USGS

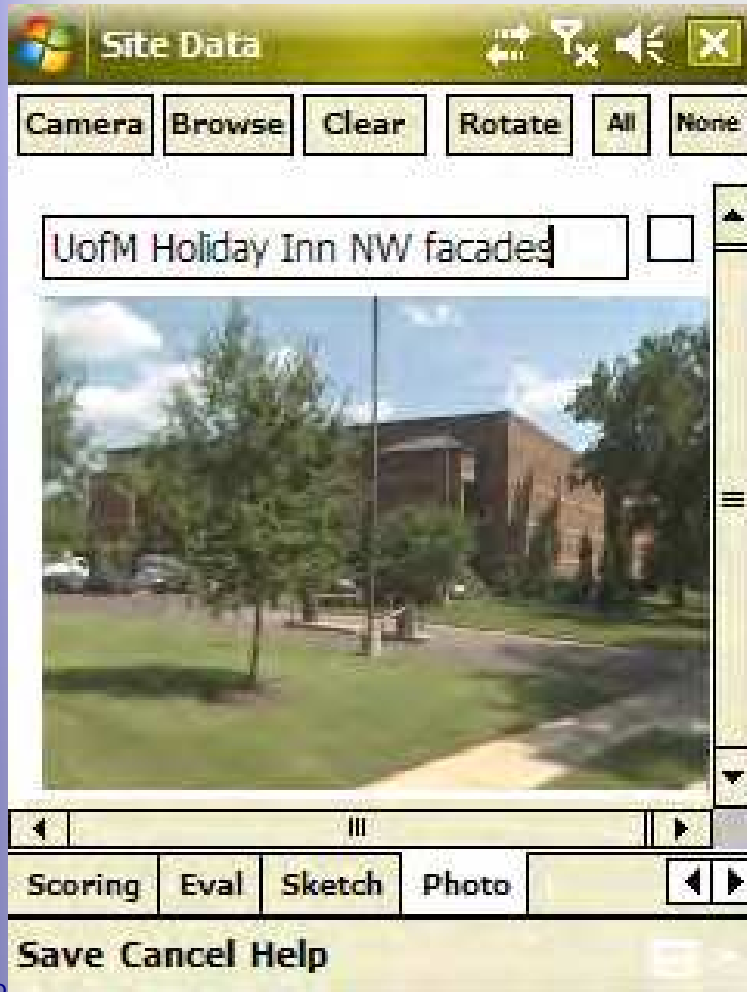
Multiple Captioned Photos

- Use phone's onboard camera
- Photo appears in database
 - ◆ A challenge for paper form
- Unlimited captioned photos
 - ◆ 8GB = 200,000 VGA jpgs
- Photo is later watermarked
- There is also a sketch

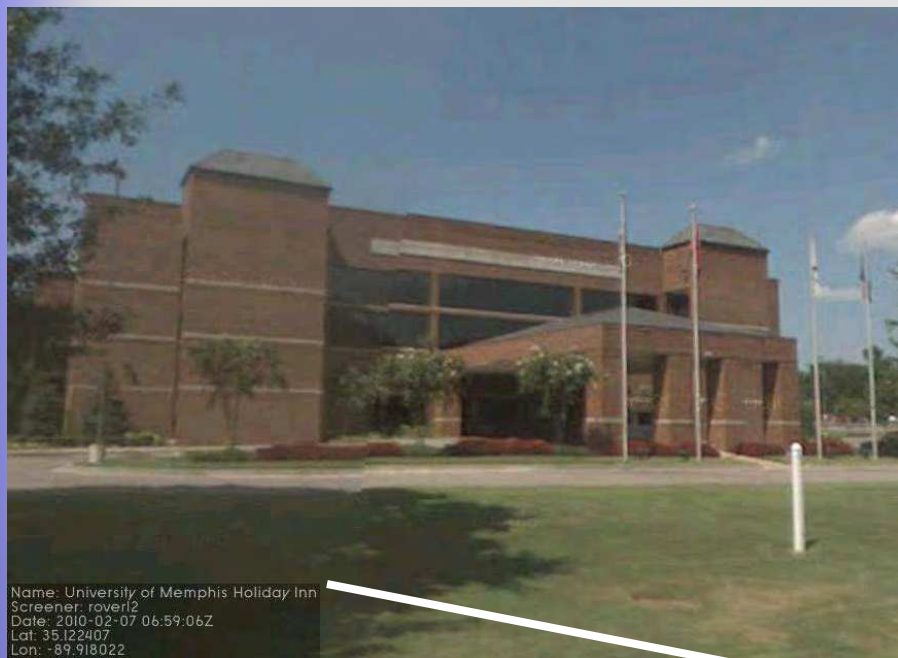
Automatic Watermarks Added

Name: University of Memphis Holiday Inn
Screener: rover12
Date: 2010-02-07 06:59:06Z
Lat: 35.122407
Lon: -89.918022

- Server adds watermark to each photo
 - ◆ Building name
 - ◆ Screener ID
 - ◆ Date & time
 - ◆ Lat & lon
- Can add captions on client or server

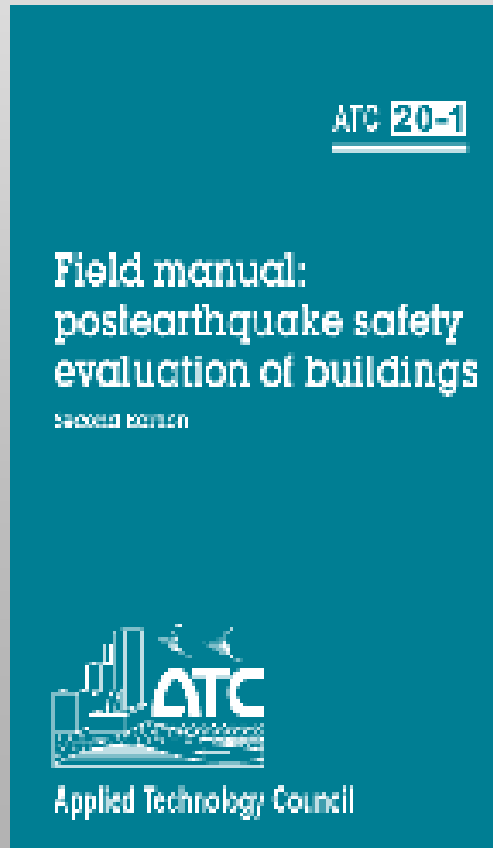
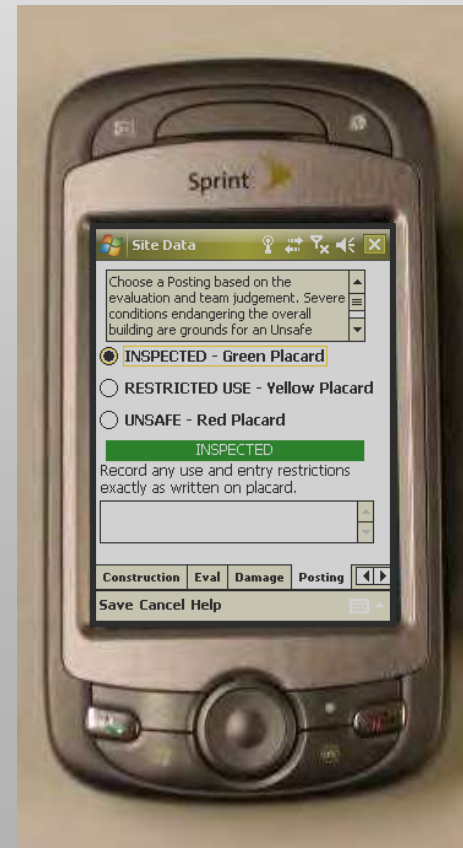
ATC-20 (1989, 1991, 1996)

- Applied Technology Council, 1996. *ATC-20: Procedures for Postearthquake Safety Evaluation of Buildings*. Redwood City, CA, 144 pp.
- De facto international standard post-earthquake safety inspection
- Used 100,000s of times
- Red/yellow/green tag

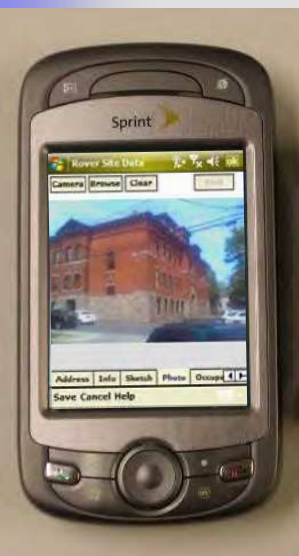
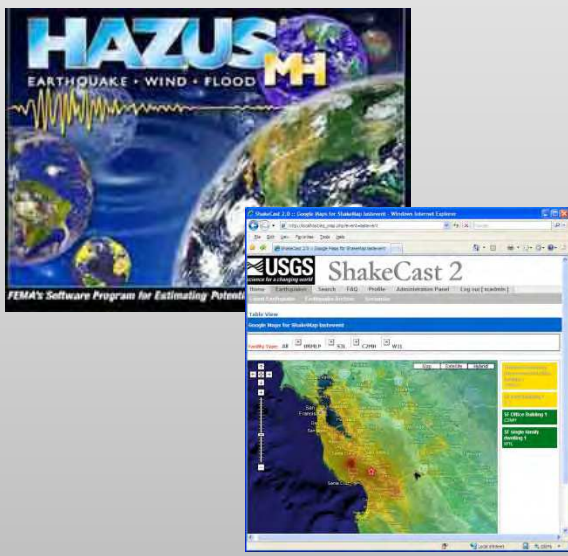
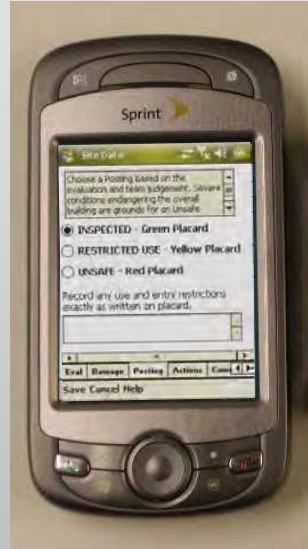
Summary: End-to-End Building Data Tool

Pre-earthquake

Post-earthquake
