HISTORIC RESOURCE INVENTORY FORM

Property name (if any) Orchid Ledge Farm
Address or Street Location 4830 Thompson Road
County Erie Town/City Clarence Village/Hamlet: _____
Owner _____ Address _____
Original use Residential / Agricultural Current use Residential / Agricultural
Architect/Builder, if known _____ Date of construction, if known 1824

Study: Town of Clarence Intensive Level Survey of Historic Resources

Property name (if any) Jacob Eshelman Homestead
Address or Street Location 5880 Thompson Road
County Erie Town/City Clarence Village/Hamlet: _____
Owner _____ Address _____
Original use Residential / Agricultural Current use Residential / Commercial
Architect/Builder, if known _____ Date of construction, if known Circa 1846

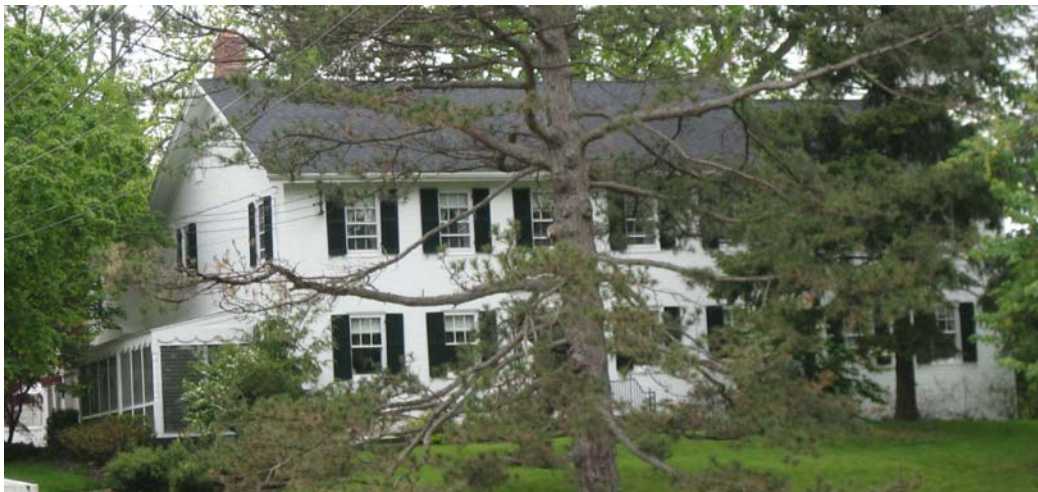
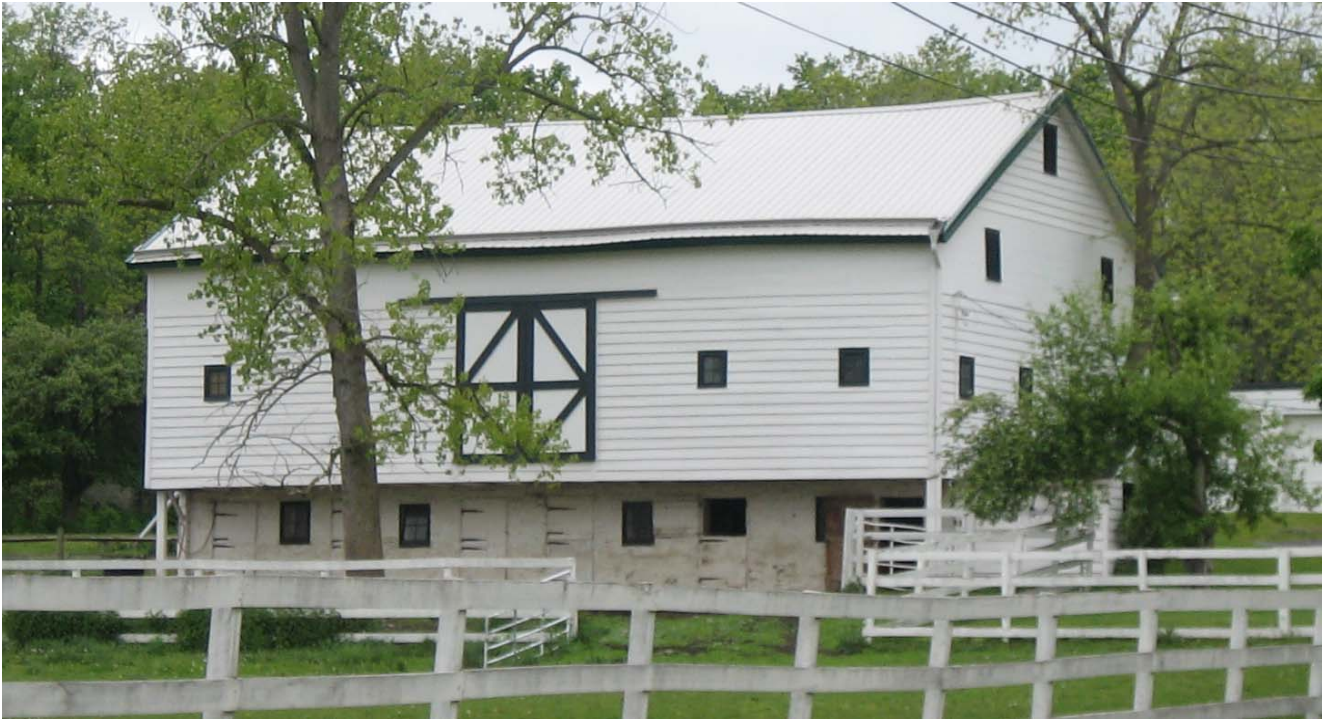
PHOTOGRAPH (Town of Clarence Intensive Level Survey of Historic Resources) NY_Erie County_ Town of Clarence_4830 Thompson Road

The building at 4830 Thompson Road is set on a large 16.70 acre parcel, located on the west side of the street between Main Street and Greiner Road. Thompson Road is a residential north-south corridor that runs from Clarence Center south to Clarence Hollow/Harris Hill. This building resides in the southern portion of the site. The main block of this substantial 2-story side gabled painted brick building is five bays wide and two bays deep. A two story two bay by two bay addition to the north extends the building to seven bays. An enclosed sunroom is to the south, and a historically added rear block with greenhouse/conservatory is to the west. Further west is a side gable three car garage with cupola, and to the south west are several large barns, one with fieldstone base. A running stone wall lines the property north of the driveway, and a fenced paddock is to the south.

The primary entrance to the building is located in the center of the original block, with pedimented enframement and sidelights. The fenestration is regular and even with shuttering and six over one double-hung windows (possibly historically replaced circa 1920). An additional entrance with connection to additions is located to the south. Brick chimneys are visible in the ridge in the north and south gables.

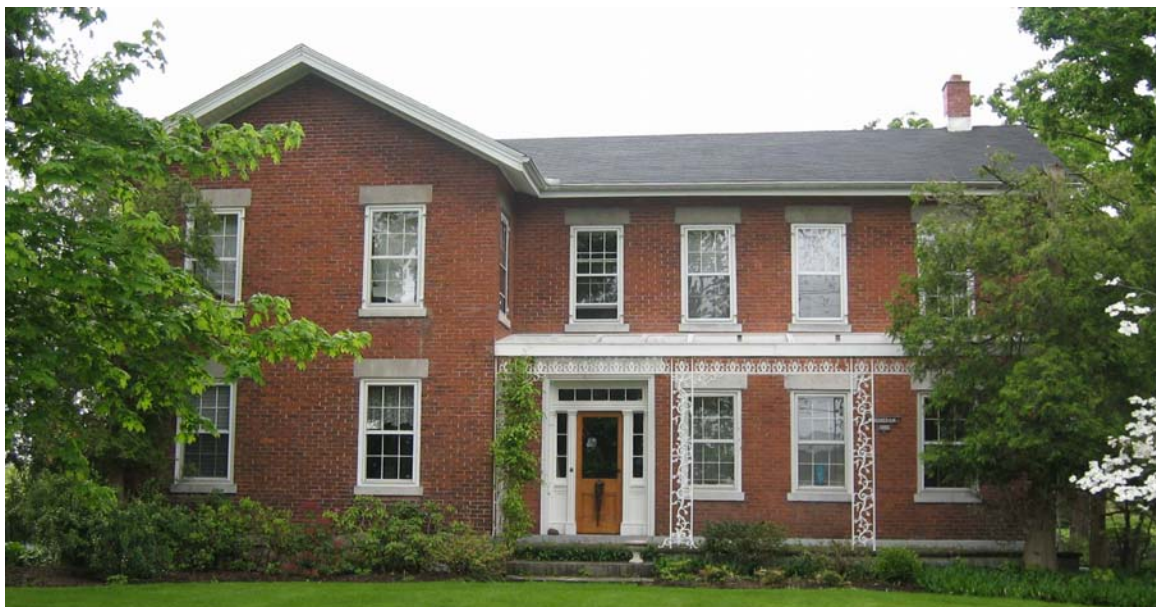
PHOTOGRAPH (Town of Clarence Intensive Level Survey of Historic Resources) NY_Erie County_ Town of Clarence_5880 Thompson Road

The building at 5880 Thompson Road is set on a large parcel located on the west side of the street between Roll Road and Clarence Center Road. Thompson Road is a residential north-south corridor in the Clarence Center section of Clarence that runs down through Harris Hill. This building resides in the Clarence Center section of the road. This 2-story, cross gabled, vernacular brick building has two primary blocks. The side gabled front block is four bays wide by two bays deep. The cross gable block to the south is two bays wide by three bays deep. To the rear is a large 1 ½-story front gabled brick addition two bays wide and four bays deep. Opposing cross gable dormers are in the third bay. A two story open porch is to the rear of the addition. Several outbuildings, including a barn and silo, are to the rear and are part of a commercial complex.

The primary entrance to the building is in the south bay of the north block protected by a notable, large, flat roofed, open porch with intricate wrought iron supports and frieze detail extending across the façade from the L. The entrance is enframed and has sidelights and a transom. The fenestration is regular, even six over one double-hung sash (replaced) with stone sills and lintels.

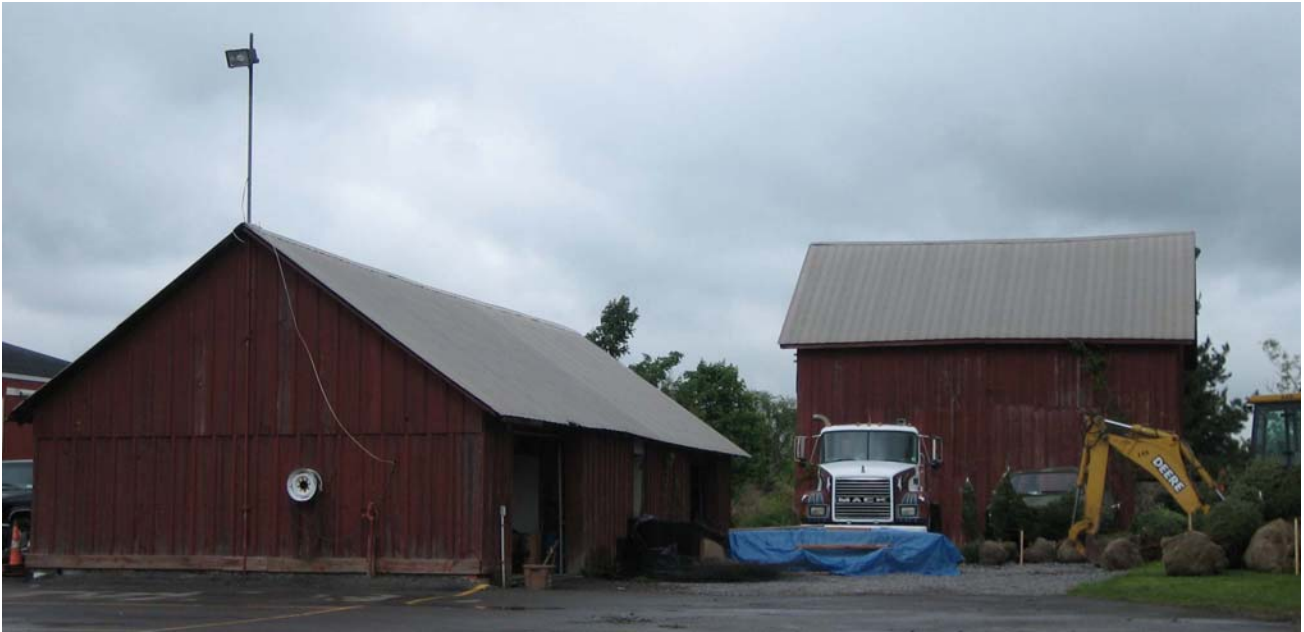
NY_Erie County_Town of Clarence_5880A Thompson Road

Other materials and their location: Remaining barn and silo. Stone sills and lintels
