NAME	Otis Building			REF. NO. 187
ADDRESS	101 West Fourth Street			
CITY	Santa Ana	ZIP	92701	ORANGE COUNTY
YEAR BUILT	1889	LOCAL REGISTER CATEGORY: Key		
HISTORIC DISTRICT	Downtown	NEIGHBORHOOD		
NATIONAL REGISTER CRITERIA FOR EVALUATION	C	NATIONAL REGISTER STATUS CODE	1D

ARCHITECTURAL STYLE: Renaissance (originally built as a Queen Anne in 1889)

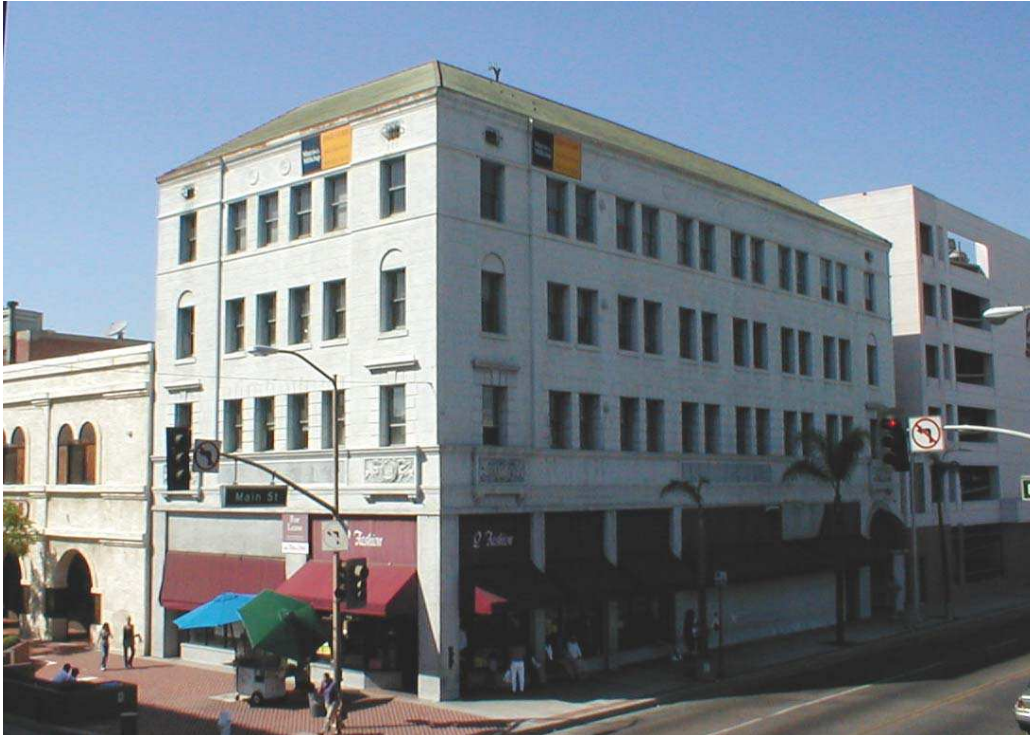
This rectangular shaped four-story retail and office building has a façade of brick with coursed smooth ashlar. The storefronts are 1950's commercial on the first story with deep bays flanked by display windows. The upper façade is of a Renaissance style with simplified elements. Two ornate cartouches are located beneath the second story and each level has a different articulation. Six double hung windows are vertically segmented in three divisions and the building has three upper floors of which the topmost is delineated by a simple belt course. Two small square attic windows flank decorative medallions on the upper level. A mansard roof of asphalt shingle caps the building.

The present façade dates from 1925 when an extensive remodeling of the old First National Bank building resulted in the H. H. Helbush Building with its main entrance at 408 N. Main. The building was sold next year and was renamed the Otis Building by its new owners.
