# Inspection Report

123 Bay Towers

Pensacola, FL

10/13/05

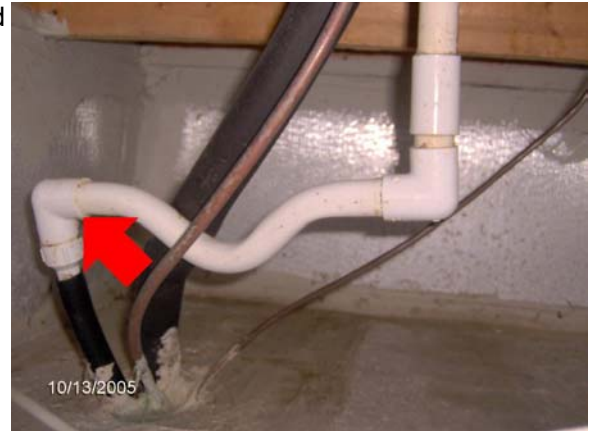
CONDENSATE DRAIN LINE: A condensate drain line is installed and is presently draining to the exterior. **Noted a small leak at one of the joints of the condensate drain line under the unit. Repair needed.**

Noted a small leak at one of the joints of the condensate drain line under the unit. Repair needed.

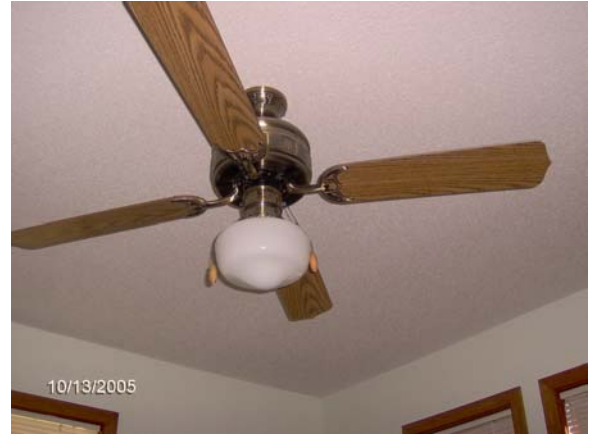
COMMENTS: The second bedroom ceiling fan does not operate. Repair / replace as needed.

The second bedroom ceiling fan does not operate. Repair / replace as needed.

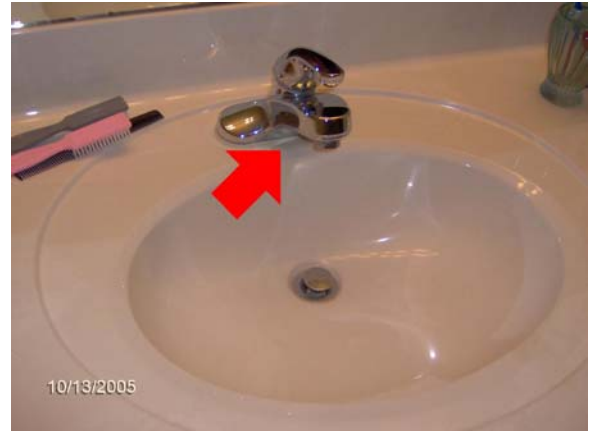
**FAUCET & SUPPLY LINES:** The sink faucet in the hall bath is drip leaking and is loosely mounted to the sink. Repair / adjust as needed.

The sink faucet in the hall bath is drip leaking and is loosely mounted to the sink. Repair / adjust as needed.

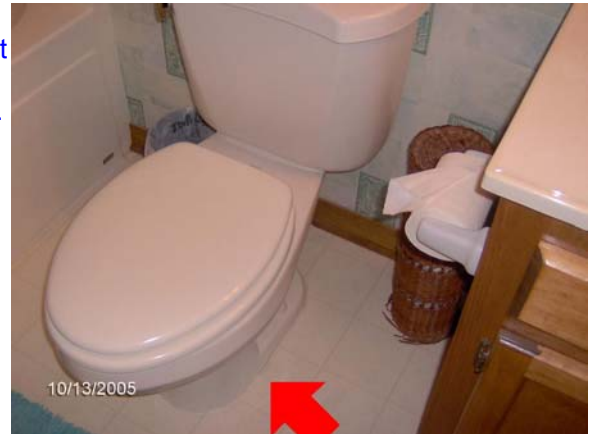
**TOILET CONDITION:** The toilet in the hall bathroom is not properly secured to the floor, allowing it to wobble, move back and forth, and possibly leak. Re-secure it to the floor.

The toilet in the hall bathroom is not properly secured to the floor, allowing it to wobble, move back and forth, and possibly leak. Re-secure it to the floor.
