Victorian Tearooms Robinswood Hill

Archaeological Evaluation on Outbuildings to Victorian tearooms at
Robinswood Hill
Gloucester

NGR SO 83831 15827

Title: Excavations on Victorian tearoom outbuildings

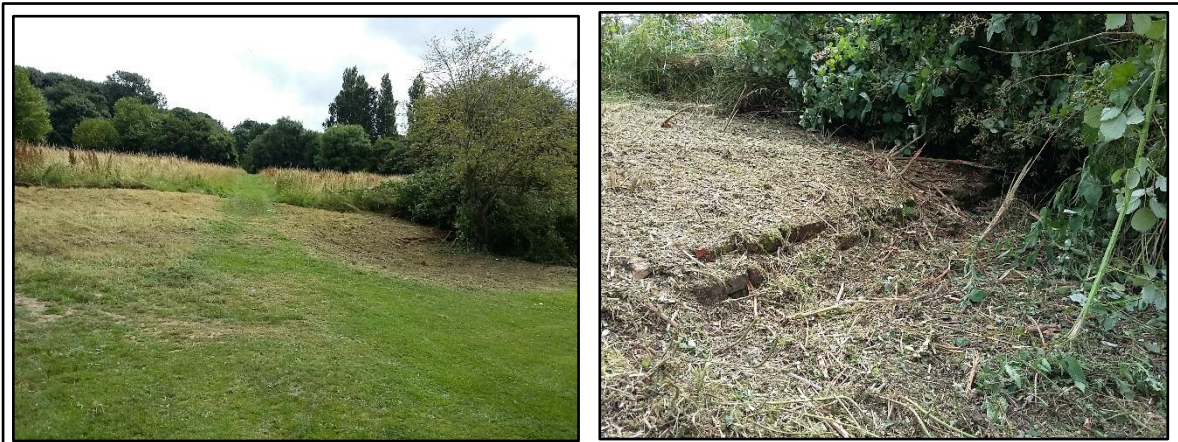
buildings. The site slopes slightly due to the buildings being terraced into the hill behind. A number of courses of brickwork protrude from the surface betraying the presence of some walls (figure 2).

Figure 2: Site before excavation.

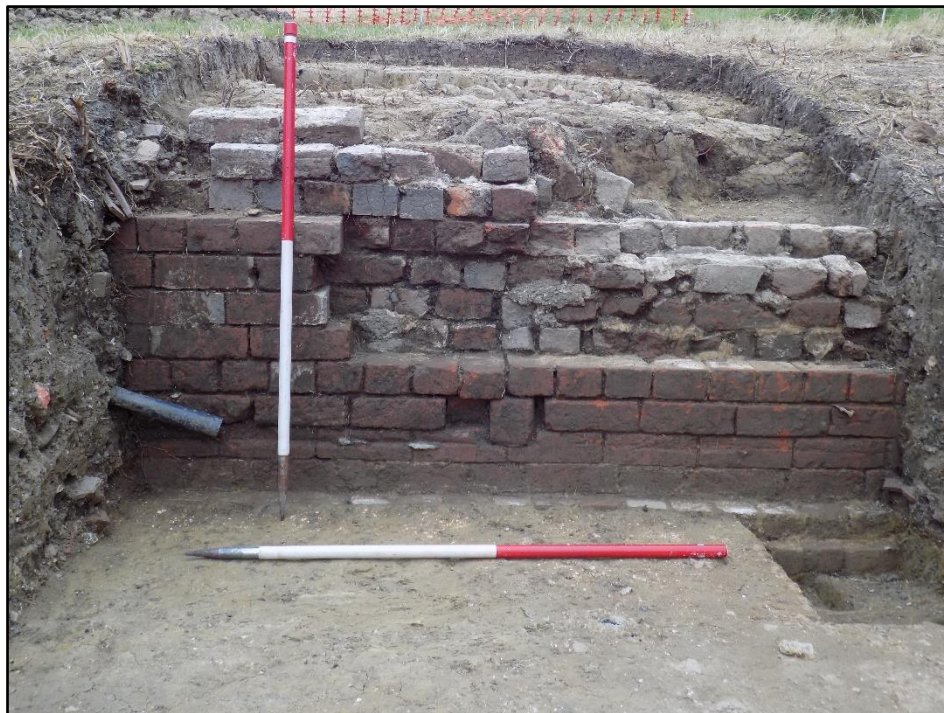
4.2.1 Trench 1 was designed to be a section across what, from all of the geophysical and mapping evidence available, was believed to be one of the outbuildings of the Victorian tearooms. Part of the initial evaluation of the site, the trench would reveal both the interior and exterior of the building. The trench was laid out as 2 x 7m in size. The trench diagram is at Annex I. The trench contained an outbuilding constructed of brick measuring 3.5m wide. The rear wall of the building [119] was terraced into the hill (figure 3). The slope had been cut away for the brick wall to be constructed and then a rubble fill (110) placed back. Up to 11 courses of brick still survived. The front wall [119] was also constructed of brick and measured 0.4m wide. To the front of the building brick had been used to construct a forecourt [120] interpreted as an entrance to the building (figure 4).

Figure 3: Rear wall of building.

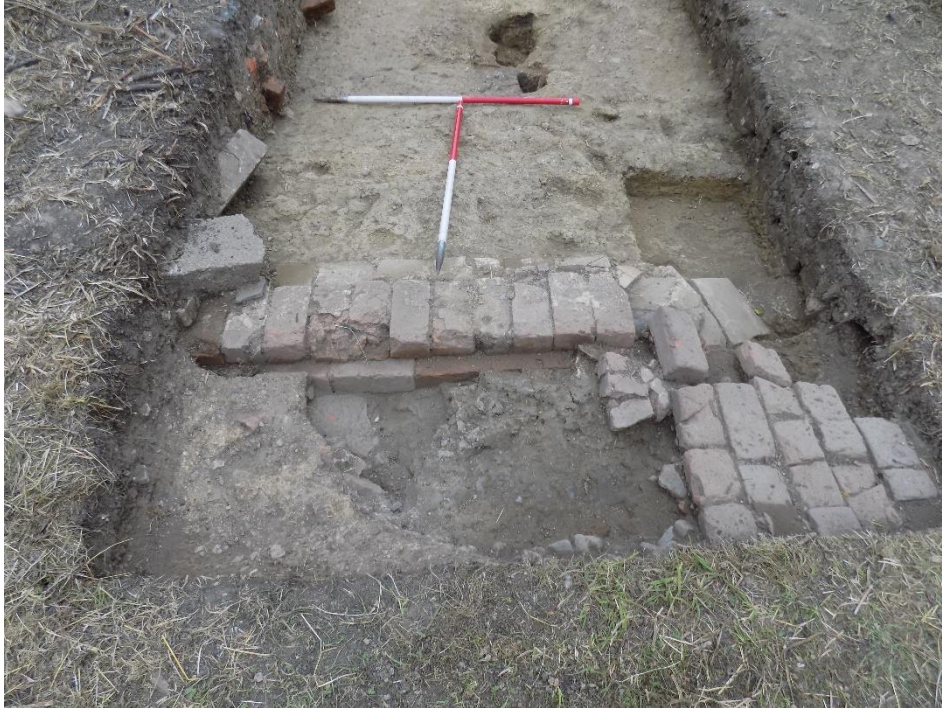
Figure 4: Front of building.

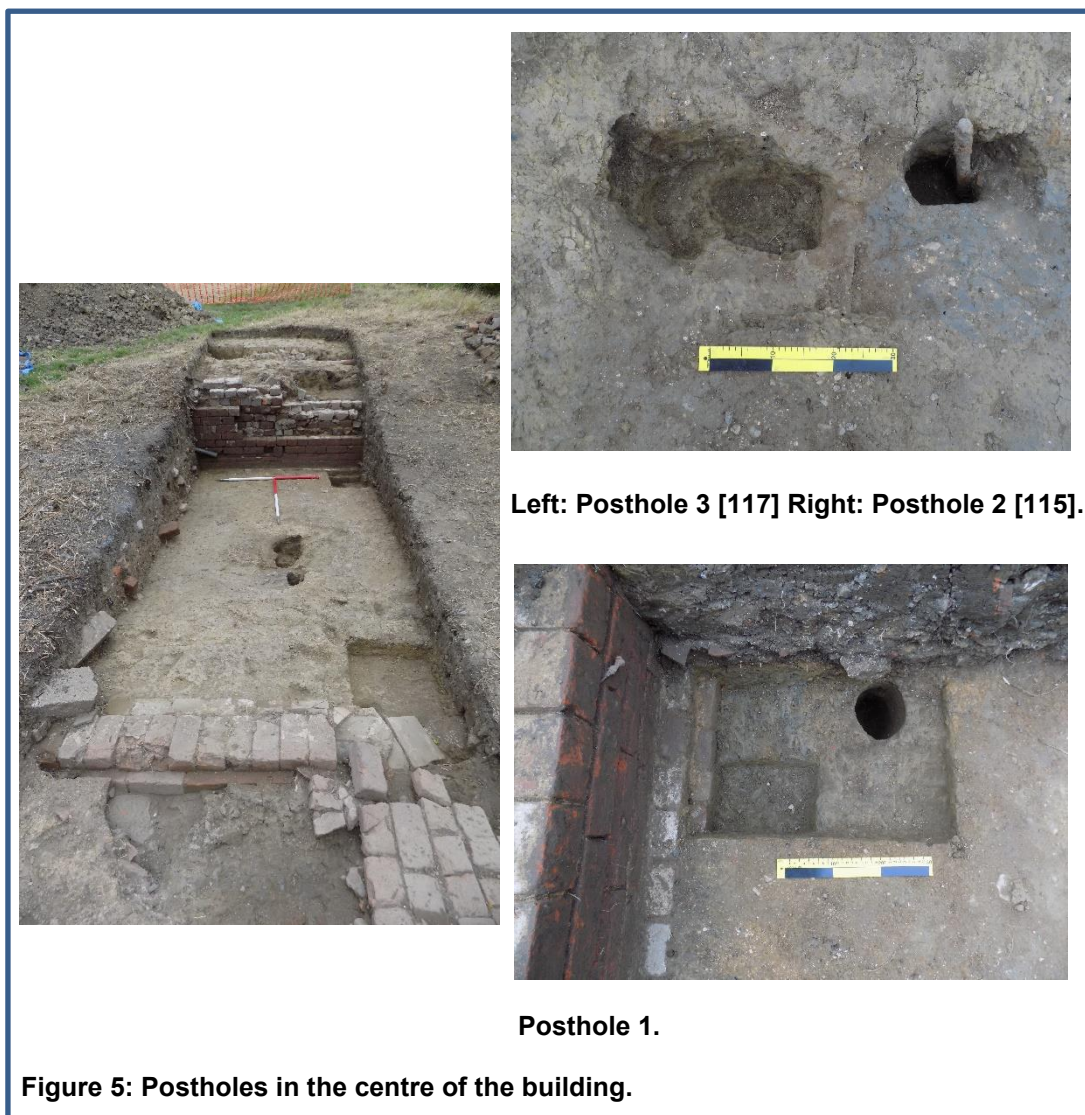
4.2.2 The internal floor was constructed of clay. Lying over the clay was a fine layer of a more gravelly material (108) that may represent the bedding for floor tiles. Cut into the floor in the centre of the building was a series of postholes (figure 5) which indicate a sequence of repairs over the lifetime of the building. Post hole 3 [117] is centrally located and is probably the original supporting the central post to support the roof. Located slightly North of this is posthole 2 [115]. This square posthole appears to be a replacement for the original and has itself been repaired. The original square timber in this hole was held in place by the placement of a blue clay (113a). At some point, presumably when this post also became unstable, a metal bar was rammed in next to the wooden post to provide stability. At the base of the hole a tile had been placed to act as a post pad. A gravelly deposit (113) had been placed in a shallow depression over the area of the post holes probably to make the area level again following repairs. A teaspoon SF101 was recovered from this layer. A smaller possible posthole (posthole 1) was uncovered close to the rear wall within sondage 1 which also confirmed another layer of masonry on the back wall below the floor level. sondage 2, close to the entrance, indicated that there may have been some tiles located on the floor in this area.

5.1 The section placed over the outbuilding to the Victorian tearooms revealed a 3.5m wide building constructed of brick with a tiled roof. The roof was probably held up by wooden structure the main vertical posts being located in the centre of the construction. A sequence of repairs over the lifetime of the building was evident from the succession of postholes in the centre of the room. Post hole 3 [117] is centrally located and is probably the original supporting the central post to support the roof. Located slightly North of this is posthole 2 [115]. This square posthole appears to be a replacement for the original and has itself been repaired. The original square timber in this hole was held in place by the placement of a blue clay (113a). At some point, presumably when this post also became unstable, a metal bar was rammed in next to the wooden post to provide stability. At the base of the hole a tile had been placed to act as a post pad. A gravelly deposit (113) had been placed in a shallow depression over the area of the post holes probably to make the area level

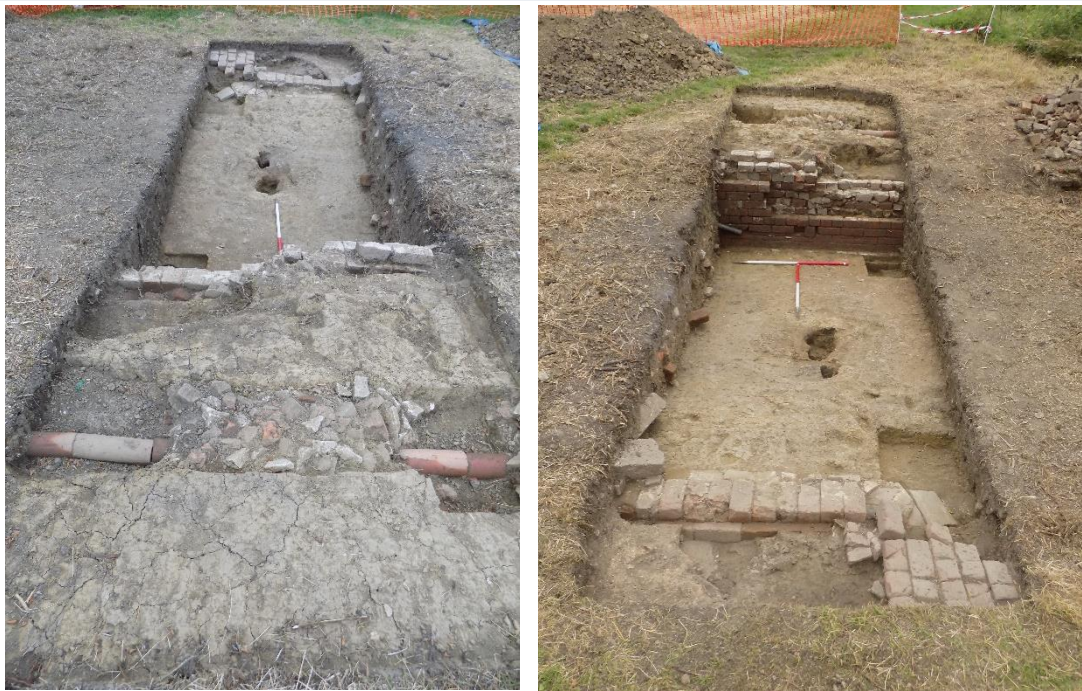
4.2.3 The entire interior of the building was filled with a uniform fill (102) which contained a lot of Victorian, and more recent, pottery, glass and other artefacts (figure 6). This was overlain by the topsoil (101) which reflected the same assemblage. On the uphill side of the building a drain had been laid running parallel with the back wall (figure 7). A trench [104] had been cut the pipe laid in and then rubble placed around the drain to both firm and act as a soakaway. A small shallow gulley [106] drained into the pipe trench. All seemed contemporary with the buildings.

Figure 6: Interior of building.

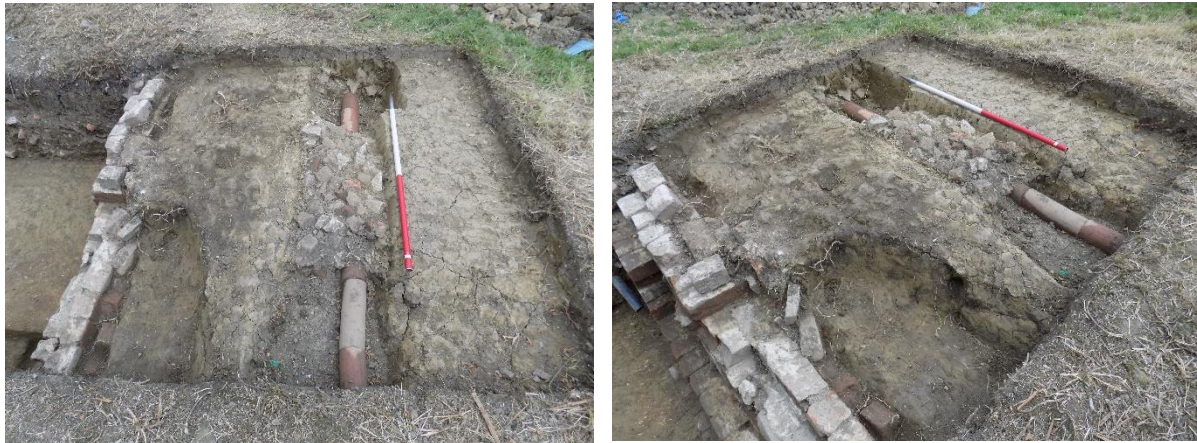
Figure 7: Drain at rear of building.

5.2 To the South the building had been cut into the slope behind and a drain ran parallel with the back wall. This was higher than the floor level of the interior of the building and presumably drained water from the roof of the structure and also prevented run-off down the slope to the back of the building. Constructed from clay pipe and held in by rubble it was contemporary structure to the building.

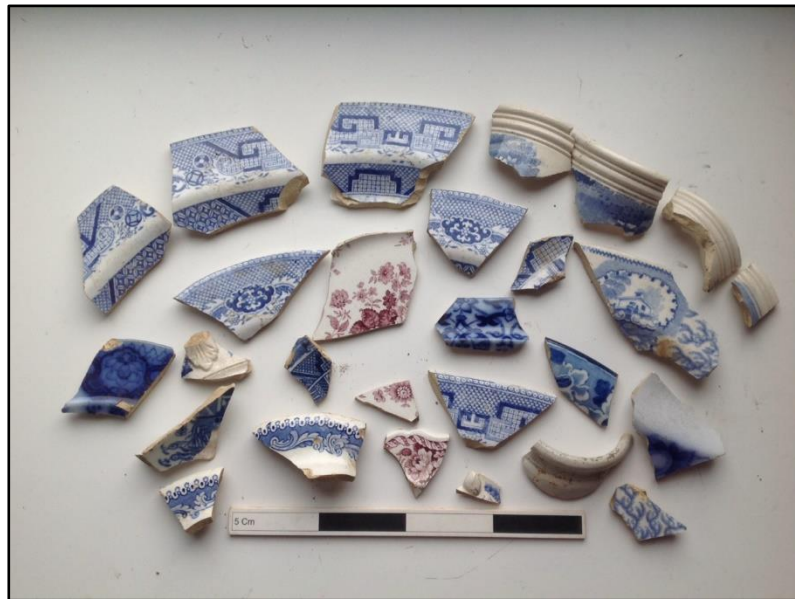
Figure 8: Decorated china.

4.3.1.1 The archaeological work resulted in the recovery of 301 sherds of pottery weighing 1931g largely consisting of blue willow pattern china with the occasional piece with a predominantly red design (280 sherds weighing 1815g). Also recovered were 14 fragments of stoneware (260g). All of this assemblage dates from the mid/late Victorian period to the early 19th Century (Figure 8). Evenly distributed across the site it was recovered mainly from the backfill of the interior of the building (202) but was also present in the fill of the pipe trench (103) and the backfill behind the rear wall of the building (110). A couple of decorative china mouldings were also present.

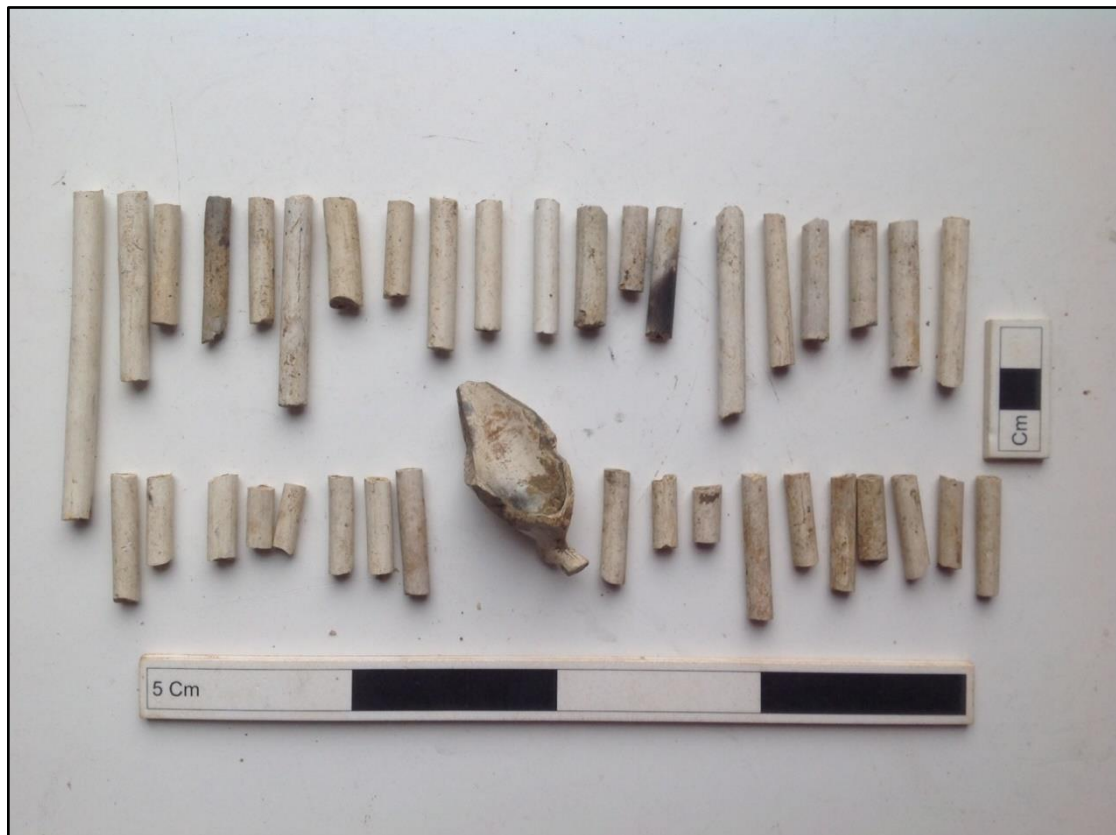
Figure 11: Clay tobacco pipes from (102).

4.3.5.1 In total 42 fragments of clay tobacco pipe were recovered including one partial bowl (figure 11).

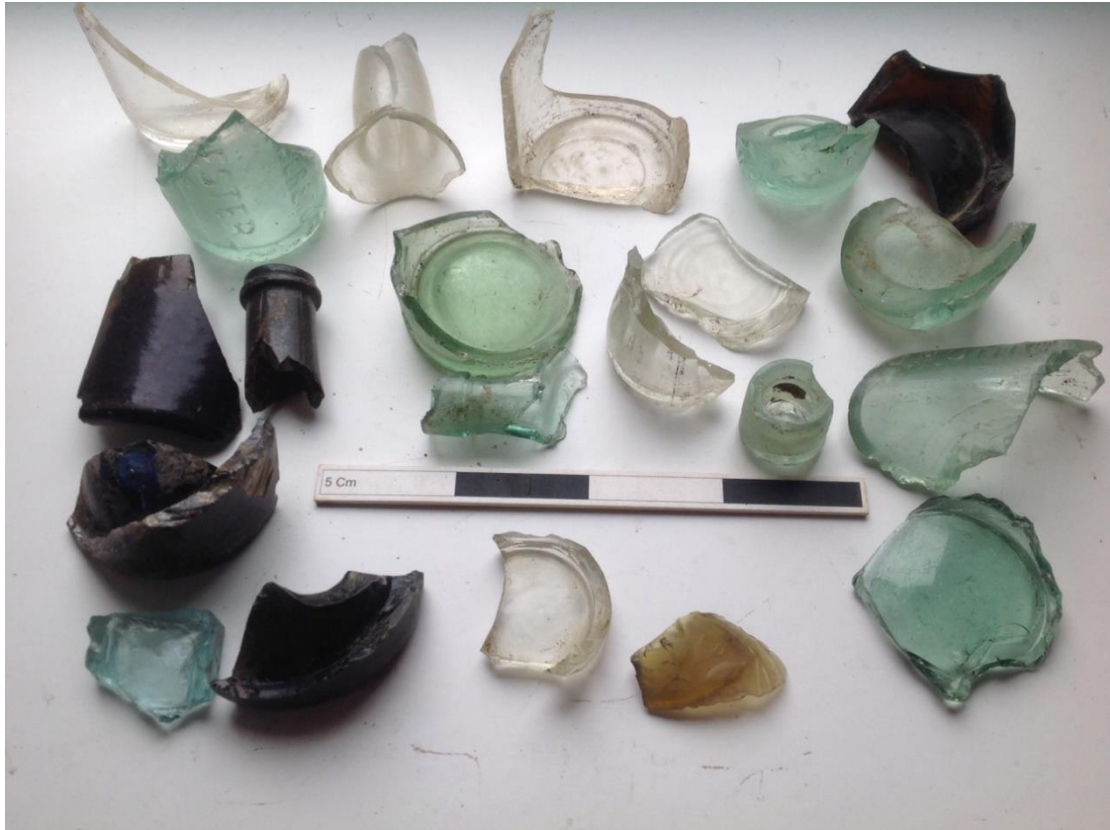
Figure 12: Selection of glass bottle bases.

4.3.6.1 The excavation recovered 315 fragments of glass weighing a total of 4260g. Fragments from all periods from the Victorian period to present were present in the backfill across the site. The more interesting pieces included a number of bases to bottle (figure 12). Some were partially identifiable with partial inscriptions still legible including:

'-ESTER'
'TH & MORETON'
'-DING & CO'
'MONMOUTH'

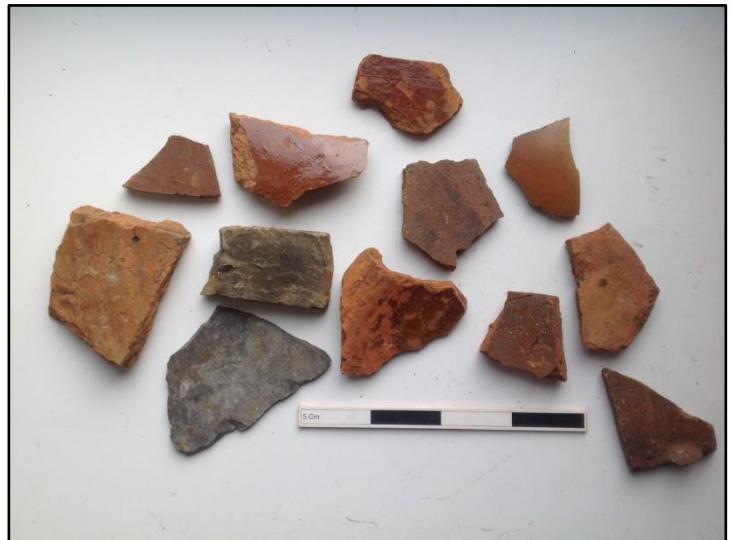
4.3.7.1 A total of 8470g of ceramic building material (CBM) was recovered. This consisted mainly of glazed pipe, tile and slate (figure 13) all consistent with the construction of the outbuilding.

Figure 13: Selection of CBM.

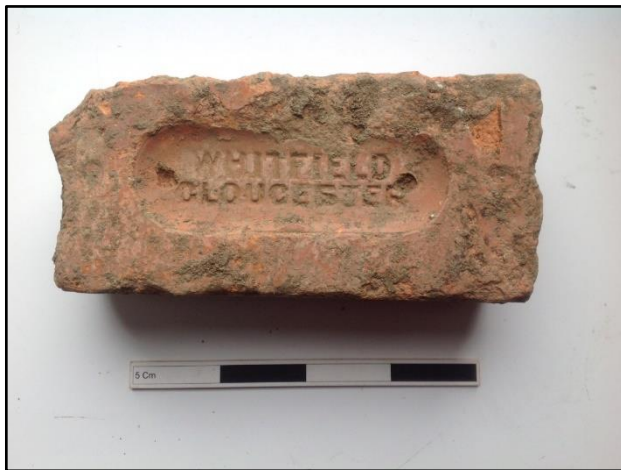
4.3.7.1 Of note, was the presence of bricks stamped from the Whitfield brickworks of Gloucester that was once located on the lower slopes of Robinswood Hill (Figure 14). G. T. Whitfield opened his brickworks on Robinswood Hill, Tuffley, Gloucester, in the early 1890s. It was closed by the 1950s. Another find was a ceramic electrical insulator recovered from context (102) (figure 15).

Figure 14: Brick from Whitfield brickworks.

again following repairs. Some local bricks, manufactured at the local Whitfield brickworks, were recovered from the interior of the building. However, the original building was not constructed of these as the brickworks was operating between the early 1890s until the 1950s. The building is shown as existing on local maps before the 1890s. This is probably evidence of repair and modification over the lifetime of the building.

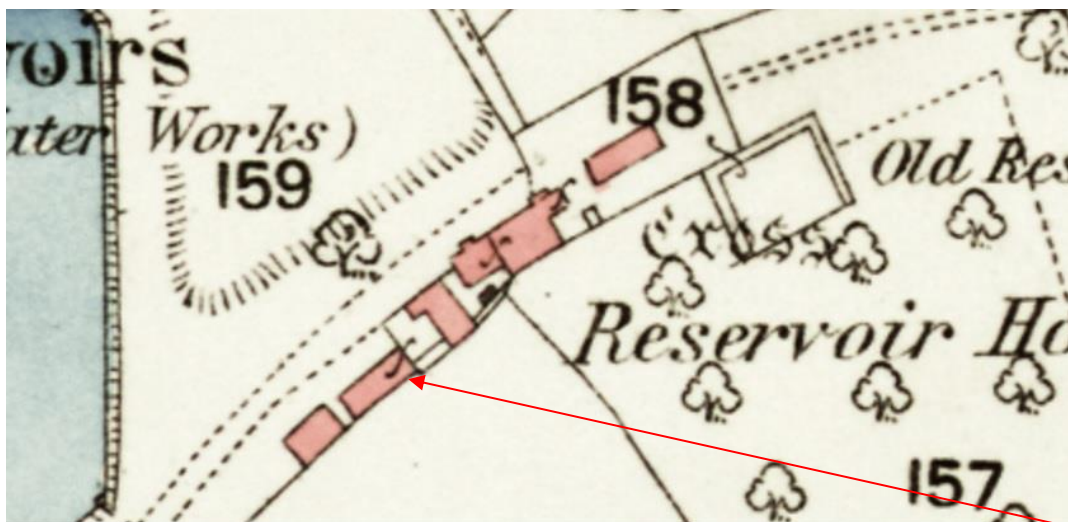
Ordnance survey 1880

2.4.1 The site is noted on a number of Ordnance Survey maps, the earliest being 1880 (Annex C). The buildings that were excavated are shown as the Western-most range on the maps. A photograph taken in 1900 (Annex D) shows the building complex viewed to the North with the outbuilding excavated to the left (West) of the main house. It is possibly a farmhouse complex located to the South of the main Reservoirs that may have origins earlier than the Victorian period. It was used as tearooms in the Victorian period as the image at Annex E depicts. Local belief is that it served as a public house before this. Some maps depict the outbuildings to the West as being pump rooms possibly to service the reservoir complex.

Building excavated

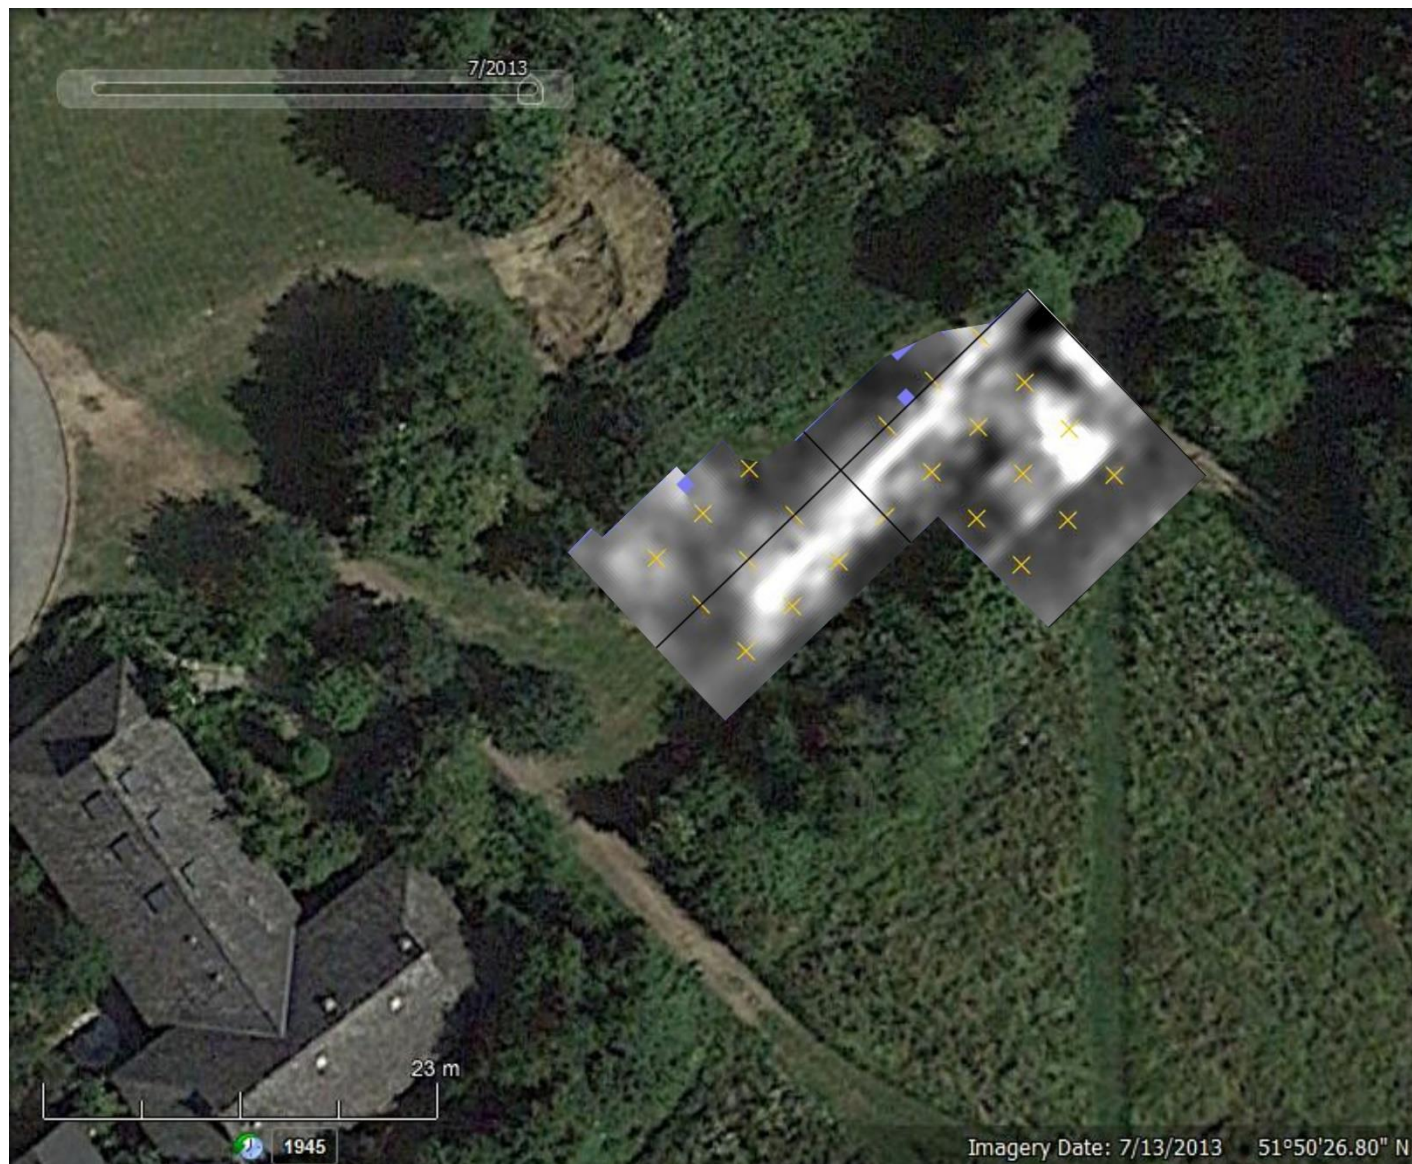
Title: ROBINSWOOD HILL
Tea Room Geophys July 2016
Scale:
Drawn By: A J ROBERTS
ARCHEOSCAN archeoscan@hotmail.co.uk www.archeoscan.com 07901 746140 © A J ROBERTS

4.1.1 The result of the resistance survey is at Annex F. The areas of high resistance are depicted in white and low resistance in black. In the colour version the high resistance is depicted in red. There is a clear high resistance linear anomaly that is aligned East to West that runs across the survey area. This is clearly the old road that fronted the original buildings and is depicted on the older maps. To the South East of the survey the clear straight lines of high resistance indicate the harder surfaces of the wall lines of the old buildings. It is these areas that were targeted for the excavation.
