The Battleship Action 14-15 November 1942

By Robert Lundgren

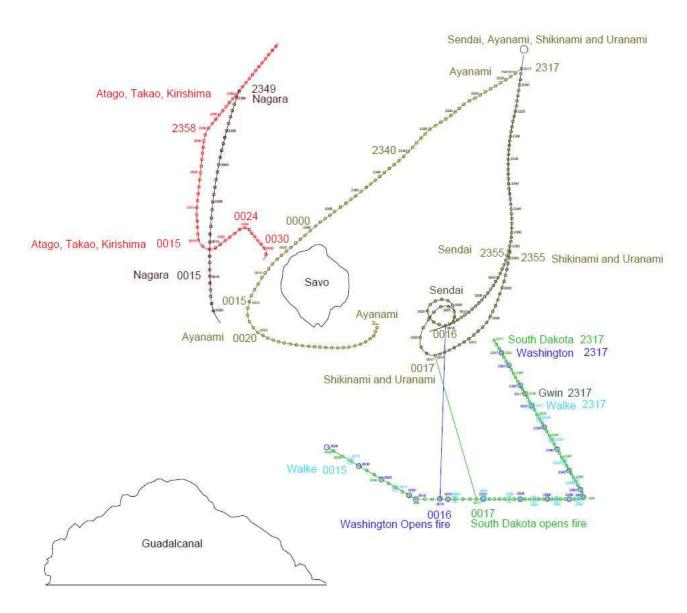
Opening Phase from 2317 to 0020 Figure 1

In the track charts *Atago, Takao*, and *Kirishima* are in red, *Nagara* is brown, *Sendai* and *Ayanami* are in yellow, *South Dakota* is green, *Washington* is dark blue, *Walke* is light blue, other US destroyers are represented by turquoise.

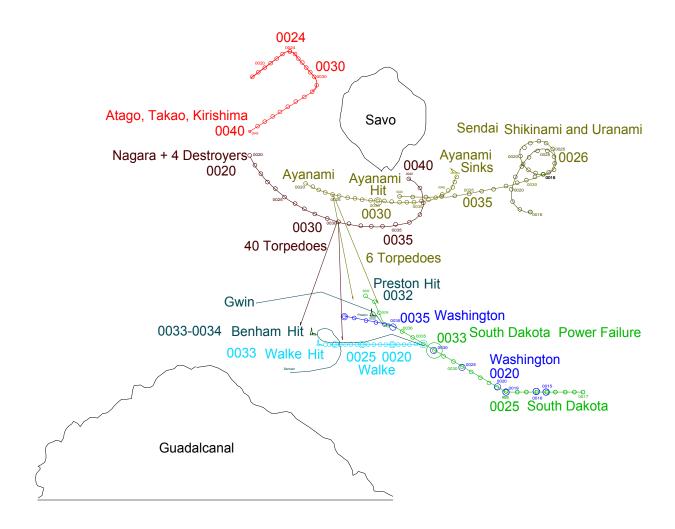
Destroyer Action from 0020 to 0040 Figure 2

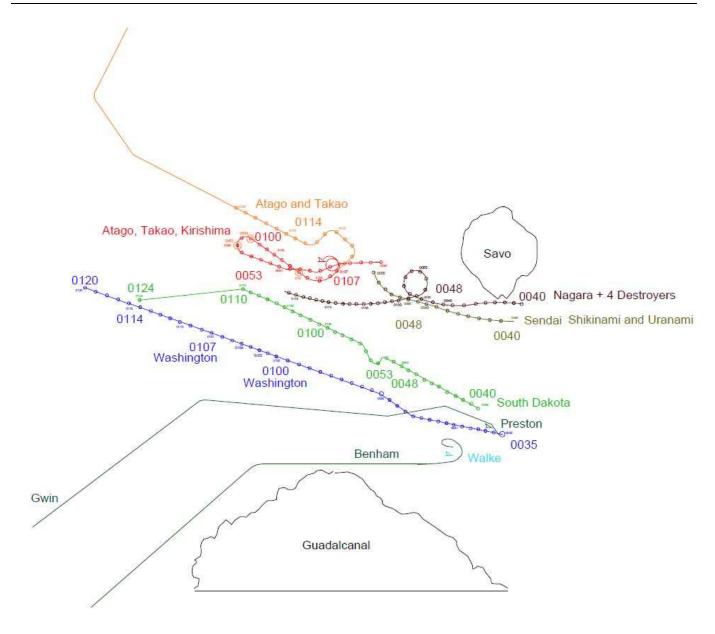
The Battleship Action from 0040 to 0114 Figure 3

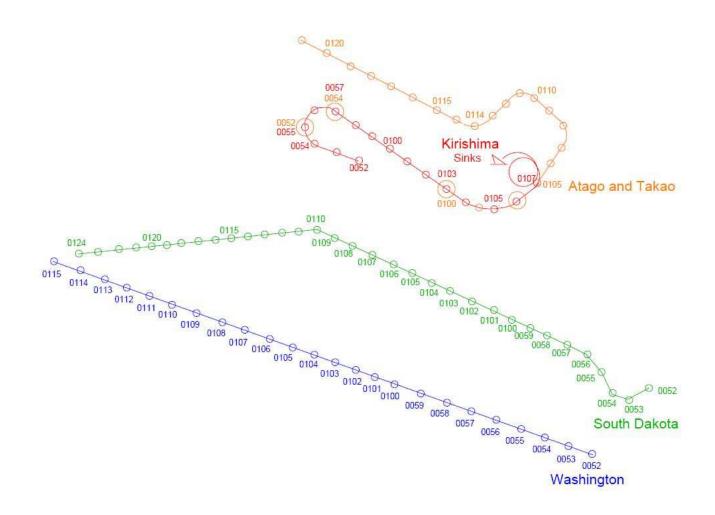
The Battleship Action from 0050 to 0114 Figure 4

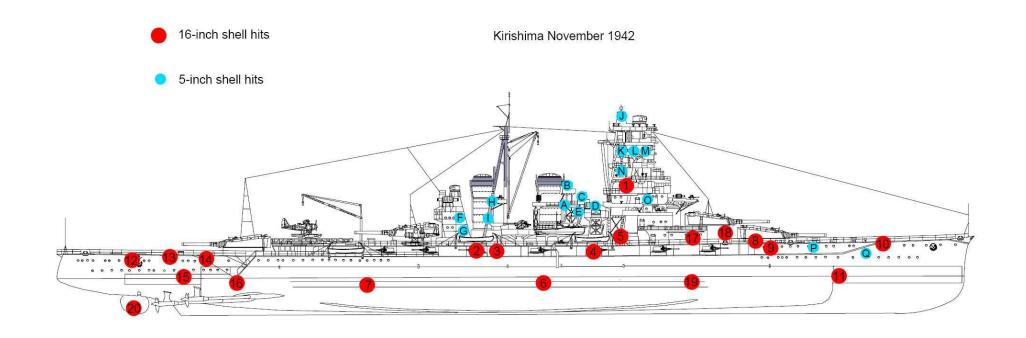
Kirishima's hit locations
16-inch shell hits in red and 5-inch shell hits in blue
Figure 5

According to Ikeda the chief damage control officer Lt.Cdr. Hayashi told him that *Kirishima* had received fourteen major caliber hits above the waterline and 17 medium caliber hits as well as six underwater hits all rated as major caliber. According to Ikeda, *Kirishima* fired 68 Type 3 [incendiary], 22 Type 0 [HE], and 27 Type 1 [AP] 14-inch shells at the enemy battleship. Lookouts reported ten 14-inch shell hits on *South Dakota*. The Damage Control Officer Hayashi prepared a hit scheme in which Ikeda meticulously copied.
