A-1 Home Inspection Service, LLC

Home Inspection Report 129 Queensland Ct. Fountain Inn, SC

Report Number: 02147

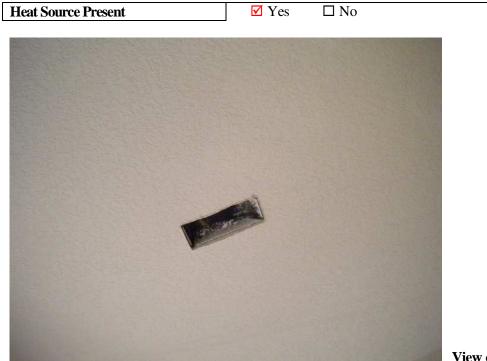
View of Ceiling Vent@ Kitchen

Rep	air: The heating vent loc	ated on the ceiling in the kitchen is missing	. Recommend replacing the vent.
-	U	0 0	1 0

Repair: The heating vent located on the ceiling in the kitchen is missing. Recommend replacing the vent.

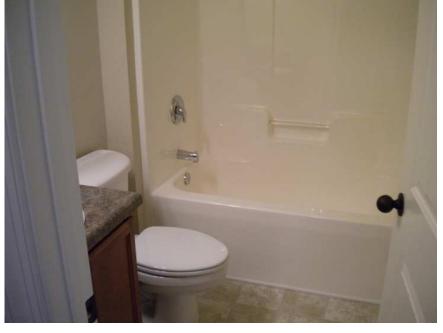
View of Hall Bathroom

Improve: Observed the Hall bathroom has no door stop.

Repair: Observed the Hall bathroom has no door stop.
