**DEPARTMENT OF TRANSPORTATION**

Contract #: 04-0120F4Cty: SF/ALA Rte: 80 PM: 13.2/13.9File #: 69.28**WELDING INSPECTION REPORT****Resident Engineer:** Pursell, Gary**Address:** 333 Burma Road**City:** Oakland, CA 94607**Report No:** WIR-000259**Date Inspected:** 29-Jun-2007**Project Name:** SAS Superstructure**OSM Arrival Time:** 1000**Prime Contractor:** American Bridge/Fluor Enterprises, a JV**OSM Departure Time:** 1600**Contractor:** Zhenhua Port Machinery Company, Ltd (ZPMC), Changxing Island **Location:** Shanghai, China**CWI Name:** Lu Jian Hua**CWI Present:** Yes No**Inspected CWI report:** Yes No N/A**Rod Oven in Use:** Yes No N/A**Electrode to specification:** Yes No N/A**Weld Procedures Followed:** Yes No N/A**Qualified Welders:** Yes No N/A**Verified Joint Fit-up:** Yes No N/A**Approved Drawings:** Yes No N/A**Approved WPS:** Yes No N/A**Delayed / Cancelled:** Yes No N/A**Bridge No:** 34-0006**Component:** Electrode Containers & Tower Base Template**Summary of Items Observed:**

# WELDING INSPECTION REPORT

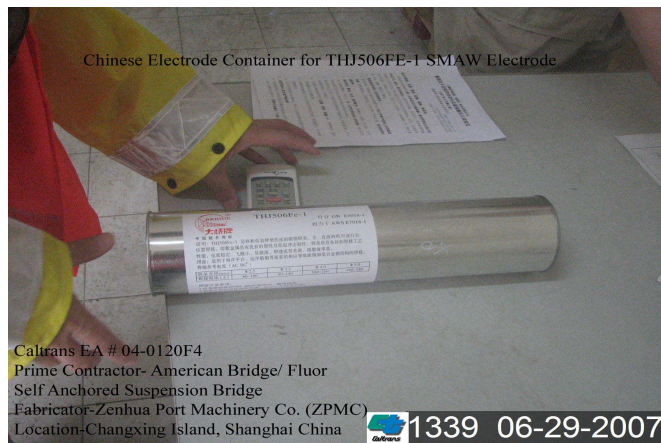
Caltrans representatives, Mr. Stan Ku, Mr. Ady Velasco and the Caltrans QA Inspector were escorted by ZPMC representatives, Mr. Lu Jian and Welding Engineer Mr. Zhou Rui Kang for the purpose of observing as received Chinese brand 7018 electrodes identified as THJ506Fe-1. The Caltrans QA Inspector observed that the presented electrodes are contained within a cardboard box that holds the metal cylindrical containers for the electrodes. The information on the cardboard box and also the metal cylindrical container has identification information that is written in Chinese characters and also some English characters. The Caltrans QA Inspector identified that the cardboard box and also the metal container have identification as THJ506Fe-1 and AWS E7018. There did not appear to be any

evidence in English characters identifying the low hydrogen designation. Observation of the shielded metal arc electrodes within the metal container identified that the identification on the electrodes is difficult to read and also do not include a low hydrogen designation, H value. The metal cylindrical electrode containers appeared to be hermetically sealed. Review of the Chinese electrode manufacturers supporting documents for the presented electrodes was not completed by the Caltrans QA Inspector at the time of this observation. Included below are digital pictures of these observations.

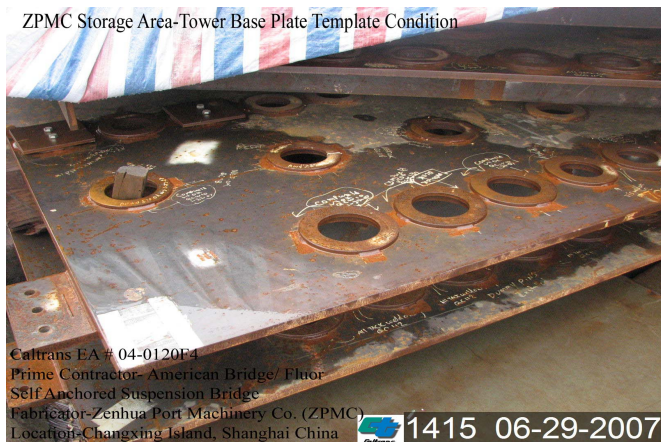
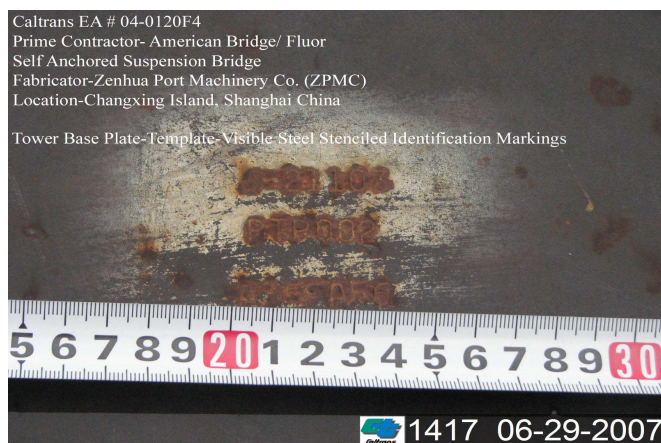
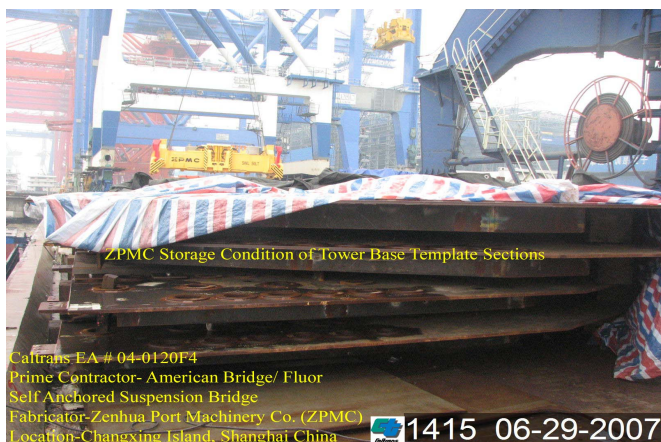
| 3 | Tower Base Plate Template | N/A | N/A | N/A |

Caltrans representative Mr. Stan Ku and the Caltrans QA Inspector are escorted by ZPMC representative Mr. Lu Jian Hua for the purpose of observing the storage area for the tower base plate template. The Caltrans QA Inspector observed that the tower base plate template that was fabricated in the USA is protected from the elements with tarps. Visual observation of the template is limited based on actual storage conditions. The Caltrans QA Inspector was able to observe some areas of the perimeter of the template. The Caltrans QA Inspector observed surveying identification markings as well as steel stenciled identification marking for assembly that were applied by Kiewit Offshore Services in the USA. Based on visual observations the template does not appear to contain significant rust that is resulting in the steel template to have pitting or cross sectional loss that may impact the intended use of the steel template. Included below are digital pictures of observations of the stored tower base plate template.
