PORTION 4 OF THE FARM NO 491

APPLICATION FOR

REZONING & CONSENT USE

SILVER FALCON TRADING 96 PTY LTD

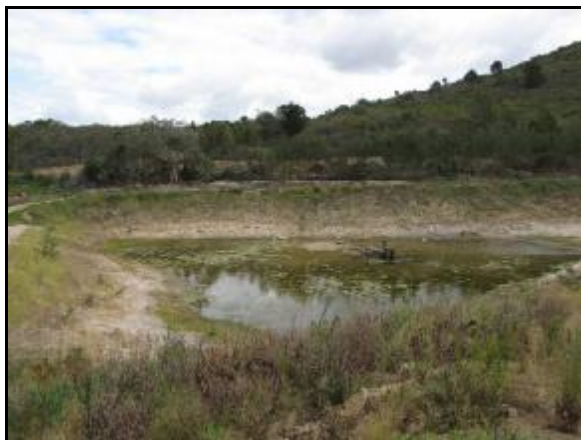
FIGURE 8: REHABILITATED QUARRY

As mentioned in Paragraph 1 of this report, Portion 4 of the Farm no 491 was originally known as “Funda Quarry”, that was mined by DenRon. Mining on the site has been in operation for 10 years under licence held by Derby Concrete cc. Given that the period of mining as agreed with the surrounding agricultural community, had expired, and activities were accordingly terminated on 30 April 2009 which coincided with the termination of the Mining Licence, the Licence holders have decided to lodge a closure application for the site. Mining activities have recently come to an end. The quarry was decommissioned and the property was sold to Silver Falcon Trading 96 (Proprietary) Limited during 2008.

Attached in **Annexure E** one will find a copy of DenRon civil's application for closure of the sand quarry. This proves that it is not a natural watercourse but, scaring in the landscape to due human activity.

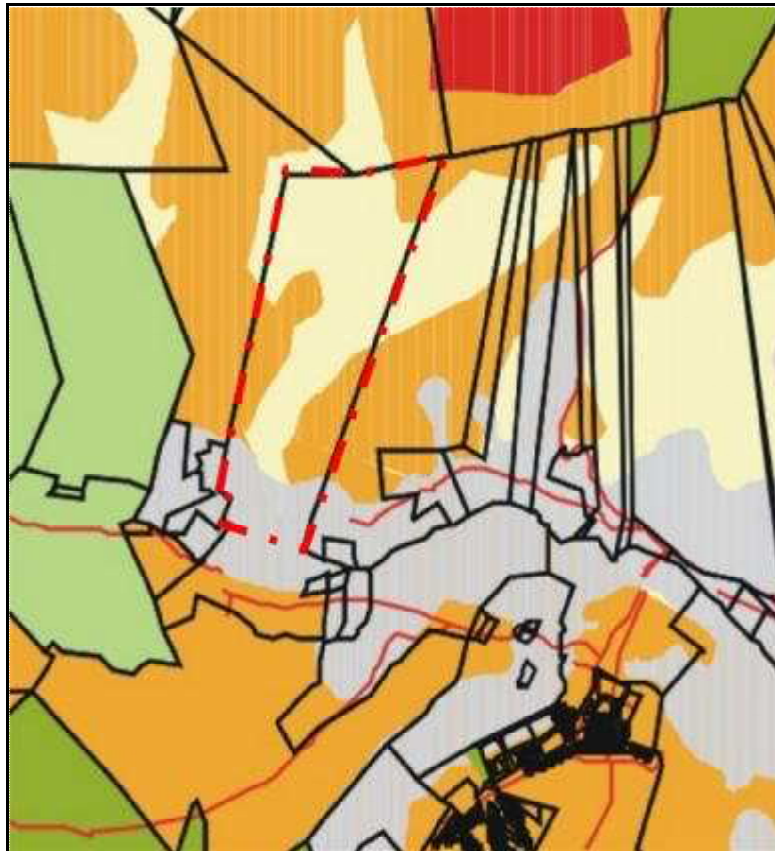
FIGURE 11: EXTRACT FROM THE DRAFT BITOU SDF.

This SDF earmarks the northern part of the farm as a transitional area and the southern part of the farm as a buffer area for ecological processes. The ecological processes most likely refer to the flood plain of the Bitou River. It should be noted that the mapping of this plan is on a very broad brush scale and that the boundaries of the different SPC categories should not be applied on a fine scale. The areas of the farm where the additional units; tourist facilities and agricultural industry are located; are most definitely not within the floodplain of the Bitou River. It is therefore argued that the proposed units are within a buffer / transition area and that it will not have any detrimental impacts on the Bitou river ecological corridor.

According to this draft SDF, activities that have a minimal ecological footprint can be permitted in the Buffer Area. For example, eco-estates and resorts whose buildings have minimal footprints (already existing or built on timber piers), use off grid services (solar power, rainwater harvesting, grey water recycling, urine diversion/eco loos) and are built from local recyclable materials. Buildings primarily associated with managing biodiversity or agriculture, including for tourism purposes will be permitted in buffer areas.

The proposal is therefore consistent with the draft Bitou SDF.

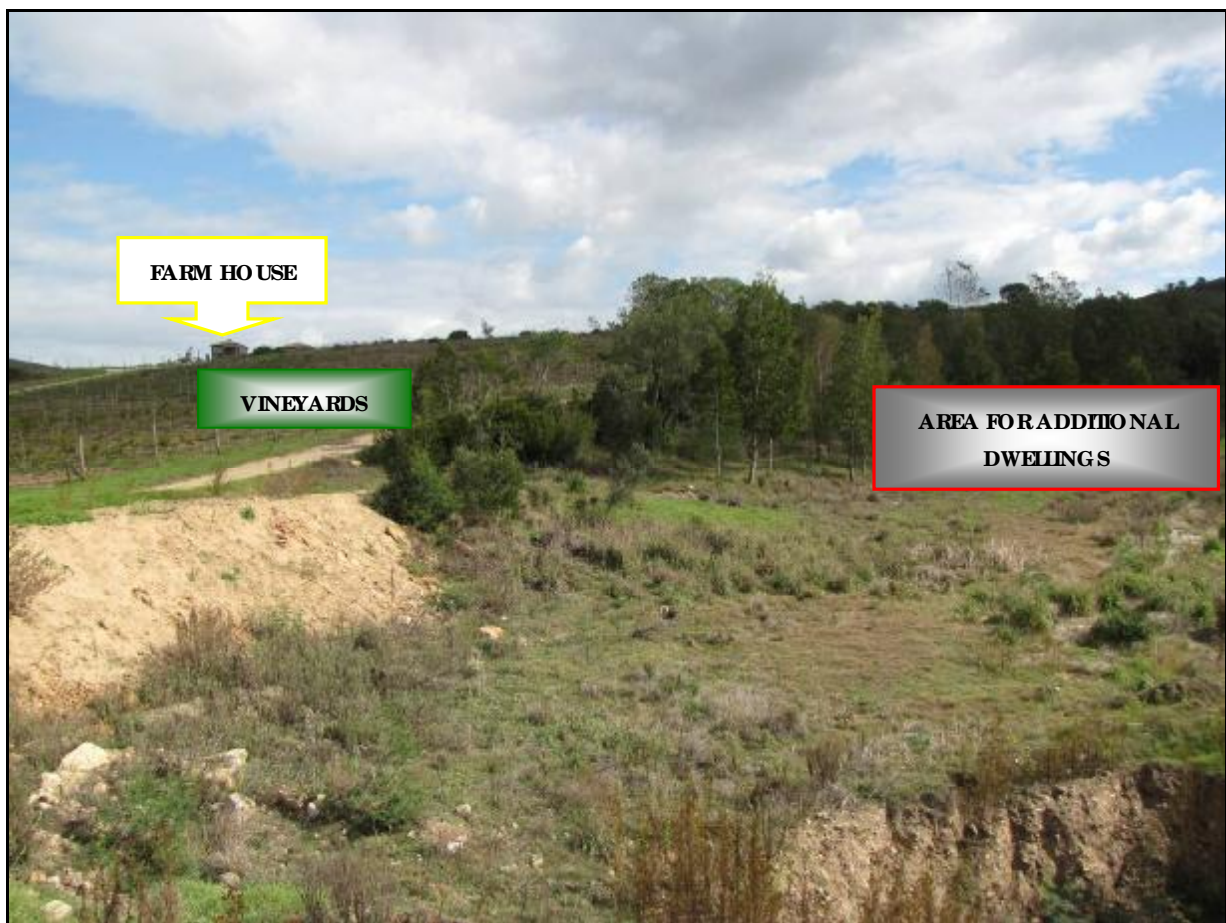
FIGURE 13: AREA OF PROPOSED ADDITIONAL DWELLINGS

approximately 1767m² in extent. Visiting family and friends of the owners of the property will reside in the additional dwellings on a temporary basis. It is also proposed to provide accommodation for students and lectures attending the proposed organic farming teaching centre.

Application is therefore made for a consent use to allow five additional dwellings on Portion 4 of the Farm No 491. It should be noted that although five new residential dwellings will be built on the application area, the land use on the property will remain agriculture, and no change of land use on the farm is envisaged. If one refers to Plan 3 one will see that the proposed additional dwellings are located in around the quarry in on disturbed soil. This area is unusable for agricultural purposes due the topography and that it has been disturbed before. It should be noted that the proposed dwelling units will be located on non-productive agricultural land.

The portion where the proposed additional dwellings are proposed is located to the east of the farm and is located in close proximity to the existing quarry and farm house. This area is mainly disturbed and was previously used for sand quarry.

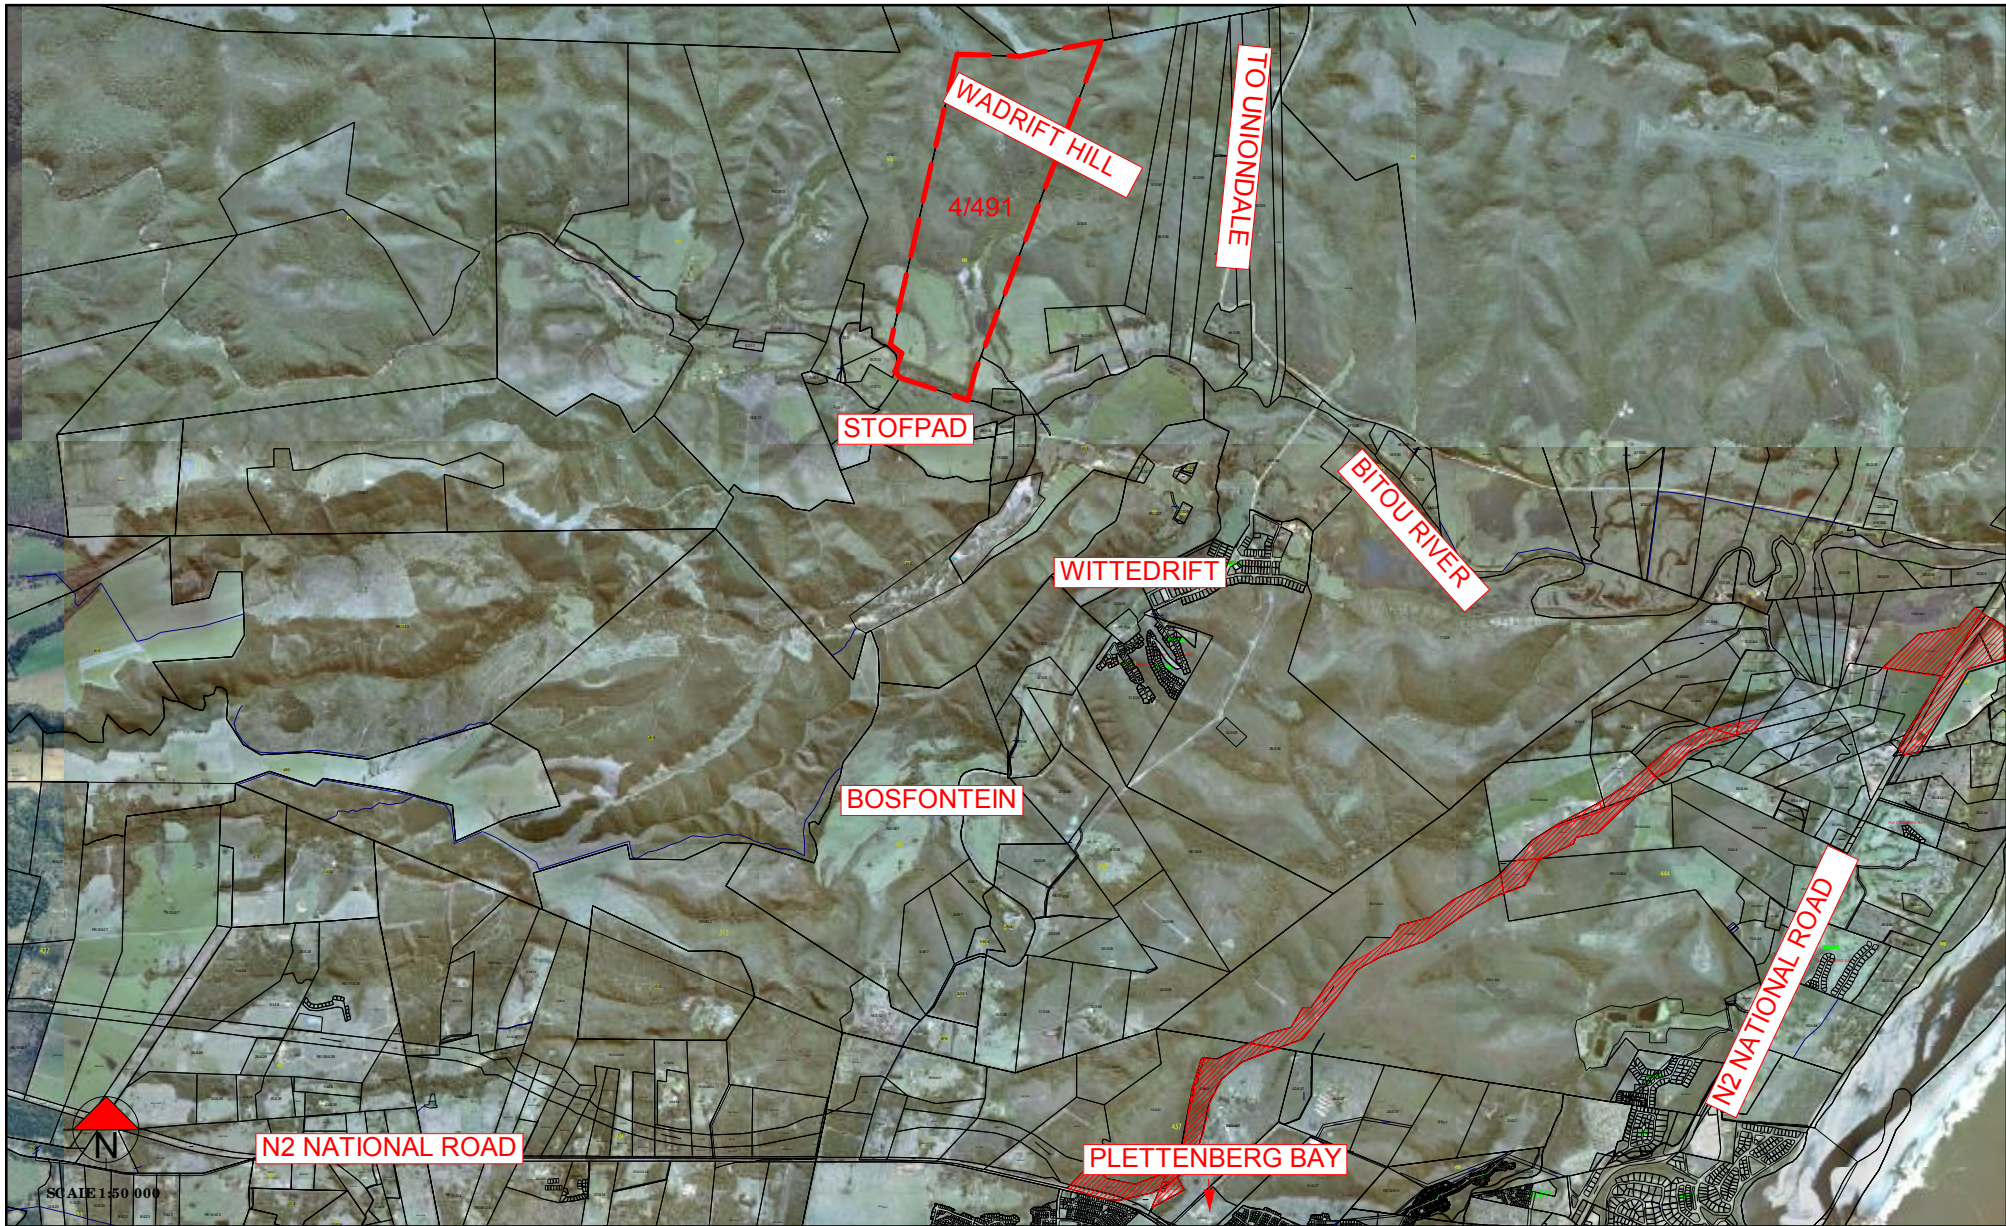
CHARACTER OF THE AREA

The application area is located northwest of the existing Wittedrift village and receives vehicular access from the “Stofpad” Road via a servitude road across Portion 3 of the Farm Wittedrift No 306. The application area is approximately 2.5km from Wittedrift.

The farm is located on the south western slopes of the Wadriht hill. The Bitou river road forms the southern boundary of the farm. A tributary stream of the Bitou River runs through farm.

The topography of the site is characterised by steep undulating hills to the north, with a moderately southwester sloping plateau that is used for agricultural purposes.

The highest part of the application area is to the northwest, with an average altitude of 200m above MSL. The lowest part of the application area is on the Bitou River at approximately 20m above MSL.
