## Property Inspection Information

1111 Sample St., Sample City, AK 09876

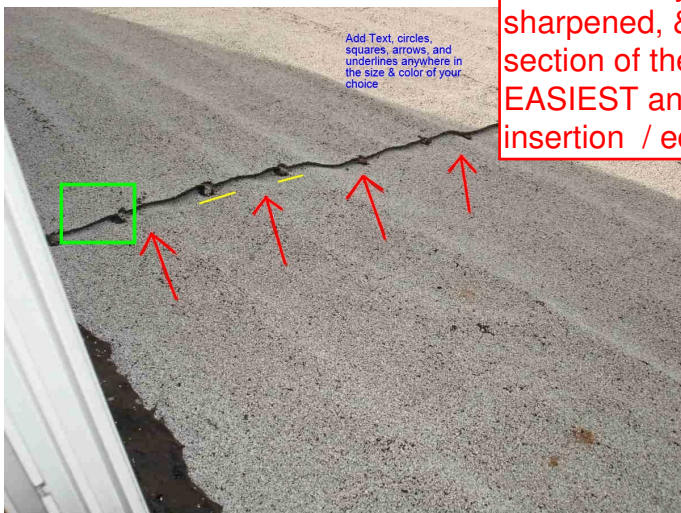
Roof Covering / Style / How Viewed - THE COVERING IS IN NEED OF REPLACEMENT  
*Rear - Roll Roofing. Install a single ply membrane*

[THE COVERING IS IN NEED OF REPLACEMENT](#) - The roof covering should be removed and replaced, and the deck / structure should be evaluated, deteriorated areas should be replaced prior to installing a new covering.

THE COVERING IS IN NEED OF REPLACEMENT - The roof covering should be removed and replaced, and the deck / structure should be evaluated, deteriorated areas should be replaced prior to installing a new covering.

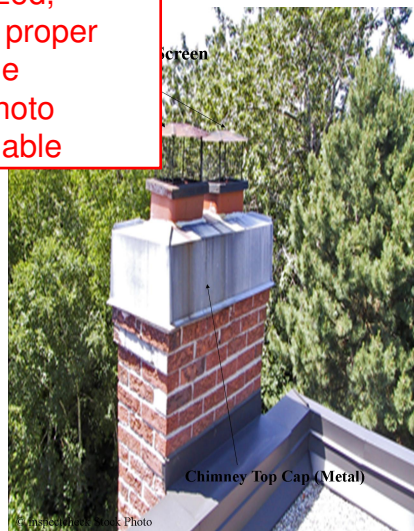
Chimney type / Condition - RECOMMEND INSTALLING A RAIN CAP / SPARK SCREEN

RECOMMEND INSTALLING A RAIN CAP / SPARK SCREEN - Installing a cap and screen at the top of the chimney will help prevent water from entering the flue. The screen will extinguish small sparks and prevent birds from making a nest.

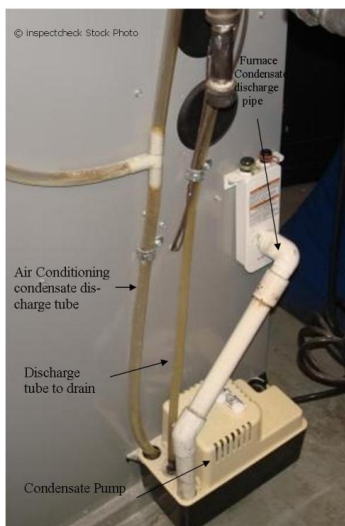
Air Handling / Filter - DAMAGE / MISSING / IMPROPER INSTALLATION OF CONDENSATE DISCHARGE LINE

*Install Condensate Pump*

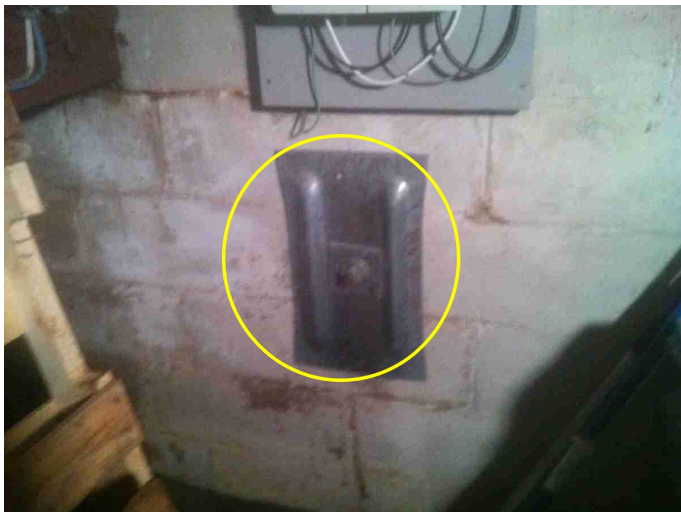
[Repairs / Patching / Reinforcement - INTERNAL](#) - Area(s) of foundation walls / components have been patched / reinforced or repaired. These areas should be closely monitored for movement, shifting, cracking, or moisture penetration. If any of these conditions are noted, a structural engineer should evaluate. Any warranty information should be secured from the current property owners.

Type / Location / How accessed / Viewed / Condition - Repairs / Patching / Reinforcement - INTERNAL  
*Earth Anchors Noted*

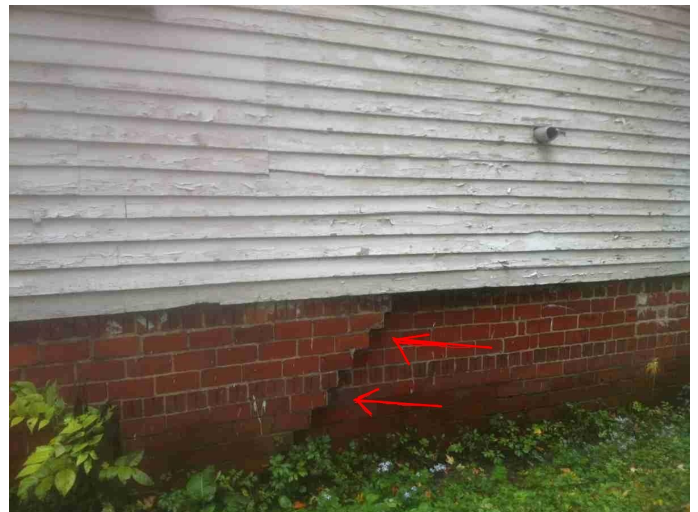
[Large Vertical / Angled Cracks - EXTERNAL](#) - Large cracks in the foundation can indicate serious problems that can lead to failure of all or part of the foundation or structural components. Recommend immediate evaluation by a structural engineer.

Type / Location / How accessed / Viewed / Condition - Large Vertical / Angled Cracks - EXTERNAL  
*Rear foundation wall*

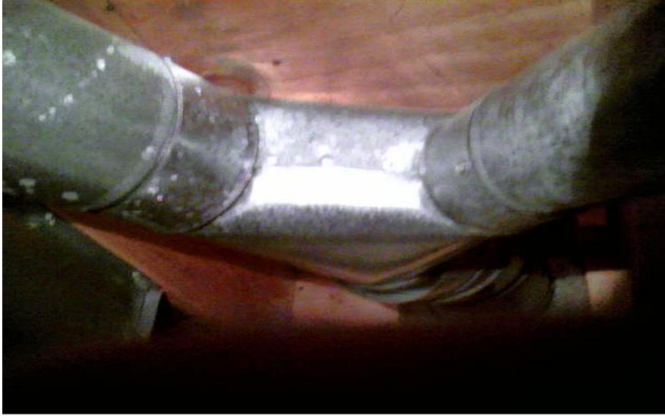
### Wye Connection

Flue / Vent Pipe - RECOMMEND VENT / FLUE STACKS ARE JOINED WITH A WYE "Y" PIPE

[RECOMMEND VENT / FLUE STACKS ARE JOINED WITH A WYE "Y" PIPE](#) - A wye connection helps prevent backdraft of flue gasses and Carbon Monoxide. Recommend a qualified contractor change this connection

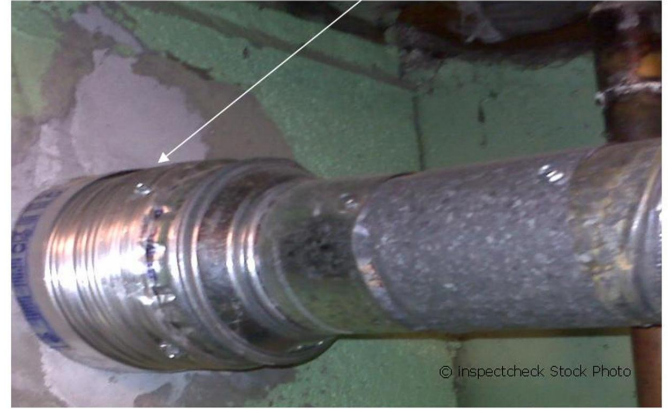
### Flexible Stainless Steel Liner

Flue / Vent Pipe - INSTALL FLUE LINER

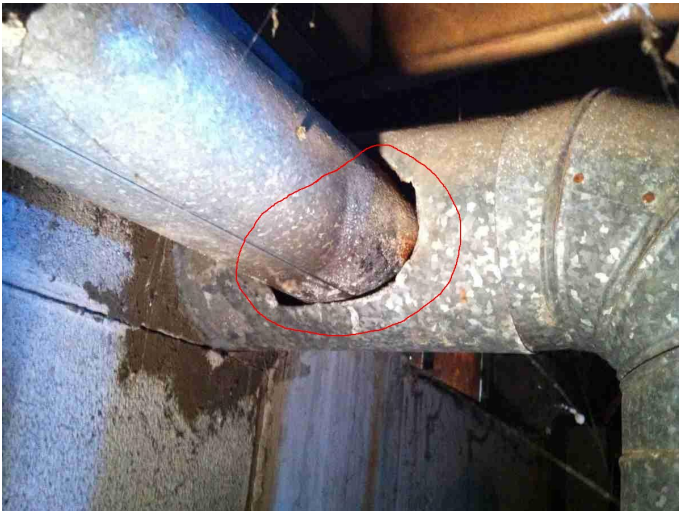
Flue / Vent Pipe - PROPERLY SEAL / JOIN FLUE/VENT PIPE

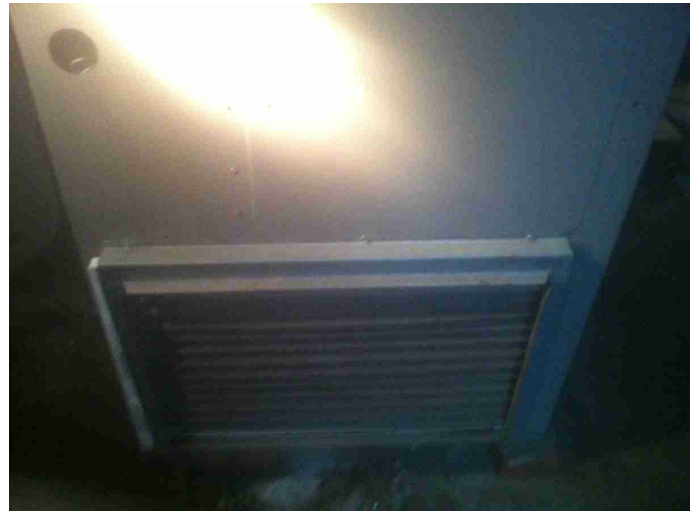
Supply / Return Ducts / Pipes - OPEN DUCTS / RETURNS

OPEN DUCTS / RETURNS - Open returns can be potentially dangerous. If a flue pipe becomes disconnected or other toxic fume is present in the area of the open return, it will be drawn into the furnace and be delivered by supply ducts to registers in the living space. Exposure to Carbon Monoxide can case **SERIOUS PHYSICAL INJURY AND DEATH**. Recommend the ducts are properly sealed.

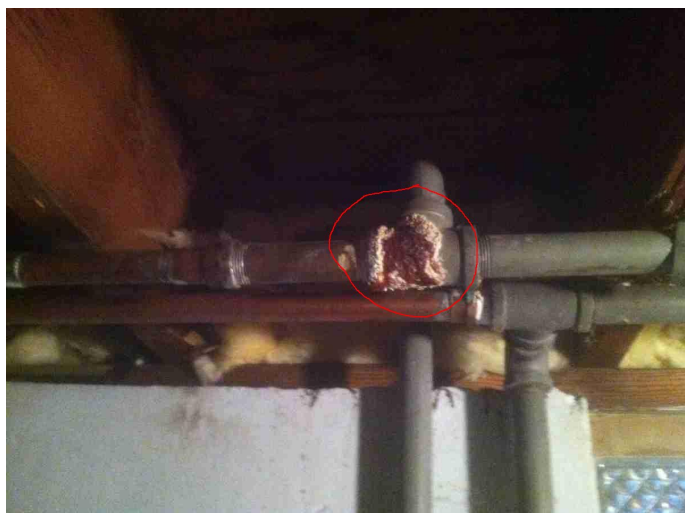
Water Source - CONSIDERABLE DAMAGE / CORROSION / UNSATISFACTORY CONNECTIONS NOTED

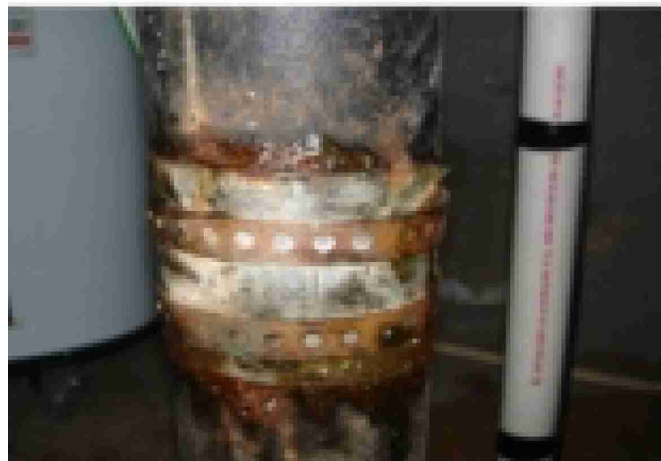
Drain / Waste / Vent - Sewer - TEMPORARY REPAIRS  
*On Main Drain Waste Vent stack in basement - see photo*

[TEMPORARY REPAIRS](#) - These areas should be closely monitored for leaks / damage and repaired using approved materials by a licensed plumber.

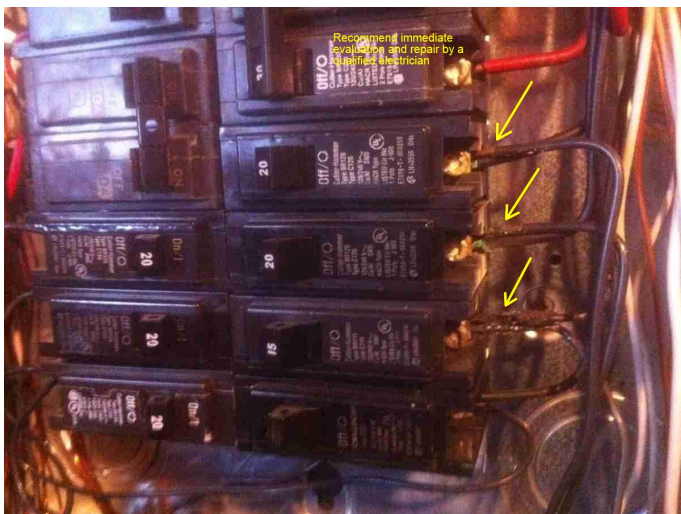
Service Panels / Type / Condition - EVIDENCE OF OVERHEATING (MAIN SERVICE PANEL)

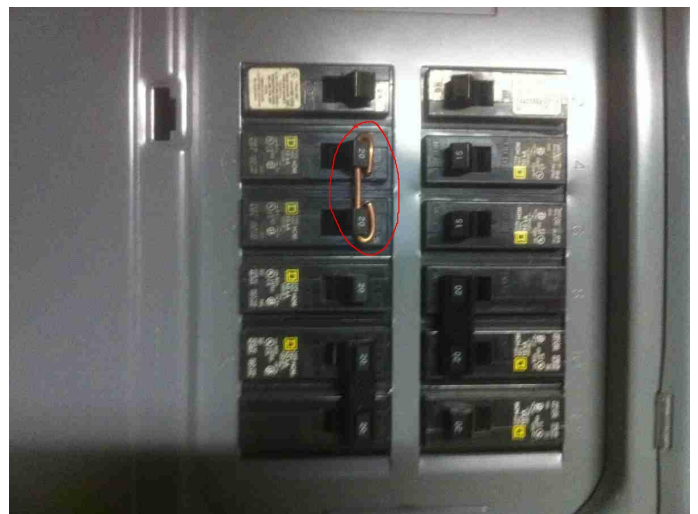
Service Panels / Type / Condition - COUPLER / LINK MISSING FROM 240 VOLT CIRCUIT BREAKER

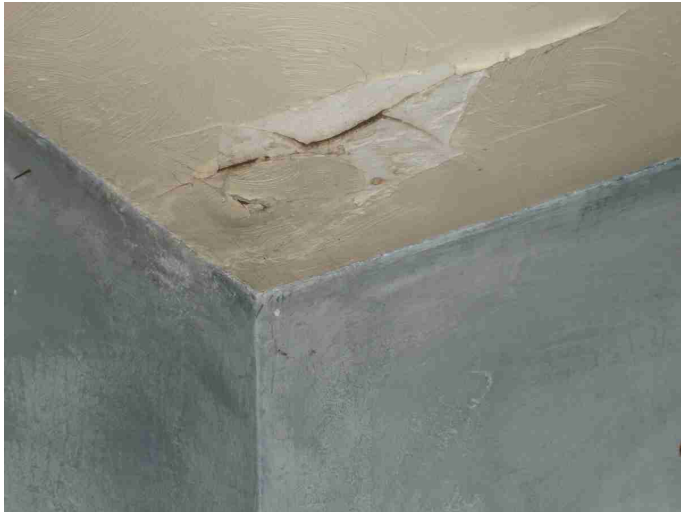
Wall / Ceiling Coverings - WATER / MOISTURE STAINS

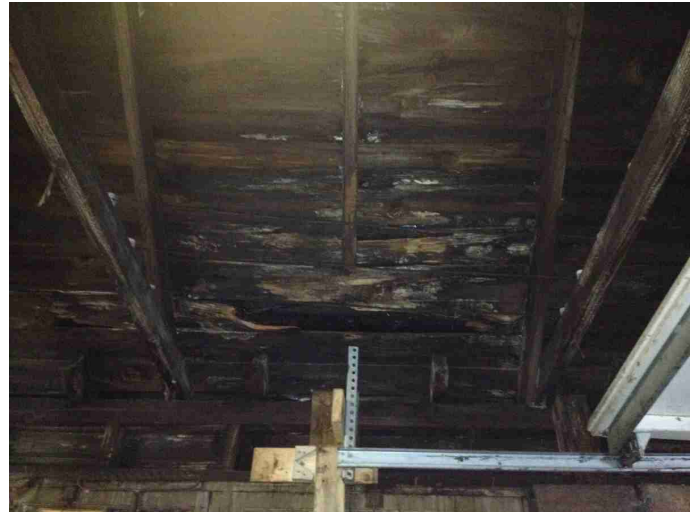
Structure / Attic / Crawl Space & Ventilation - CONSIDERABLE DAMAGE / DECAY / NOTED TO MEMBERS
