# *Sweezer's Inspection Service*

## Property Inspection Report

1111 San Diego, Sample, CA 90811  
Inspection prepared for: Joe Sample & Jane Sample  
Date of Inspection: 11/6/2013  
Age of Home: 56 years old Size: 1700 sq ft  
Weather: clear

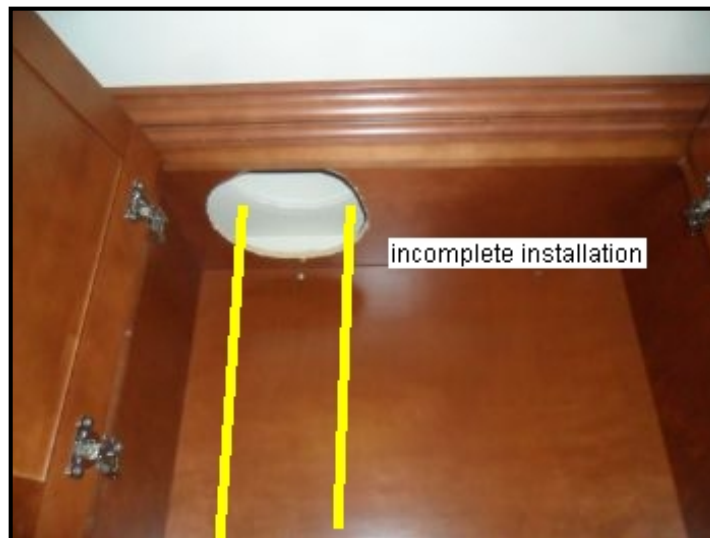
Kitchen Vent Condition

- Incomplete installation

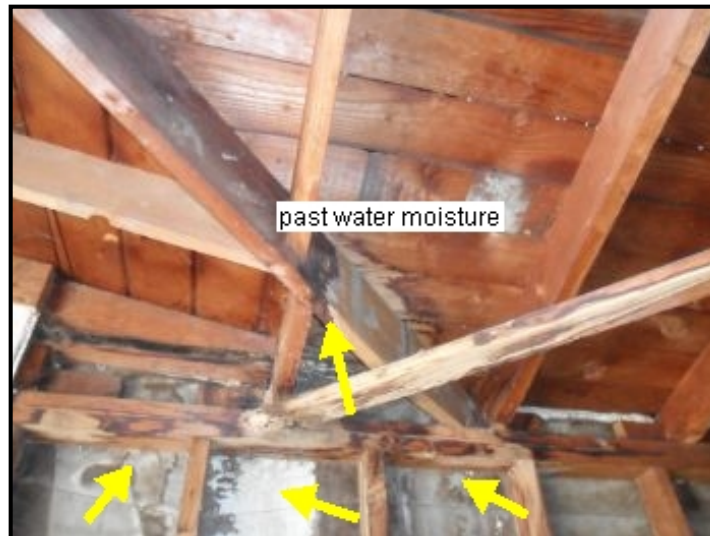
Garage Roof Condition

Materials: Roofing is the same as main structure.  
Materials: Asphalt shingles noted.

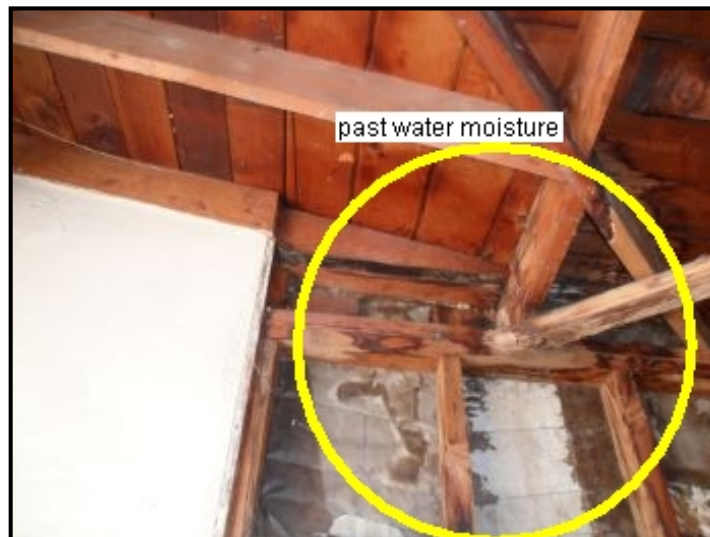
Garage Walls

- Fire wall between garage & house not continuous.

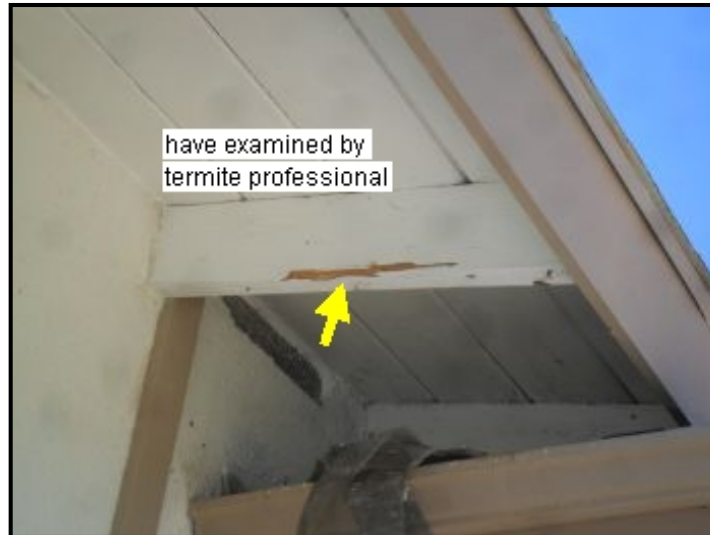
Roof Roof Condition

- No major system safety or function concerns noted at time of inspection.

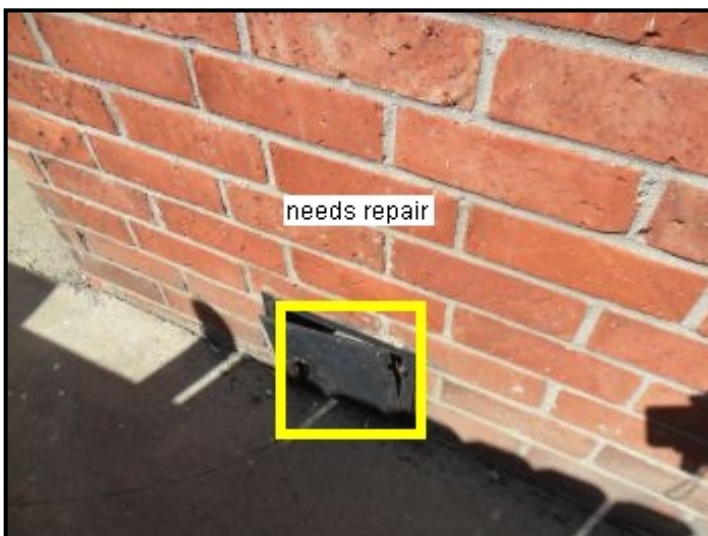
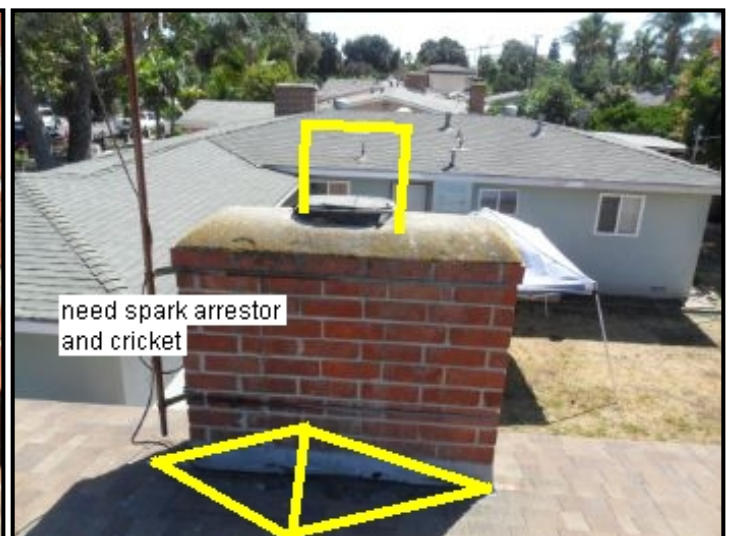
Roof Chimney

- No "Cricket" (a small ridged roof section just above the chimney to shed water off to the sides) is installed above the (wider than 2') chimney. Keep clean of any accumulated debris which may cause leaks. No Spark Arrestor installed.

- No chimney rain cap observed, suggest installing a chimney raincap to prevent the entrance of the elements and local wildlife and to preserve the life of the chimney as well as minimize maintenance.
- Spark arrestor and rain cap suggested.

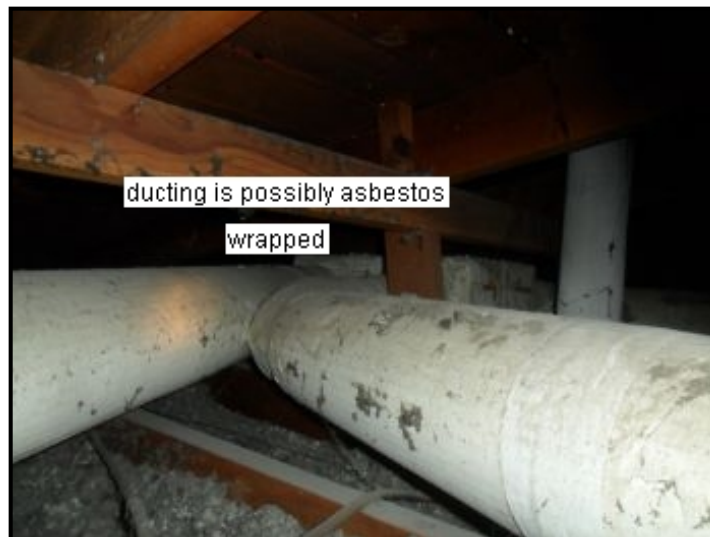
Attic Duct Work

- Possible asbestos materials observed. The materials were torn, ripped, or damaged at the time of inspection. This is a possible safety hazard. Suggest further review by a licensed asbestos testing lab be performed prior to closing for repairs/replacement needed to ensure safety.

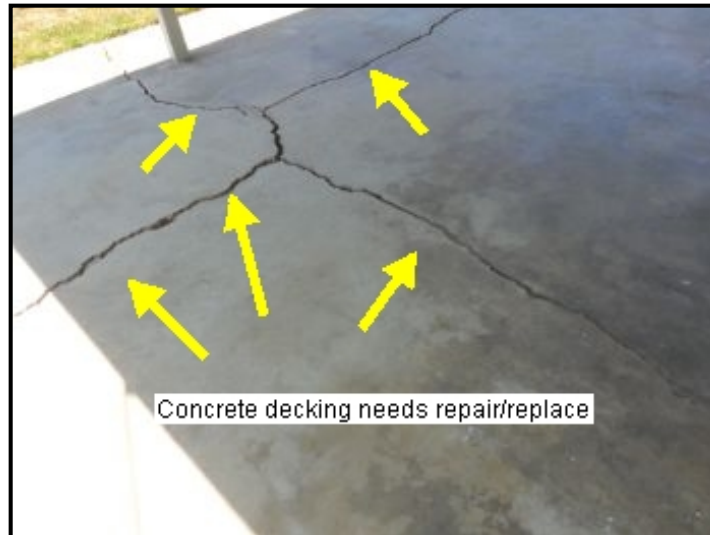
Grounds Patio and Porch Deck

- The patio area does not have a enclosure, and the concrete decking is heaving with large cracks.

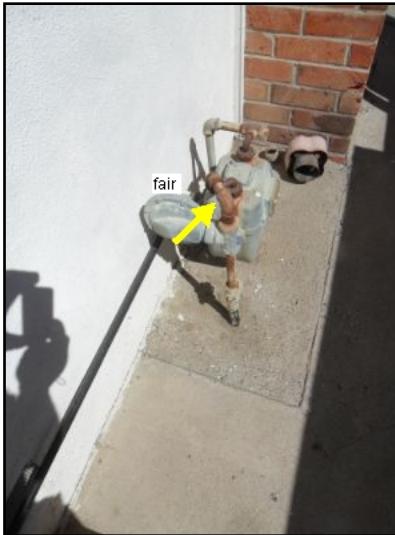
Grounds Main Gas Valve Condition

Materials: Exterior of structure.

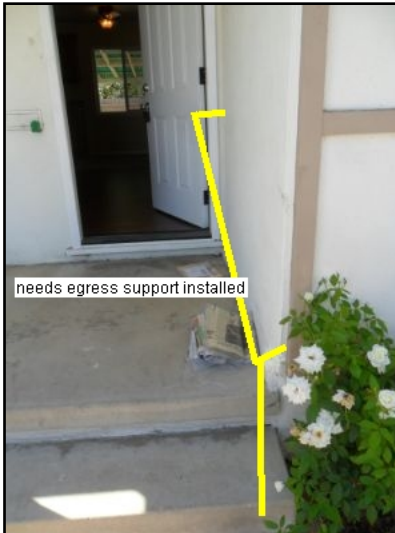
Grounds Patio and Porch Condition

- No major system safety or function concerns noted at time of inspection.
- The steps needs a rail for egress.
