Chapter 4

The industrial effects of zebra mussels in England

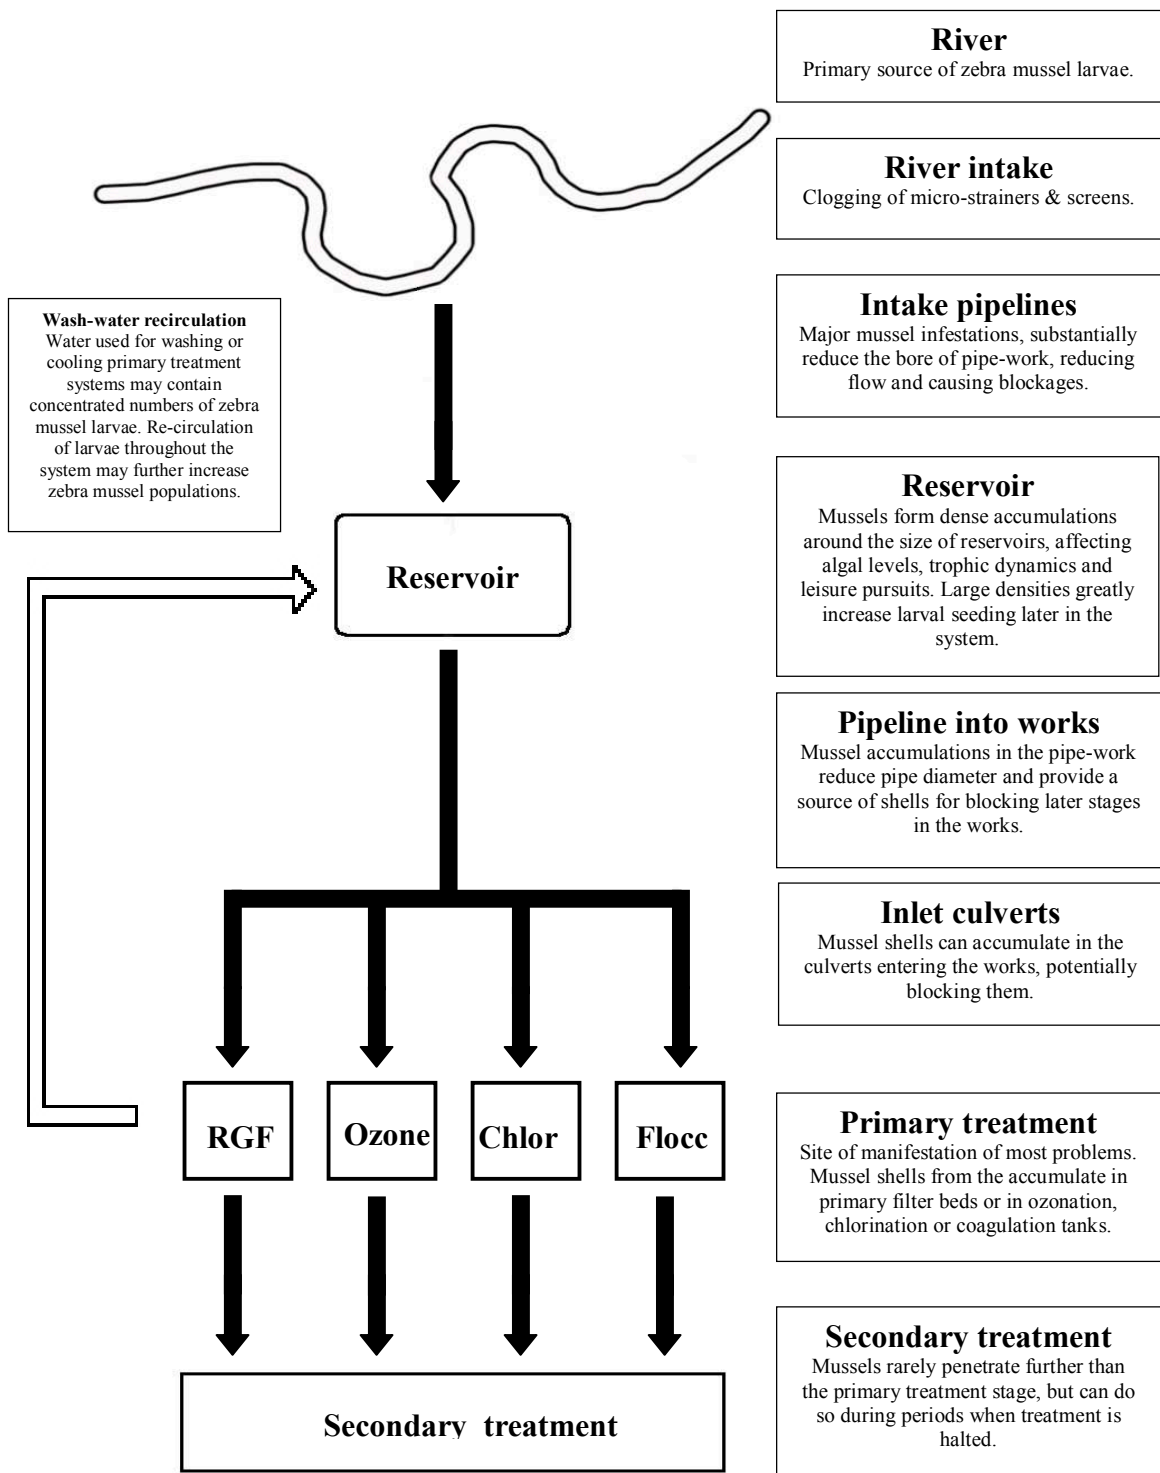
Figure 4.3 The distribution of problems associated with zebra mussels within a generalised water treatment facility (based on experiences reported by 30 English WTWs).

downstream of these pipelines depend upon the particular layout of each works. Living and dead mussels are often displaced from the surface of the pipelines, particularly at times of large flow fluctuation. These are washed into the works where they clog pipes and processing machinery. Mussels tend to accumulate at the first obstruction to water-flow, such as filtration beds, ozone tanks and microstrainers. The potential affects of zebra mussels within a generalised WTW are summarised in Figure 4.3 and explained with examples in the following sections.

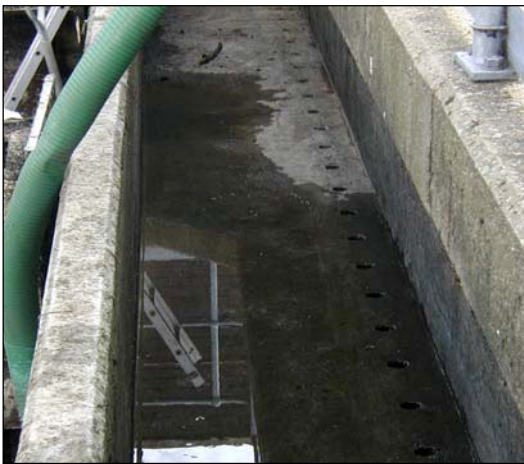
Figure 4.4 A Primary filter bed inlet at Coppermills WTW, North London before an influx of mussels.

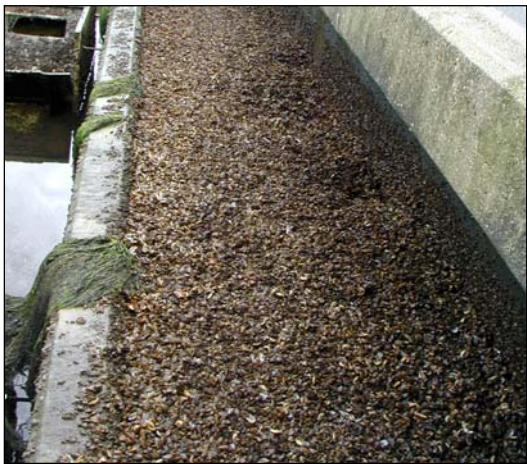
Figure 4.5 The same filter bed inlet as in Figure 4.4, after an influx of mussels.

Thames Water's Coppermills treatment facility in North London receives a continuing influx of loose mussels (both living and dead) into the RGF inlets and beds from the inlet culvert (Section 4.3.3). There were at least seven distinct shell influxes

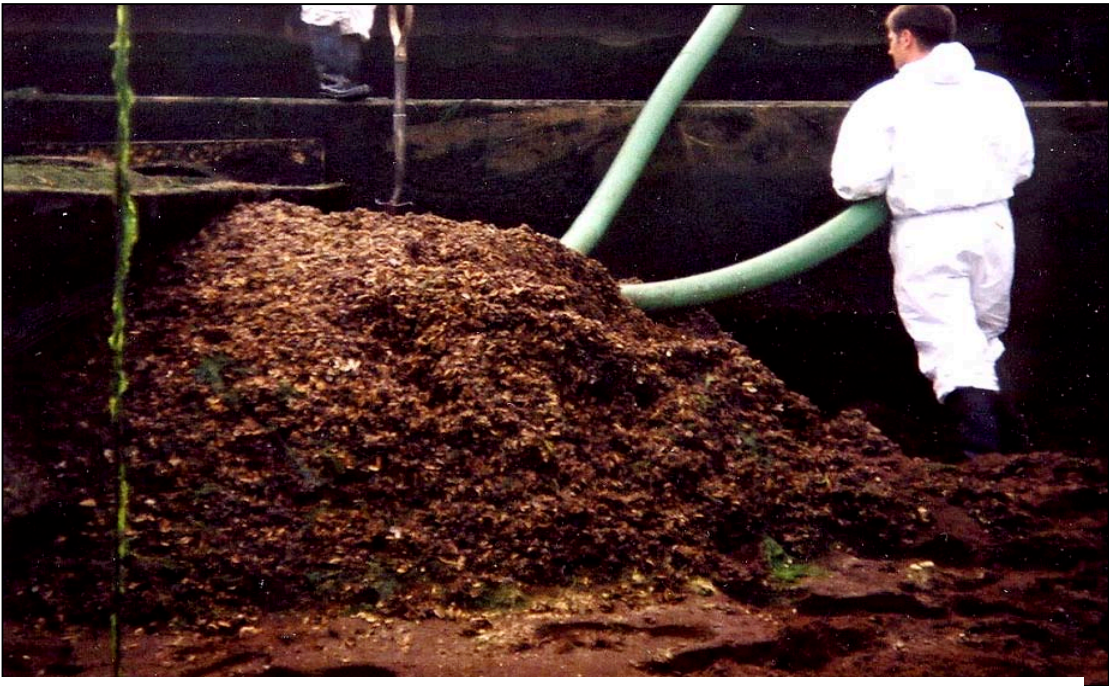
Figure 4.6 Mussel shells in a primary filtration bed at Coppermills WTW (October 2001).

between 2000 and 2003 (Roy Grubb, Water Manager, Thames Water, pers. comm.). A typical example occurred in October 2001 when two of the RGFs had to be drained and external companies contracted to clean them at an approximate cost of £10,000 per bed. Figures 4.4, 4.5 and 4.6 show the extent of an influx. The first manifestation of problems involved an increase in the depth of the RGF 12 from $656 \pm 3\text{mm}$ in August 2000 to 720mm in September 2001 (Figure 4.7).

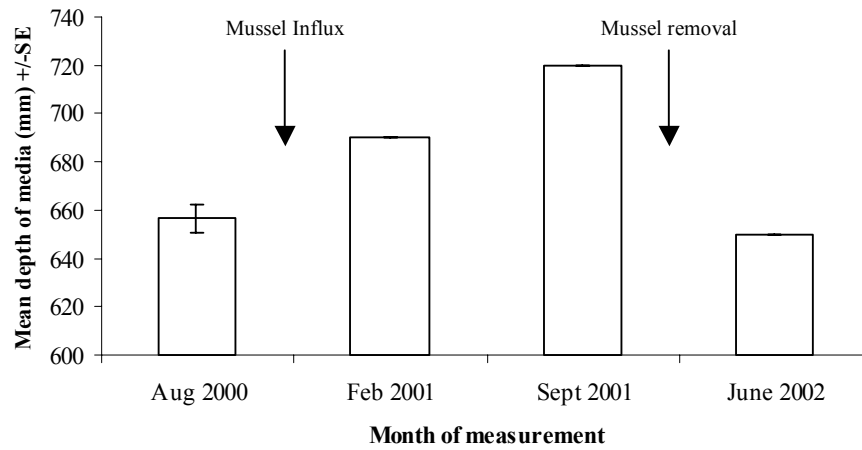
Figure 4.7 Depths of sand in Rapid Gravity Filter 12 at Coppermills WTW before, during and after an influx of zebra mussels. Data supplied by Alf Ives (Thames Water).

Firstly, the effects of shell influxes on the depth of a Rapid Gravity Filtration Bed (RGF) were measured by process engineers at Coppermills during 2001 and 2002. The depths of the filtration media in RGF 12 was measured at approximately 6-monthly intervals, starting just after the filtration media was replaced in August 2000. Measurements were taken from three locations along the side of the bed's inlet channel using an ultra-precision laser plane levelling system (spectra physics laser plane 220).

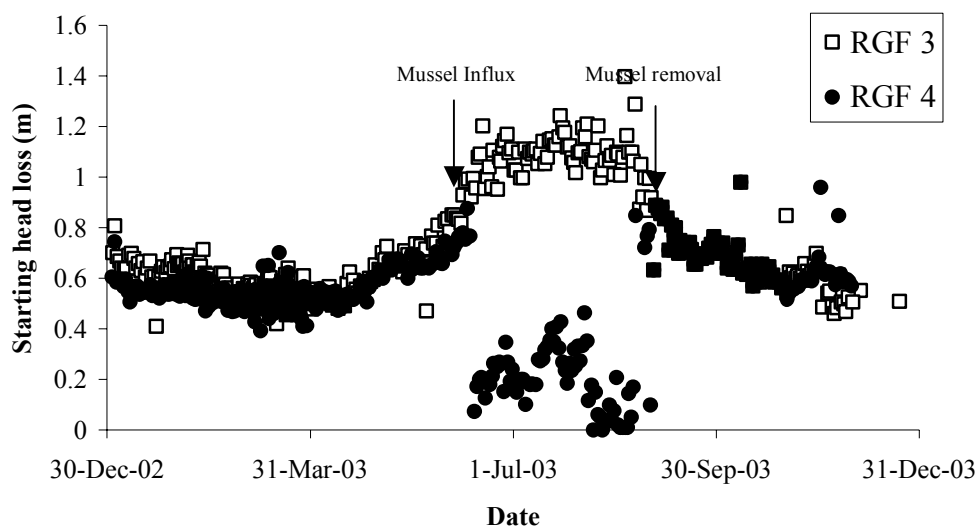
Figure 4.8 Starting head-loss in RGF 4 before, during and after an influx of zebra mussel shells. (Compared to an unaffected bed, RGF 3).

Secondly, the starting head-loss of another affected bed, RGF 4, was studied across 2004. Head loss is a measure of the loss in water pressure due to obstruction by the filter sand grains; *starting* head loss is an indication of the effectiveness of the filter immediately after it has been back-washed to remove algae. On-site head-loss gauges were used to monitor the starting head-loss in RGF 4, and RGF 3 (an unaffected bed) at daily intervals across 2004. The starting head losses of RGFs 3 and 4 were compared across July and August (during an influx), and across October and November (after mussel removal) using paired t-tests, with head losses matched for sampling times.

RGF 4 had a mean starting head loss of 51.5 ± 0.43 cm SE across March and April which dropped to a mean of 24.3 ± 2.6 cm SE during July and August after the zebra mussel influx (Figure 4.8). In contrast, the head loss in the unaffected RGF 3 rose from a mean starting head-loss of 53.7 ± 0.4 cm in March and April to a mean of 111 cm ± 1.1 cm SE in July and August. The starting head-loss of RGFs 3 and 4 differed significantly across July and August (Paired t test, $t = 29.59$, d.f.=109 $p < 0.001$). The shells were removed in early September, and by October and November RGFs 3 and 4 did not significantly differ in mean starting head loss (Paired t-test, $t = 1.47$, d.f.=112, $p = 0.147$).

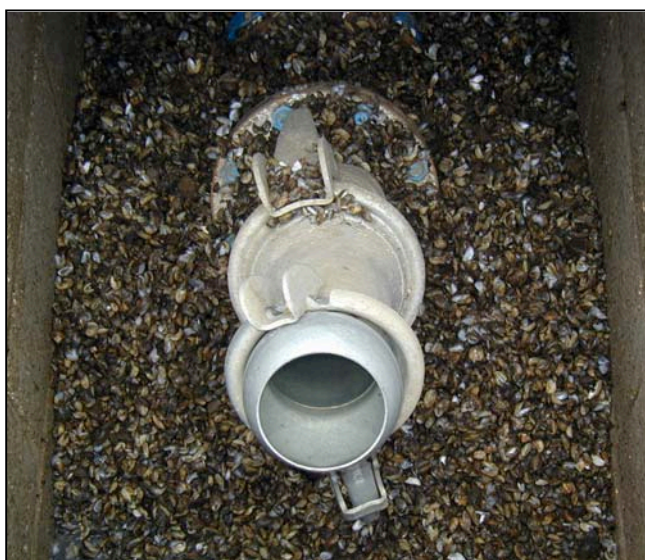
Figure 4.9 Mussels in the drainage chamber of an ozone tank at Walton-on-Thames WTW.

Similar problems were also noted at Veolia's Walton-on Thames WTW in South London. Large numbers of dead zebra mussels were found in the facility's ozonation chambers for the first time in 2001 (Lindsay Neal, Veolia Water, pers. comm.). The mussels were promptly removed by means of a drainage pipeline (Figure 4.9). Zebra mussels were being washed into the ozone chambers from large populations in the pipelines leading from the settlement reservoirs, as revealed by boroscopic imaging of these pipelines. The facility has implemented a £250,000 pre-chlorination strategy to clear these pipelines of zebra mussels.

Problems associated with ozone tank blockages have involved a reduction in the contact time of water, and the destruction of ozone diffusers due to the sheer weight of shells. The cleaning of ozone tanks is very problematic due to the hazardous nature of the disinfectant. Cleaners must wear full protective equipment, including breathing apparatus (Figure 4.10).

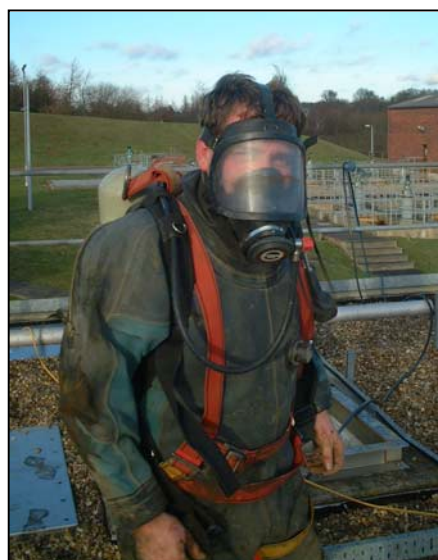
Figure 4.10 Protective equipment used to clean mussels from ozone tanks at Alton WTW, Suffolk.

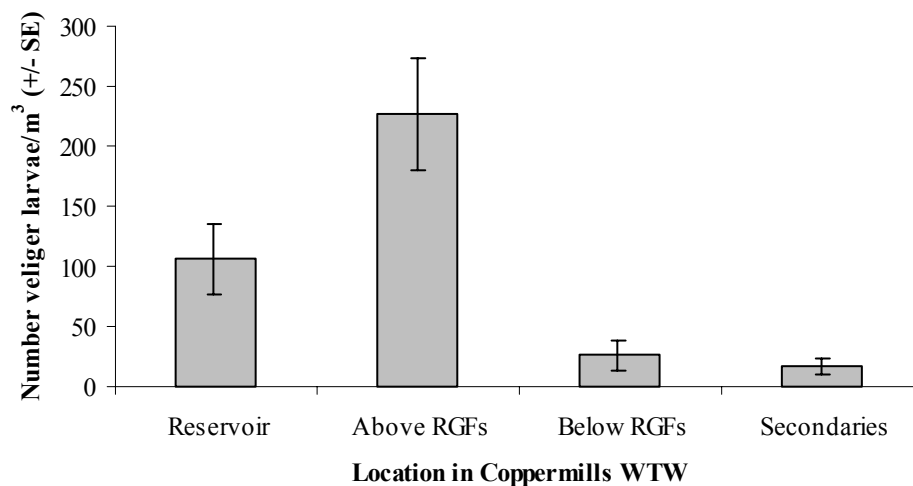
Figure 4.11 Numbers of zebra mussel larvae m⁻³ at different treatment stages in Coppermills WTW, North London in early July 2004.

At Coppermills waterworks larval densities increased from 105.9 ± 29.5 SE veligers.m⁻³ in the Warwick reservoir, to 227.1 ± 46.4 veligers m⁻³ above the rapid gravity filters. Veliger abundance dropped to 25.9 ± 12 SE veligers m⁻³ below the RGFs and then to 17.0 ± 6.2 SE veligers.m⁻³ in the secondary filter beds. The densities of veligers differed significantly between the 4 sample points (Kruskall-Wallis, $H=8.2$, d.f.=3, $p = 0.042$; Figure 4.11).

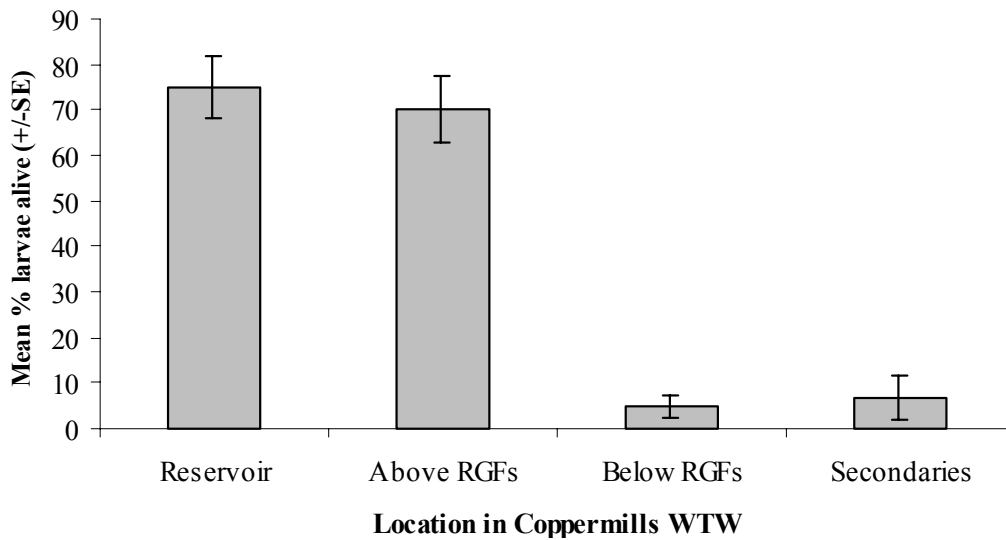
Figure 4.12 Percentages of zebra mussel larvae alive at different treatment stages in Coppermills WTW, North London in early July 2004.

The proportion of live zebra mussel larvae was significantly higher in the two sites above the primary filters than those below (Mann Whitney U, $U=45$, $n=12$, $p=0.0074$; Figure 4.12). Survivorship dropped from $70.0 \pm 7.2\%$ SE immediately above the RGFs to $4.9 \pm 2.5\%$ SE below them.

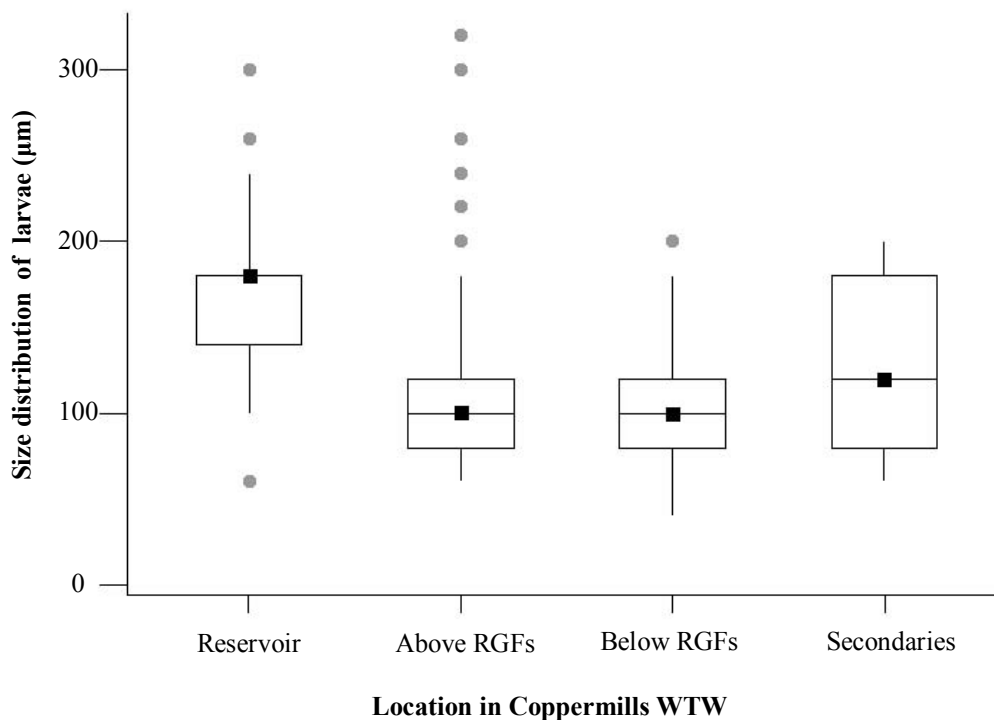
Figure 4.13 Size ranges of larvae at different treatment stages in Coppermills WTW.

■ = Median, Box = Inter-quartile range, ● = Outlier, Line = range of values.

The size distributions of larvae at Coppermills also differed significantly between the four sample points (Kruskall Wallis, $H=258.61$, d.f.=3, $p<0.001$; Figure 4.13). The larvae in the reservoir (median shell length $180\mu\text{m}$) were larger than those above and below the RGFs (median shell length $100\mu\text{m}$) and those in the secondaries (median shell length $120\mu\text{m}$).

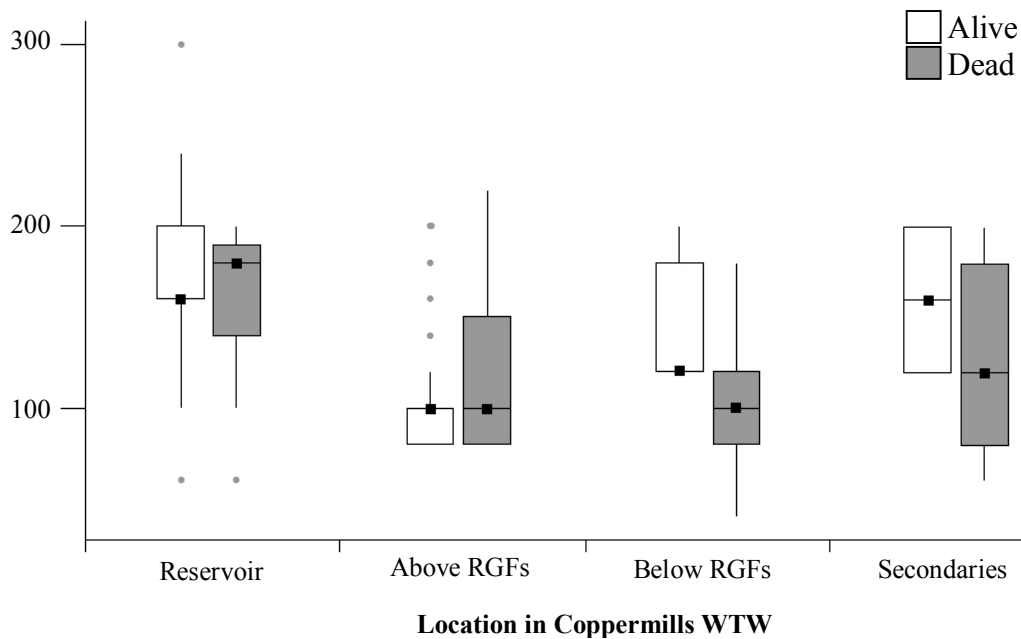
Figure 4.14 Size ranges of living and dead larvae at different treatment stages in Coppermills waterworks, North London. ■ = Median, Boxes = Inter-quartile range, ● = Outlier, Line = Range of values.

There was no significant difference between the sizes of the living and dead larvae in the reservoirs (Mann-Whitney, $U=3796$, $n=100$, $p=0.7321$; Figure 4.14), or the secondaries (Mann-Whitney $U=1204$, $n=50$, $p=0.3343$). However, above the RGFs dead larvae were significantly larger than live larvae (Mann Whitney $U=7328$, $n=150$ $p=0.0096$). Under the RGFs, dead larvae were significantly smaller than live larvae (Mann-Whitney $U=183.5$, $n=56$, $p=0.0228$). No on-going zebra mussel problems had been documented beyond the treatment points.

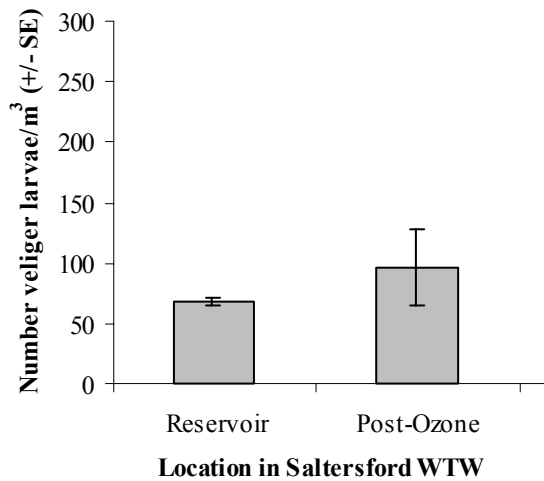
Figure 4.15 Numbers of veliger larvae m⁻³ at two sites in Saltersford WTW.

At Saltersford WTW, there was no significant difference in the numbers of larvae in the reservoir and below the ozonation and ferric dosing (Mann-Whitney U , $U=17431$, $n=6$, $p>0.05$; Figure 4.15). However, there were more larvae alive in the reservoir than after ozonation and flocculation (t-test on arcsine transformed data, $t=7.15$, $d.f.=3$, $p=0.006$; Figure 4.16). Survivorship dropped from $75 \pm 5\%$ SE before ozonation and ferric dosing to $28 \pm 6\%$ SE afterwards.

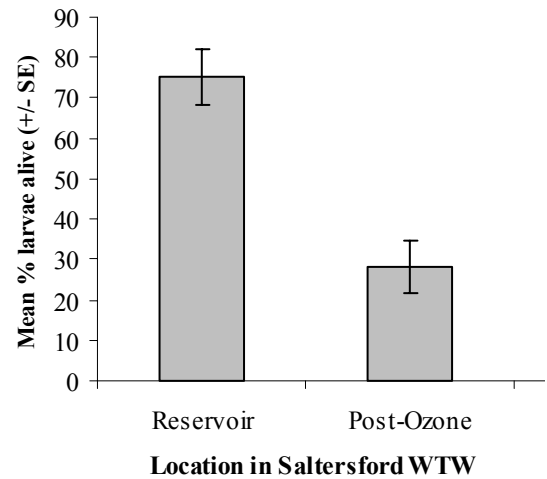
Figure 4.16 Percentages of veliger larvae alive at two sites in Saltersford WTW.

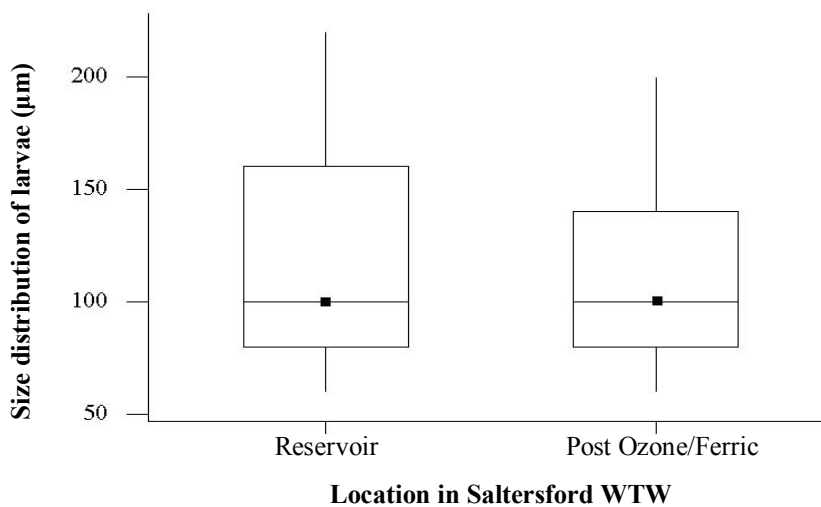
Figure 4.17 Size ranges of larvae at different treatment stages in Saltersford WTW.

■ = Median, Boxes = Inter-quartile range, ● = Outlier, Line = Range of values

There were no significant differences in the sizes of larvae before and after the treatments at Saltersford (Mann Whitney $U=22788.5$, $n=262$, $p=0.0573$; Figure 4.17). There was a significant difference between the sizes of living and dead larvae in the reservoir (Mann Whitney, $U=3407.5$, $n=100$, $p=0.0022$, Figure 4.18). However, there was no difference in the sizes of living and dead larvae below the ozone/ferric dosing (Mann Whitney $U=2902$, $n=150$, $p=0.4037$, Figure 4.18). No zebra mussel problems have been documented below the dosing points.

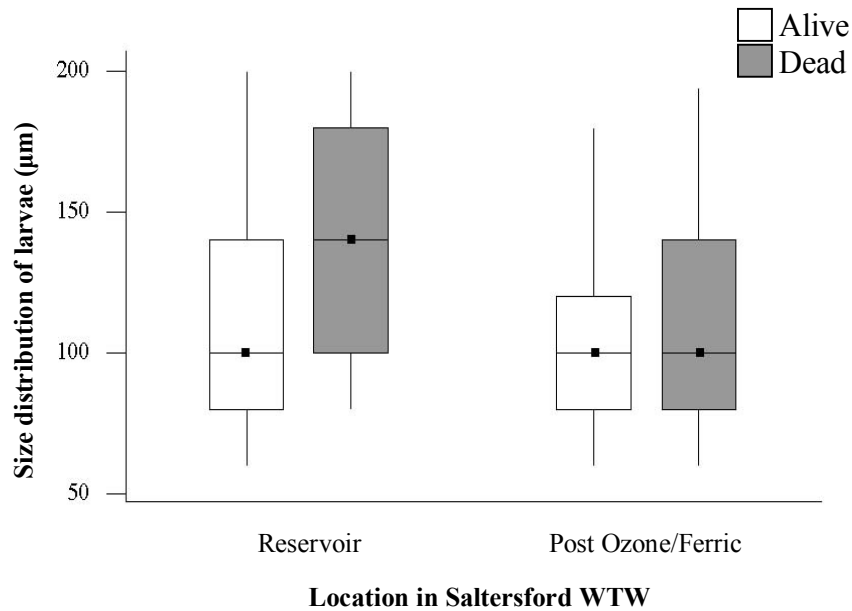
Figure 4.18 Size ranges of living and dead larvae at different treatment stages in Saltersford WTW. ■ = Median, Boxes = Inter-quartile range, ● = Outlier, Line = Range of values

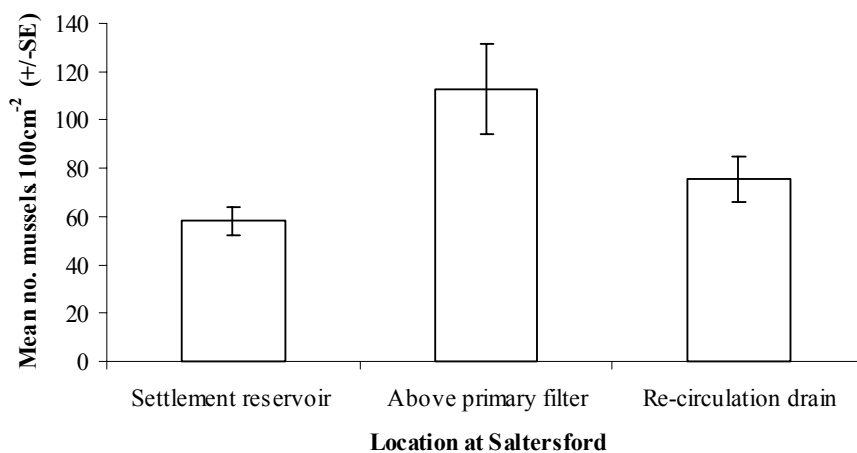
Figure 4.19 Densities of zebra mussels infesting different treatment stages at Walton-on-Thames WTW.

The densities of mussels in each of the sampling locations at Walton-on-Thames facility did not significantly differ from each other (Kruskall-Wallis, $H = 5.40$, d.f.=2, $p = 0.067$; Figure 4.19). However, the size distributions of zebra mussels throughout the works did significantly differ ((Kruskall-Wallis, $H = 377.4$, d.f.= 2, $p < 0.001$); Figure 4.20), the mussels in the primary filter (immediately after ozonation) being significantly smaller than those elsewhere.
