Accident Investigation of a Crush Zone Incident – Tool Box Talk

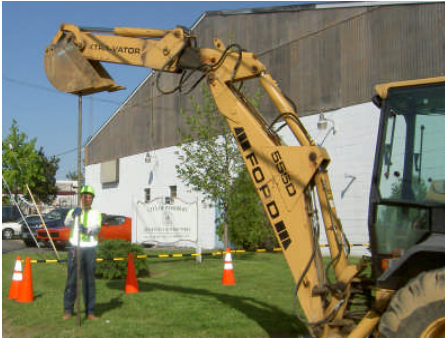
It is the practice of several Public Works to use a backhoe or front end loader to drive posts into the ground. The process has one worker hold the post plumb under the raised bucket of the machine (see above photo). Several agencies investigated the incident. The following are several 'facts' that were discovered.

- The machine was driven by the crew to the site without incident. Once at the site, the old post was pulled from the ground with the bucket. It was reported that no one noticed anything unusual with the bucket. The bucket was then used to push the new sign post in the ground. The first push was made without incident. The pole was repositioned for the final push. As the push was begun the bucket detached and fell on the worker under the bucket, in the Crush Zone.

- The mounting brackets on both the bucket and boom were intact. The connecting pins were intact.
- The operator did not visually confirm that the pins and brackets were locked in place. The driver did not leave the seat.

- ☐ Having a departmental procedure that allowed for using the front-end loader for this purpose
- ☐ Having an inexperienced worker attaching the bucket
- ☐ After attaching bucket, not checking connection as per manufacturer instructions (only "shaken" to verify attachment).
- ☐ No visual confirmation of pin placement in the brackets
- ☐ Operator relying on dash indicating light, (commonly called idiot light)
- ☐ The experienced worker using the machine for a purpose that it was not intended for
- ☐ Having an inexperienced worker positioned within the Crush Zone
- ☐ Miscommunication (or lack of communication) between worker attaching the bucket and the crew using the machine, especially of the difficulty experienced in making switch
